**Region 2 Barrier ID: W097 (Barrier).**

**Barrier Name:** SR-70 West Branch Bridge.

**Linear Infrastructure:** SR-70.

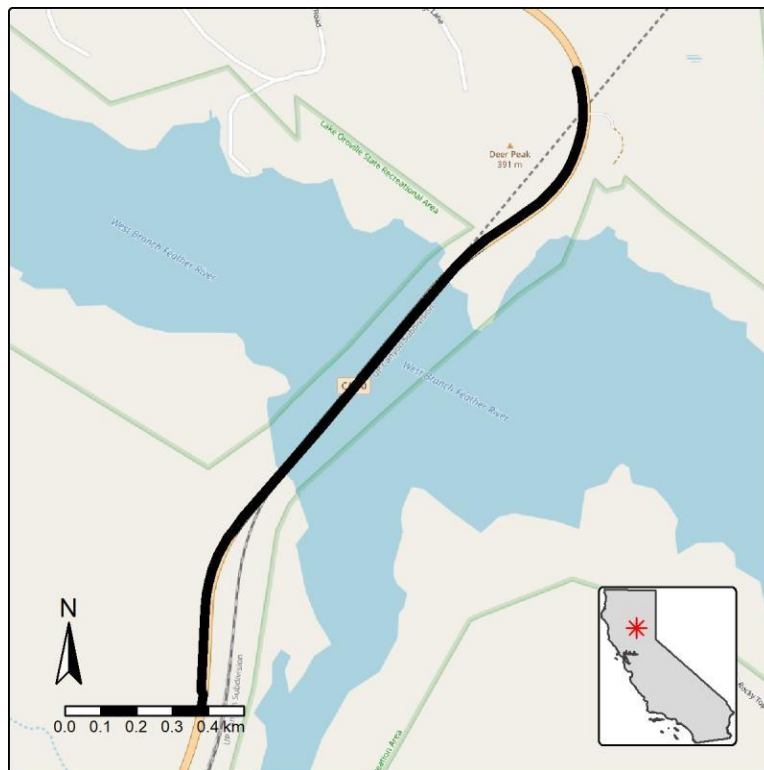
**Figure:** SR-70 at the West Branch Bridge is a Region 2 wildlife connectivity barrier.
