California Department of Fish and Wildlife
Environmental Enhancement Fund (EEF) Grant Program
Final Progress Report
The Little River State Beach Nearshore Dune Habitat Restoration and Coastal Resilience Project

Date: April 1, 2025

Agreement No.: Q2275069

Project Title: Little River State Beach
Nearshore Dune Habitat Restoration and
Coastal Resilience Project

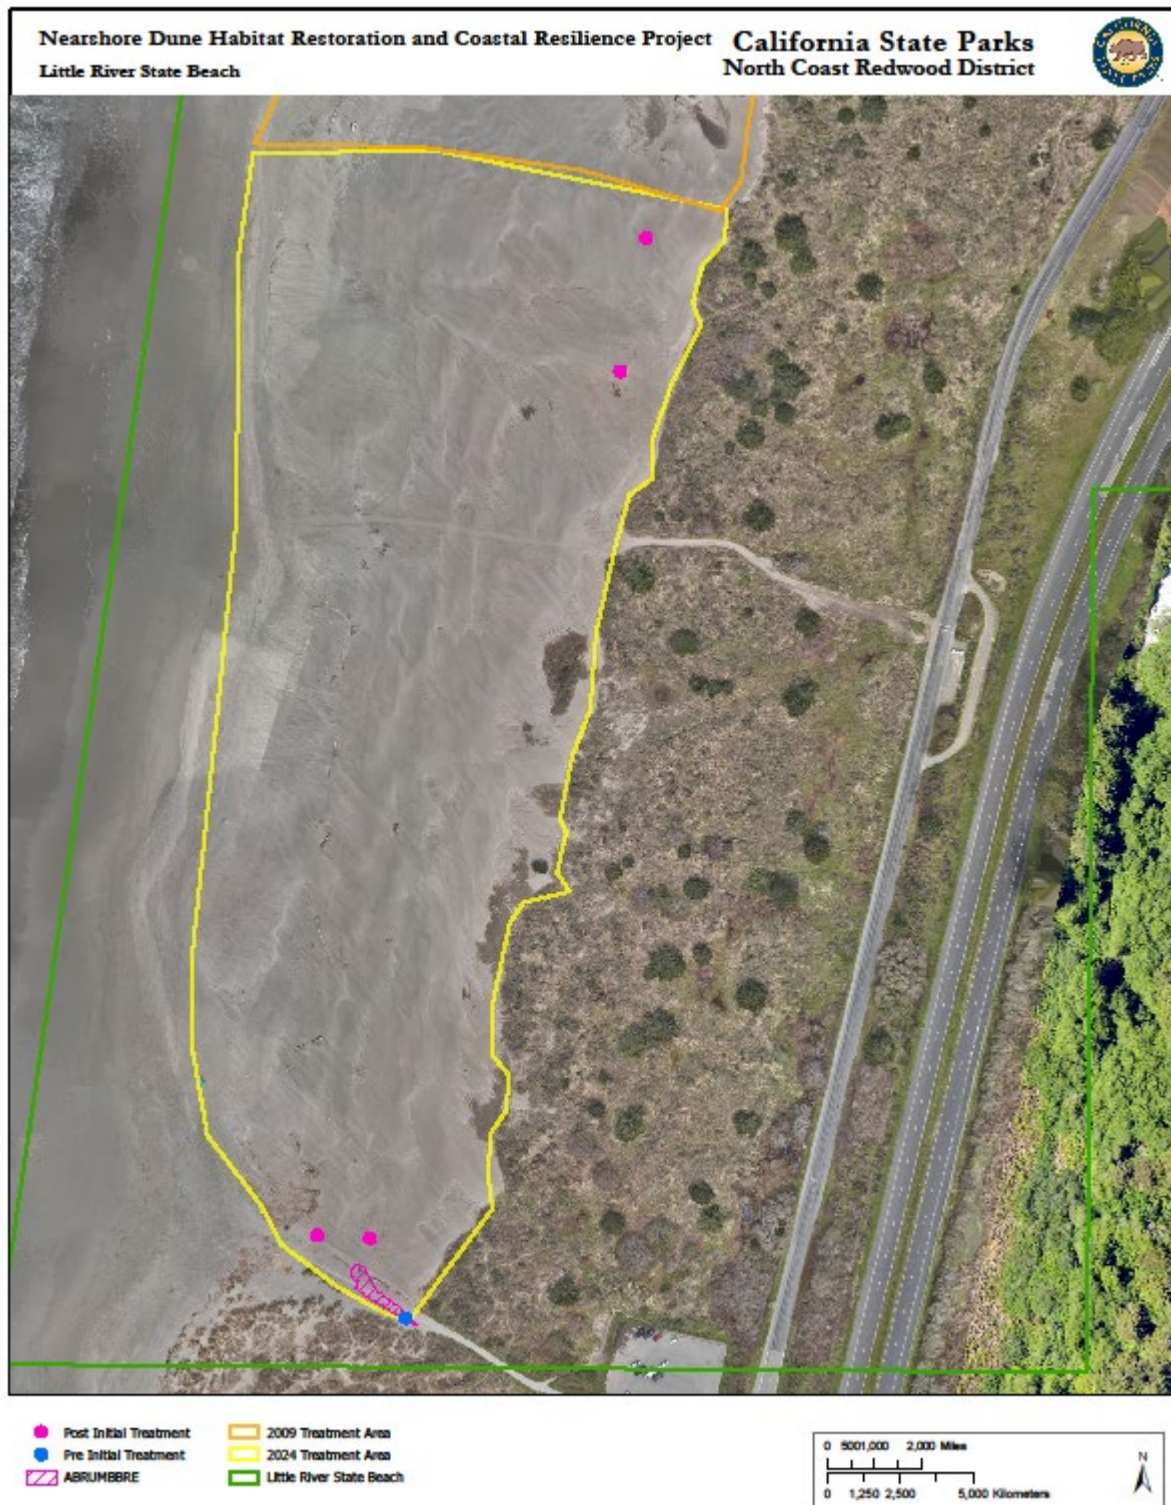
Figure 3. Pink sand verbena locations before and after initial treatment in the Little River State Beach Nearshore Dune Habitat Restoration and Coastal Resilience Project area.

- In December 2024, the project area was surveyed for sensitive plant species and there were 25 pink sand verbena plants found in four locations (2 previously locations and 3 new locations) (Figure 3).

This project has already shown an increase in sensitive native dune mat vegetation. One special status plant species, pink sand verbena, was found with a total of twelve plants in two locations in the project area prior to initial treatment (Figure 4). In December 2024, the project area was surveyed and there were 25 pink sand verbena plants found in five locations (2 previously locations and 3 new locations) in the 22-acre project area. Recent surveys have documented multiple native dune mat species establishing in the project area and over 90% of the American dune grass transplants have survived for over 1 year. Evidence of Western snowy plovers in the project area have been documented along with other wildlife. In addition, there has been an increase of sand movement in the northern part of the project area.

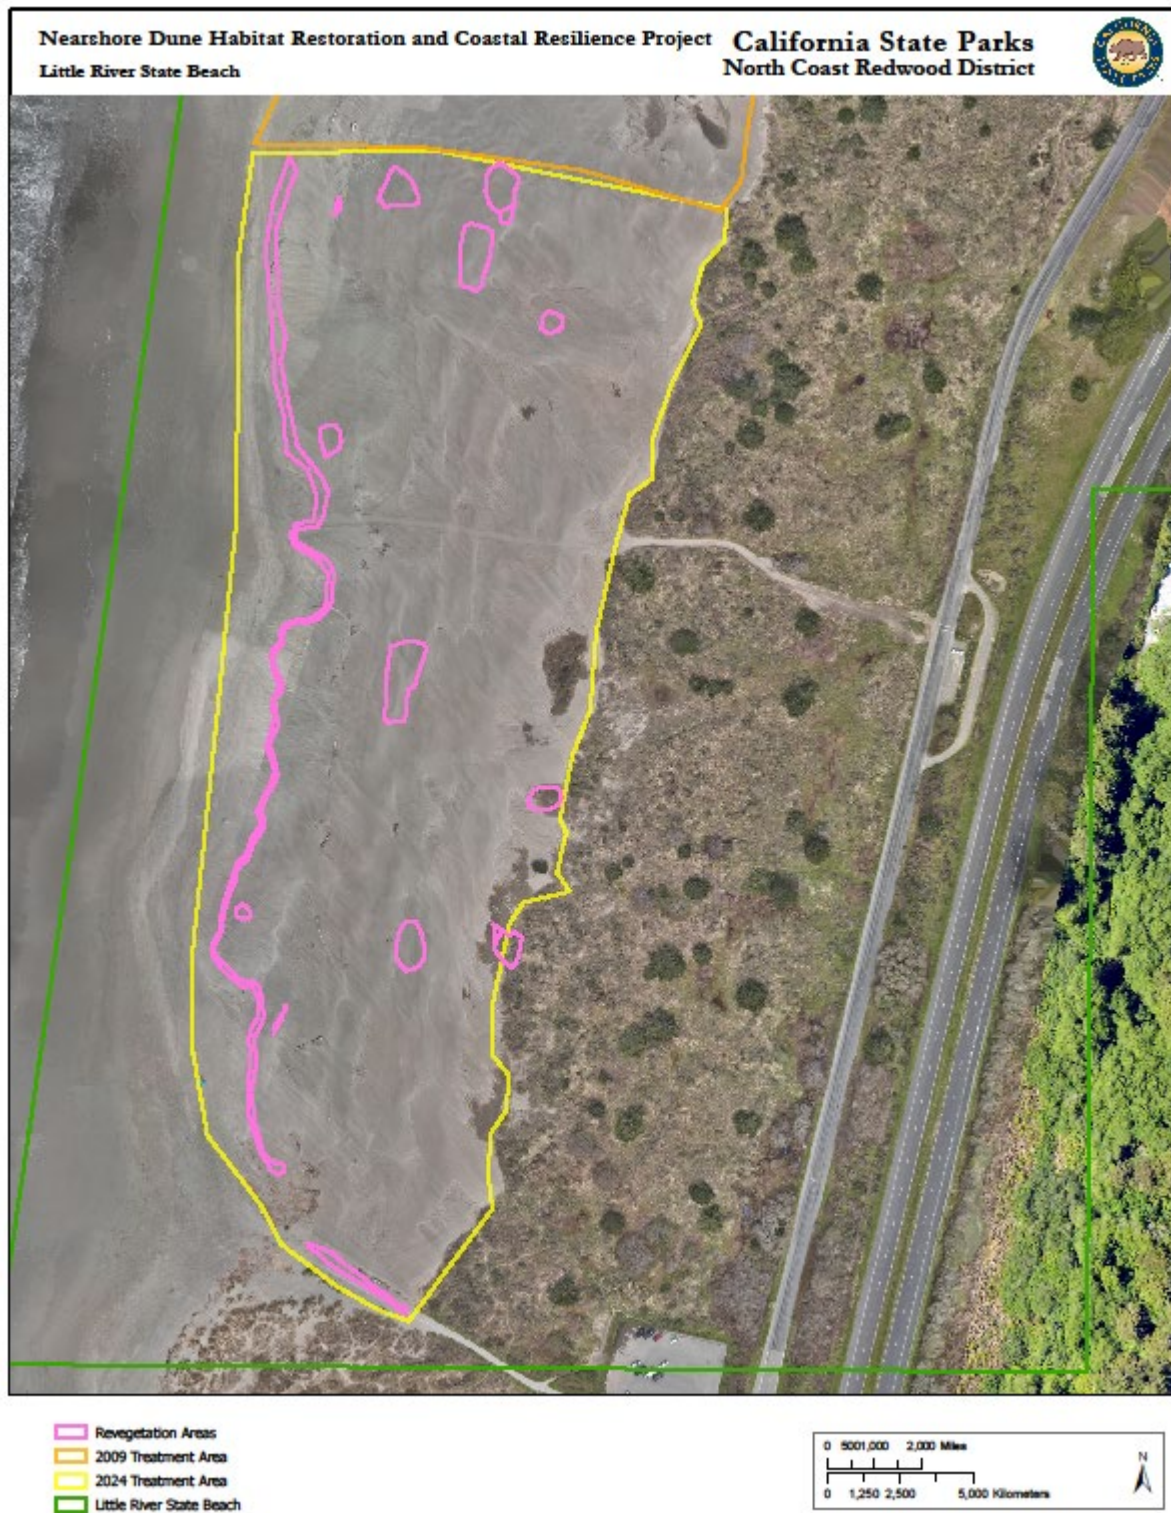
Figure 4. Seed broadcast and transplanting areas in 2024 and 2025 in the Little River State Beach Nearshore Dune Habitat Restoration and Coastal Resilience Project area.

- In January and February 2024, initial treatment of European beachgrass (*Ammophila arenaria*) using heavy equipment was conducted.
- In March 2024, 1,686 ounces of native dune mat seeds and approximately 94 ounces of native dune swale seeds were broadcasted in multiple locations in the project area and 240 American dune grass (*Leymus mollis*) plants were transplanted into the foredune of the project area (Figure 4).

- Retreatment of invasive non-native species, primarily European beachgrass occurred between July 2024 and February 2025.
- In February 2025, 973 plugs of native dune mat species were planted in the project area (Table 2, Figure 4).

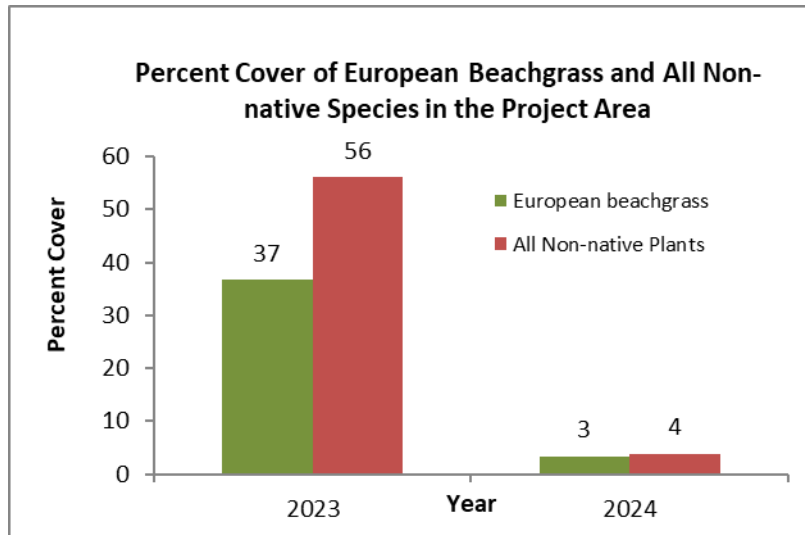
Figure 5. Percent cover of European beachgrass and total non-native species cover before and after initial treatment of the nearshore dunes in the project area at Little River State Beach.

Vegetation monitoring of upland dune habitat was conducted in five macroplots pre initial treatment, in September 2023 and six months after, in August 2025 following the Little River State Beach Restoration Monitoring Plan. Prior to initial treatment there was an average of 37% cover of European beachgrass and an average total cover of 56% of non-native plant species across all macroplots (Figure 5). After initial treatment European beachgrass cover was reduced to an average of just under 3% and total non-native plant species cover was reduced to just under 4% (Figure 5).

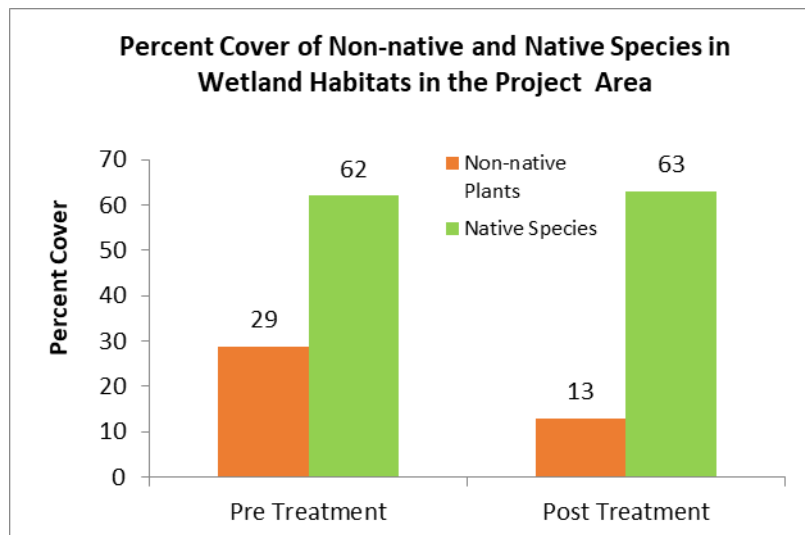
Figure 6. Percent cover all non-native and native plant cover before and after initial treatment of the wetland in the project areas at Little River State Beach.

In the dune swale wetland, hand removal methods were used to treat the invasive non-native species in and within 15 feet of the wetland edge. Vegetation sampling of the wetland was conducted in five 1m² quadrats pre initial treatment in April 2024 and three months after initial treatment in July 2024. Prior to initial treatment, there was a 29% cover of non-native plant species (Figure 6). After initial treatment non-native plant species cover was reduced to 13% (Figure 6). Total native plant cover stayed approximately the same between pre and post initial treatment (62% and 63%) (Figure 6).

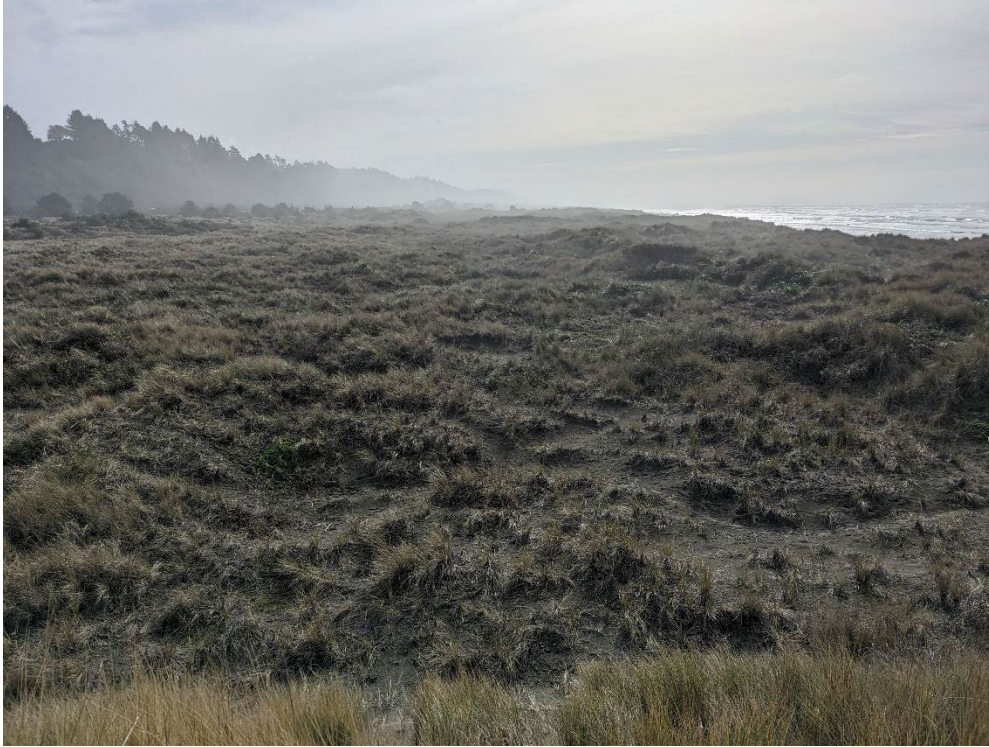
Photo 1. Photo point 4, facing south, Little River State Beach Nearshore Dune Habitat Restoration and Coastal Resilience Project prior to heavy equipment treatment in 2023.

- In December 2023, pre-treatment photo monitoring was conducted. Twenty-five photo monitoring points were established and a GPS point was recorded for each point (Photos 1, 3, 5, and 7).

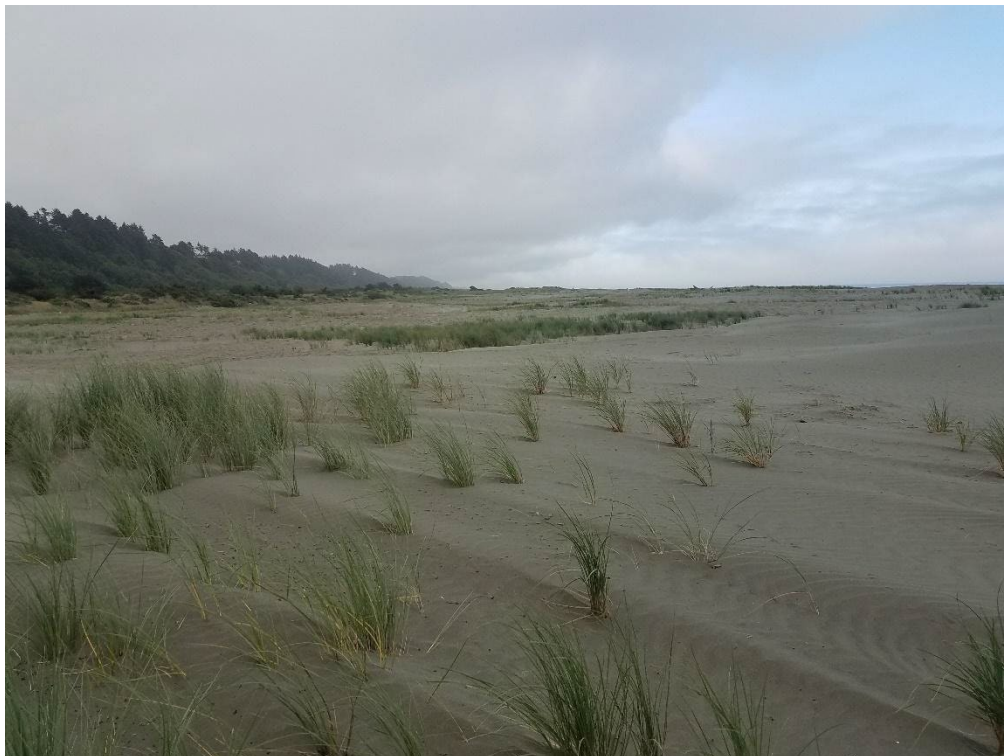
Photo 2. Photo point 4, facing south, LRSB Nearshore Dune Habitat Restoration and Coastal Resilience Project 5 months after heavy equipment treatment in 2024.

- Post initial treatment vegetation monitoring occurred in June 2024.
- In August 2024, 5 months after initial treatment, post-treatment photos were taken from the 25 previously established photo points (Photos 2, 4, 6, and 8).

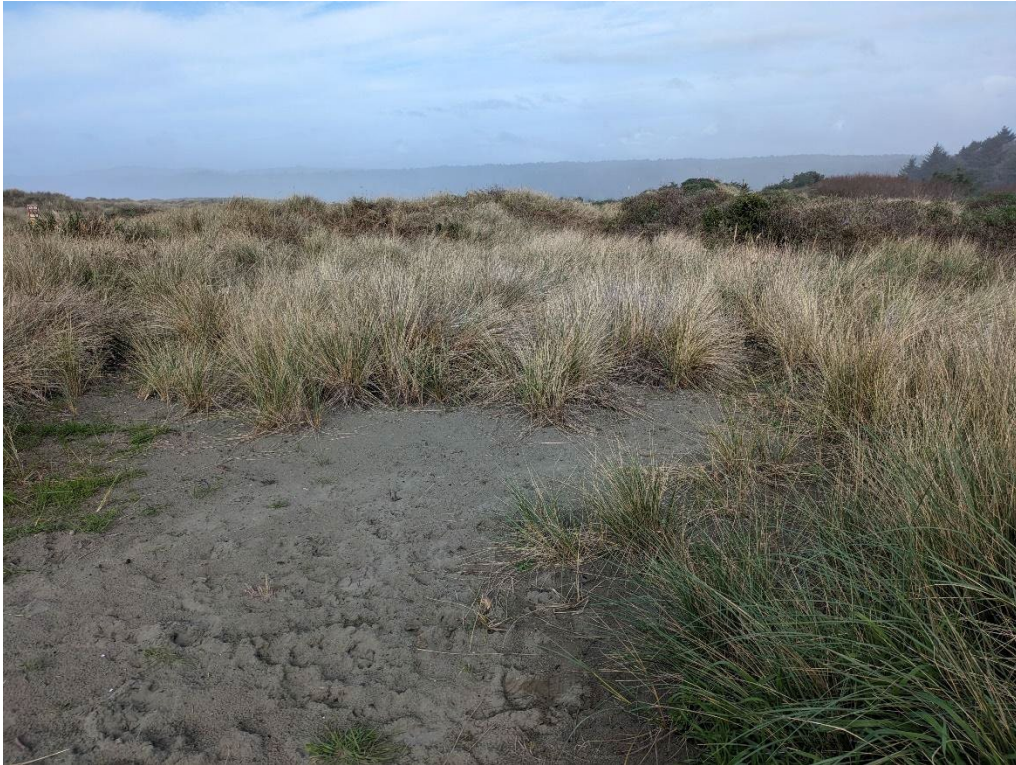
Photo 3. Photo point 17, facing north, Little River State Beach Nearshore Dune Habitat Restoration and Coastal Resilience Project prior to heavy equipment treatment in 2023.

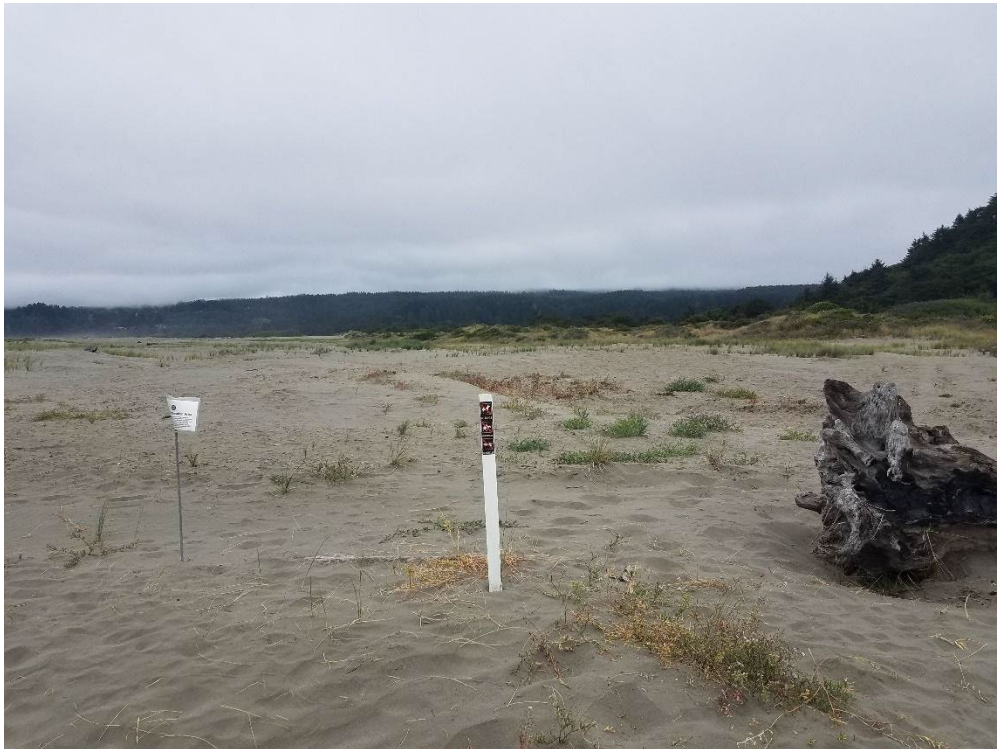
Photo 4. Photo point 17, facing north, LRSB Nearshore Dune Habitat Restoration and Coastal Resilience Project 5 months after heavy equipment treatment in 2024..

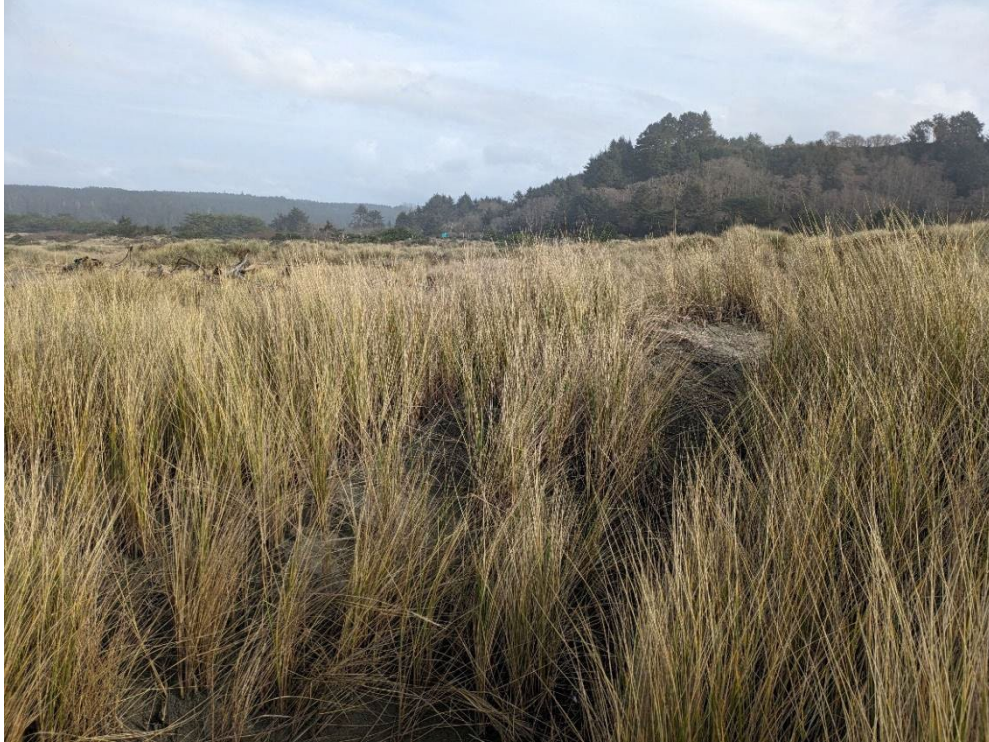
Photo 5. Monitoring photo point 1, Little River State Beach Nearshore Dune Habitat Restoration and Coastal Resilience Project prior to heavy equipment treatment in 2023.

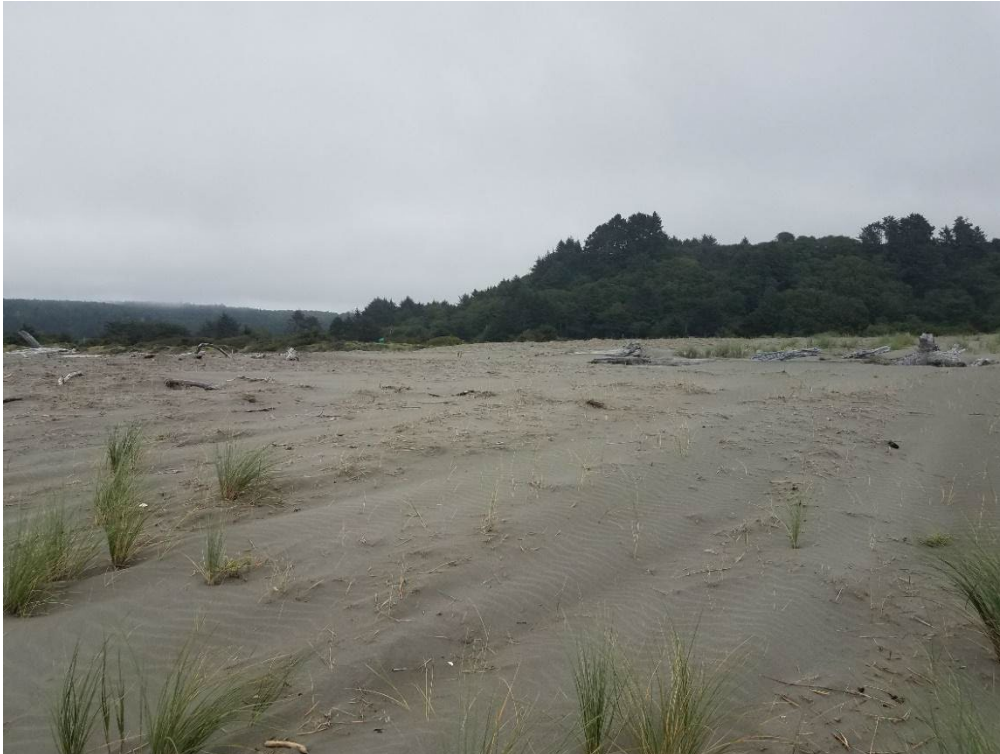
Photo 6. Monitoring photo point 1, LRSB Nearshore Dune Habitat Restoration and Coastal Resilience Project 5 months after heavy equipment treatment in 2024.

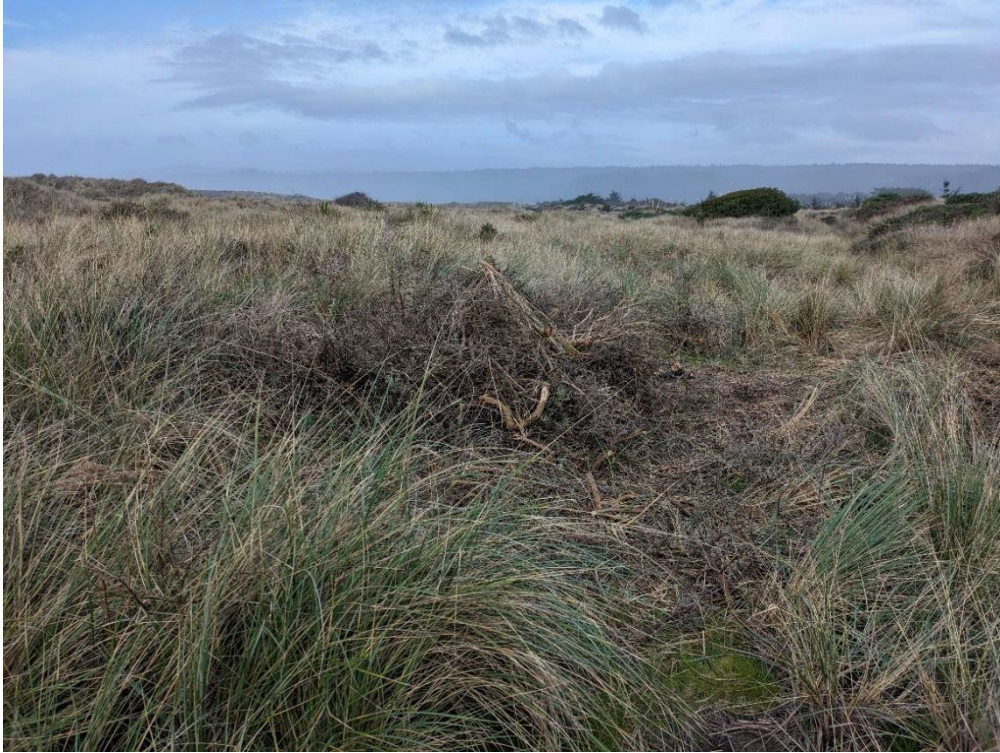
Photo 7. Monitoring photo point 2, LRSB Nearshore Dune Habitat Restoration and Coastal Resilience Project prior to heavy equipment treatment in 2023.

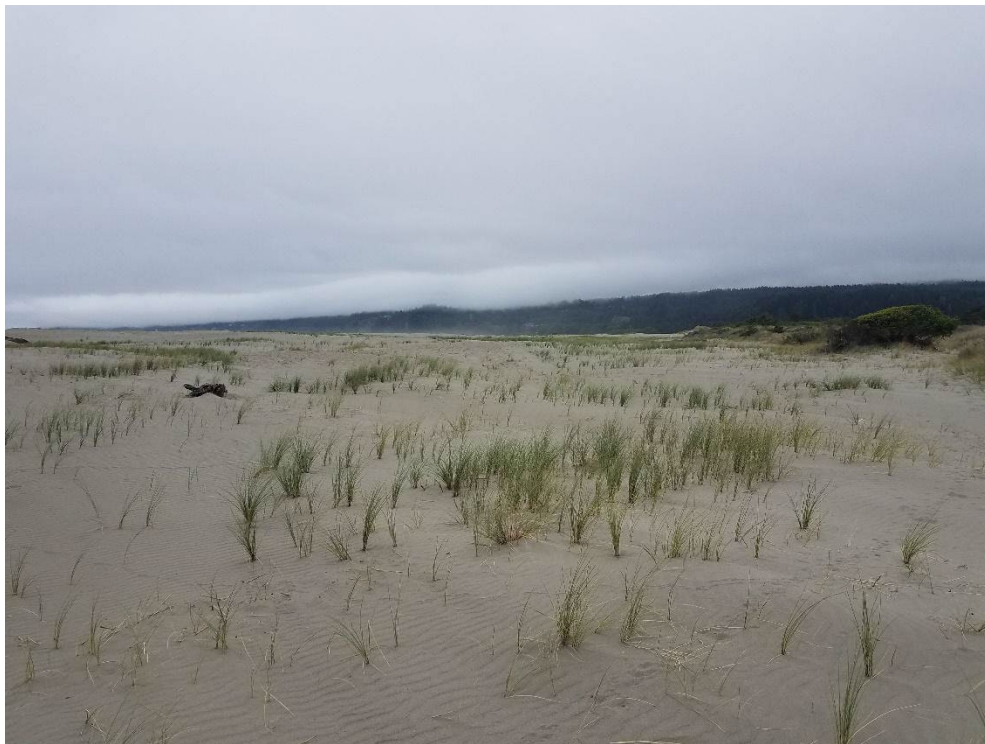
Photo 8. Monitoring photo point 2, LRSB Nearshore Dune Habitat Restoration and Coastal Resilience Project 5 months after heavy equipment treatment in 2024.
