Rapid Response and Eradication Plan for the Invasive Green Alga *Caulerpa prolifera* in San Diego Bay

Southern California *Caulerpa* Action Team

September 2023¹

Adaptive Management Memorandum #1 (November 2023)

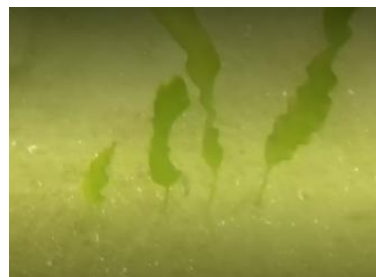
Photo 1. *C. prolifera* blades growing along a rhizome at Antigua Village.

The *C. prolifera* occurrence varies from a dense central portion to a low-density perimeter with rhizomes that appear to be growing outward in an expansive manner. No eelgrass or other submerged aquatic vegetation was observed growing within or immediately adjacent to the *C. prolifera* patch. However, minor amounts of eelgrass were observed nearby in other portions of the Antigua Village survey area.

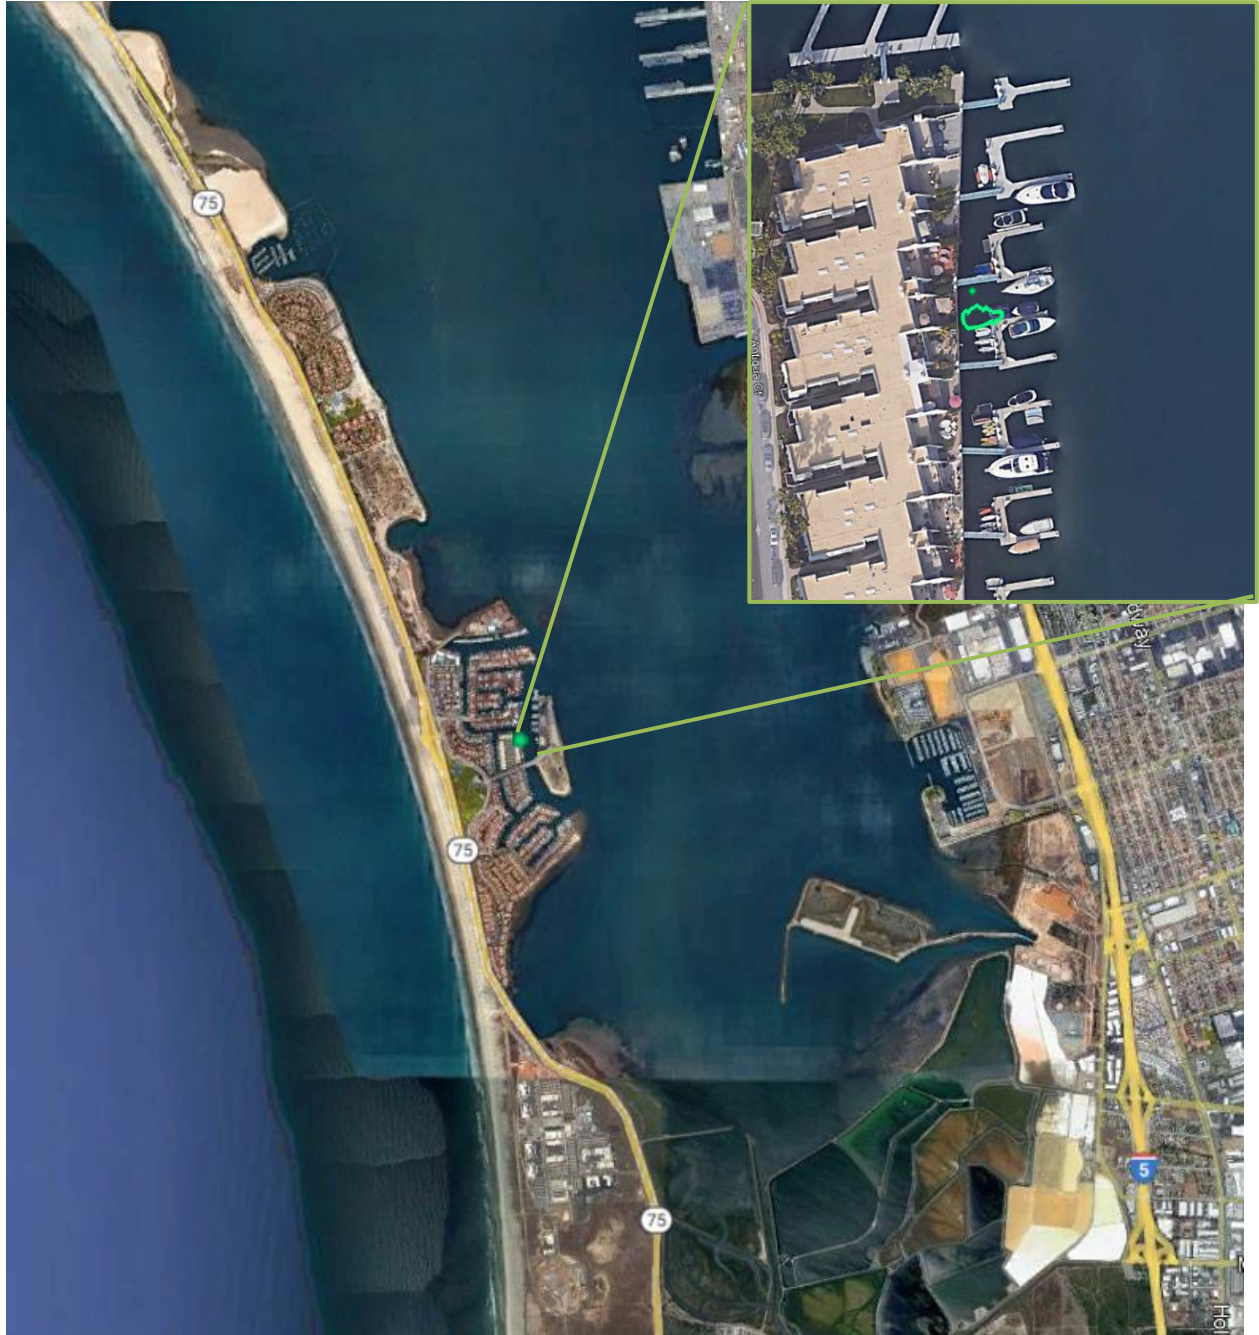
Figure 1. Distribution of *Caulerpa prolifera* at Antigua Village in the Coronado Cays (known as of 9/27/23). Inset shows the specific location (green polygon and green point.)

At the time of the discovery in Antigua Village in San Diego Bay, the dive team mapped the portion of the seabed where *Caulerpa prolifera* was identified (MTS 2023). The team mapped a primary bed area of 22.5 square meters and a satellite patch that consisted of three fronds and covered an area less than 0.1 square meter (Figure 1).

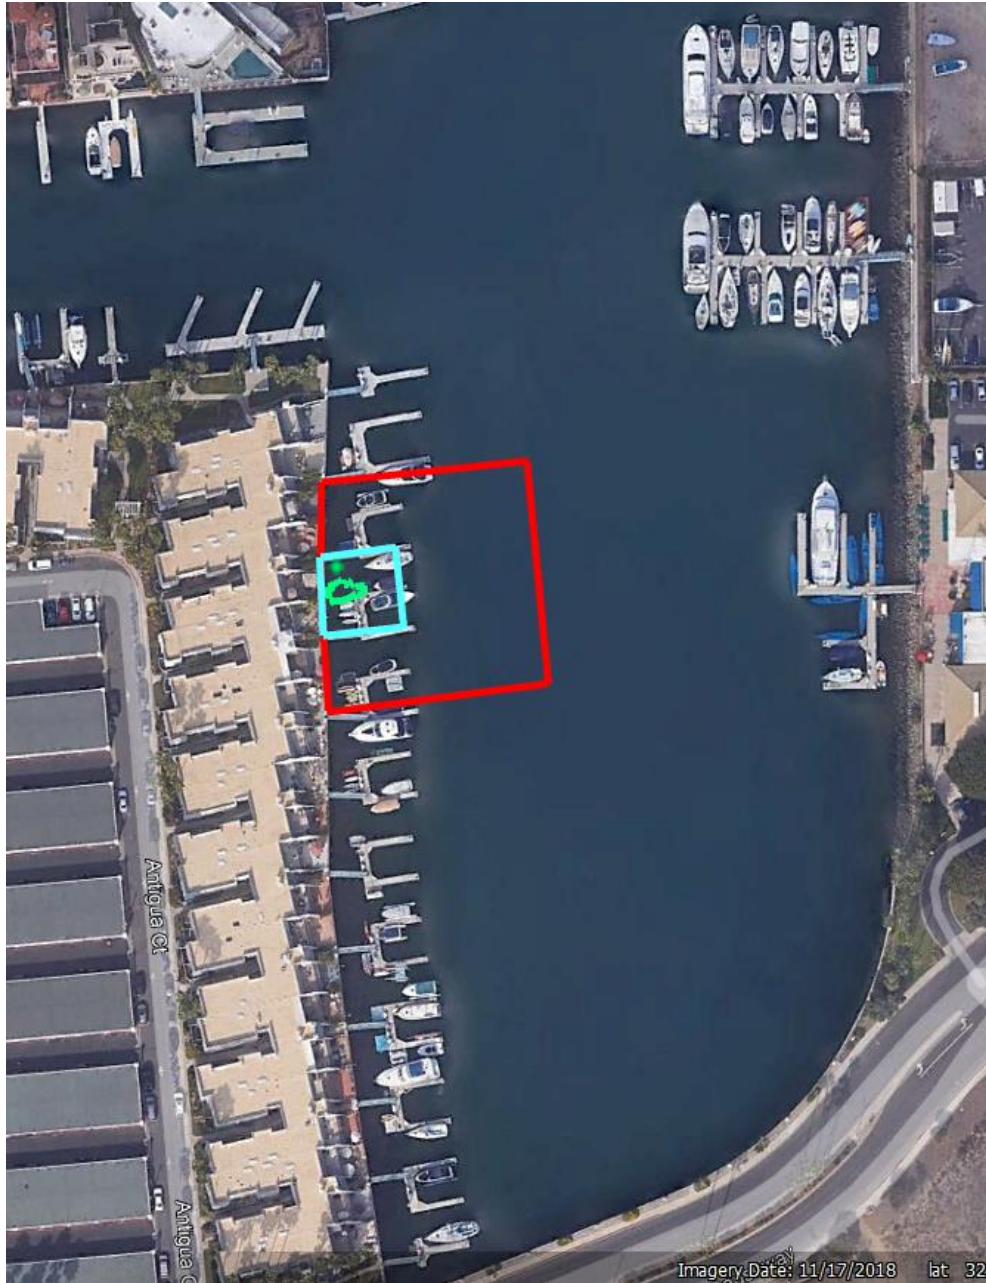
Figure 2. Distribution of *C. prolifera* (green) with the area designated as the infestation area (red) for the purpose of focused surveys and the area designated to receive barrier (treatment area; blue) at Antigua Village in the Coronado Cays, San Diego Bay.

proposed means to isolate and eliminate the currently known *C. prolifera*. Two divers will first systematically survey the area depicted in red (infestation area) (Figure 2). Any loose fragments of *C. prolifera* will be picked up by hand and placed in a fine mesh bag (pore size less than 1 mm) and brought to the surface for disposal. Once the infestation area survey is complete, divers will place benthic barriers over the currently known patches of *C. prolifera*.

The barriers will be placed over an approximately 17 x 17-meter treatment area. This will require approximately 9 benthic barriers. Each benthic barrier measures 6 x 7.6 meters. Barriers will overlap 0.6 meter along the long sides and approximately 1 meter on the short ends. Barriers will be secured to the bottom with rebar pins and sandbags. Barriers will be composed of pond liner material consisting of between 20 and 40 mil HDPE or EPDM or similar.

Dive teams will begin with individual barriers that are rolled up. The rolled-up barriers will be gently placed at the toe of the seawall. The corners will be pinned to the seabed and the barriers will be slowly unrolled to minimize water movement that could dislodge any *C. prolifera*. As the barriers are unrolled, rebar pins will be placed along the margin every 1.5 meters. Once all barriers are unrolled and pinned to the bottom, bins of sandbags will be lowered to the bottom and placed on top of the barriers. Divers will then move the sandbags to seal the perimeter of the barrier complex. Sandbags will be placed continuously along all seams and the entire perimeter. Additional sandbags will be placed in the middle of each barrier to further secure the barriers to the seafloor.

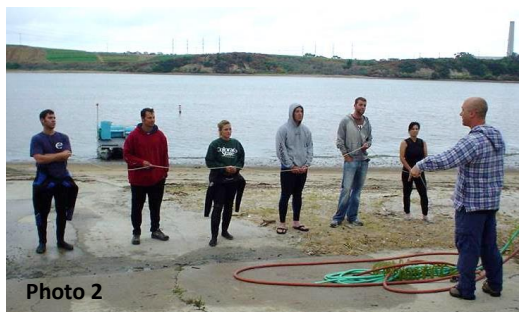
Photo 2

Photo 2. Divers spaced by a section of knotted rope during training on signals and procedures used during the survey. Photo 3. A team of divers aligning themselves at the surface and preparing to swim a laid transect.

knot tied at each diver's position will be created to assist divers in maintaining spacing during the survey. A diver spacing of no more than 1.5 meters is recommended. Thus if 4 divers are utilized, the diver rope would be 6 meters long. The lead diver will then follow the transect line approximately 0.75 meters to its side. Each subsequent diver will keep pace with the lead diver but follow slightly behind on their transect side. This arrangement prevents the team from circling inward toward the transect line. At the end of the transect, the lead diver tugs the line to indicate that the team should pivot 180 degrees around the lead diver and then proceed along the opposite side of the transect line toward the start point. The water clarity and habitat complexity (e.g., bare bottom, eelgrass cover) dictates the speed and spacing of the survey team. All divers will be qualified and trained in *Caulerpa* and native species identification.

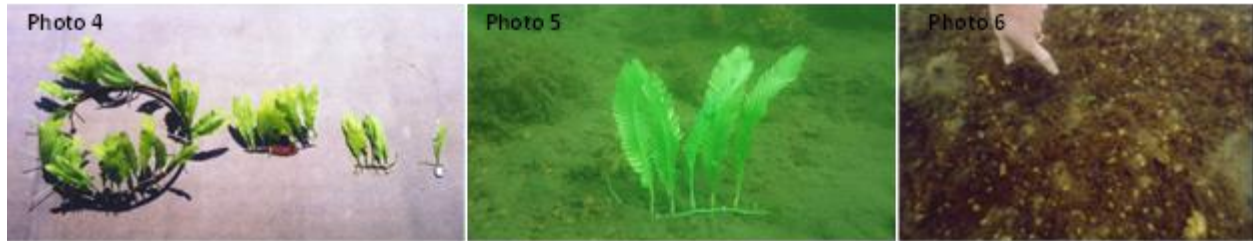
Photos 4 & 5. Artificial *Caulerpa* placed to quantitatively assess the confidence level for each survey, key to calculation of Eradication Certainty. Photo 6. Viable fragments of real *Caulerpa* as small as several millimeters (right) can be easily missed by divers.

The second criterion is evaluated by quantifying the confidence in the post-removal surveillance efforts. Patches of artificial *C. prolifera* are placed within the site during the regular diver surveys. Confidence in the results of each survey for live *C. prolifera* can then be quantitatively estimated based on the amount of artificial *C. prolifera* found during the surveys (Merkel & Associates 2005). The results of these consecutive assessments of the surveys ultimately allow for an estimation of the Eradication Certainty: the certainty that all real *C. prolifera* existing at the treated site had been found and that eradication had been achieved.

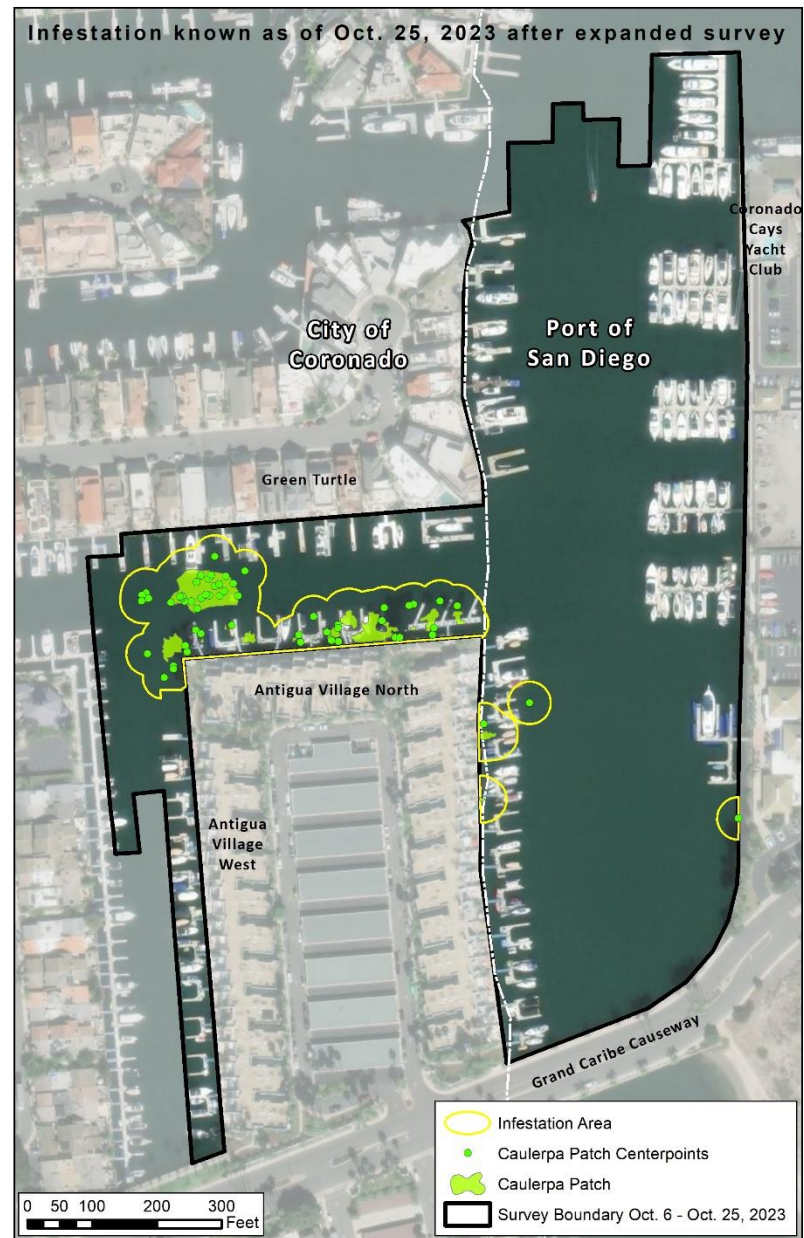
Figure 2. The known *Caulerpa* infestation site after the initial survey on September 21, 2023 (left) and the expanded *Caulerpa* infestation site following surveys performed between October 6 and October 24, 2023.

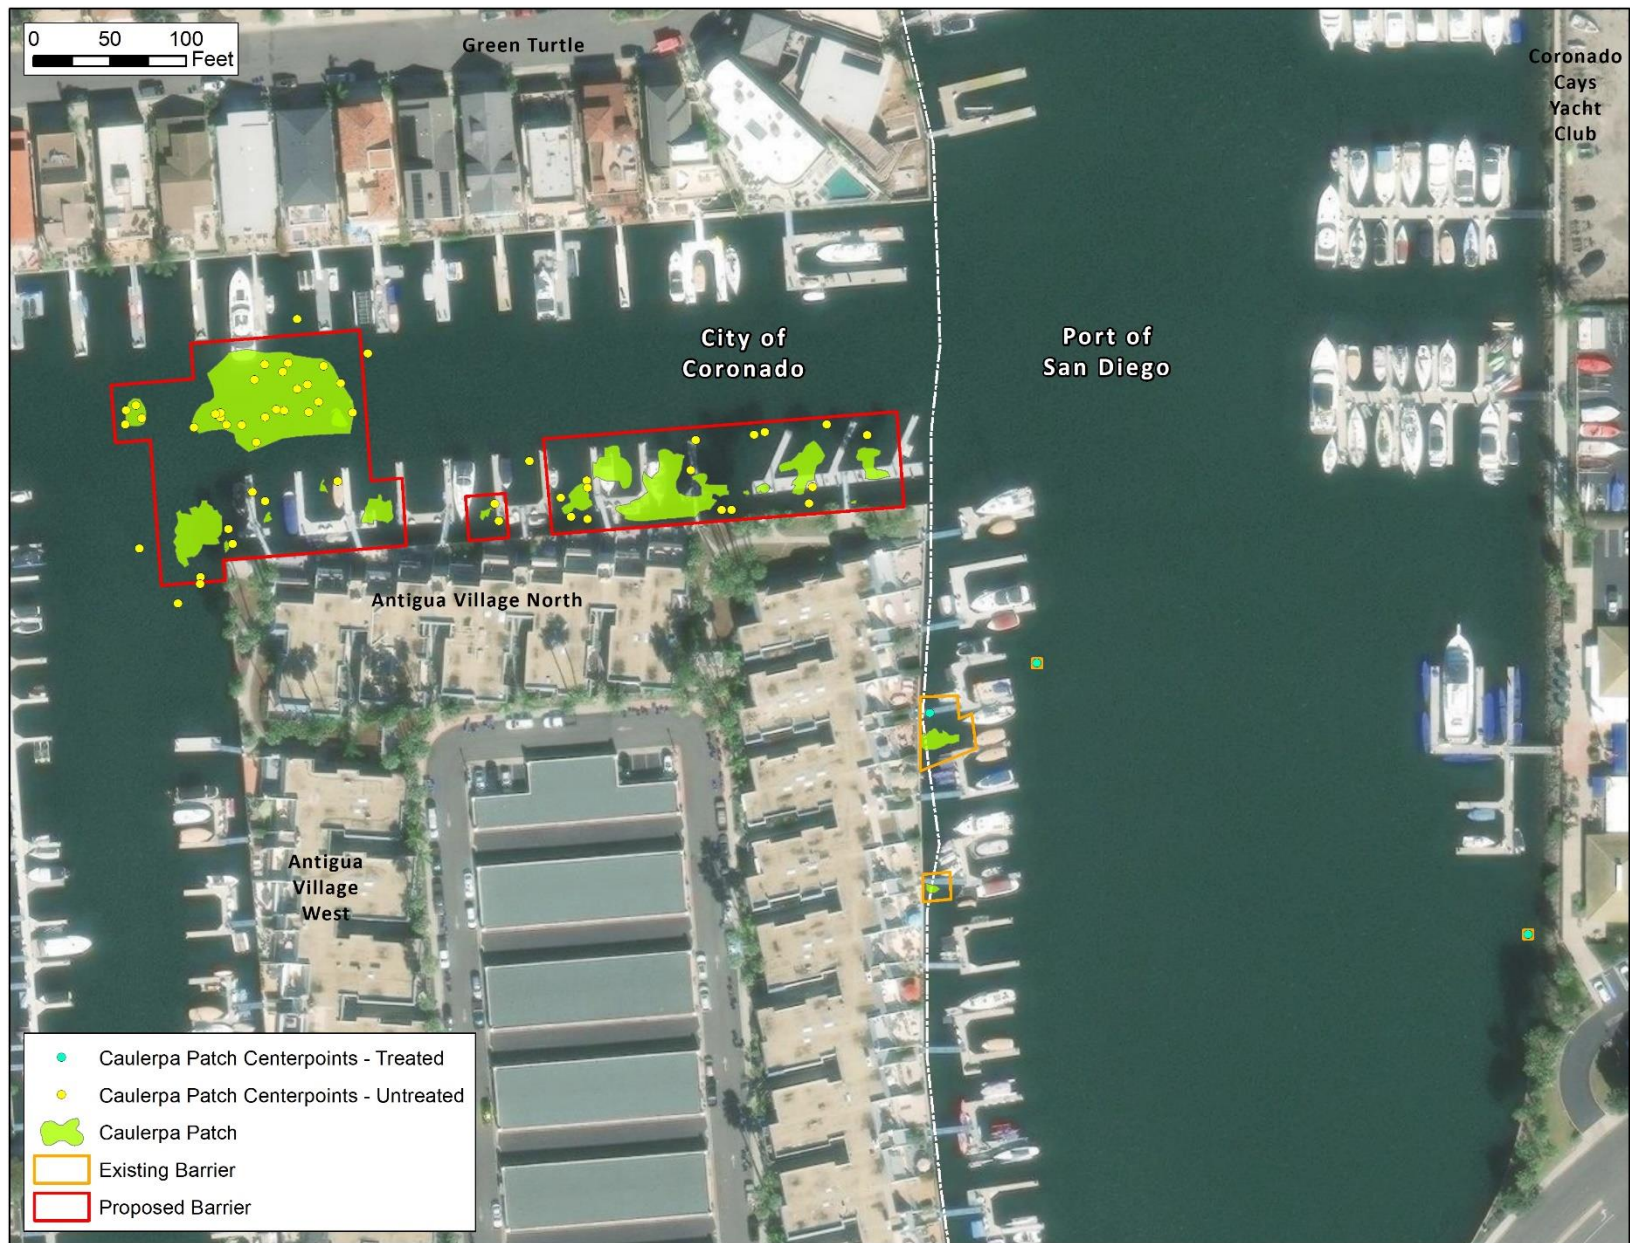
Figure 1. The above figure shows a potential barrier arrangement that covers all of the larger *C. prolifera* beds and most of the small patches. Additional small barriers not shown or hand picking would be used to treat any small patches not shown to be covered by the large barriers shown above in red. Proposed barrier area is 3,471 square meters.

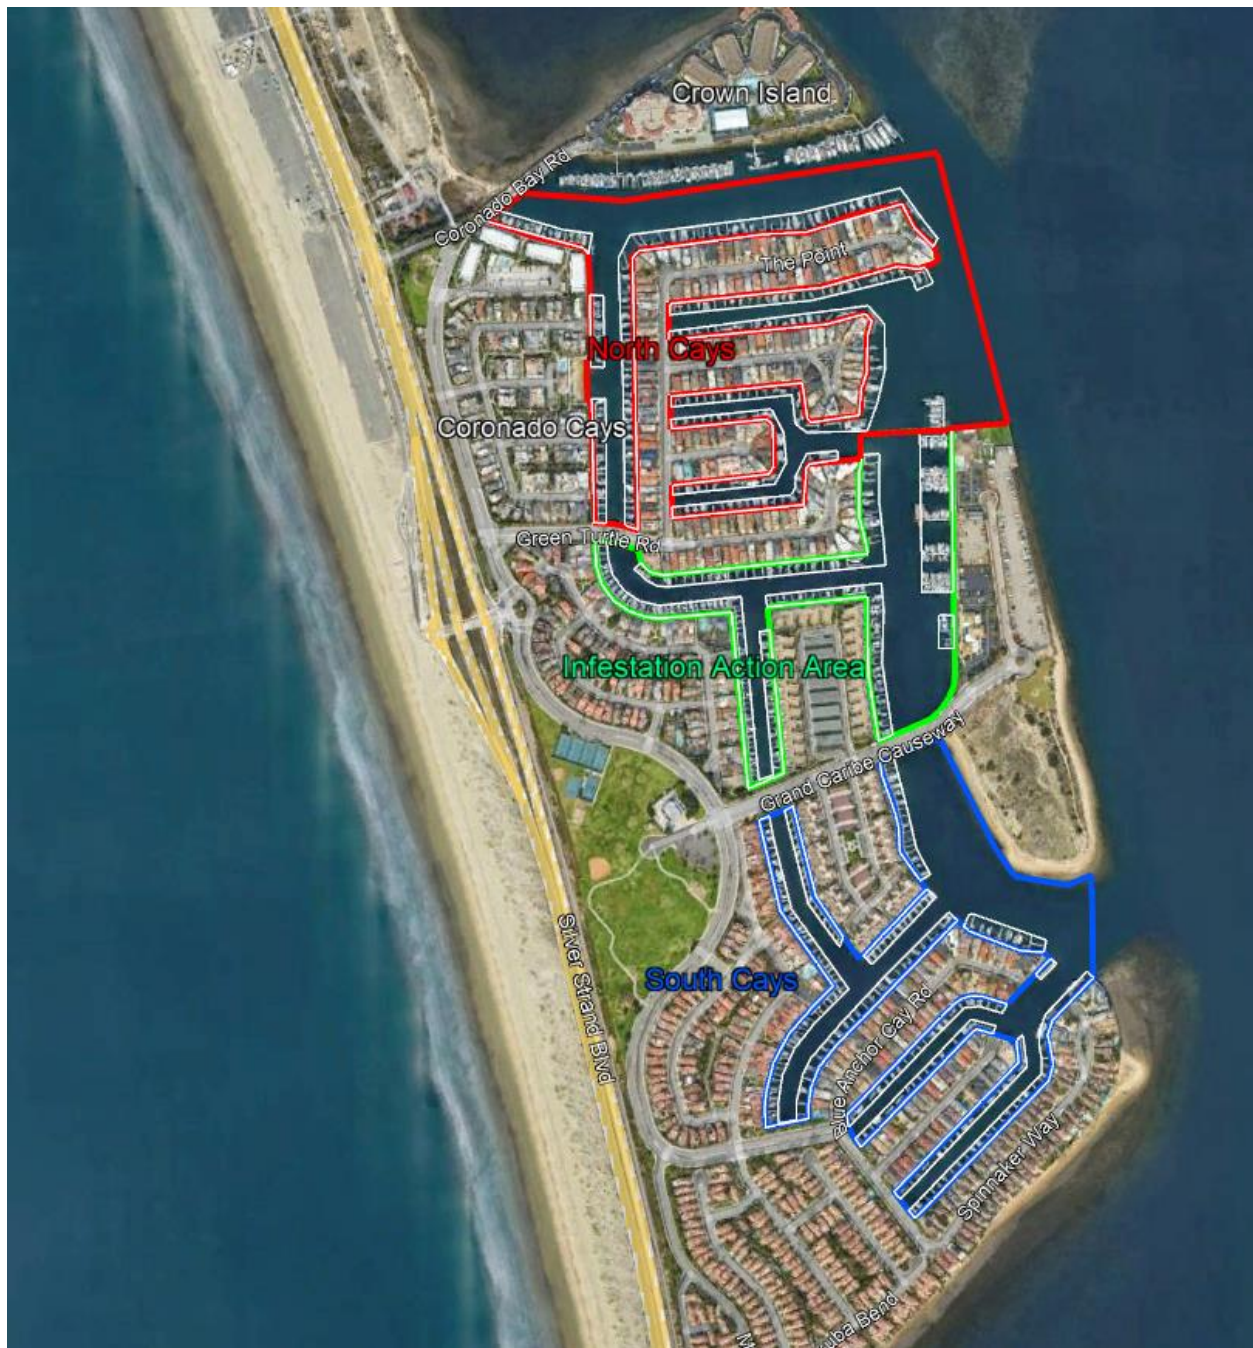
Figure 2. The above figure shows the infestation action area (green), north Coronado Cays (red), and south Coronado Cays (blue). Areas in white are the dock areas used to help partition costs between dock areas and open water.

The entirety of the Coronado Cays should be surveyed at least one time at the eradication level (100% coverage). Given that there is no penetration connecting the water area across Grand Caribe Causeway, if no *C. prolifera* is identified in the southern portion of the Coronado Cays, that area would require no further investigation. However, it would be prudent to survey the northern Coronado Cays again at some point after treatment of all known *C. prolifera* and prior to any determination that *C. prolifera* has been declared eradicated. The costs to survey within these additional areas used the same estimated costs per hectare to survey under docks and within the channels as provided above for the infestation action area. Refer to Figure 2 for the relative locations of the infestation action area, north Coronado

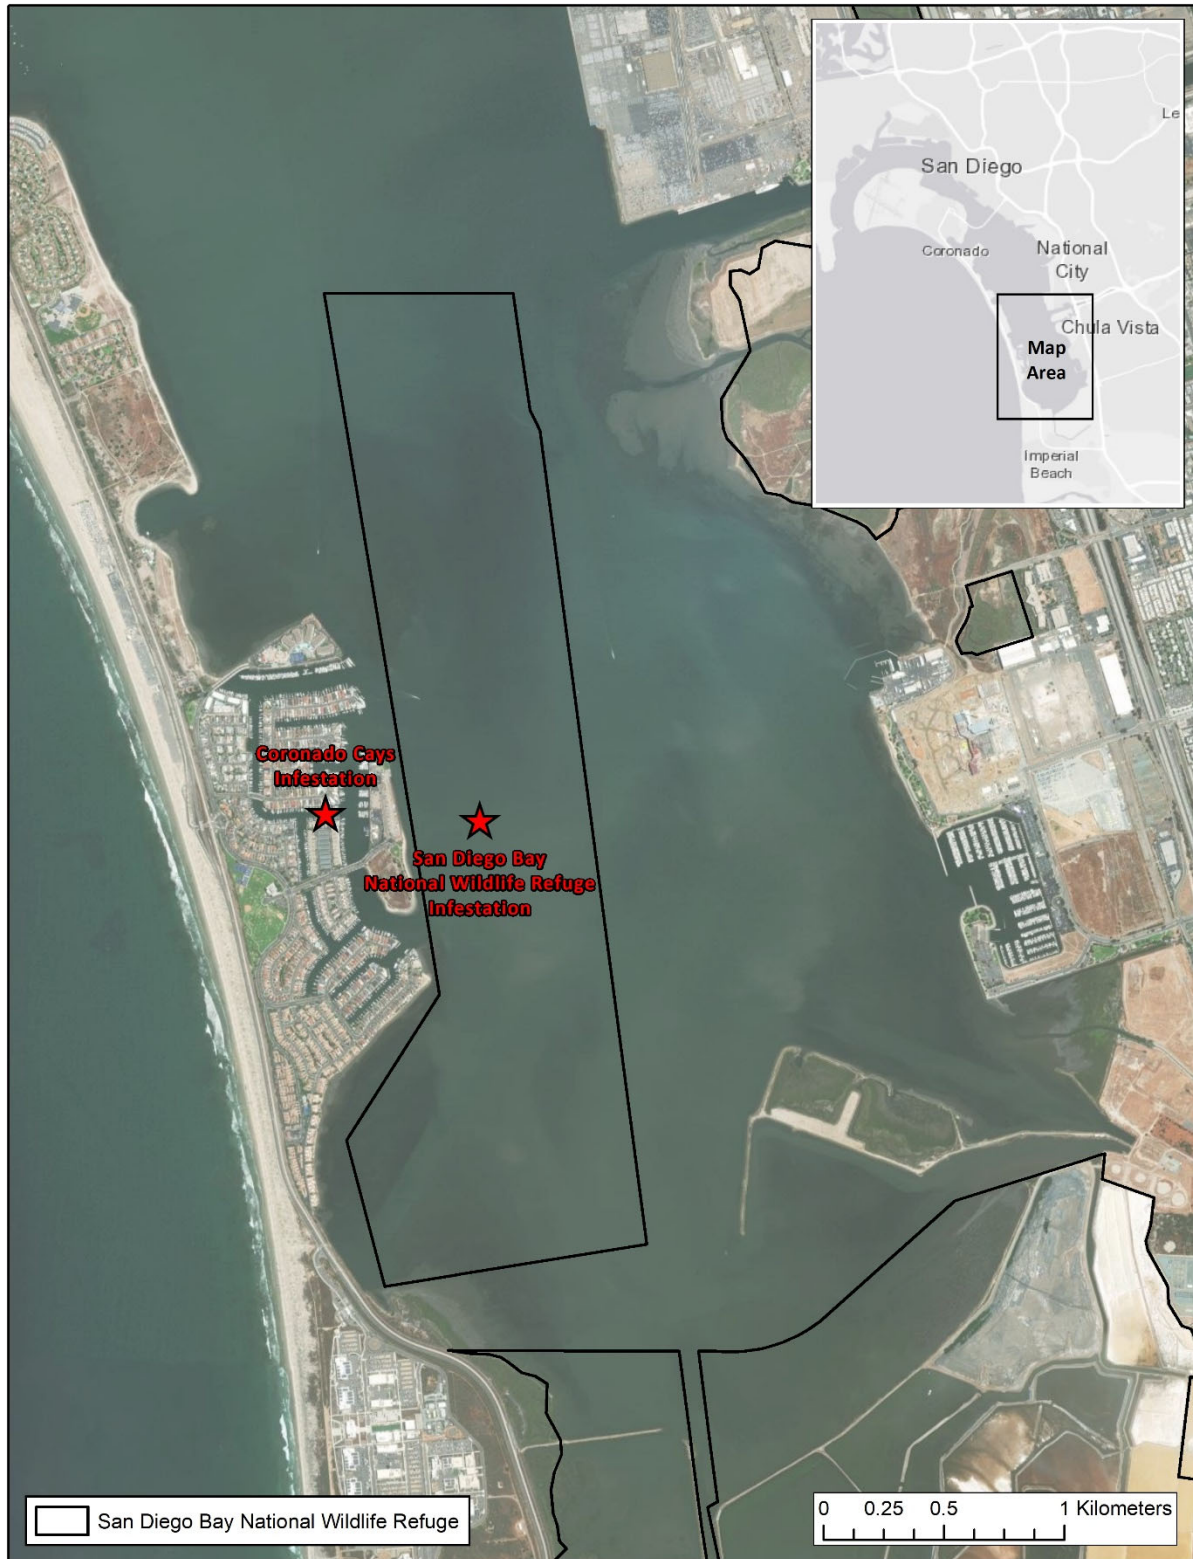
Figure 1. This locator map shows the position of the *Caulerpa prolifera* infestation in south San Diego Bay as of May 2024.

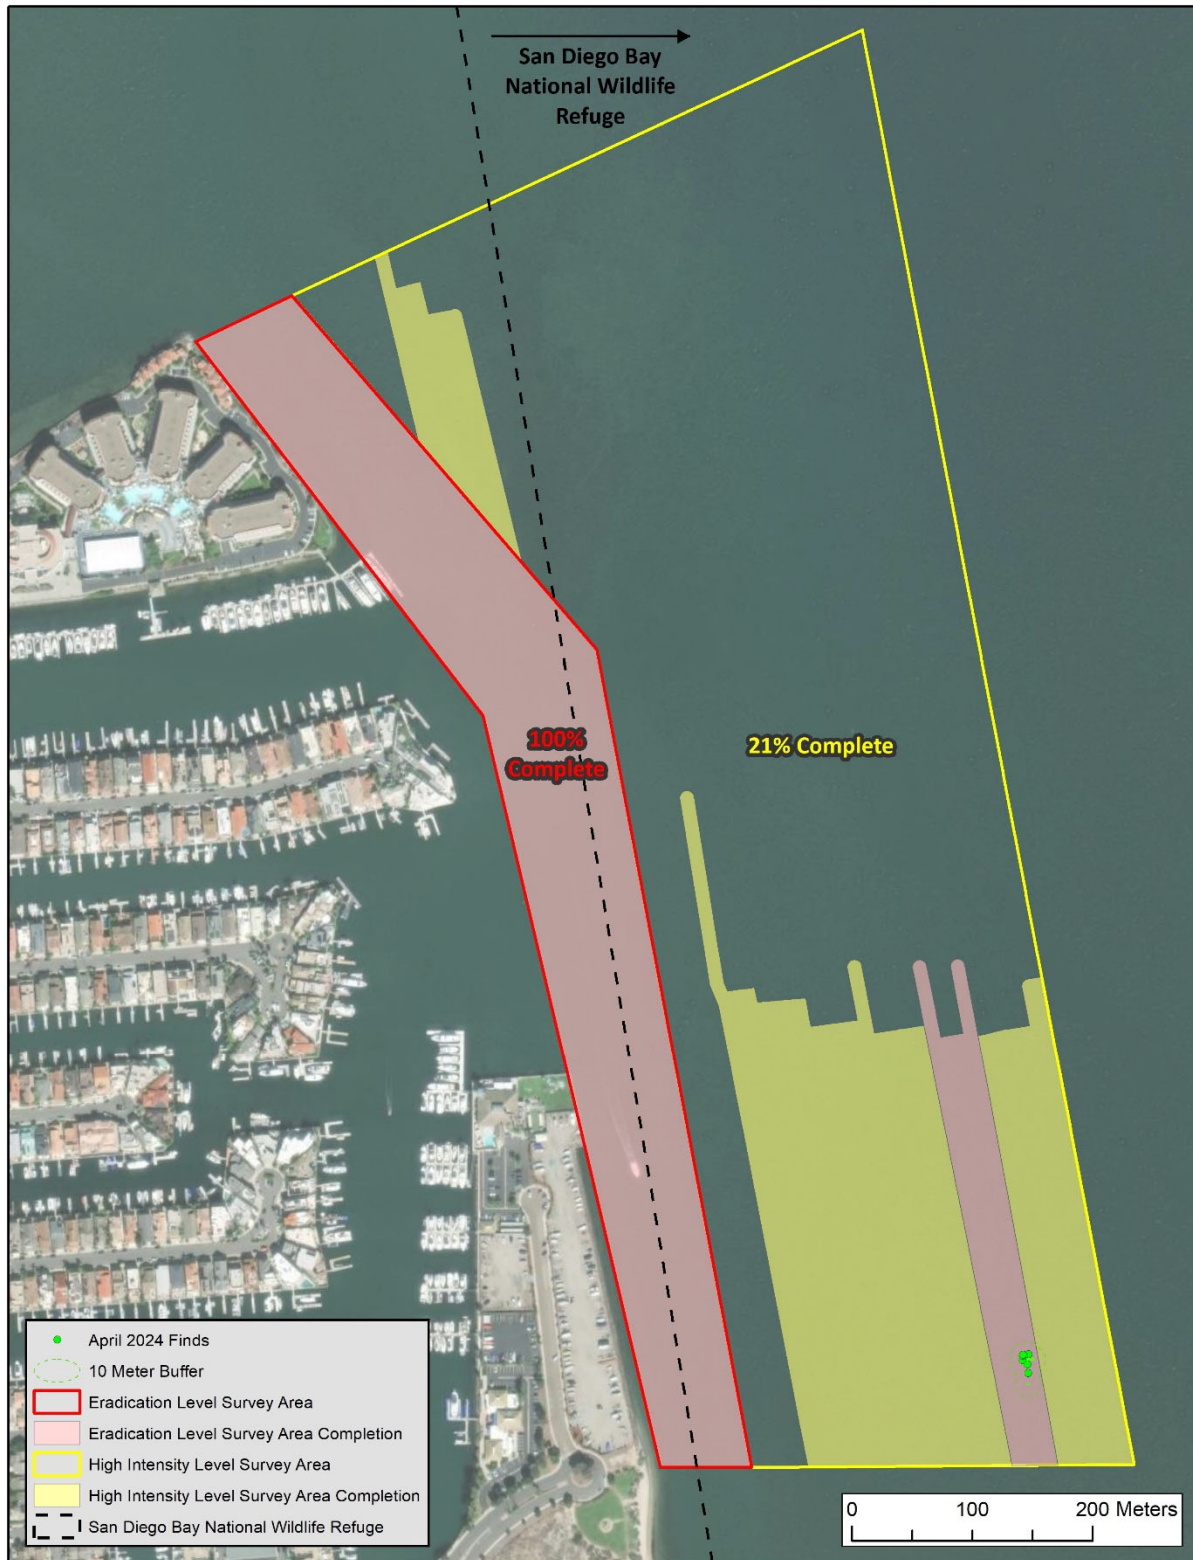
Figure 2. The above figure shows the 15 square meters of *Caulerpa prolifera* discovered in the San Diego Bay National Wildlife Refuge in April 2024.

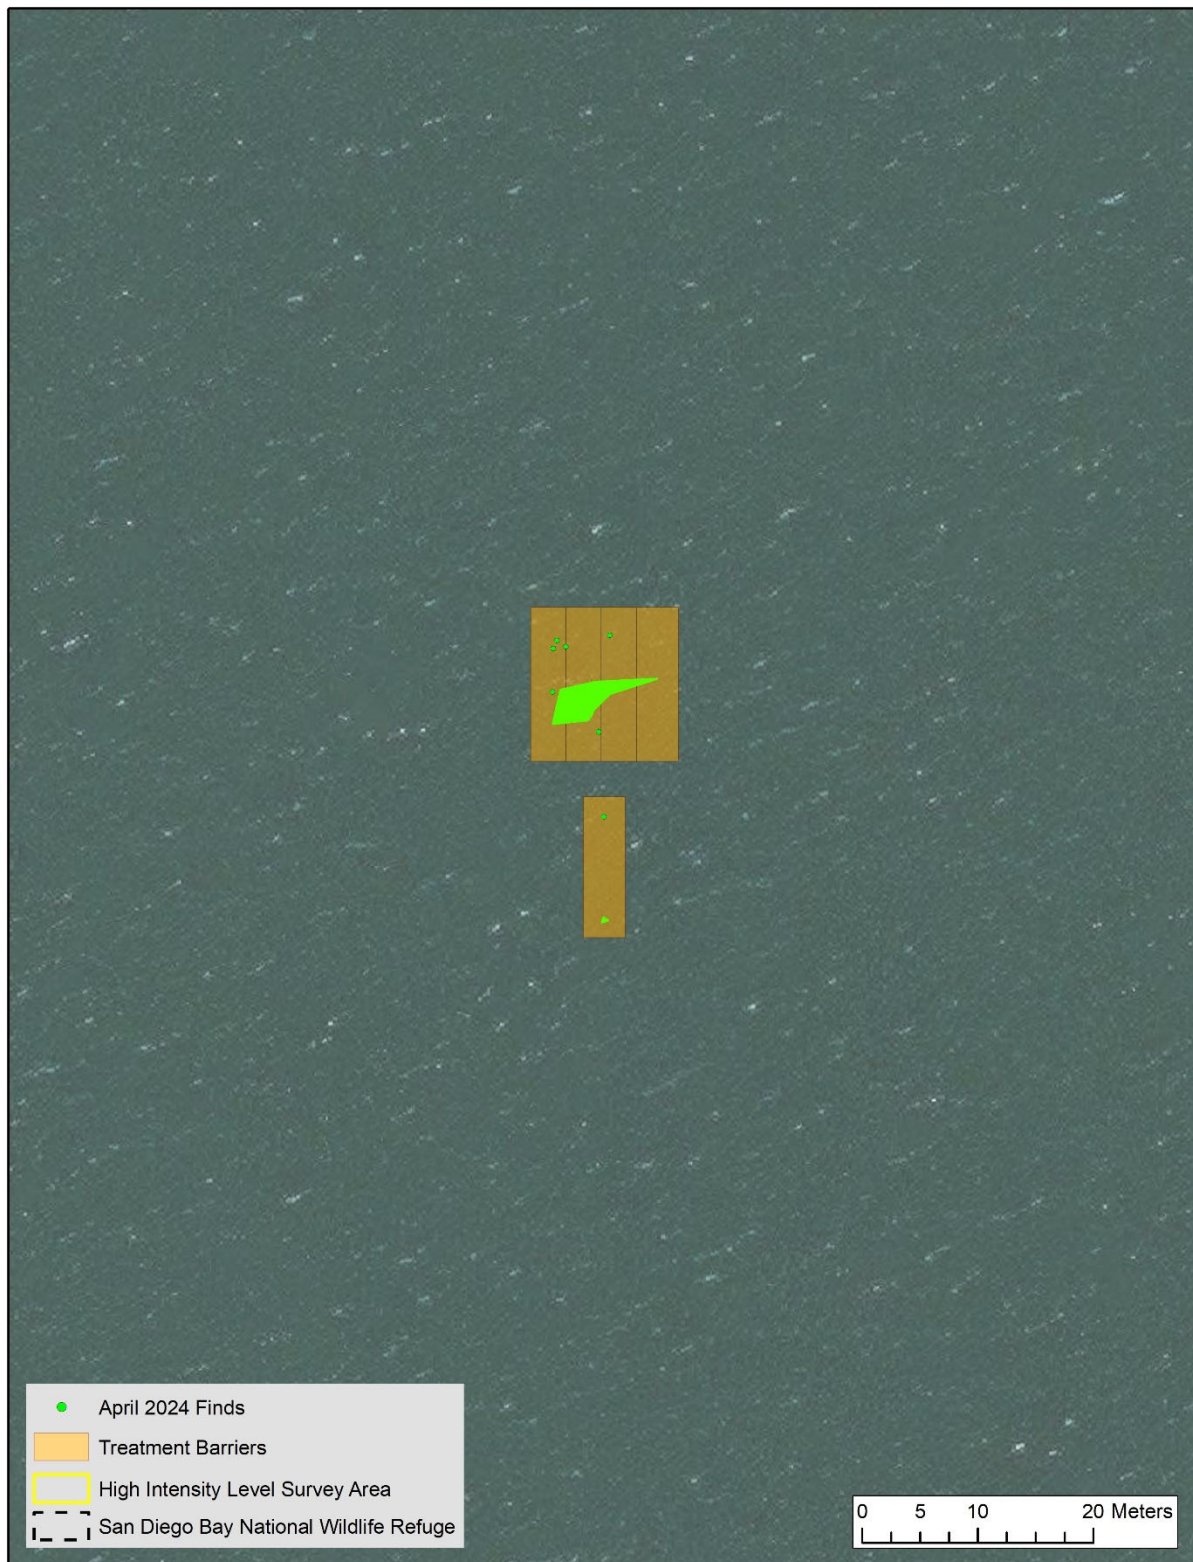
Figure 3. The above figure shows the proposed barrier placement over the *Caulerpa prolifera* discovered in the San Diego Bay National Wildlife Refuge in April 2024.

The planned response to isolate and eliminate the April *C. prolifera* infestation found in SDBNWR follows the methods outlined in the Eradication Plan. Divers will first systematically re-survey the infested area and collect any loose fragments, place them in a fine mesh bag, and bring them to the surface for disposal. Once the infestation area survey is complete, divers will place benthic barriers over the patches of *C. prolifera*. Barriers will overlap 0.6 meter along the long sides and approximately 1 meter on the short ends and will be secured to the bottom with rebar pins and sandbags. Following placement, the surrounding area will be re-inspected by the dive team for any fragments of *C. prolifera*. The re-inspections will be continued until SCCAT has adequate confidence that existing fragments have been found based on efficacy assessments and/or consistently declining find numbers.
