NPS Cosco Busan Recreational Use Program

Project: Rodeo Beach Restroom and Picnic Area Rehabilitation Final Programmatic Report

April 2024

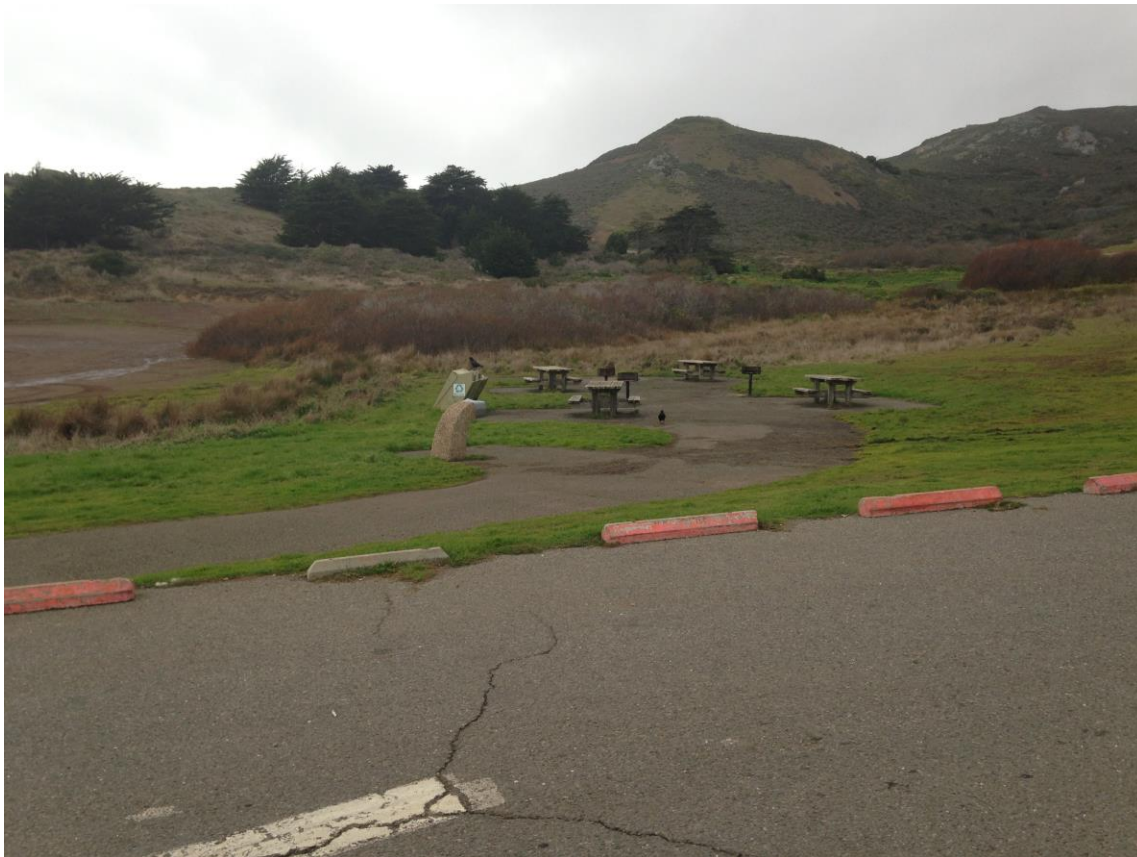
Figure 1: Picnic area before rehabilitation.

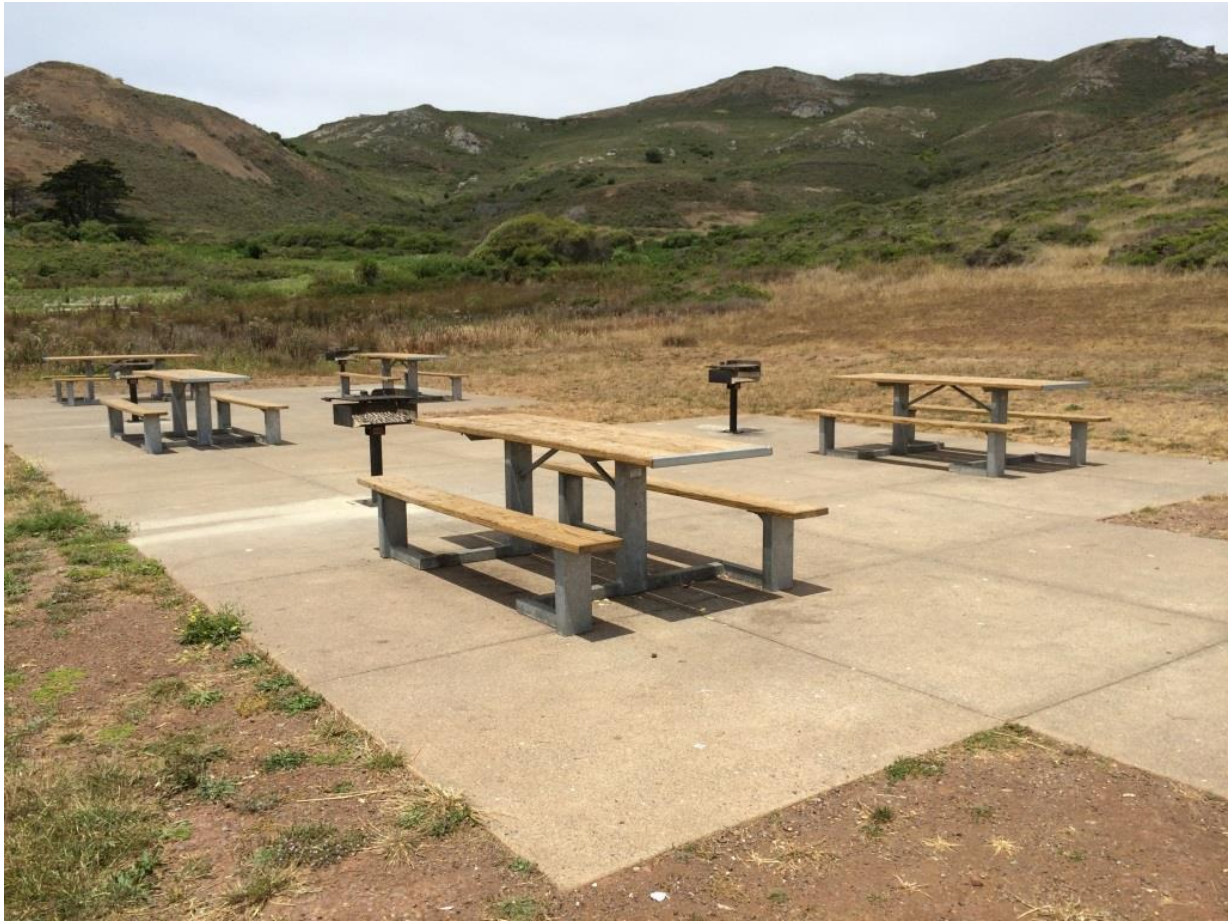
Figure 2: Picnic area after rehabilitation, July 2014.

The picnic area was repaved (and retained in the same location) using the same concrete that the Federal Highways parking lot improvement project had used for an accessible path from the parking lot to the bathroom/shower house and picnic areas. Five new picnic tables and four grills were installed in an arrangement intended to better accommodate large groups, replacing the four previously existing tables. Two water fountains were removed, and one accessible water fountain was installed.

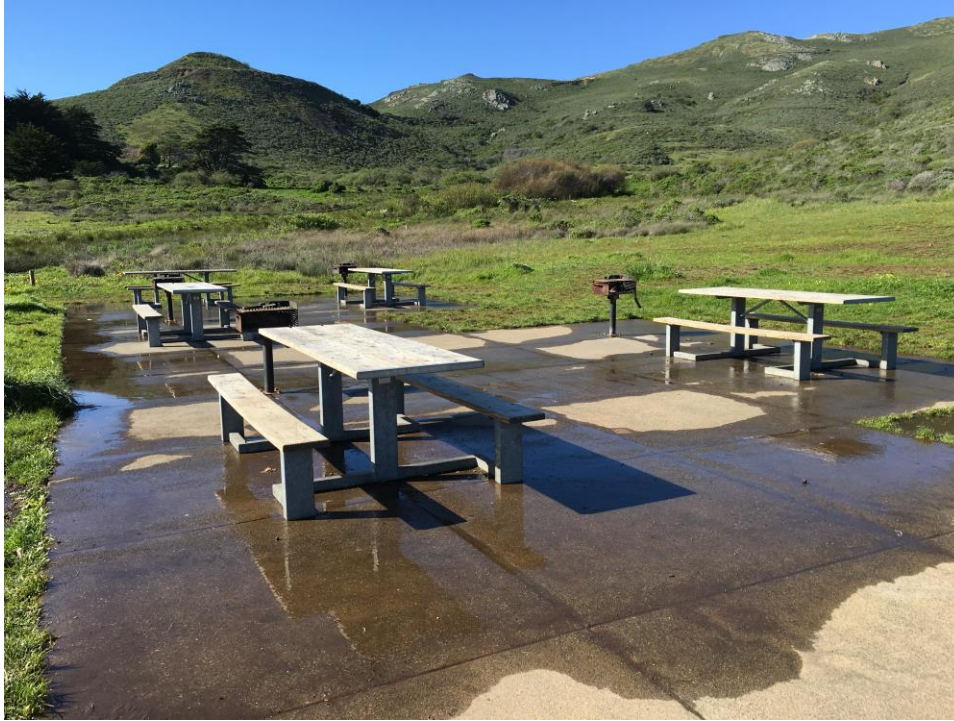
The concrete pad at the picnic area is located downslope of a wetland. Water drains towards the picnic area, so the concrete pad is often wet. This oversight in design was likely due to a misunderstanding about how much water was in the area and where it drained to. The time periods when the picnic area is the wettest are usually times when the weather is not conducive to picnicking, so the issue has not had a large impact on visitor experience.

Figure 3: Picnic area after rehabilitation in March 2016, with water seeping onto the concrete.
