Dutch Bill Creek Dam Removal and Creek Restoration Project

The Market St. Fish Passage Project

The Dutch Bill Creek Fish Barrier Elimination Program

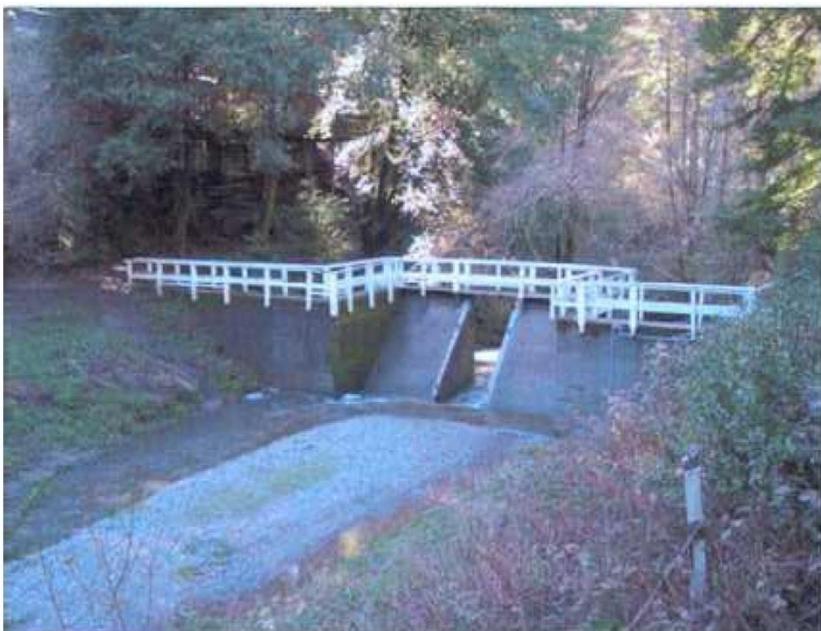
The Old Camp Meeker Dam
Photo taken April 4, 2008

The Camp Meeker Dam was constructed in the 1940s to form a swimming lake on the mainstem of Dutch Bill Creek in the community of Camp Meeker. The dam measured approximately 15' in height, and with a triple concrete weir on its downstream side, posed an insurmountable barrier to spawning coho salmon. Because of restrictions from the California Department of Fish and Game (DFG) instream dams for recreational uses, such as the one in Camp Meeker, were no longer considered compliant with beneficial uses of salmonid bearing streams, and the lake had not been filled since the late 1990s, the dam flashboards removed, and the site had become overgrown with non-native plants.

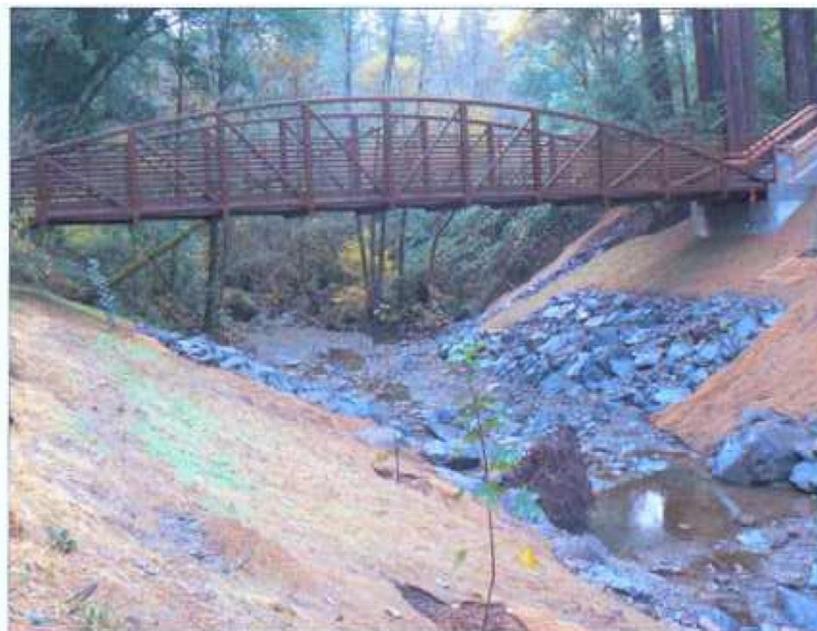
The New Camp Meeker Bridge
Photo taken December 1, 2009

The new pedestrian bridge was placed on October 22, and restoration work - including riparian revegetation and placement of erosion control measures - and Phase I of the project was brought to a successful conclusion in early November, in time for the next major storm.

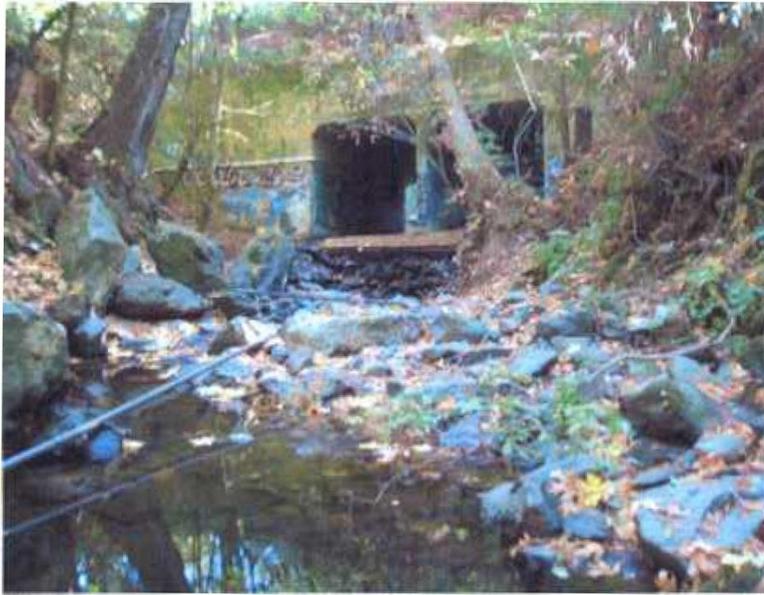
Pre-Project. Photo taken October 17, 2005

The Market Street project site consisted of a 1960s-era concrete double culvert with a low-gradient concrete apron at its outlet. The apron created a drop of 3-5 feet to the natural stream channel, and was a complete barrier to upstream migration of spawning coho salmon, while the culvert itself posed a velocity barrier to fish migration. The restoration project called for the retrofitting of the interiors and outlets of both culverts with concrete baffles to disperse flow energy and create a low-flow channel in each culvert, as well as removal of the apron and the construction of 6 boulder weirs between the culvert and the natural channel to create a series of pools that would be passable to fish. This portion of the project was designed by Eric Austenson, PE (Streamline Engineering).

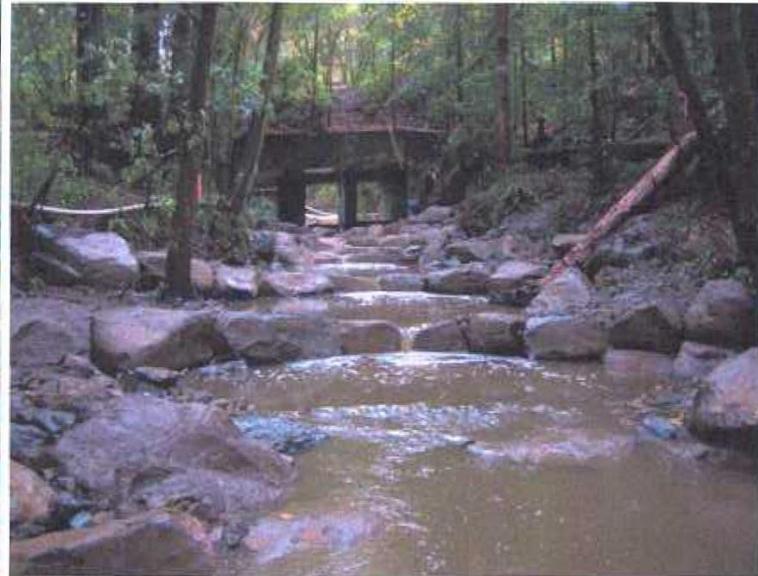
**Weirs below the Market St. Bridge
looking Upstream - Photo taken
November 6, 2009**

The Dutch Bill Fish Barrier Elimination Program entailed three major project components: the removal of a small (15' high) dam that formerly impounded a swimming lake for the community of Camp Meeker, the retrofitting of the Market St. culverts, and the installation of rock weirs below the culver.. Both sites were partial barriers to adult steelhead spawning migration and complete barriers to coho salmon.

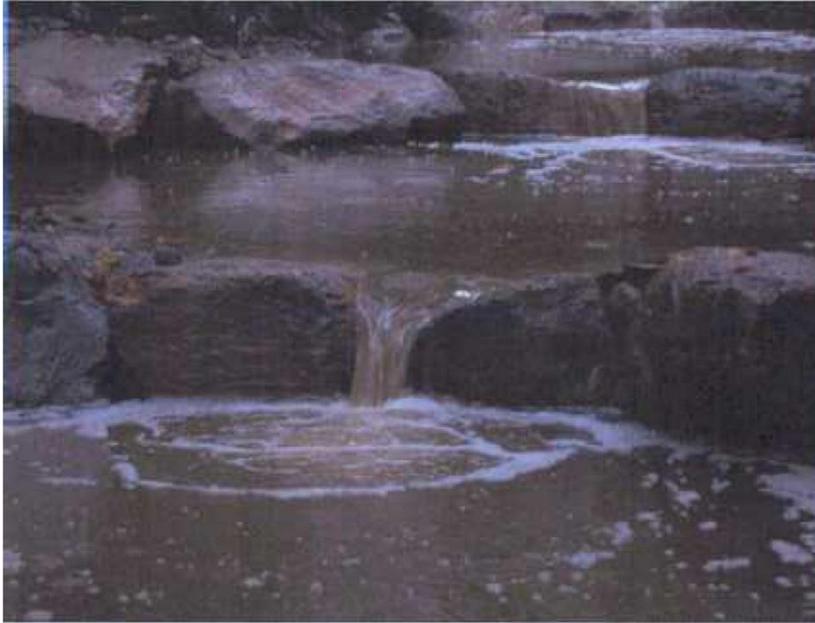
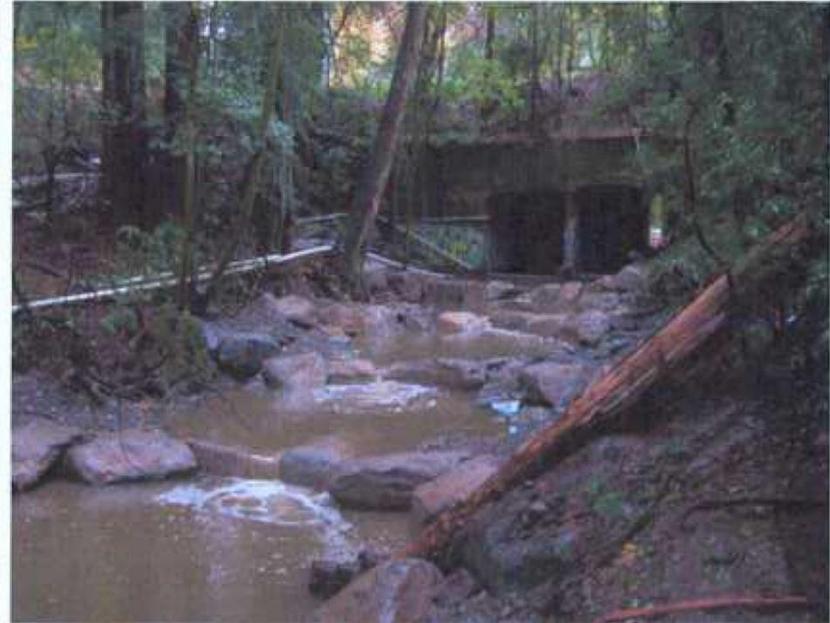
**Rock Weir #1 -Photo taken November 6,
2009**
