California Department of Fish and Wildlife  
Fisheries Restoration Grant Program  
Restoration Project Case Study

**Q2010505 Somerville Creek Instream Restoration Project**

**Q1910506 Morrison Creek Tributary Barrier Removal Project**

**Q2010506 Sproul Creek Salmonid Habitat Restoration Project**

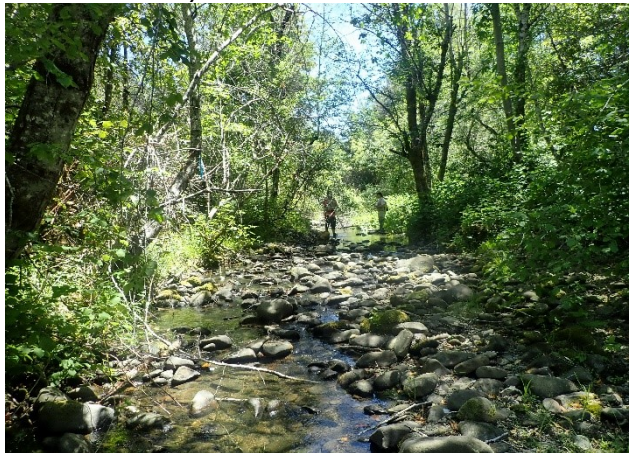
**Figure 1.** Looking upstream at a riffle before LW placement.  
Pre-treatment photo date: 6/2/2021

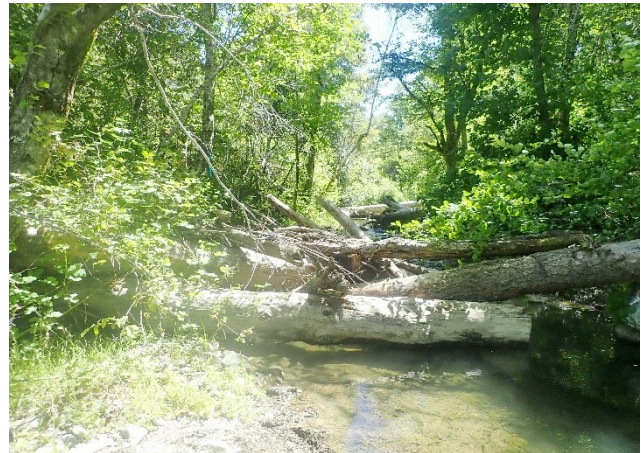
**Figure 2.** Looking upstream at LW that has slowed stream flow and scoured a pool on the left bank.  
Post-Treatment photo date: 5/28/2024

In May 2024, post-treatment effectiveness monitoring on 26 of the 28 LW features found all features remained in their original position, except one that had shifted slightly. Sixty-five percent of features with a stated objective to scour and increase maximum residual water depth were successful.

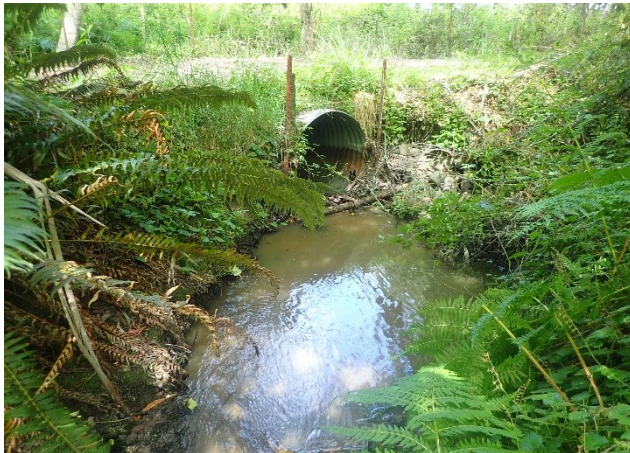
**Figure 1.** Upstream view of inlet to undersized culvert prior to project implementation.  
Pre-treatment photo date: 5/20/2021

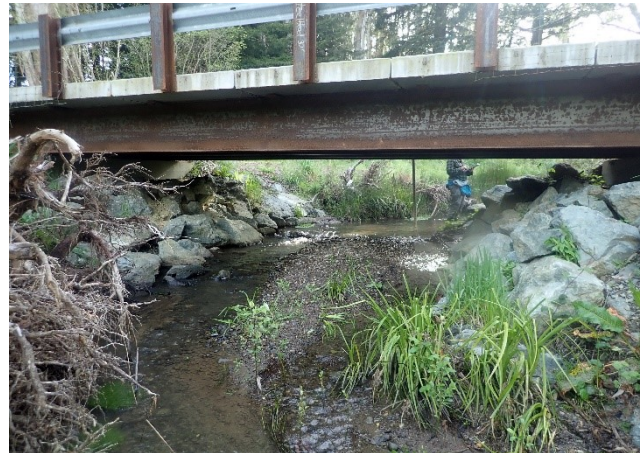
**Figure 2.** New 30' spanning bridge that opens fish passage above crossing.  
Post-treatment photo date 4/16/2024

Post-treatment monitoring was conducted after two very wet winters to document site changes following high flows. There were no fish passage issues remaining. Rootwads embedded in the right bank downstream of the bridge provided bank stability and added cover. Single logs were buried in the streambed materials for grade control and scoured pools below each log.

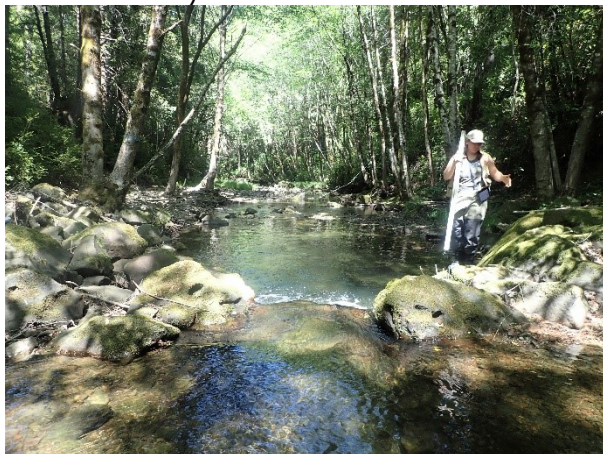
**Figure 1.** Boulder weir and plunge pool before LW feature was installed.  
Pre-treatment photo date: 5/17/2021

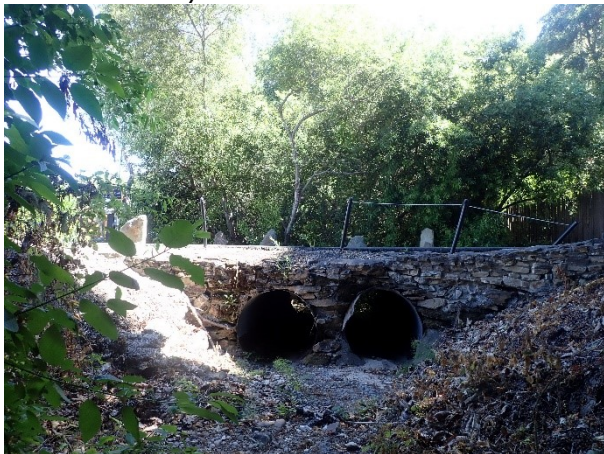
**Figure 1.** Facing downstream at the pre-treatment conditions of the site, showing the culverts slated for removal, which acted as total fish passage barriers. Pre-treatment photo date: 8/3/2021

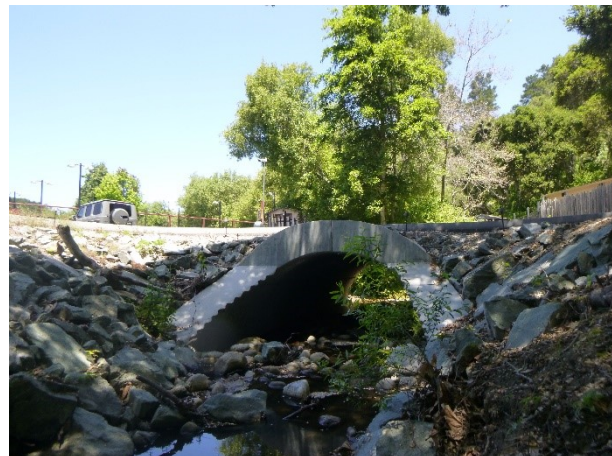
**Figure 2.** Facing downstream of the embedded arch culvert and reconstructed channel that replaced the previous culverts. No man-made fish passage barriers remain at this site. Post-treatment photo date: 6/5/2024

The multi-plate pipe arch culvert and channel reconstruction with ESM treatments at the upper crossing site on Potrero Creek were monitored for post-treatment effectiveness in June of 2024, approximately three years after implementation. The project successfully removed the barrier to steelhead trout passage at the crossing. Components of the pipe arch culvert and concrete collars appeared to be in good condition and were functioning as intended. The reconstructed channel retained gradient and substrate composition matching the surrounding channel as intended, even after significant flow events following implementation.

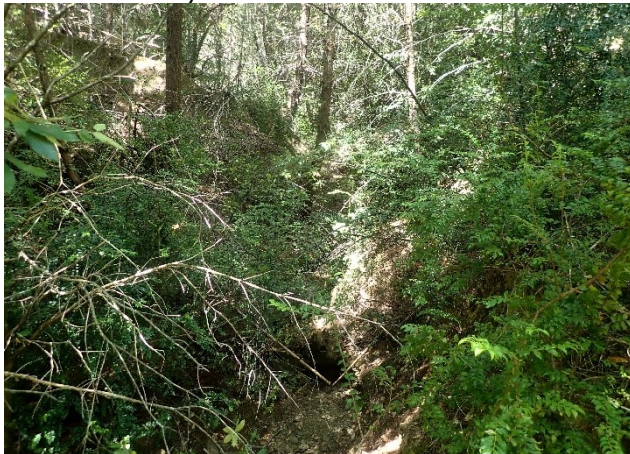
**Figure 1.** A stream crossing feature showing erosion and improper grade. Pre-treatment photo date: 07/14/2021.

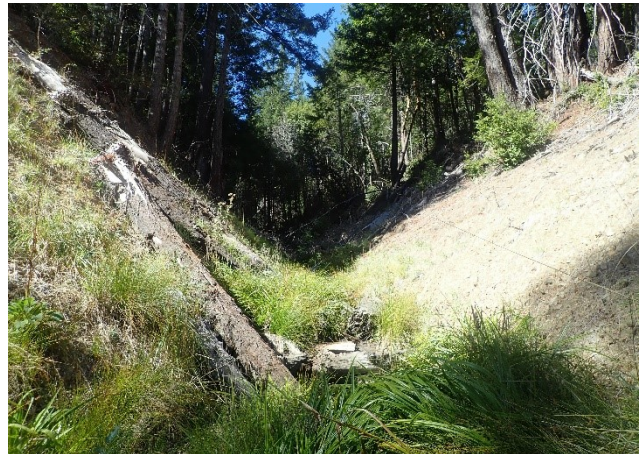
**Figure 2.** A restored stream bed with a 2:1 bank ratio. Placed woody material is visible along with returning vegetation. Post-treatment photo date: 09/30/24.

Most treated stream crossings showed little to no evidence of sediment delivery since treatment. However, there was deep head cutting above two treated stream crossings that had scoured over 20 cubic yards of sediment. Good amounts of woody material were placed throughout each crossing and moderate vegetation regrowth was visible. Six upland features were also treated, and less than three cubic yards of scour were observed at half the sites with none at the other half.
