California Department of Fish and Wildlife
Fisheries Restoration Grant Program
 Restoration Project Case Study

P1610504 James Creek Coho Stream Habitat Enhancement Project

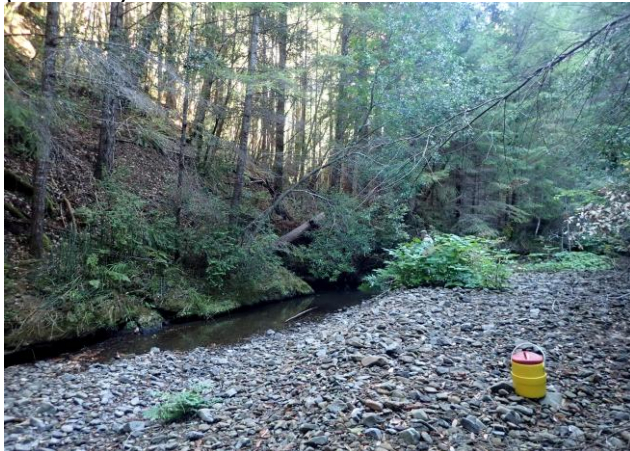
Figure 1. Untreated stream with narrow, shallow flatwater habitat.
 Pre-treatment photo date: 09/17/2019

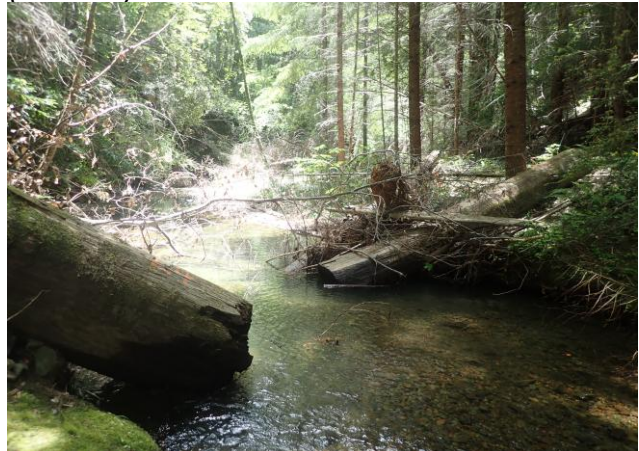
Figure 2. After the addition of large wood wetted width, depth, and cover increased.
 Post-treatment photo date: 06/14/2023

Twenty-five of the 26 features monitored at pre-treatment received post-treatment effectiveness monitoring in June 2023, following three winter flow seasons. Large wood features consisted mainly of one to three logs anchored with rebar and cable or wedged between live trees. Features were predominately functioning as intended by adding cover complexity. Twenty-one features had increased residual pool depth at post-treatment monitoring.

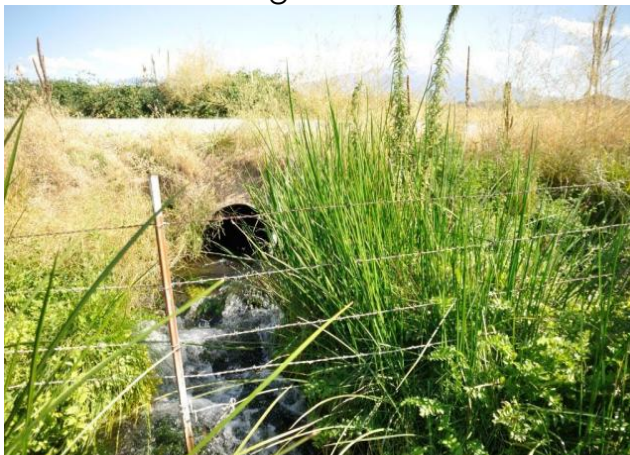
Figure 1. Pre-construction view of 30" CMP culvert outlet.
 Pre-treatment photo date: 2014

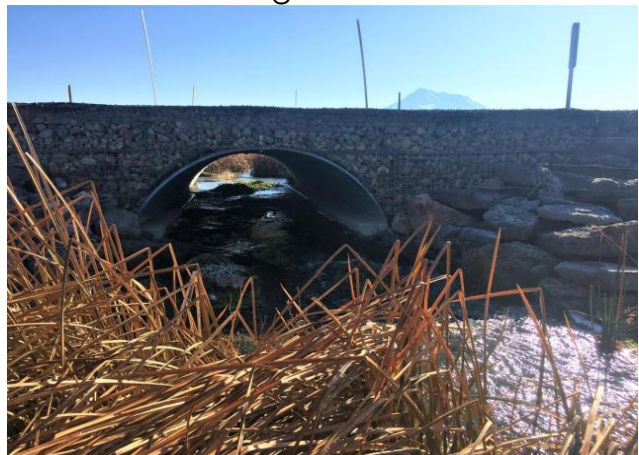
Figure 2. Post-construction view of 10' X 36" multi-plate arch culvert outlet.
 Post-treatment photo date: 2020

Post-treatment monitoring was completed on June 27, 2023. The crossing was in good condition and functioning as intended with no fish passage issues remaining. Minnow trapping was conducted during pre-treatment and post-treatment monitoring visits with traps set upstream and downstream of the crossing. No salmonids were trapped during either visit. Speckled dace were caught at pre-treatment above and below the crossing. No fish were captured at post-treatment, but small fish were observed from the surface and presumed to be Speckled dace.

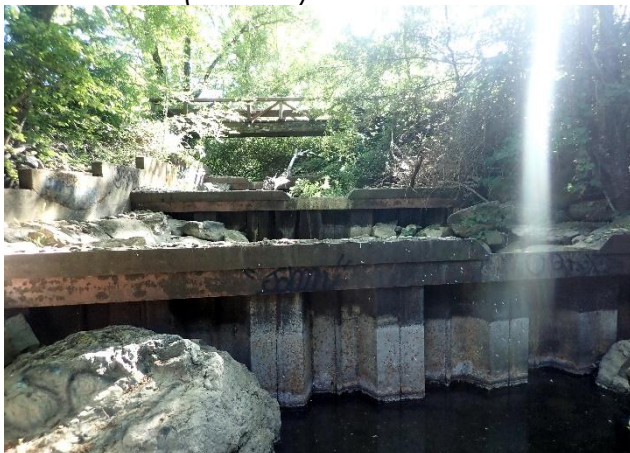
Figure 1. Concrete dams create Roy's pools with the former fish ladder on the left.

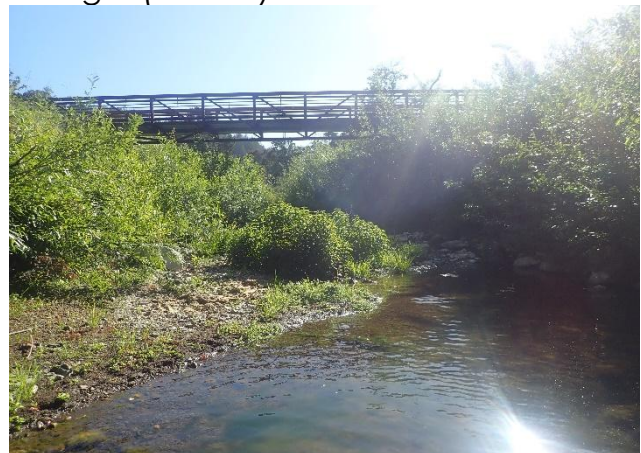
Figure 2. Reconstructed channel after dam removal with new spanning pedestrian bridge.

Post-Treatment monitoring was conducted in June 2023. The concrete dam, four sheet metal weirs and fish ladder were removed successfully. The newly graded roughened stream channel was implemented as proposed, and the original main channel became a narrow side channel. The four revegetation features along the main and side channel had good growth and high survival.

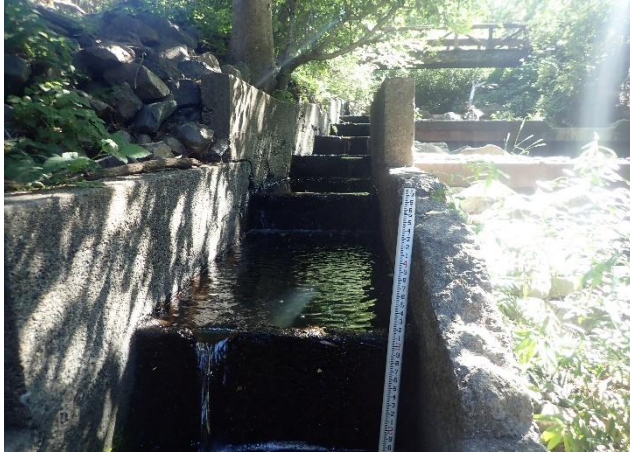
Figure 3. Concrete fish ladder next to the former dam and pools.
 Pre-treatment photo date: 06/30/2020

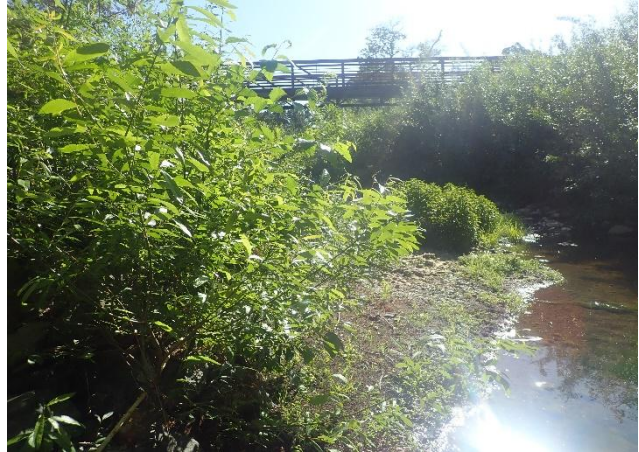
Figure 4. Reconstructed channel following removal of the fish ladder.
 Post-treatment photo date: 06/21/2023

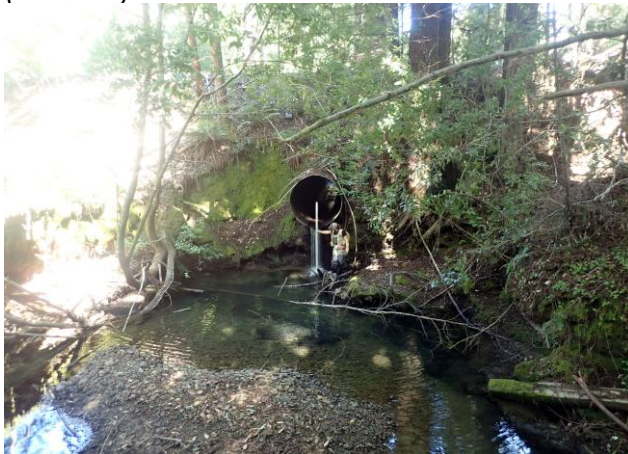
Figure 1. Outlet of perched culvert prior to removal.
 Pre-treatment photo date: 02/26/2020.

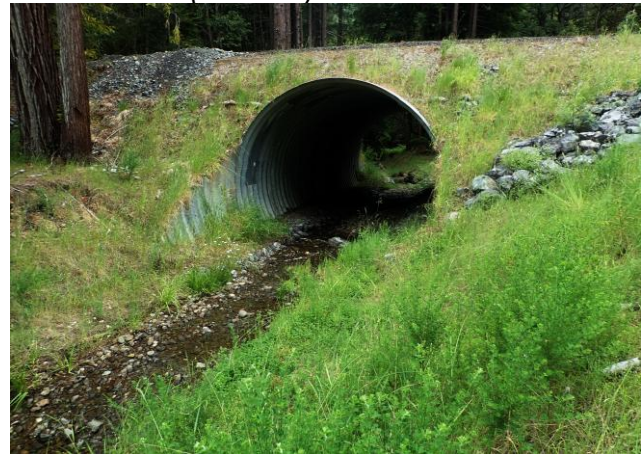
Figure 2. Culvert installed to allow for fish passage.
 Post-Treatment photo date: 05/30/2023

The upgraded crossings, bank stabilization, and instream work were monitored for effectiveness on May 30, 2023. The crossings were no longer barriers to fish passage, but at low flows the lower crossing had subsurface flow within the culvert. Rock armoring along the lower crossing had also eroded at points, especially on the downstream and right bank. Rock weirs scoured out pools and fish were visible from the surface below the lower crossing. Logs and rootwads were stable and keyed in, but the uppermost rootwad was mostly out of the active channel.

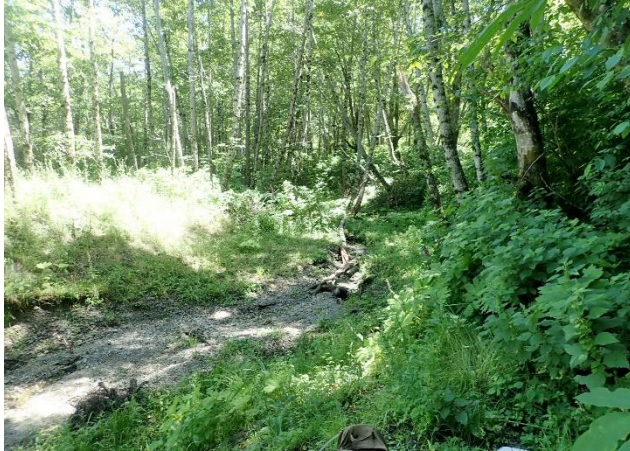
Figure 1. Main channel site C2 prior to excavation.
Pre-treatment photo date: 06/04/2020

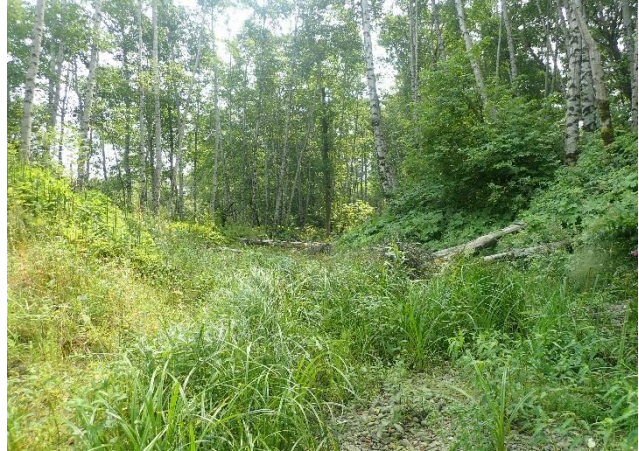
Figure 2. Eight hundred feet of excavated slough and alcove at site C2.
Post-treatment photo date: 07/19/2023

Post-treatment monitoring was completed on July 19, 2023. Unanchored large wood structures in the newly excavated channel created shallow pools, 2-4 inches in depth. Vegetation covered the banks and there was no sign of erosion. Willow

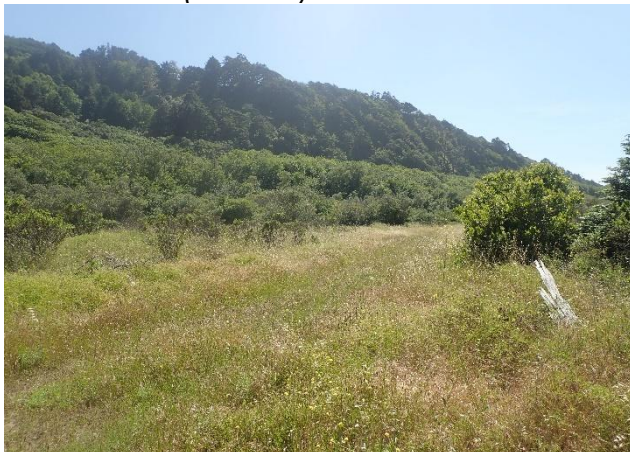
Figure 3. Left bank river terrace before treatment.
Pre-treatment photo date: 06/04/2020

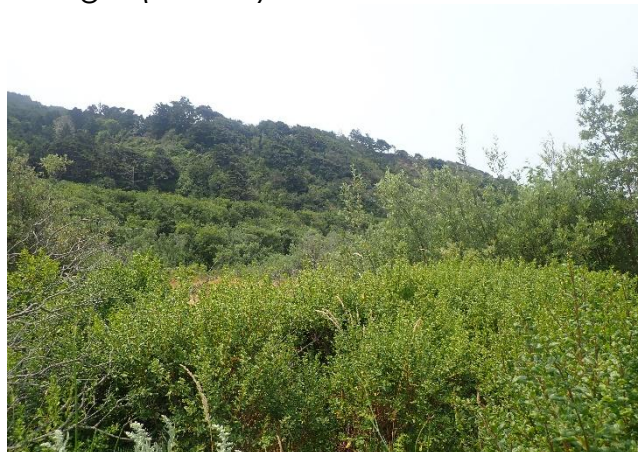
Figure 4. Willow baffles planted at treatment site.
Post-treatment photo date: 07/19/2023

plantings on the left bank floodplain terrace of the Mattole River had high survival, looked healthy and had good growth.

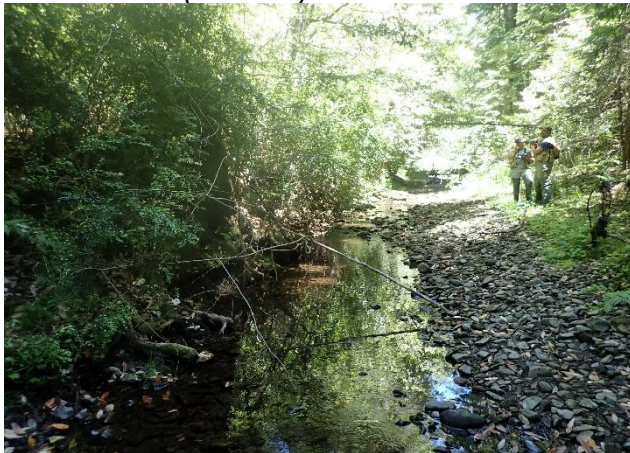
Figure 1. EBNF Big River prior to addition of large wood showing low diversity habitat.
Pre-treatment photo date: 06/08/2020

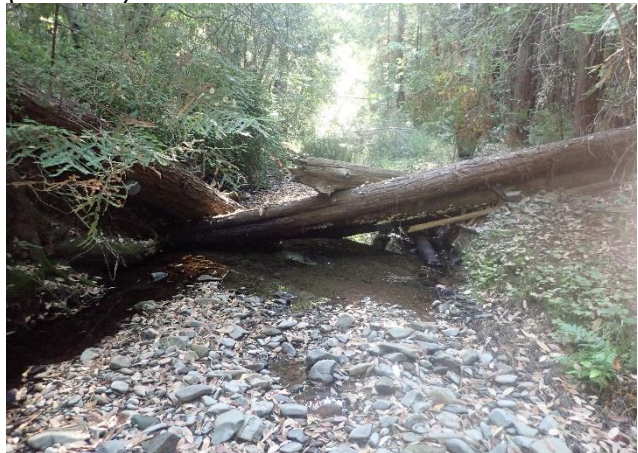
Figure 2. Large wood placed in the wetted channel of EBNF Big River redirected flow to scour a pool, provide cover and improve salmonid habitat.
Post-treatment photo date: 08/29/2023

Twenty-nine features monitored at pre-treatment received post-treatment effectiveness monitoring on August 29, 2023. All large wood structures were in their original position and in good condition. All features created pool habitats and added cover complexity. Twenty-seven pools increased residual depth, while two stayed the same.

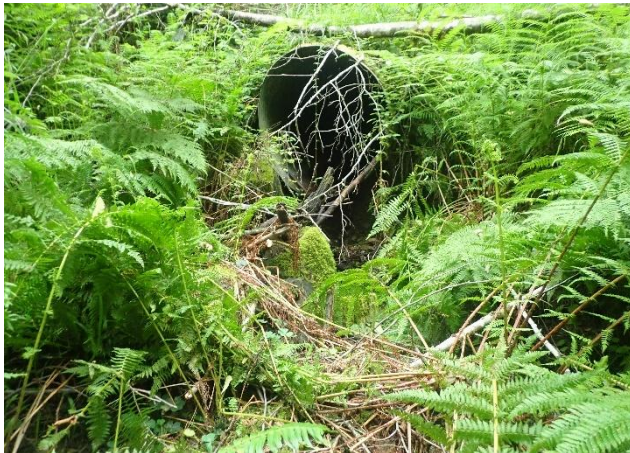
Figure 1. Perched culvert prior to decommissioning on logging road 4200. Pre-treatment photo date: 06/15/2020

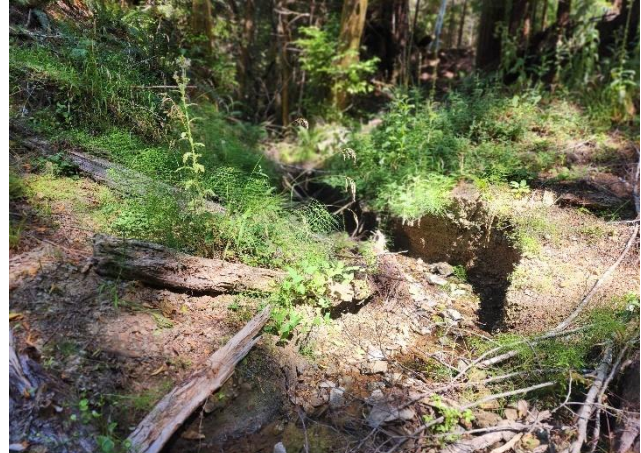
Figure 2. Excavated stream crossing, stream sides laid back at 2:1 slope. Post-treatment photo date: 07/31/2023

Post-treatment effectiveness monitoring was conducted over two days: July 31 and August 1, 2023. The two road and culvert upgrades on logging road 4000 were functioning as intended with minor bank erosion and did not seem to be contributing sediment to the creek. The decommissioned stream crossing features were well covered with slash and had good regrowth of vegetation to prevent erosion and sediment delivery to Julias Creek. All monitored upslope stabilization features were treated as planned.

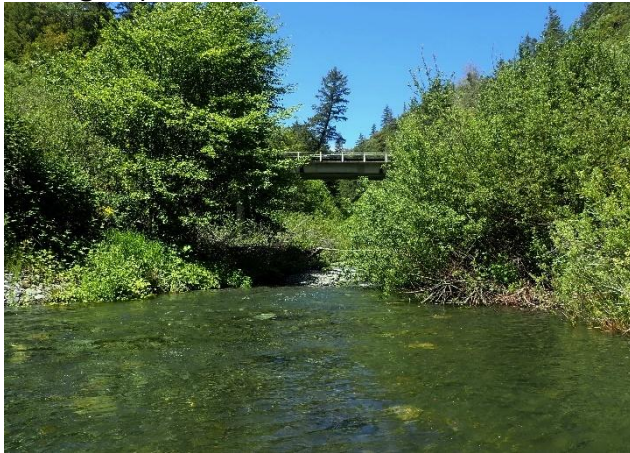
Figure 1. Slate Creek, tributary to the Klamath River, during high spring flows. No current need for modification. Pre-treatment photo date: 5/16/2022.

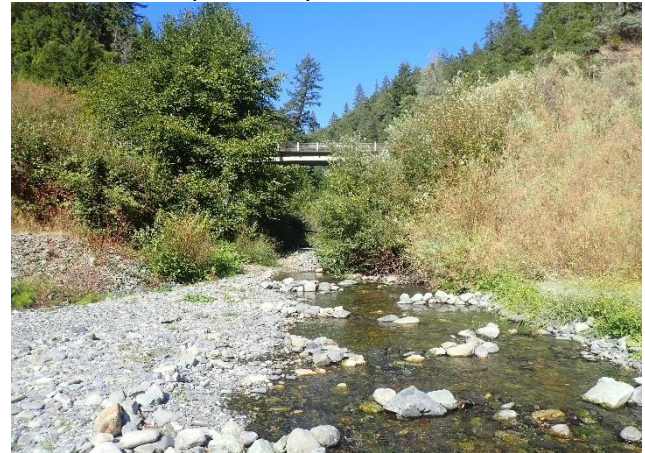
Figure 2. Slate Creek when flows are low and shallow. Implementation work concentrated flow and added rock baffling and resting pools. Post-treatment photo date: 10/5/2022.

In 2021, seven of 12 sites monitored at pre-treatment were evaluated for fish passage and an eighth site for added cover at the mouth of Methodist Creek. In 2022, 14 of 15 sites evaluated at pre-treatment received alterations (passage improvement or added cover) and were revisited for post-treatment monitoring. Three tributaries (Camp, Slate, and Nordheimer creeks) had major work done by adding resting pools and extended meanders for slower grade and flow.
