Habitat Restoration and Enhancement for the  
Cuyamaca Lake Downingia (*Downingia concolor* ssp. *brevior*)  
at Cuyamaca Rancho State Park

Emergency Drought Relief Project  
Contract # CA HER 022593

September 1994

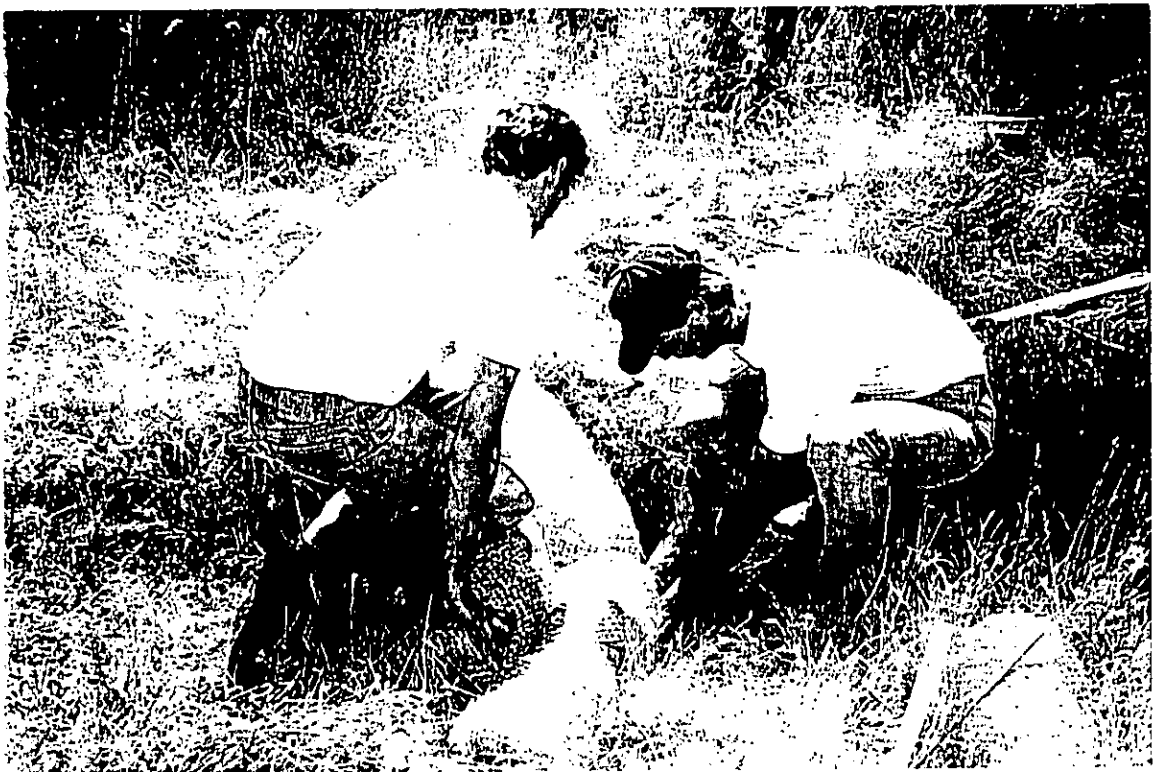
Figure 8. Photos of treatments. Top) Coir fiber on a framework of bamboo. Bottom) Placement of rice straw logs. Photos by D. Bainbridge.

Figure 9. Photos of treatments. Left Top) Broom corn. Left Bottom) Brush "dam" with "T" post framework. Right) Bamboo "dam" with coir fabric apron. Photos by S. Netto.

The construction materials were cut and prepared as much as possible at San Diego State University, taken to a parking lot in the Paso Picacho Group Camp and then carried to the site. All dams were "keyed" 10-15 cm into the sides of the banks by using a chain saw with a trencher adaptor. Shallow trenches perpendicular to the channel were incised as well. Bamboo frames were made of 5/8 inch or 3/4 inch diameter bamboo stakes and woven with 3/8 inch or 5/8 inch bamboo stakes or covered with a piece of matchstick bamboo shade. Rice straw logs were 3 feet long and consisted of cleaned rice straw contained within a mesh cover. Logs were hydrated for 2 weeks prior to placement to test for seed contamination. They were embedded in the channel using one to three logs per treatment point, depending on the width of the channel. Logs were anchored with staples made of bent lengths of small diameter rebar. Broom corn was placed vertically in the channel. As with the rice logs, it was tested for seed contamination. Broom corn comes from *Sorghum vulgare* plants that are harvested while in bloom and placed in a revolving drum to remove seed (Kirby 1963). Whisks (branches and flower panicles) are cured in drying sheds. We pushed the stem end into the soil, leaving the divided inflorescence sticking up in the channel. Coir (coconut) fiber dams had a downstream apron that was stretched to protect the channel sides as well as the channel bottom. The coir was anchored either with staples or bamboo stakes. At two locations on the eastern drainage (Map location #'s 10 and 18, Figure 4), the scour basins were so wide and deep that metal T-posts were used to frame the brush dams. Additional brush was packed behind the retention structures.

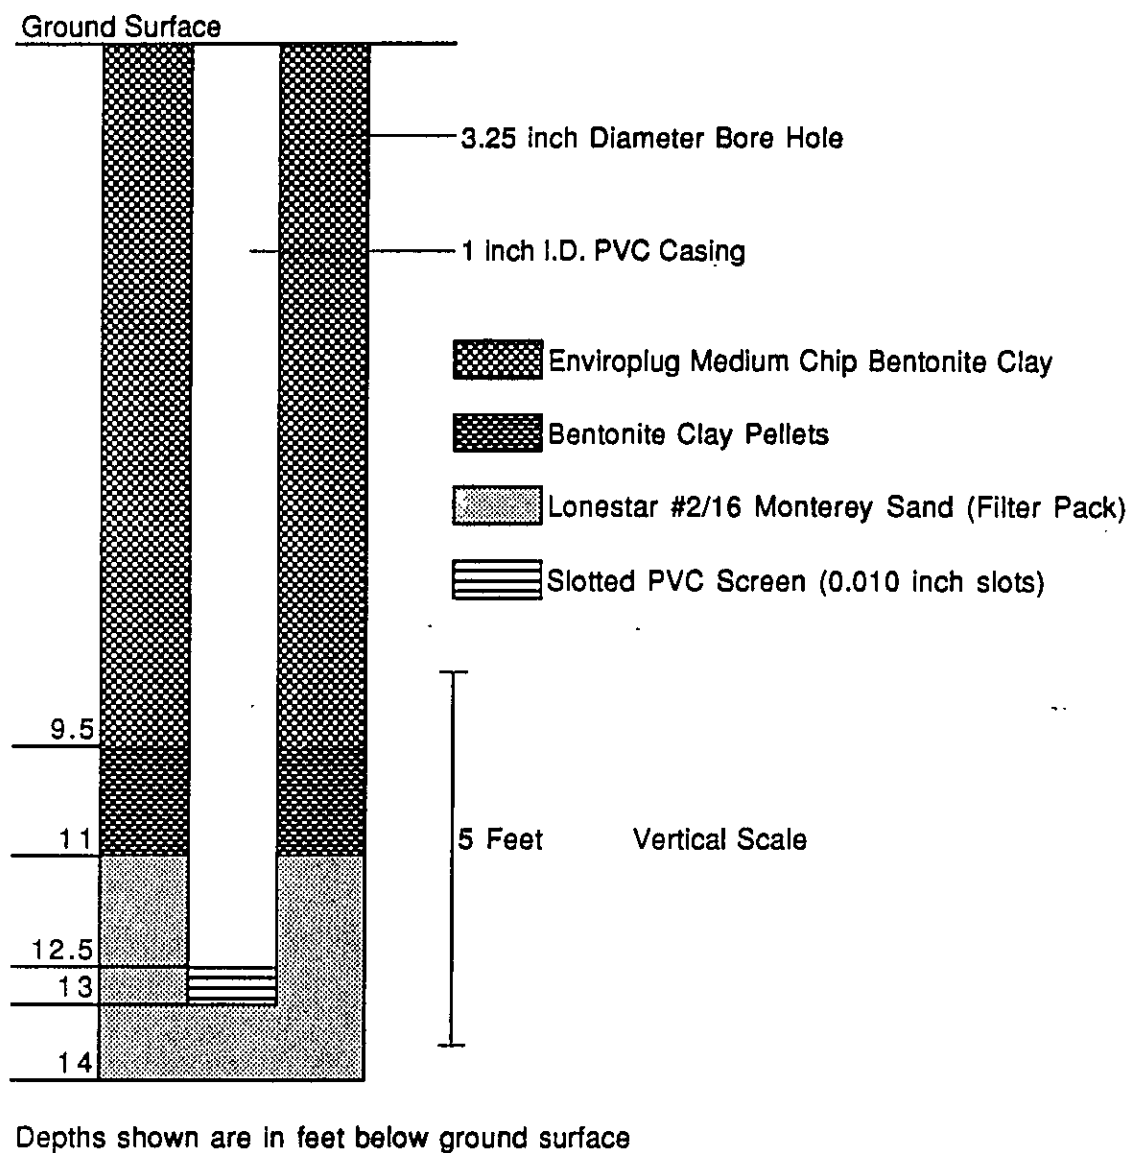
Figure 11. Piezometer design at map location 73.

Cuyamaca Rancho State Park-Paso Picacho Group Camp  
Map Location 73 (meadow north of group camp)  
Piezometer Design
