FINAL REPORT
McGinty Mountain Habitat Protection Project

Contract No. FG-9508

Final Report
McGinty Mountain Habitat Protection

Scope of Work: Eliminate trespassing and control erosion that threatens populations of Acanthomintha ilicifolia (E), Nolina interrata (E), Senecio ganderi (R), Horkelia truncata, and Tetracossus dioicus.

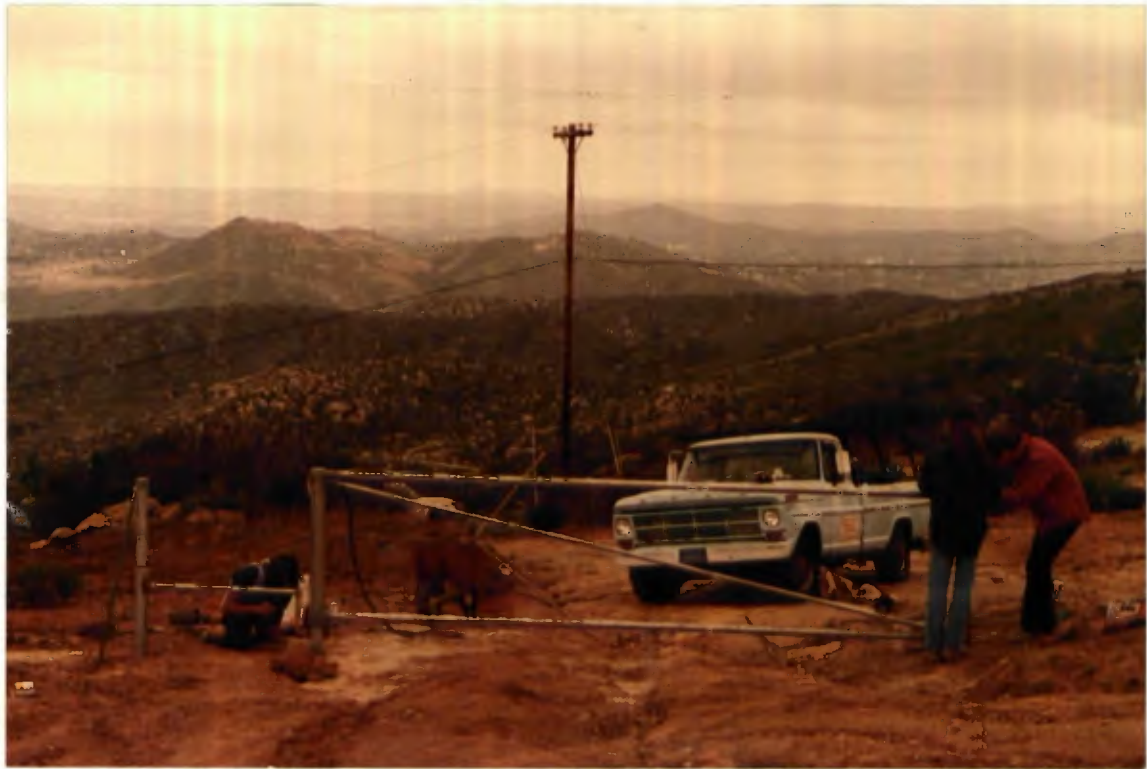
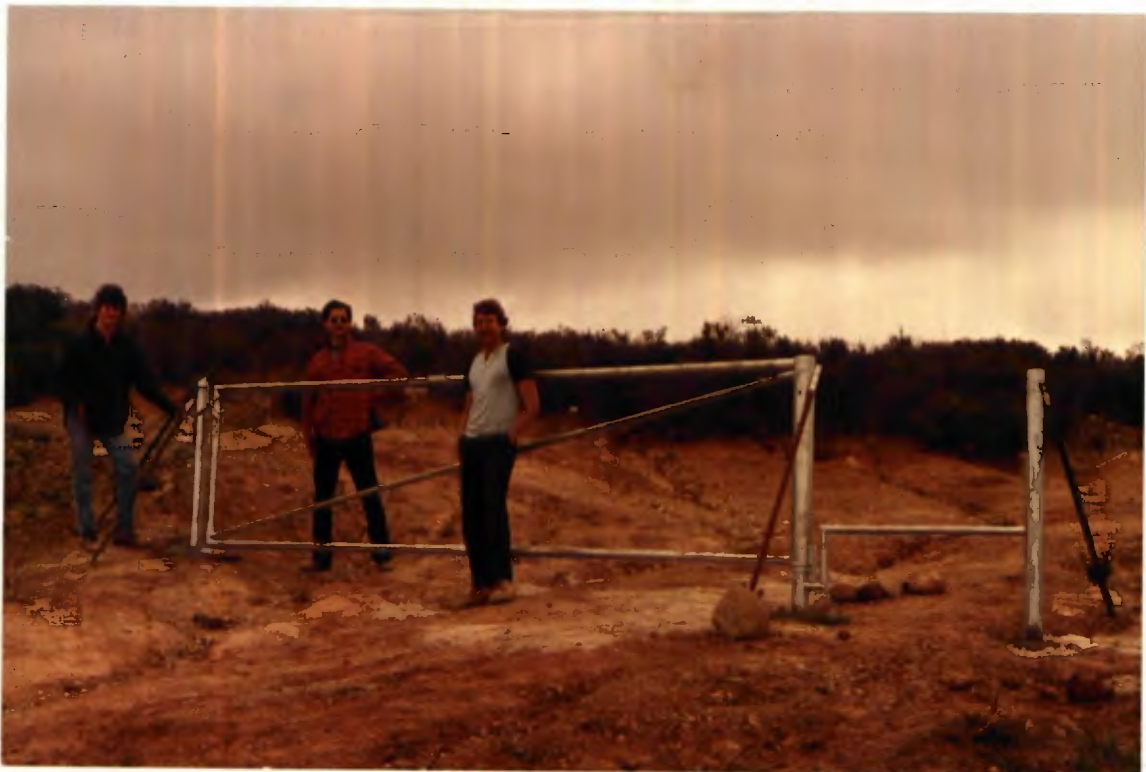
**Installation of metal gates at access points
of McGinty Mountain Preserve**

Gary Bell contracted for the construction of a heavy metal gate to secure the main access road to the site and installed the gate in April of 1991. Fences were installed lateral to the gate to prevent vehicles from simply skirting around the gate, creating increased erosion and continued access. Appropriate signs were placed at the gate to inform the public of access restrictions.

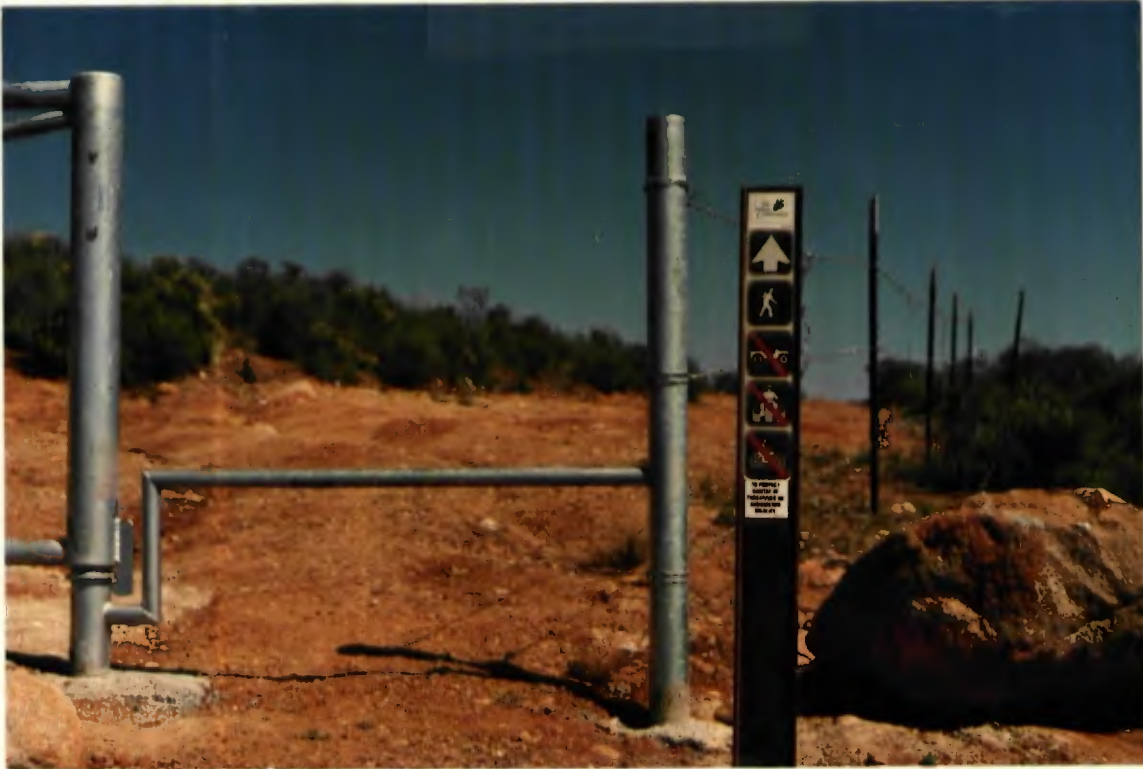
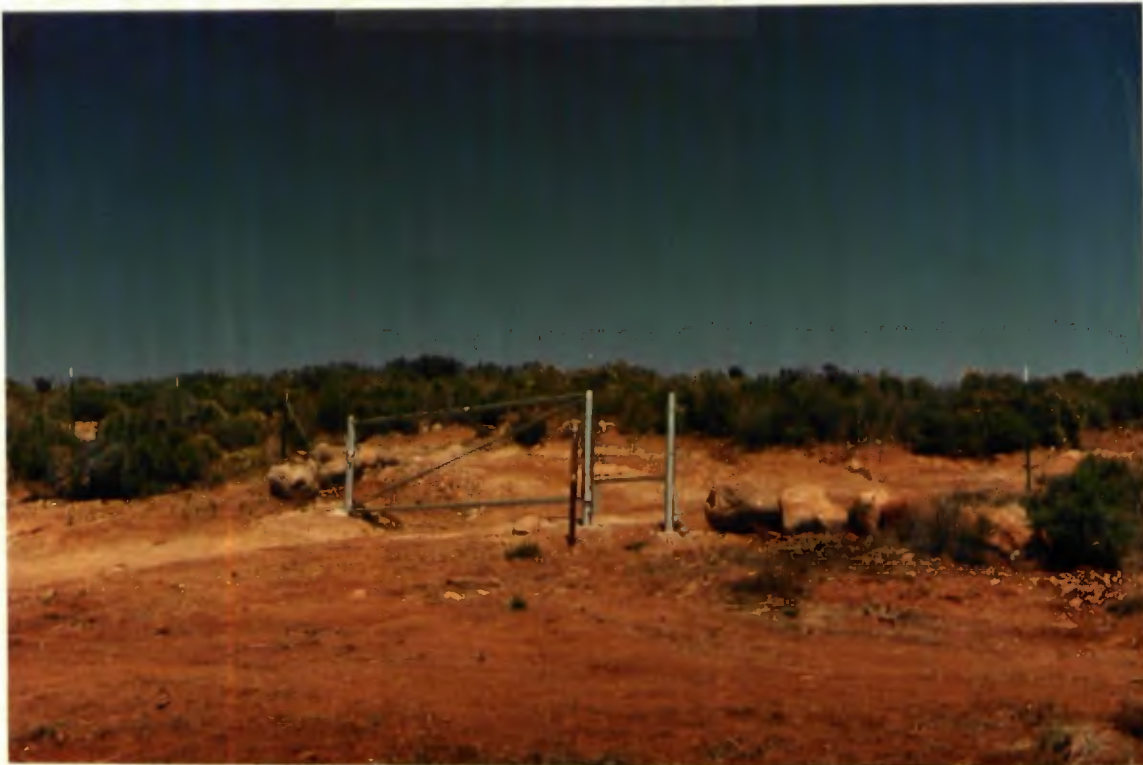
Access point closure gate, fence and sign

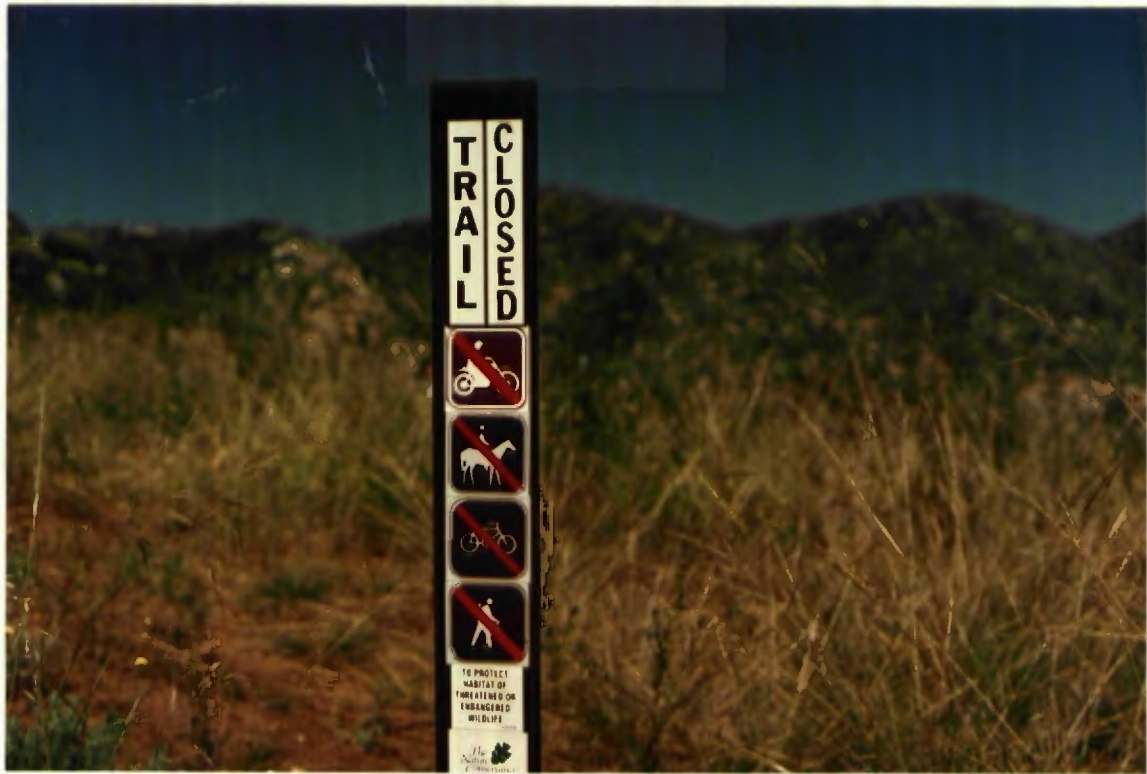
Trail sign through Diegan grassland

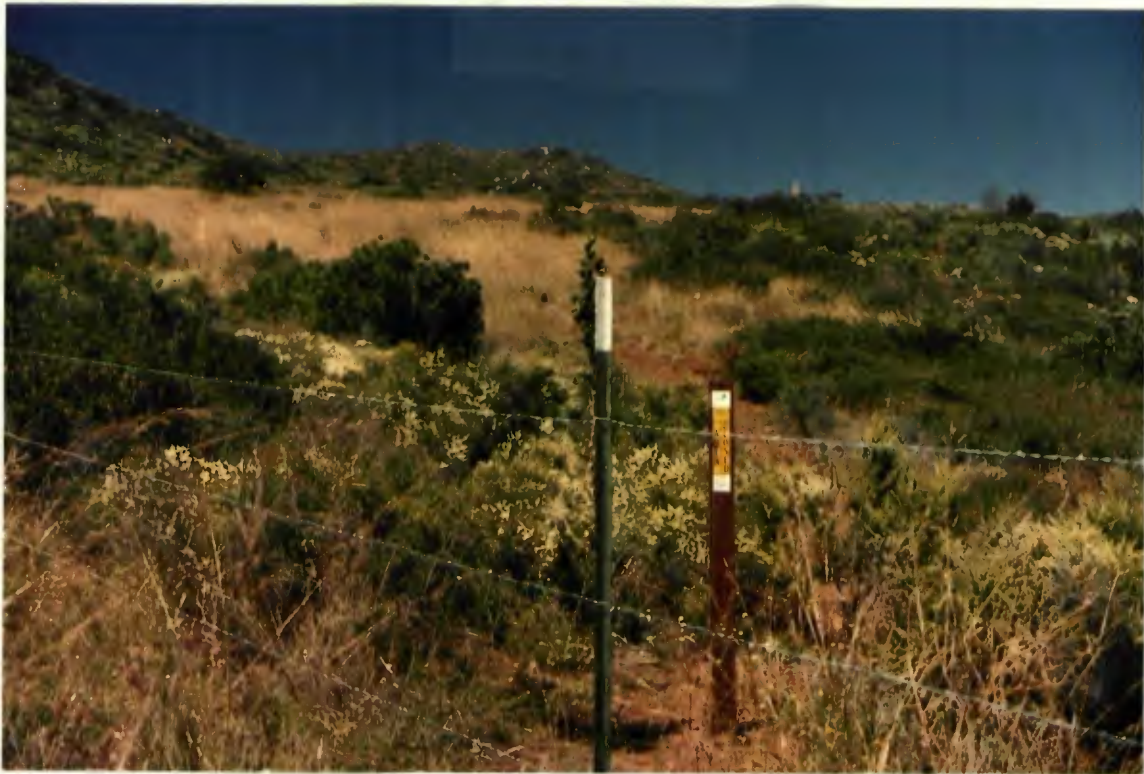
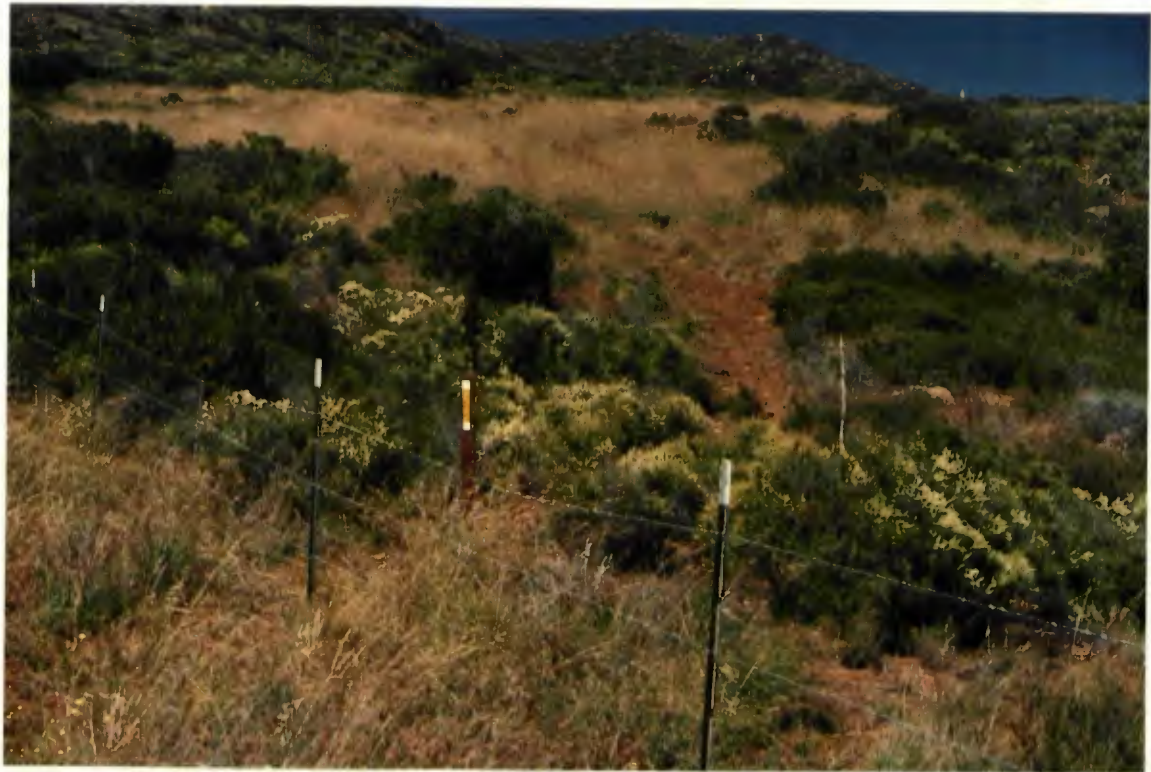
Native grassland closure fence and sign

Gary Bell, with interns, fenced access to the isolated, but rich, native needlegrass prairie. This grassland is dominated by Stipa diegoensis with Stipa pulchra as the co-dominant. It is located on expansive clay soils on the south face of the mountain. Within the grassland are typical Stipa prairie species such as Allium haematochiton, and Calochortus splendens. Also inside the fenced area, at the margin of the coastal sage scrub, is a population of about 20 Acanthomintha ilicifolia.

This site had been heavily damaged by horses in past years, but the fencing, plus appropriate signing should now eliminate that threat.

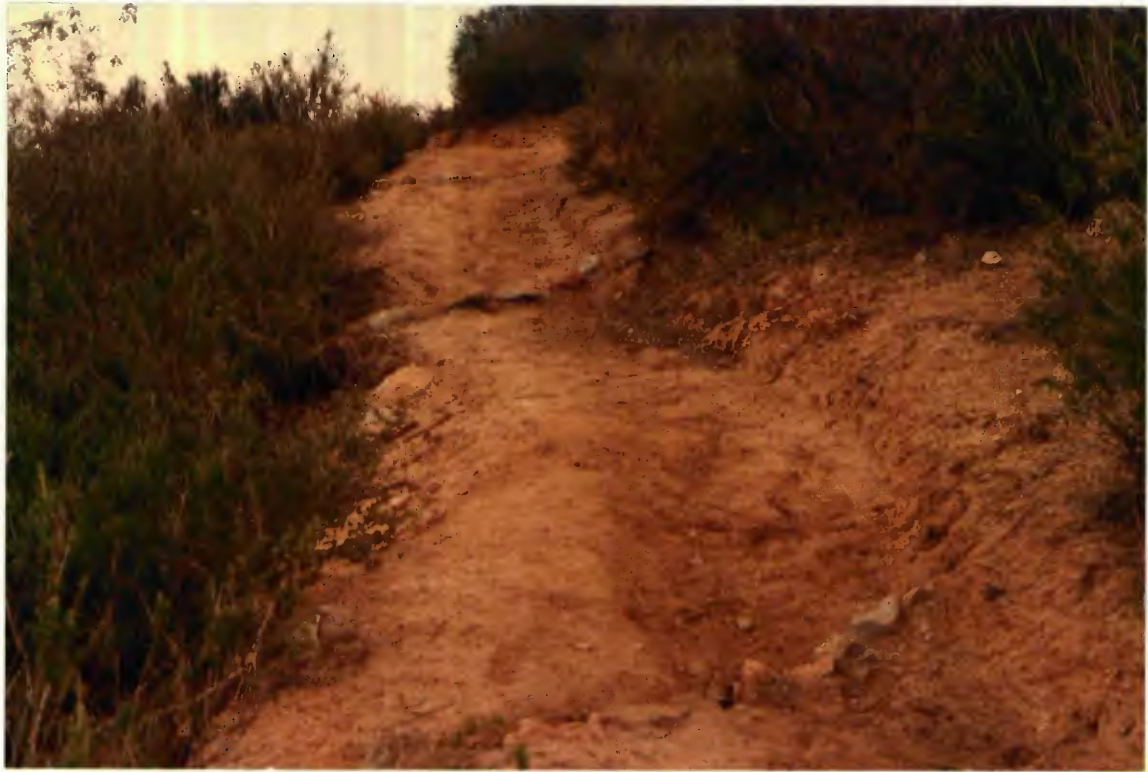
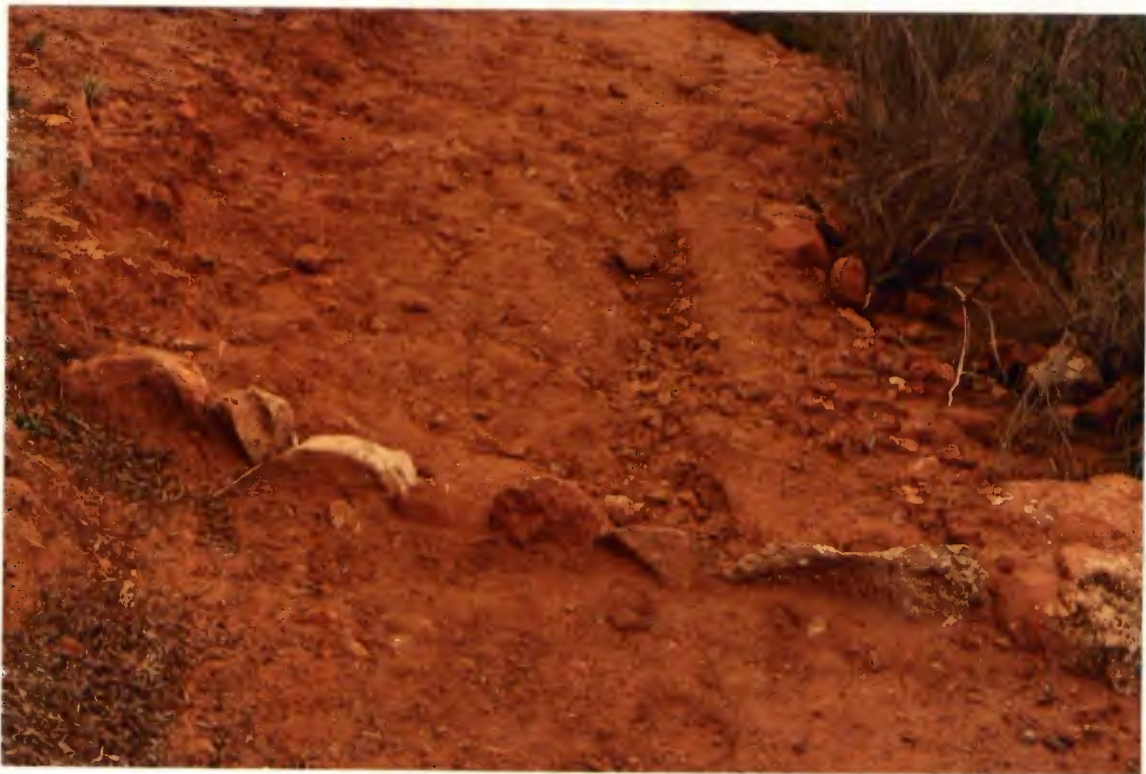
**Water bars for erosion control along the trail system
at McGinty Mountain Preserve**

Gary Bell used CCC crews to install a series of water bars across the main access trail to control water erosion. The water bars on the access trail are made of native rock collected along an old roadside on top of McGinty Mountain. The water bars are dug 12"-18" into the ground, and constructed at a slight angle into the slope to direct water off the trail. The bars are built every 20' to 100' depending upon the slope.

This system of water bars was completed before the torrential rains of February 27-28, 1991 and worked perfectly. There was almost no damage to the trail despite the 7+ inch downpour.
