# **The 2007 Mill Creek video station steelhead and spring-run Chinook salmon counts**

By  
Douglas Killam, CA Dept of Fish and Game: Northern Region  
Sacramento River Salmon and Steelhead Assessment Project  
And  
Matt Johnson, Pacific States Marine Fisheries Commission  
Sacramento River Salmon and Steelhead Assessment Project

SRSSAP Technical Report No. 08-1  
2008

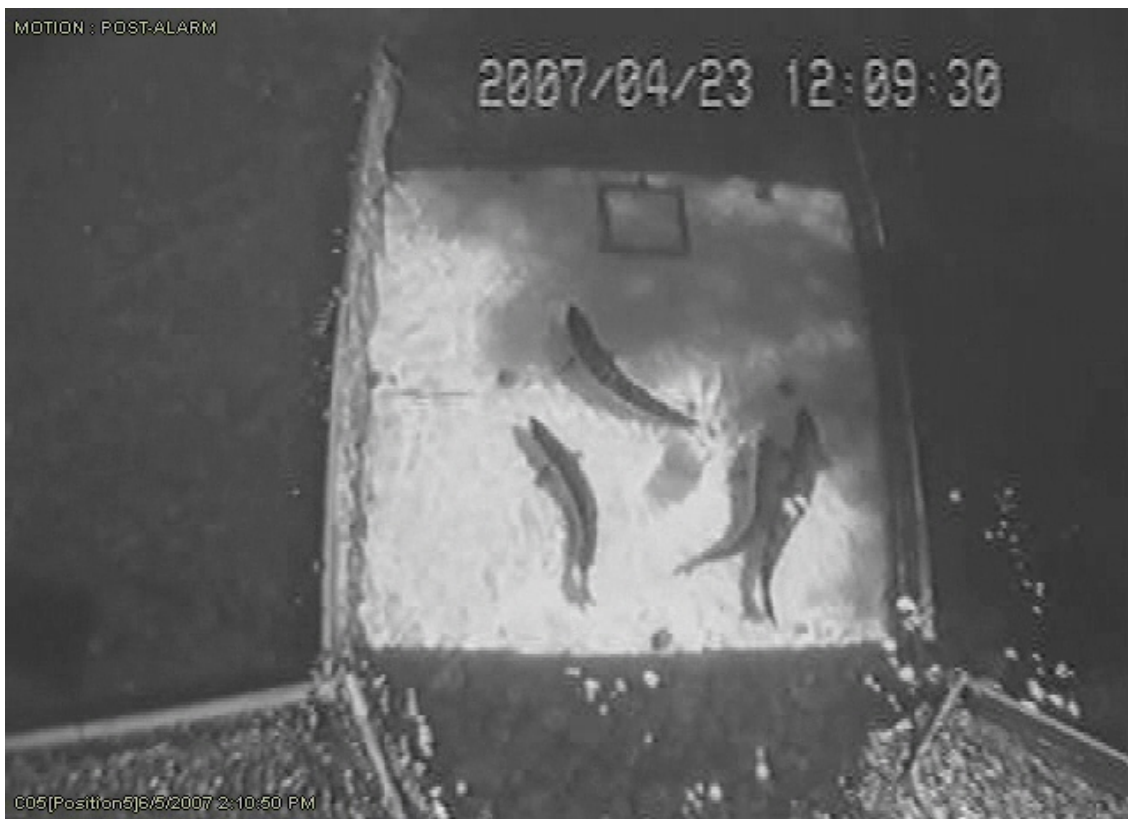
*Cover Photo: View from the overhead camera at the 2007 Mill Creek video station  
showing spring-run Chinook salmon swimming through the passageway at noon.*

White colored high density polyethylene (HDPE) sheets were staked to the creek bottom to make the observation of passing salmon easier. Two overlapping  $\frac{1}{4}$  inch by 4 by 8 feet (6mm x 1.2 m x 2.4 m) sheets were used to create a white background contrasting to the dark color of the passing fish, (Figures 3 and 4). These plates had  $\frac{3}{4}$ -inch (19mm) holes drilled around their perimeters to allow staking. Stakes were 24 inch concrete form stakes with a 2-inch (50mm) washer welded to their tops to secure the plates. A measuring device was constructed to allow tape readers to approximate the length of passing fish. A flat metal square measuring 16-inches (406mm) wide allowed tape readers to estimate fish lengths by comparison, (visible in the cover photo at top).

The goal of the video station was to collect data on steelhead in Mill Creek. The video station also collected surprisingly complete information on the spring-run Chinook salmon population (see cover photo) entering Mill Creek for spawning purposes later in the year. The Department's SRSSAP staff conducts redd surveys each year, typically occurring in October, to estimate an index of the population of spring-run salmon in Mill Creek. Crews walk the known spawning areas counting the number of salmon redds observed over the entire spawning period. The total count of new redds observed is multiplied by two (a hypothesized one female to one male ratio for each redd) to determine the total population estimate (Killam and Harvey Arrison, 2006). In 2007 the spring-run estimate for Mill Creek was 920 (Table 1) and was based on the redd count survey. The Mill Creek video station reported a total spring-run salmon count of 1,060 (Table 2). The difference between these two estimates is only 140 fish. Given the length of time elapsed between the two counts (4-5 months) and the likely mortality (otters, poachers, disease, etc) suffered by the holding salmon over that time, the two estimates are quite similar. Having two independent counting methods is a useful management tool in determining the suitability of either method. Since both methods resulted in similar estimates, managers can have confidence that either method alone should result in an accurate population estimate. The success of the video station on Mill Creek in counting spring-run salmon opens up possibilities of future stations on other creeks with spring-run populations.

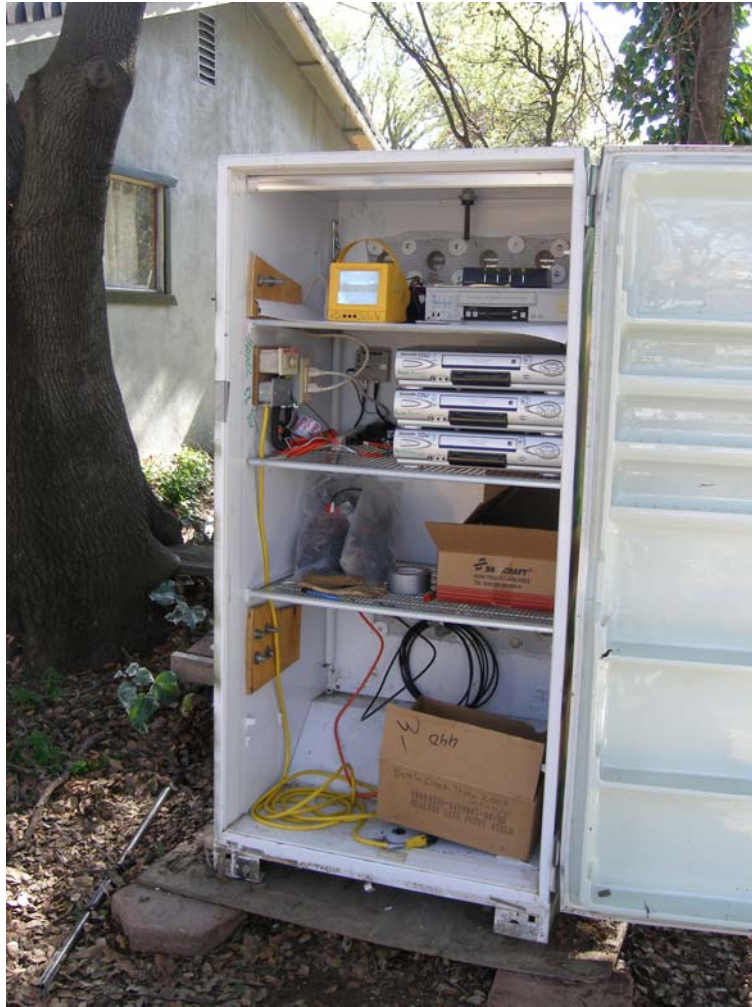
*Figure 2. Photo of the modified freezer used to house the VCR's, batteries, monitor, and other electronic components of the 2007 Mill Creek video station.*

One criteria of the Mill Creek Video Station was that it be located near a conventional power supply. The Mill Creek station did not have sufficient funding to purchase solar panels and related equipment similar to the remote Battle Creek station, so it was necessary to select a site with existing power. Mr. Johnson provided access to 120 volt household AC power via extension cord to the VCR lock box. The lock box (see Figure 2) was a modified stand up freezer that was purchased from an appliance store's salvage yard. Modifications to the freezer included vent holes, removing all refrigerant plumbing lines, and welding on a sturdy mechanism to allow secure locking of the freezer.

A back-up power supply was constructed to provide power for a 1-2 day period should a power outage occur in the regular power supply. The backup power supply consisted of 4 six-volt "golf cart type" batteries linked to provide a 12volt DC power supply to a conventional computer battery backup system. The original batteries from the 300 watt APC brand Uninterruptible Power Supply (UPS) were removed and the larger golf-cart batteries were connected giving a much greater power reserve if the grid power failed. All of the stations electronics were routed through the UPS to ensure continual video coverage in the event of a power failure.

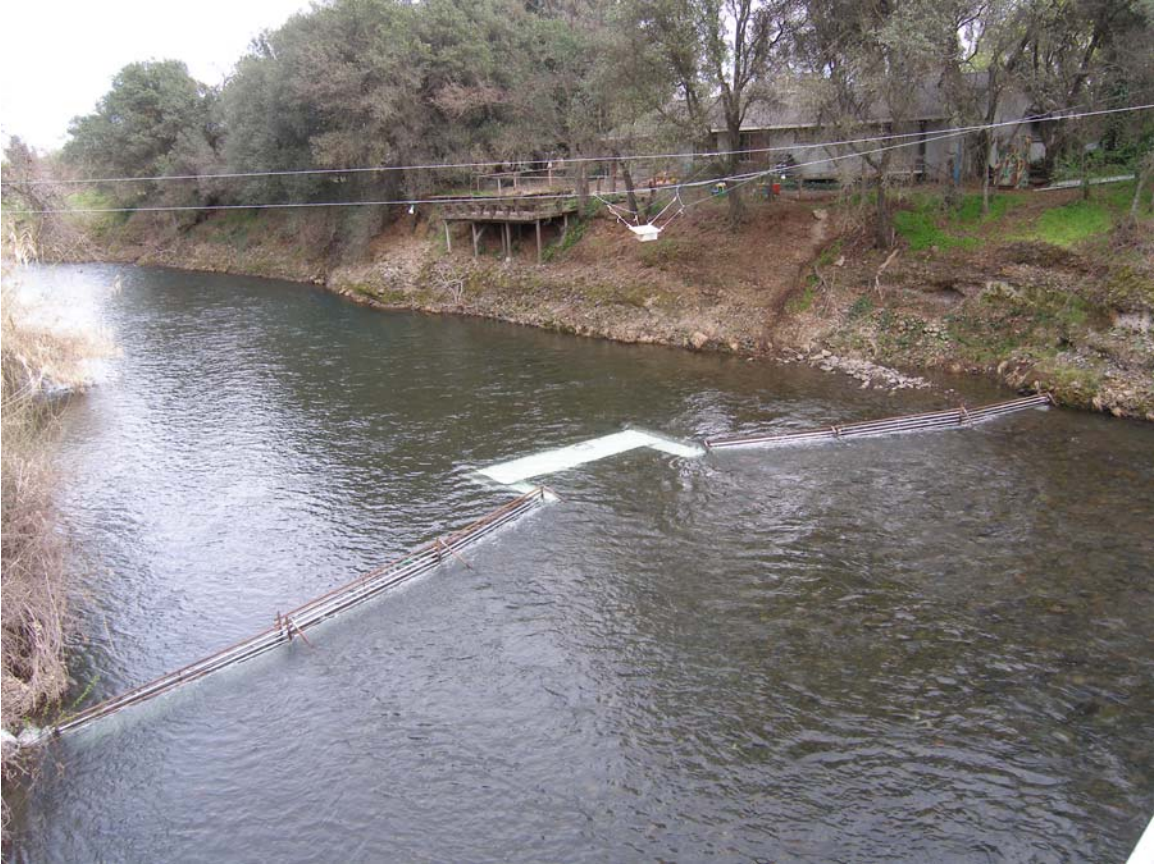
*Figure 3. Photo of 2007 Mill Creek video station from the Sherwood Avenue Bridge. Photo is looking upstream and shows weir, open area with white bottom plates, hanging camera, and lights.*

We selected a monochrome (black and white) camera (PC88WR) that provided good images in various lighting conditions. The low cost (\$115 from supercircuits.com) camera was vastly superior over other more expensive cameras in low-light situations (Killam 2006). The weatherproof PC88WR camera was attached to a "camera" box that contained remote lighting and other wiring hookups (visible in Figure 3).

A weir was constructed to channel salmon into the camera's view without causing passage delay (Figures 3 and 4). The weir was constructed of ten-foot (3m) long steel  $1\frac{1}{8}$  inch O.D. (28mm) pipes which were welded to uprights with 3" (76mm) spaces between pipes. Some taller panels used  $1\frac{1}{4}$  inch EMT conduit on the inner cross members to lighten the overall weight of the finished panel. The 10-foot (3m) wide horizontal pipe panels were designed to fit the depth of Mill Creek at the station site (i.e. panels in shallow water had only 5 or 6 cross members while panels in deeper water had up to 12 cross members). The horizontal design and spacing between bars of the weir panels allowed smaller fish and most leaves and sticks to pass through the weir while preventing large fish from passing the weir unmonitored. Six weir panels configured in a slight "V" shape facing upstream to guide fish to the center opening (Figure 3) were secured in place using downstream angled braces that provided vertical support to each panel. The braces consisted of pipe similar to the panel pipe that slid through slightly larger "dog leg" pipe fittings that attached inside the top rail of each panel allowing the entire weir to be set-up without the addition of any difficult to remove t-post fence stakes into the stream bottom.

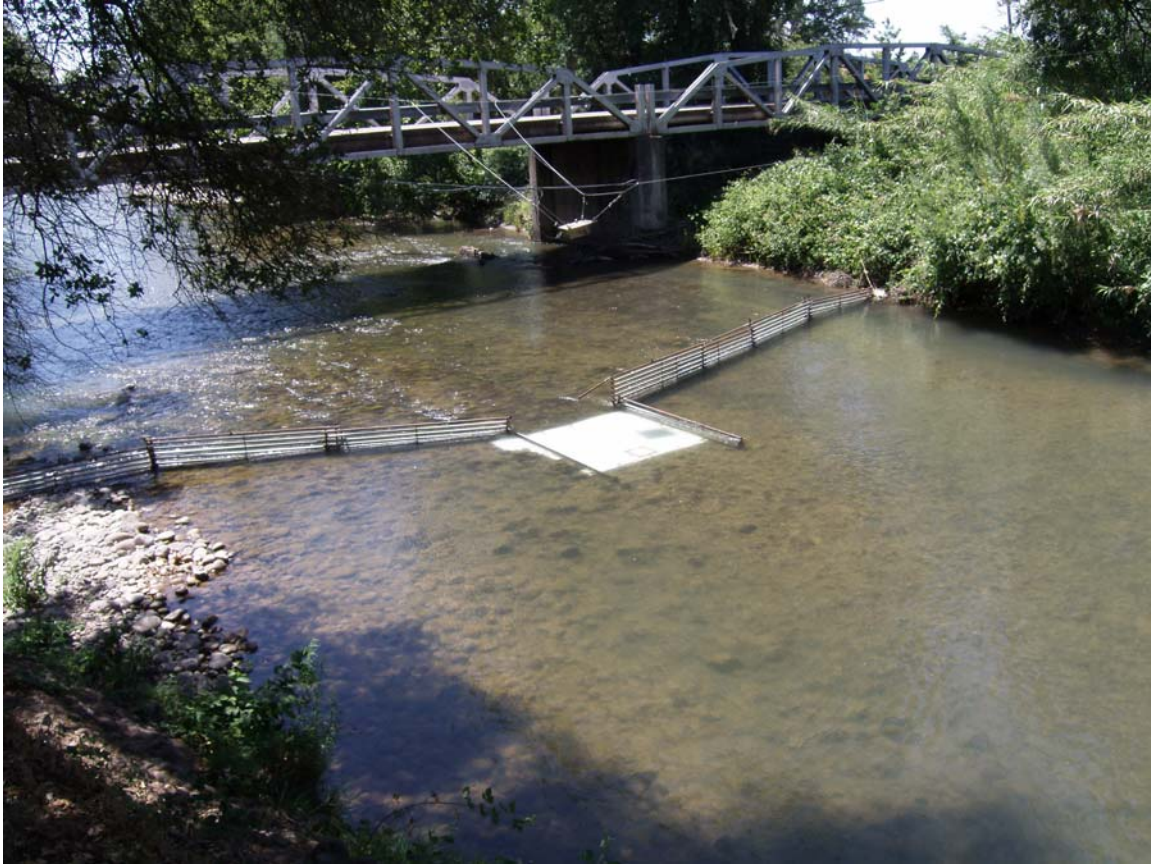
*Figure 4. Photo of 2007 Mill Creek video station. Photo is looking downstream and shows weir, open area with the narrow configuration of white bottom plates, and upstream facing guidance panels to ensure fish swim through the area of white bottom.*

Two weir panels were added as upstream facing guidance panels along the fish passage opening to prevent fish from skirting around the ends of the weir (visible in Figure 4). These guidance panels were placed along the outside edges of the white bottom plates just under the water surface and resulted in most fish swimming upstream along the entire length of the plates allowing for easier counting compared to similar weirs without these guidance panels (e.g. Battle Creek in 2003, (Killam 2006)).

Two configurations of the white bottom plates were used in 2007 in Mill Creek. The first configuration used early in the season was 16 feet wide (4.9m) and 4 feet (1.2m) deep (seen in Figure 3). This configuration was used to maximize the opening in the creek to allow potential high rain and snow melt flows an opportunity to pass through the station without damaging the ability of the weir panels to restrict fish passage outside of the camera image. The second configuration of white plates was used after the risk of potential high flows was minimized following a very dry water year. The second configuration measured 8 feet (2.4m) wide by 8 feet (2.4m) deep (seen in Figure 4). This configuration allowed better visibility of fast moving fish by tape readers since the fish were over the white plates for a longer period.

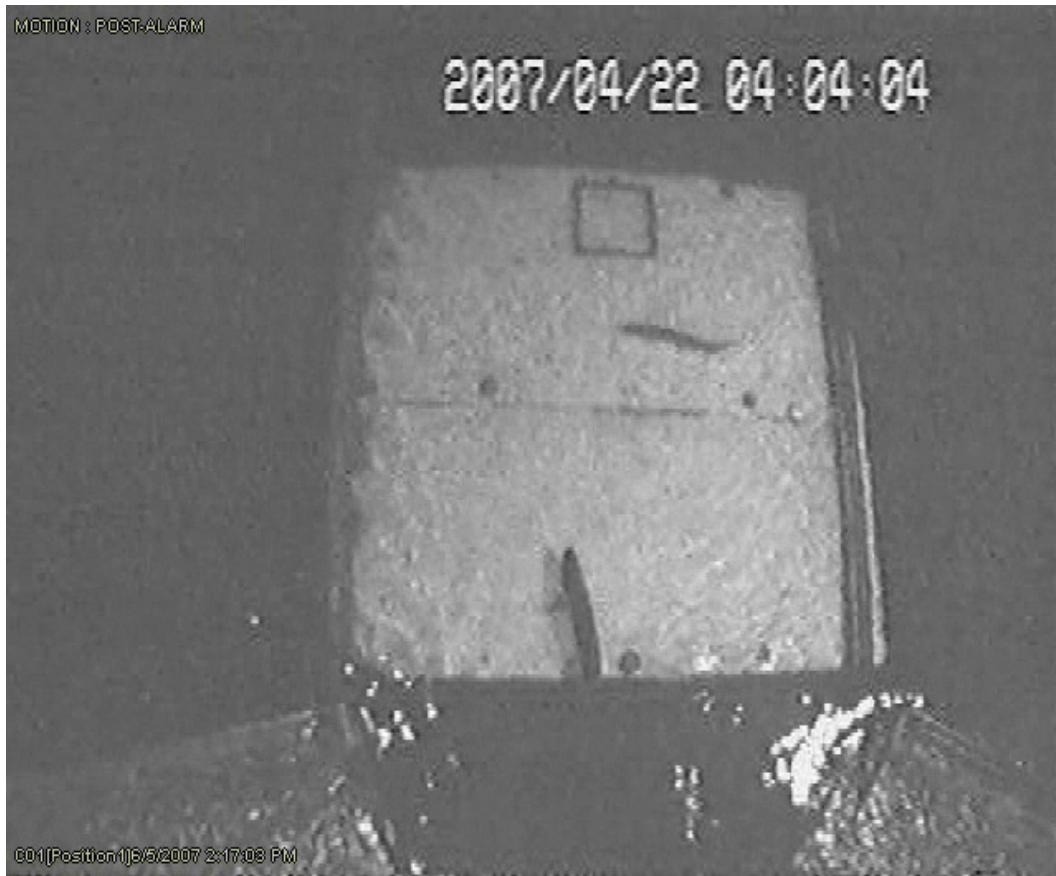
Figure 5. Image taken from Mill Creek overhead camera of steelhead kelt and Chinook salmon on 22 April, 2007 at 04:04 AM.

The data summarized in tables 2 -4 detail the phenomenon of a previously un-monitored out migration of steelhead adults (kelts) from Mill Creek. Visual identification of these targets was very confident by all tape viewers, and we had positive identification and correlation with the underwater camera image. Steelhead appear to be long and slender on their migration downstream and move with rapid, deliberate movements, unlike other species that we commonly observed (e.g. Sacramento suckers). Figure 5 is an image of a steelhead kelt and a Chinook salmon captured by the overhead camera. The downstream migration of steelhead documented in our study likely represents the completion of spawning and out-migration of a run of steelhead that entered Mill Creek before the 6 March installation of the video station. Peak out-migration of these fish occurred during early May. Little or no data exists on steelhead out migration in Mill Creek. Typically traps and fish ladders are well suited for collecting upstream migrants but not downstream traveling fish, since most fish are not funneled into the typically narrow upstream opening of a fish ladder or trap. The weir at the video station was only a few inches (see Figure 3) above the surface of the water and had no provisions to prevent fish from jumping over it, but the weir itself was apparently enough of a barrier to steer at least some portion of the steelhead kelts (145 fish) through the counting area.

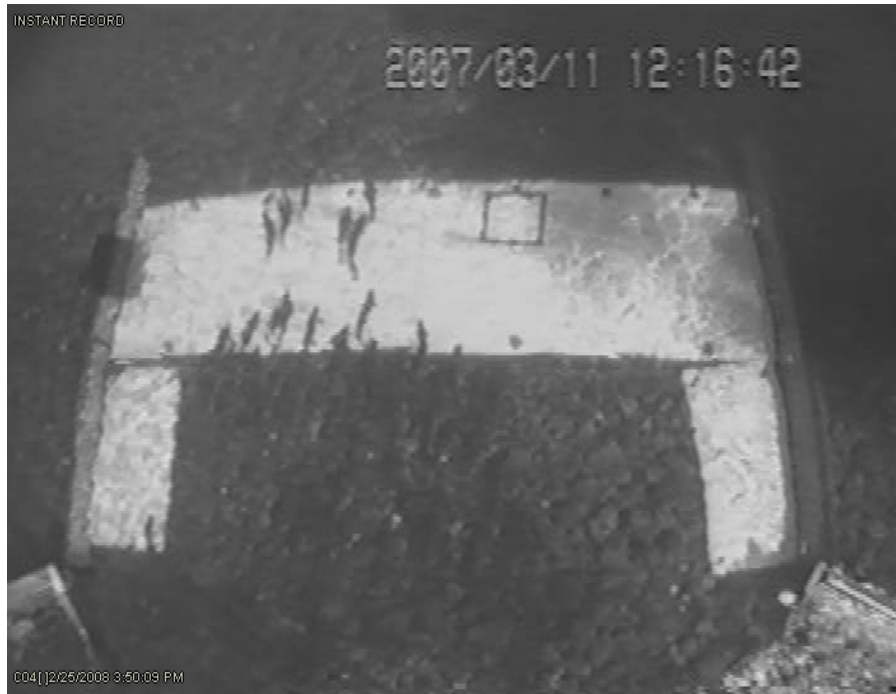
*Figure 6. Image of Sacramento suckers passing upstream at the Mill Creek 2007 video station.*

The most abundant species observed during monitoring efforts was the Sacramento sucker. Large schools of these fish numbering in the hundreds could be viewed passing through the weir opening on a regular basis starting in early March and lasting into early May. These fish were seen feeding on the stream bottom alongside the area of the white plates and would linger in the camera view for long periods of time (see Figure 6). Pacific lamprey (*Lampetra tridentate*) were often seen in late April to early May going both up and downstream (see Figure 7). Other fish that were observed were large cyprinids thought to be either Sacramento pikeminnow or hardhead (impossible to distinguish between the two from camera image). Also observed frequently were bird species including: common merganser, mallard, great blue heron, great egret, and belted kingfisher. Mammals observed included beavers, and river otters.

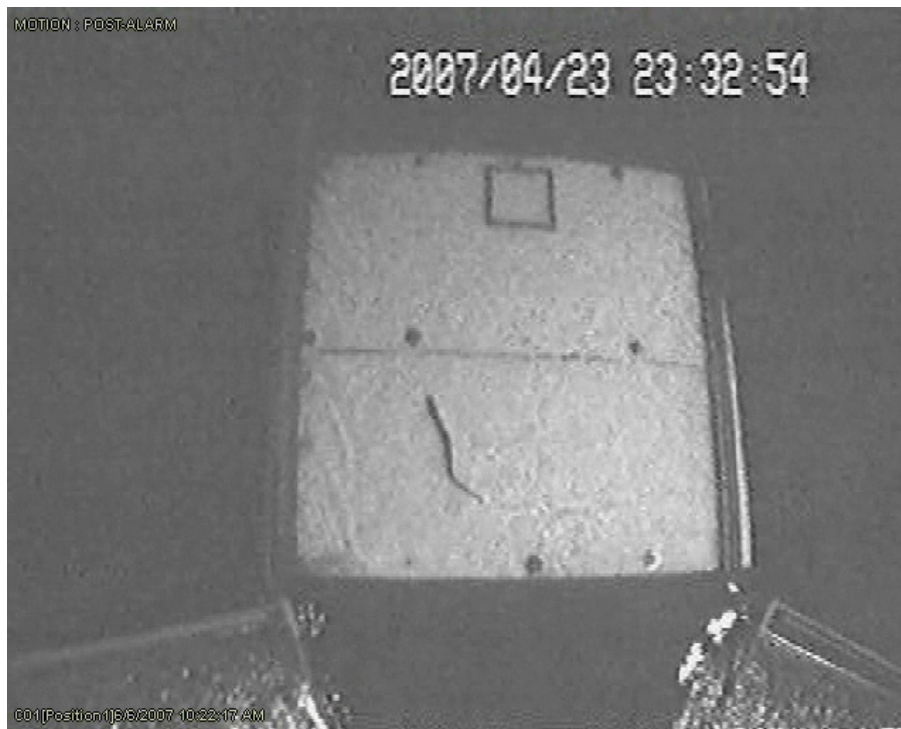
*Figure 7. Image of a Pacific lamprey passing upstream at the Mill Creek 2007 video station.*
