California MLPA Master Plan Science Advisory Team
Draft Recommendations for Evaluating Water and Sediment Quality Along
the Palos Verdes Shelf – Supplemental Guidance to the Draft
Recommendations for Considering Water Quality and Marine Protected
Areas in the MLPA South Coast Study Region
Draft revised June 17, 2009

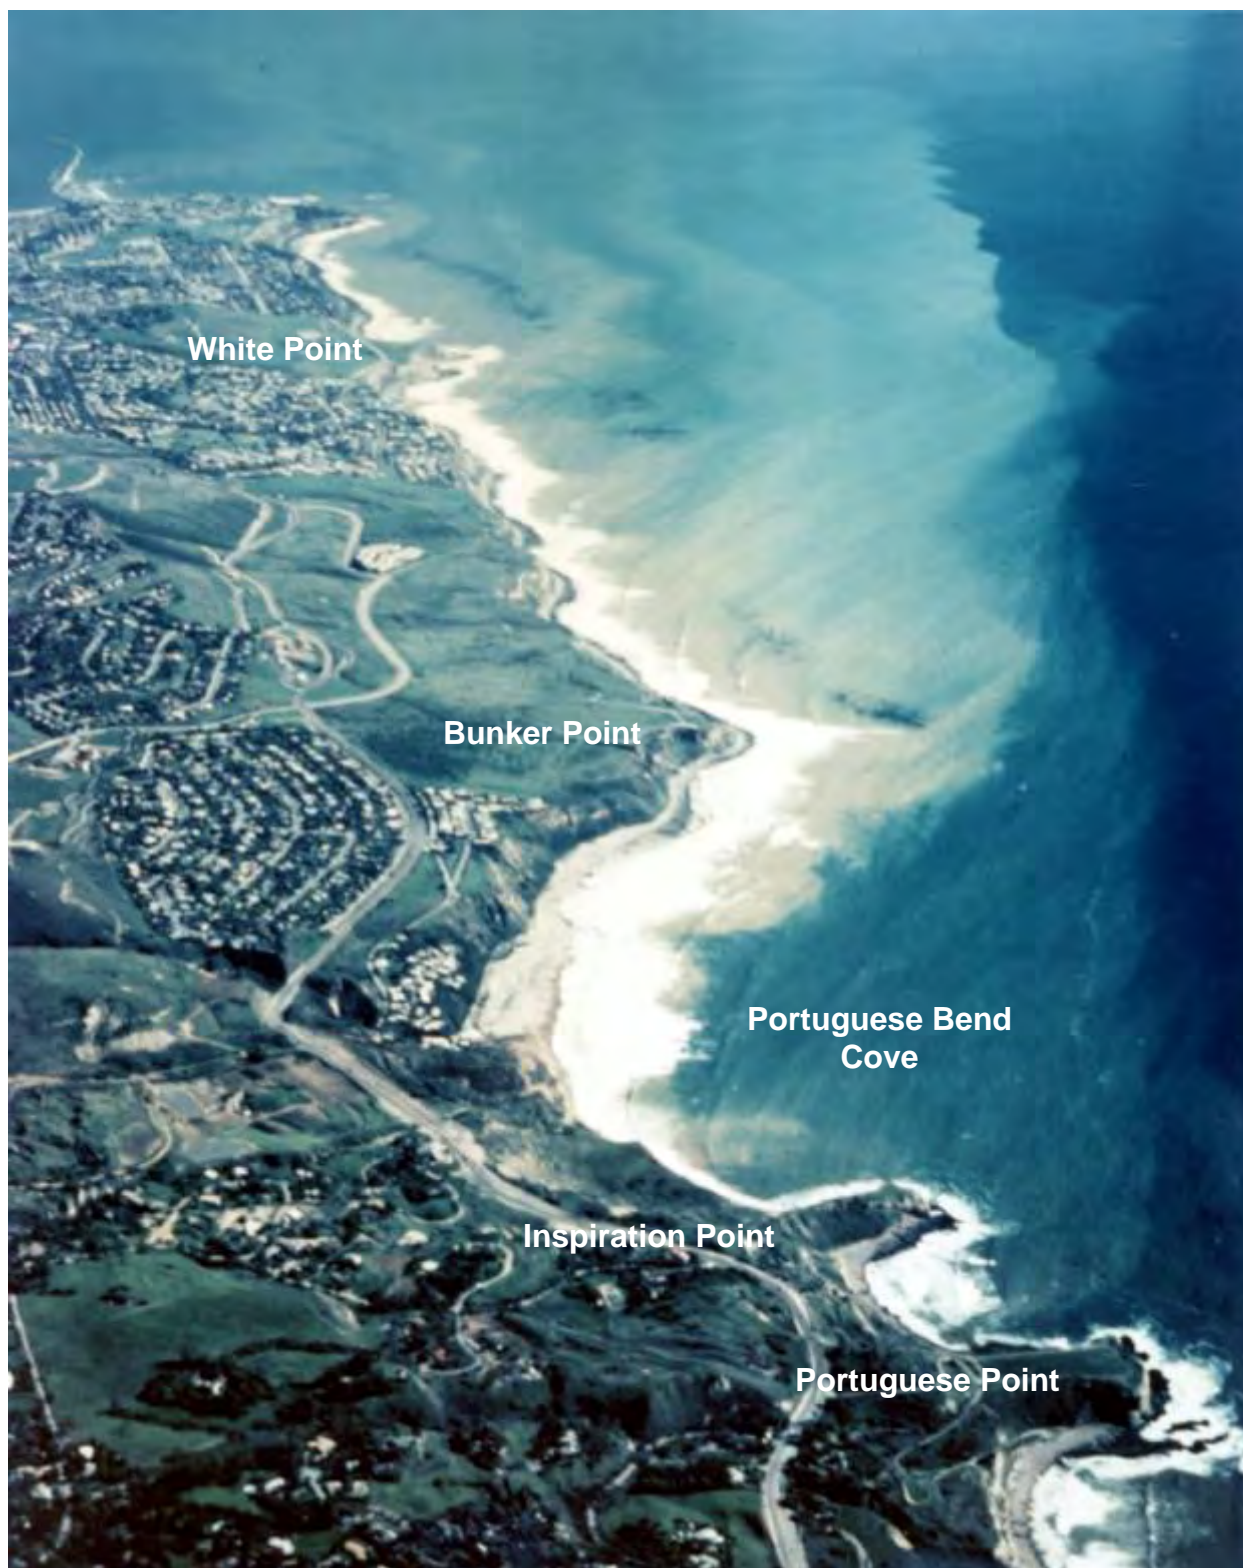
Figure 4. Example of turbidity plume from the Portuguese Bend Landslide. Photograph taken sometime in the 1980s, although similar plumes can still be observed today.

The Portuguese Bend Landslide occupies a 1.06 km² portion of the PV Peninsula. It is estimated that from 1956 to 1999 the landslide has contributed between 5.7 to 9.4 million metric tons of sediment to the inner shelf.¹⁶ A sediment plume has been visible in the waters off Portuguese Bend since the reactivation of the landslide in 1956 (Figure 4). The direction of the sediment plume is usually towards the southeast and during heavy erosion events may extend out to 1.5 km¹⁶. The sedimentation from the landslide reaches as far south as White Point, where it is known to mix with the wastewater effluent, and thus enlarging the sediment deposit on the highly contaminated solids that were discharged from the outfalls¹⁶. This sedimentation continues to bury rocky reefs in this region (Figure 5). In addition, the longshore current does shift causing the sediment plume sometimes to extend upcoast to Long Point. The Portuguese Bend landslide is a major source of sediments to the rocky subtidal and intertidal environment¹⁹.

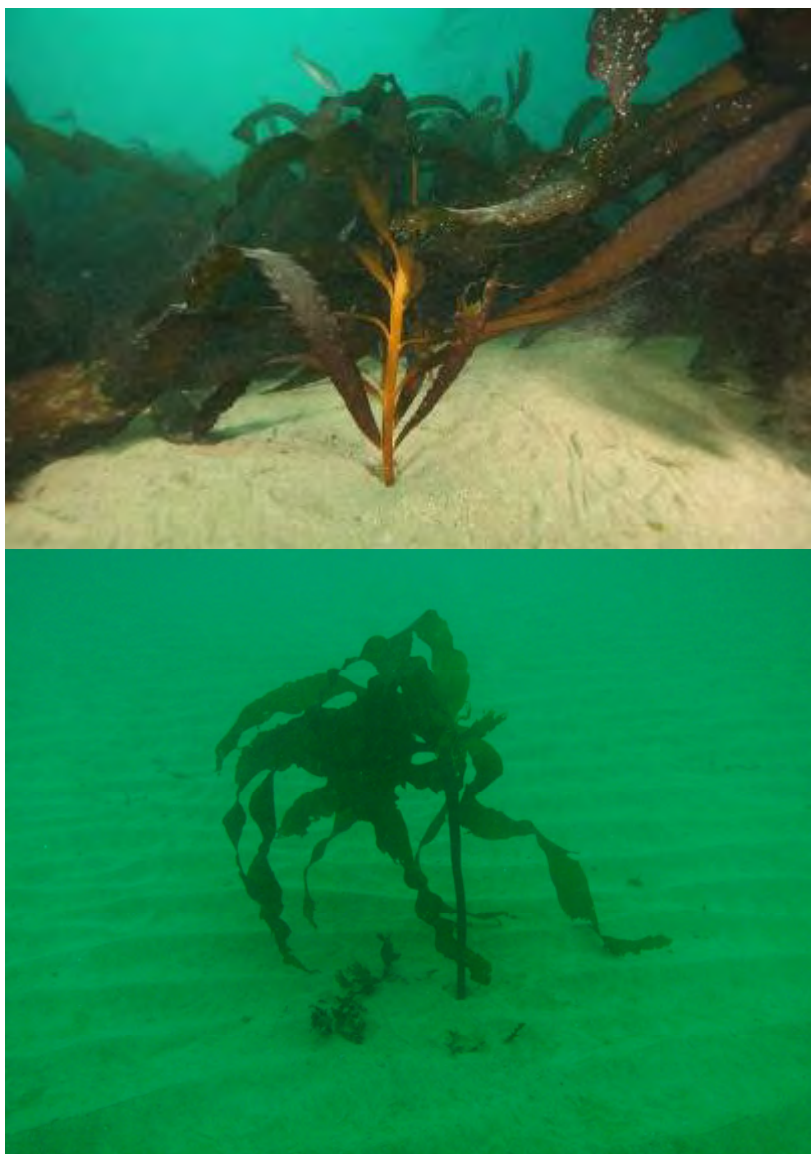
Figure 5. Examples of buried reef at Bunker Point (above), October 22, 2008 and White Point (below), June 3, 2009.
