Dibble Creek Fishway Modifications

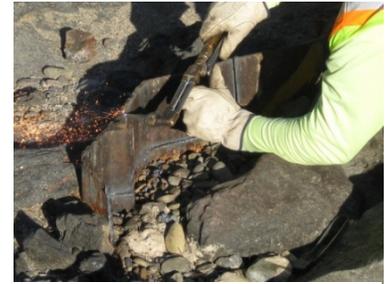
Figure 1: Cutting Low Flow Notch

- A low flow notch was cut in the sheet piles on the upstream end of the fishway.
- Under the direction of Kevin Gale, weir 2 was reconstructed, and the center boulder on weir 1 was replaced with another that better fit the low flow elevation.
- A grade control structure was constructed at the downstream pool tailwater control.
- Rock (1/4 ton to 1 ton) was placed on the south bank, just downstream of the fishway, to repair an area where the bank was beginning to erode.
- Loose rocks in the bottoms of the pools were used to fill gaps between the boulders in the weirs and the longitudinal berm along the north side of the fishway.
- Streambed material (gravel and fines) was placed on the weirs and jetted into the voids with a high pressure water hose.
- A mix of streambed material and 1/4 ton to 2 ton rock was used to build up and reinforce the longitudinal berm.

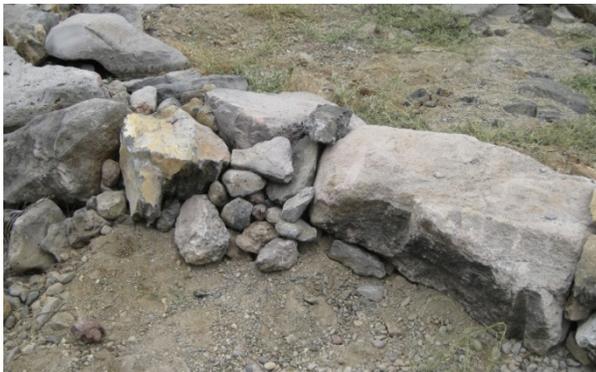
Figure 2: Weir 2 Looking Downstream

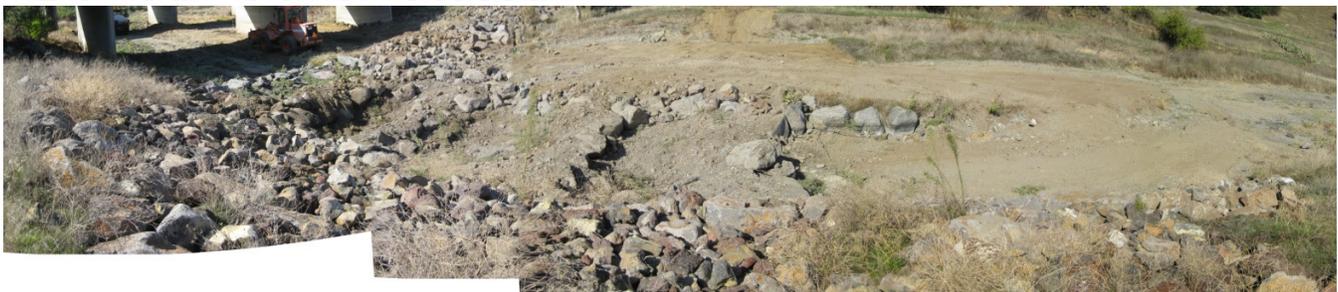
Figure 3: Fishway Flow Left to Right
