Año Nuevo Island Seabird Habitat Restoration Final Report: 2009 - 2011

Created by: Michelle Hester, Ryan Carle, and Jessie Beck
Oikonos - Ecosystem Knowledge
Contact: michelle@oikonos.org
www.oikonos.org (415) 868-1399

NFWF Contracts: 2008-0073-021, -022, -038, -050

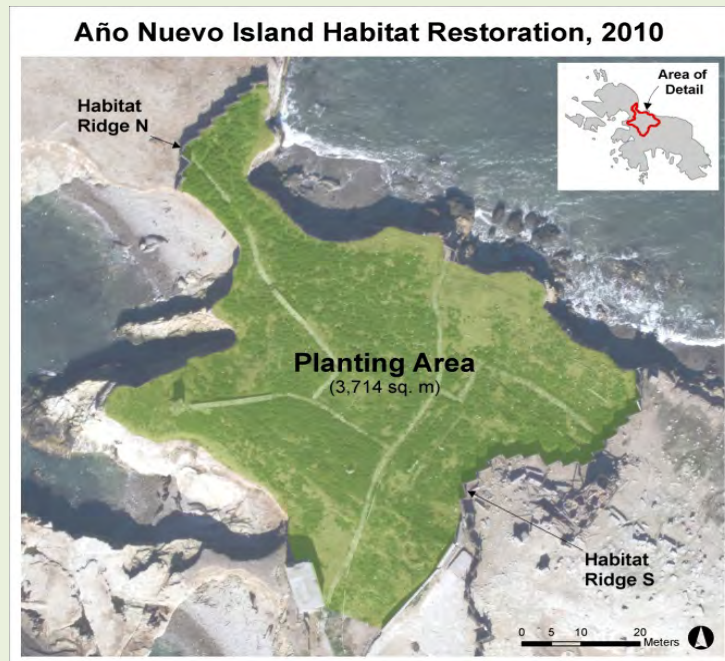
The central marine terrace was selected for restoration because it harbours the majority of the burrowing seabirds and the highest elevation with soil on the island. The target area was approximately one acre. In 2011, we expanded the restoration treatments to an additional 0.25 acres where Cassin's Auklet nesting is concentrated (not shown above).

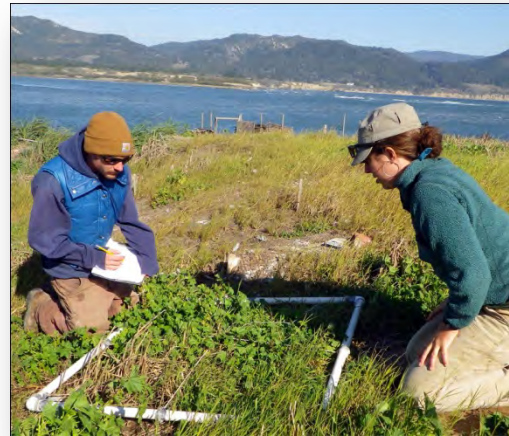
Photo: Ryan and Jessie collecting vegetation cover data to quantify restoration progress.

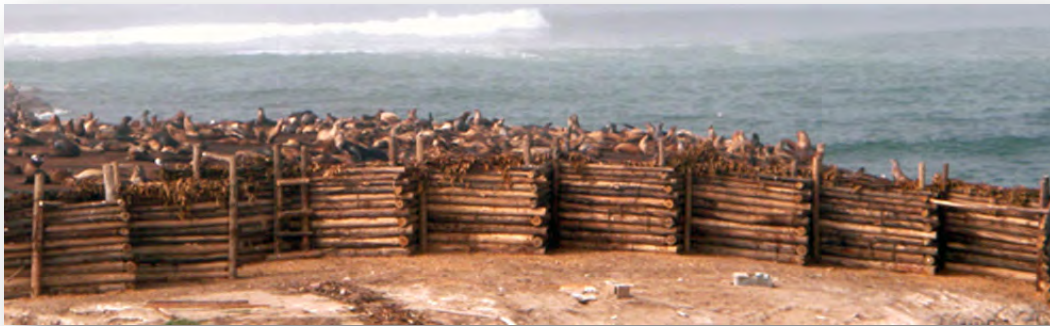
Photo: Habitat Ridge built across the North Terrace with California Sea Lions in the background.

We carefully chose locally sourced, bio-degradable, and site sensitive construction materials for the *Ridge*. The final design was built entirely from Eucalyptus logs, wooden dowels, and installed on the island in October-November 2010 and 2011. When the lifespan of the *Ridge* has expired, these materials will become driftwood rather than toxic trash. The materials and design also match the color and contours of the island, making the *Ridge* blend in from the mainland. We constructed four gates for human access with reclaimed redwood and recycled stainless steel hinges (the only metal used in the entire *Ridge*) forged by master blacksmith David Calleri.

Designing and building this unique structure required extensive efforts spanning four years. Ridge prototypes were developed on the mainland at a site provided by the Peninsula Open Space Trust. Go Native, Rebar, Oikonos, and volunteers experimented for a year before deciding on the final Ridge design. The Santa Cruz District State Parks natural resource crew cut over 1,000 eucalyptus logs from the

In the year since installation, the *Habitat Ridge* has been proven to be effective. There have been zero sea lion intrusions into the restoration area, no wildlife injuries, and no design concerns associated with the structure. In 2011 Brandt's Cormorants nested against the outside wall of the southern portion of the *Ridge*, taking advantage of the visual barrier from human activity that it provides.

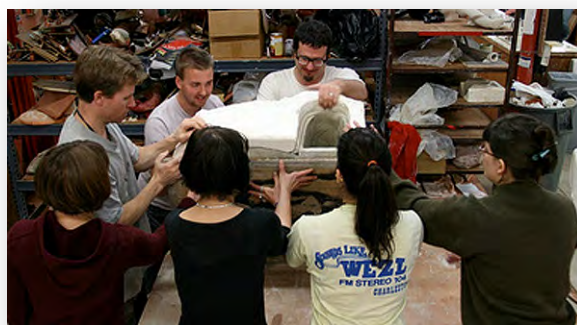
Photo: The CCA students and instructors remove the plaster from a clay module before firing.

In the spring semester of 2010, an interdisciplinary design course at the California College of the Arts in Oakland (CCA) was taught by project partners Nathan Lynch and Rebar with the goal to design, create, and deploy a new, sustainable, reproducible system of nest modules. The modules were built using clay-based "grog" - a strong, porous type of clay that has the consistency of sand. Nathan Lynch, the chair of the CCA Ceramics Department, provided matching support in the form of ceramic studio access, mold materials, and significant kiln costs for firing 90 large modules (reserving some for outreach).

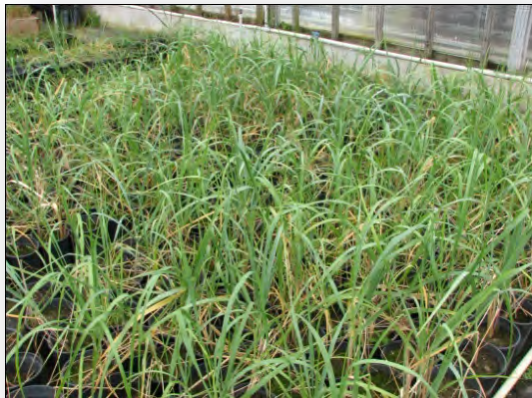
Photo: American dune grass (Elymus mollis) growing in Go Native's greenhouse in preparation for island restoration. This is one of the key native plants adapted to salt, wind and excellent at stabilizing loose sandy soil.

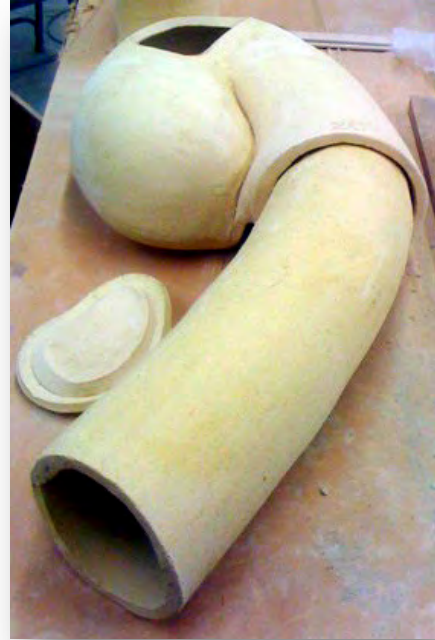
Photo: The final Rhinoceros Auklet nest module design installed underground on Año Nuevo Island.

We replaced wooden nest boxes with 87 clay nest modules for Rhinoceros Auklets that are able to withstand trampling by sea lions, require minimal maintenance, and allow researcher access to the nest cavity. The modules augment existing breeding habitat by acting as 'permanent' nest sites below ground. Over the last 13 years, we have documented that Rhinoceros Auklets will successfully raise young in artificial nests on Año Nuevo Island (*Occupancy Graph* page 12). The design of the new clay modules addressed the problems with previously used wooden and plastic boxes that required regular maintenance, were prone to flooding and high temperatures, and had a short lifespan (3 - 5 yrs).

Five nest module prototypes designed by students in the class were installed in April 2010 in the restoration area. A pair of auklets successfully fledged a chick in one of the prototypes in summer 2010, demonstrating that the modules are suitable breeding sites. One design was created incorporating the best ideas from the prototypes and consisted of a curved nest chamber and a detachable entrance tunnel. A two-piece design was decided on for ease of transport and adaptability in sloping terrain. We installed 87 underground in the restoration area in November 2010.

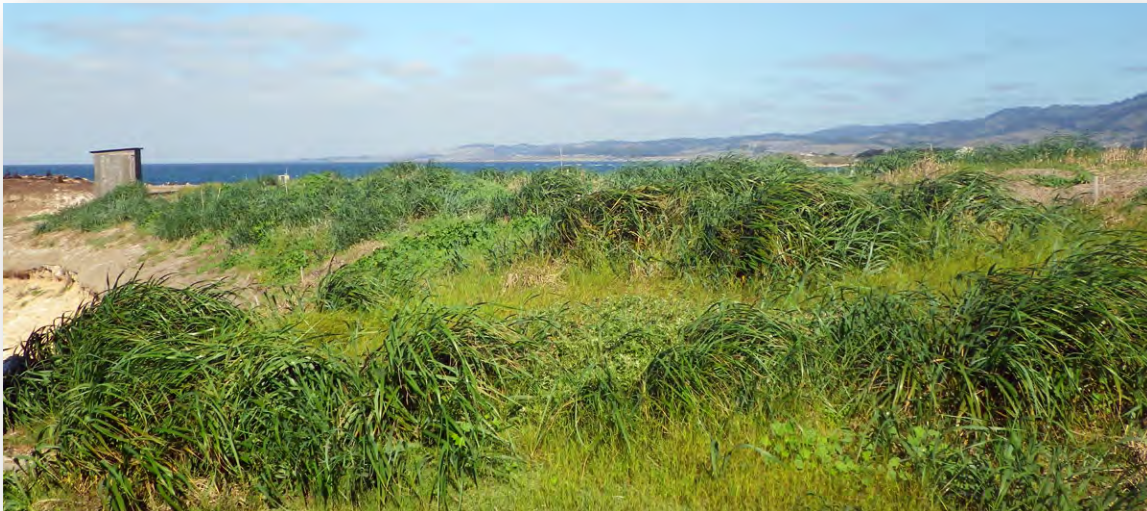
Photo: The restoration plot on Año Nuevo Island with the highest density of Rhinoceros Auklet burrows (Area 5) in November 2011. The dominant native vegetation was dune grass (34%) and salt grass (24%).

Results: Prior to the plant installments in November 2010, vegetation cover was between zero and 15% in the central terrace nesting areas. The most recent survey (conducted 1 November 2011) documented percent cover of live vegetation was over 35% in all areas (minimum 36% and maximum 81%, *Plant Cover* table page 10). The two areas with the highest density of Rhinoceros Auklet nests (Areas 5 and 7) had 56 and 81% coverage of live plants.

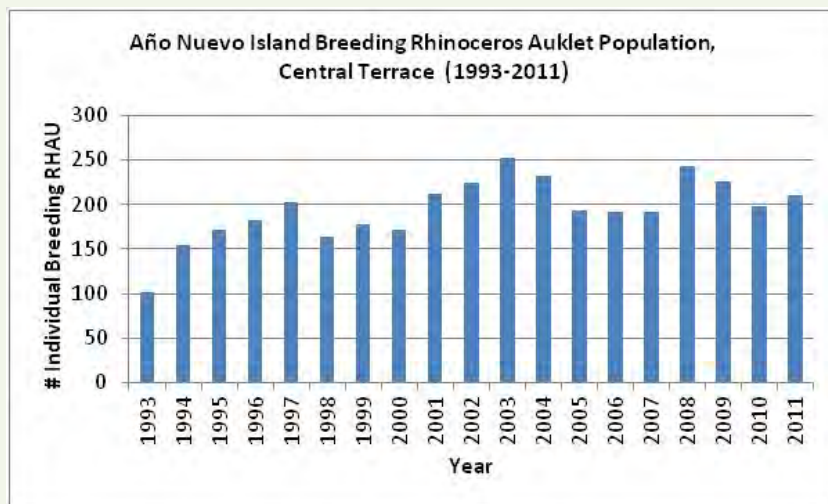
Rhinoceros Auklets were first documented breeding on Año Nuevo Island in 1982. Since then the population has increased and fluctuated annually. The estimated total island breeding population in 2011 was 242 birds (210 in the restoration area or central terrace shown in the trend graph above).

The estimated annual population of breeding Rhinoceros Auklets in the restoration area (central terrace) was 226 in 2009, 198 in 2010, and 210 in 2011. The central terrace population grew from 102 birds in 1993 to 212 birds in 2001, and then fluctuated at around 200 birds. In the period from 2002 to 2011 the population minimum was 192 in 2006 and 2007 and the maximum was 252 in 2003.
