State of California  
The Resources Agency  
DEPARTMENT OF FISH AND GAME

California Wild Trout Program  
HAT CREEK WILD TROUT MANAGEMENT PLAN  
1998 - 2003

John M. Deinstadt  
Fisheries Programs Branch

Michael A. Berry  
Northern California - North Coast Region, Fisheries Program

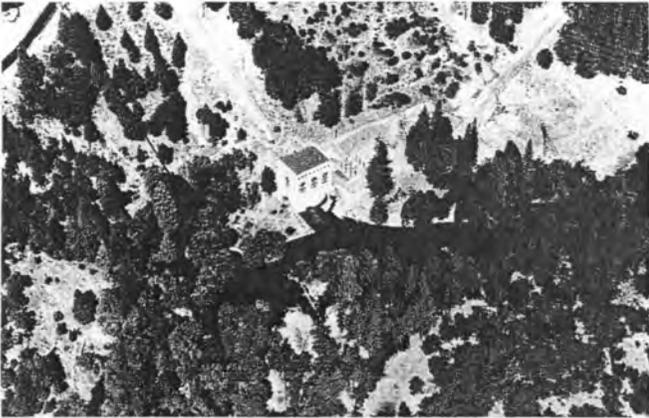
FIGURE 3. Upper boundary of the Wild Trout Area, Hat Creek Powerhouse No. 2.

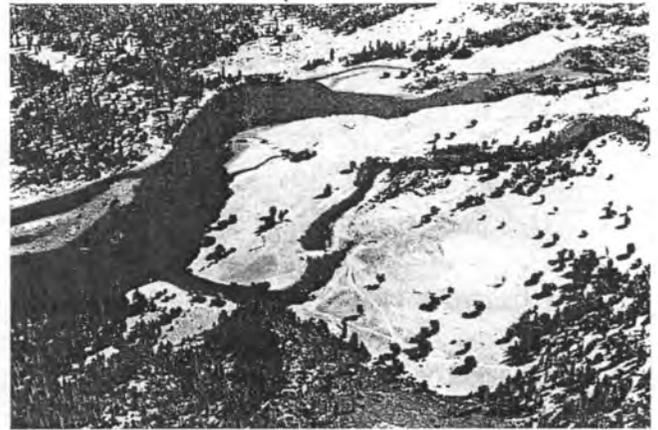
FIGURE 4. Lower boundary of the Wild Trout Area at Lake Britton and the upstream site of the fish barrier.

The fish barrier constructed in 1968 has been the key element in the conversion of lower Hat Creek to a productive trout stream (Figures 4 and 8). There is some concern that, as the barrier gets older, it may weaken structurally and fail. To avoid potentially allowing an influx of undesirable fish into the WTA from Lake Britton, the proper permits needed to replace the barrier should be acquired ahead of that time.

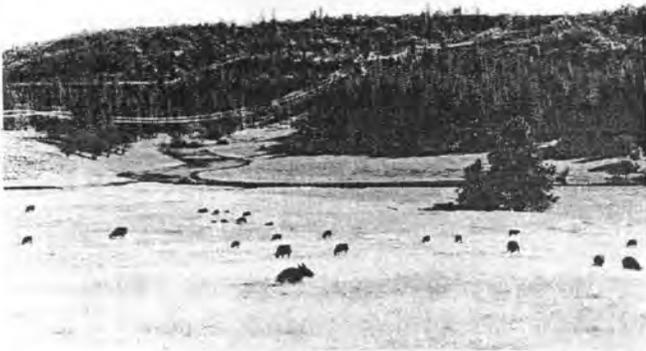
FIGURE 5. Upper, meandering reach of run section flowing through rolling grasslands.

Outflow from the powerhouse runs down a short, swift flowing riffle into a 2.2-mile long glide or run section. The upper portion of the run has a wide, slower flowing, moderately deep channel that meanders through low rolling grassland with scattered oak and conifers (Figure 5). The streambed has an underlying, sometimes exposed diatomaceous layer. Most of the channel's substrate, however, consists of silt and sand which anchor abundant beds of aquatic plants. In the lower run section, below what is known as the Carbon Bridge site, grasslands give way to thicker stands of oaks and pines (Figure 6). Beds of aquatic vegetation, numerous undercut banks, occasional deep pools, and overhanging or downed alders and other fallen trees provide excellent trout cover.

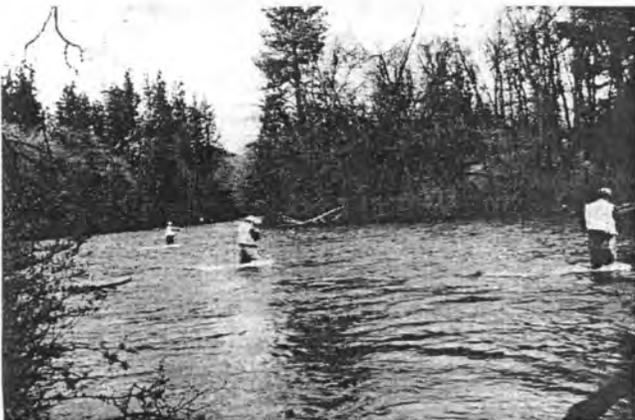
FIGURE 7. Riparian growth lining part of the lower riffle.

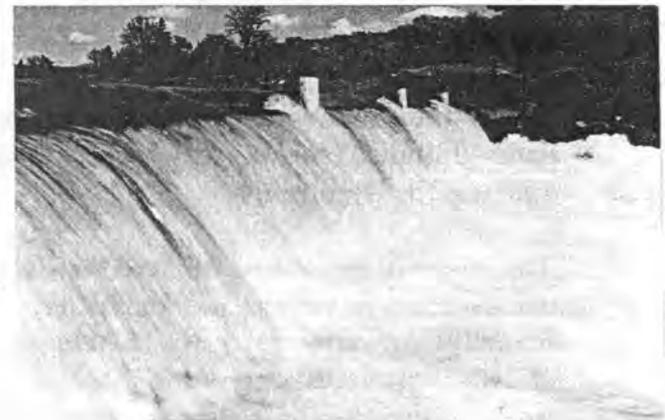
FIGURE 8. Fish barrier, a 110 x 6 ft structure with a concrete apron, located above Lake Britton.

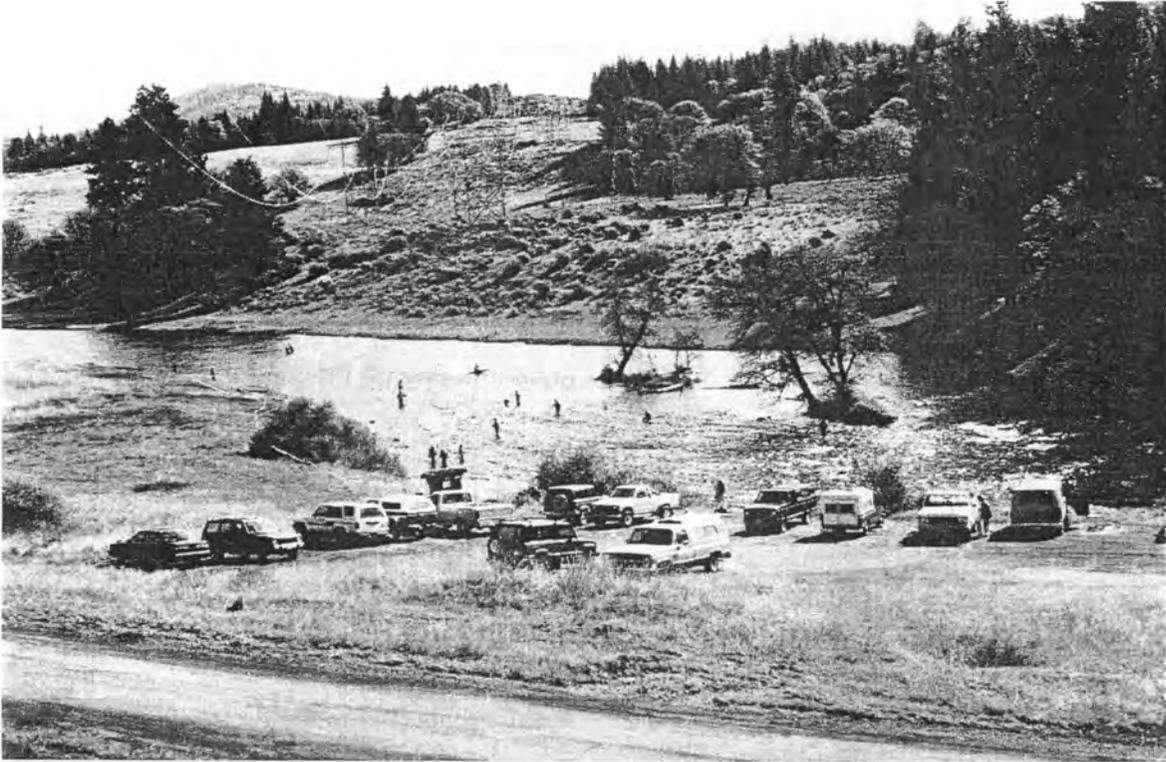
FIGURE 9. Parking area adjacent to and anglers fishing the lower end of the powerhouse riffle.

Trout Mortalities from Repeated Catch-and-Release Angling. The majority of anglers currently attracted to the Hat Creek WTA fish the lower end of the powerhouse riffle. This means that 10,000 to 15,000 hours of fishing per season occurs in about 200 feet of stream (Figure 9). Given a catch rate of at least 0.5 trout/hour, anglers fishing this short reach land 5,000 to 7,500 trout/season.

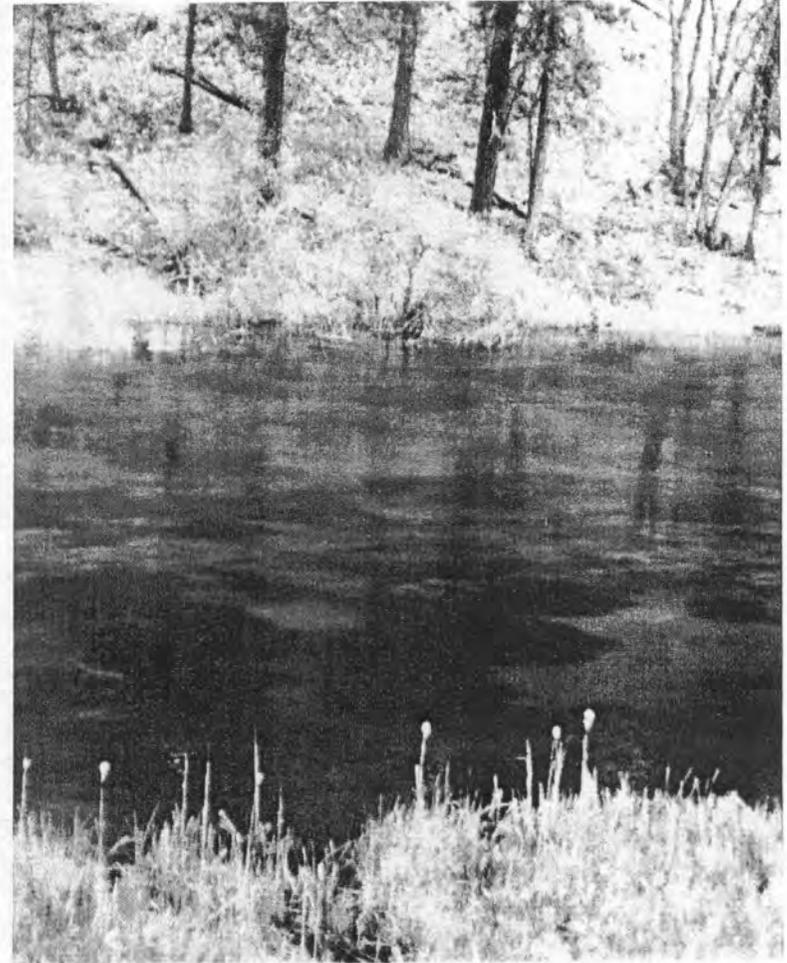
FIGURE 11. "Typical" stream section showing rooted aquatic plants in a reach above the 299 bridge prior to the prolonged sediment intrusion.

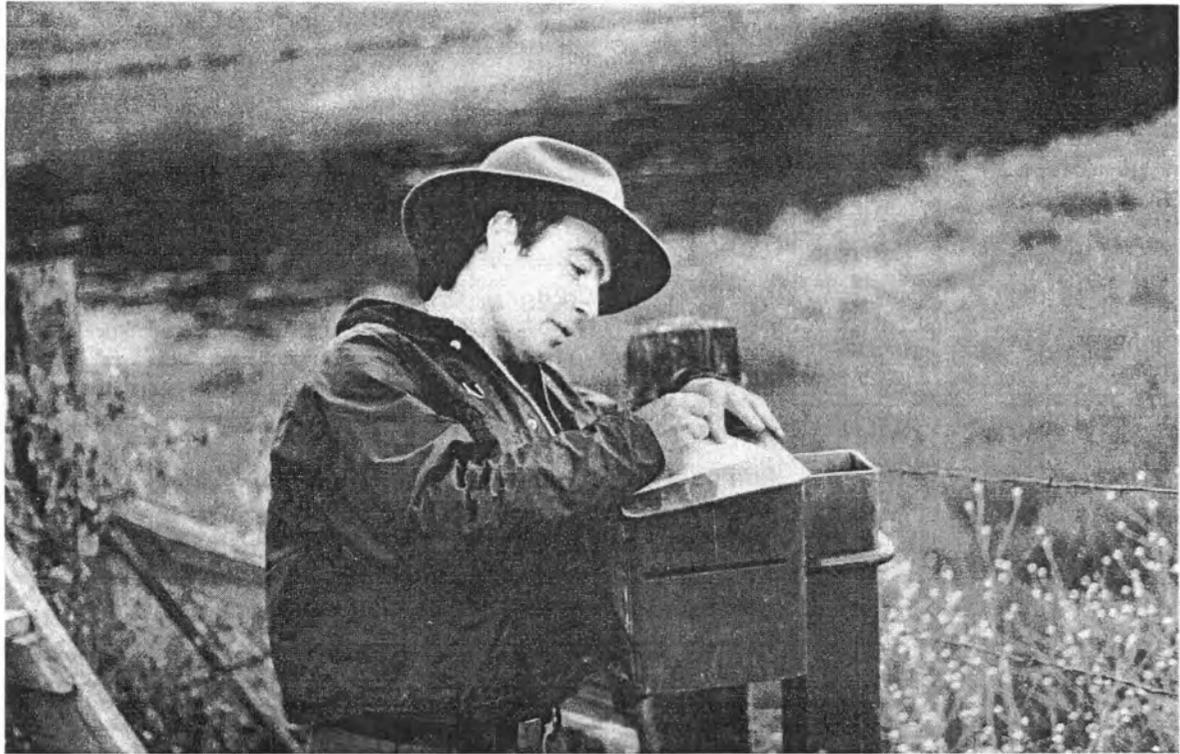
FIGURE 27. Angler completing a survey box questionnaire at the Carbon Bridge site.

Angler-survey box data are obtained from questionnaires filled out by anglers at the end of a day's fishing. The questionnaires are available in metal boxes placed at major access points. Data requested includes information on angling success and ratings of personal satisfaction with the number of trout caught, size of trout caught, and overall angling experience (Deinstadt, Lentz, Sibbald, and Murphy 1993). Boxes were located on the trail downstream of the powerhouse parking area, at the Carbon Bridge site, and on the main trail leading upstream from Highway 299 (Figure 27).
