Site Name: Ryan Creek Road

Stream Name: Ryan Creek

Structure Owner: Mendocino County Department of Transportation

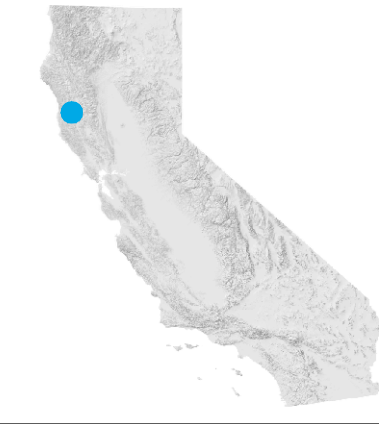
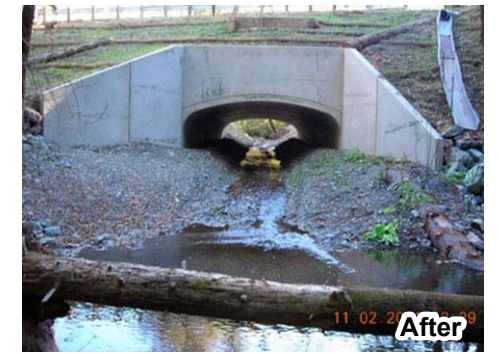
Notes: On 8/19/2013, Wiyot tribe assessed fish passage for adult pacific lamprey, and determined that this barrier is Non-barrier. New open-bottom arch culvert with natural streambed. Culvert replaced as part of mitigation for Willits bypass project. Refer to RTA (2013) for more information. Ross Taylor documented Pacific lamprey spawning in Ryan Cr. Prior to lamprey assessment: Project completed in Summer 2011, replaced with open-bottom arch structure, 100% passable. CDFW conducted spawning surveys in 2012 and found coho upstream, up to PAD ID 712813. RTA will conduct spawning surveys in 2014. BEFORE: partial barrier to adults, total barrier to juveniles. Was listed as a partial barrier.
