**Site Name:** Private Road Crossing (concrete ford)

**Stream Name:** Redwood Creek

**PAD ID:** 735125

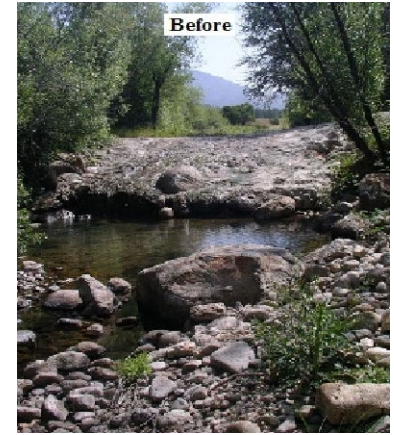
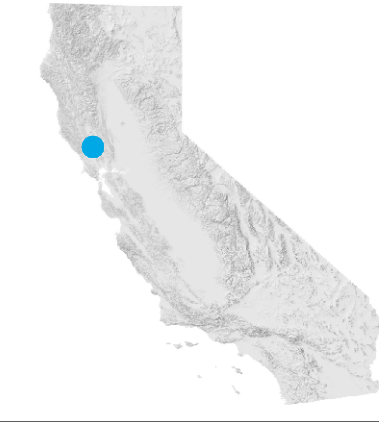
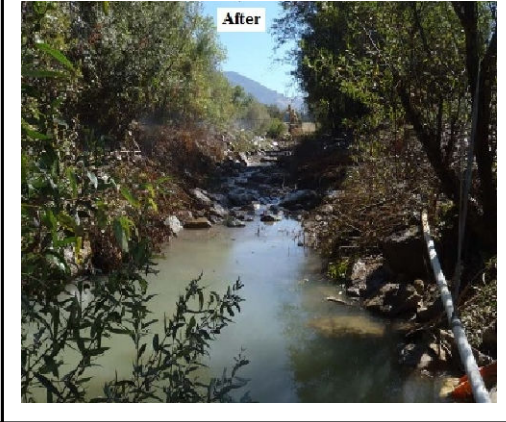
**Notes:** Concrete ford was replaced by a roughed ramp. Currently monitoring for fish presence. First storm after the ford was replaced brought adults and jacks (coho and SH) way up the watershed. After treatment, 39 juvenile trout/steelhead in a 6/25/2013 were observed from the bank. 300109: Follow-up with effectiveness monitoring. Before: Passage status was 'Total' per professional judgement by California Land Stewardship Institute. Was a complete barrier to salmonid migration following channel erosion during the 1/1/06 flood.
