Site Name: concrete sill
Stream Name: Bridge Creek
Structure Owner:
Year Remediated: 2011
Site Type: Other
Site Status After Remediation: Not a barrier
Species Benefited After Remediation: coho
Immediate Downstream barrier PAD ID:

PAD ID: 758267
Tributary To: South Fork Eel River
Barrier Remediation By: Unknown
Barrier Description Prior to Remediation: Partial
Count of Barriers Downstream:
Count of Barriers Upstream:
Distance Upstream to Next Barrier or Limit of Anadromy : Miles

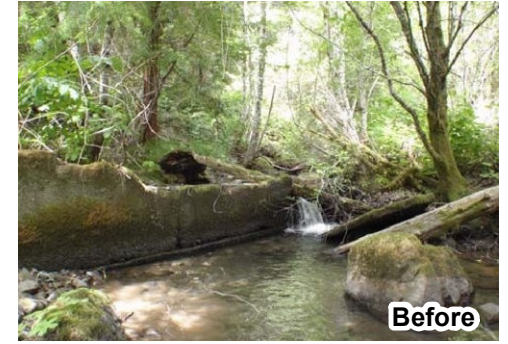
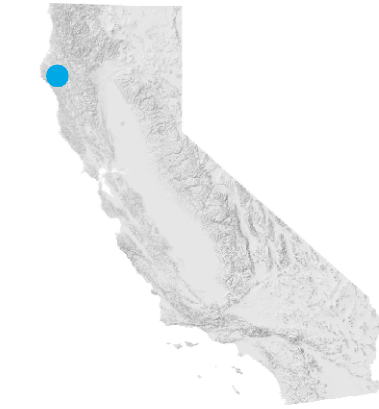
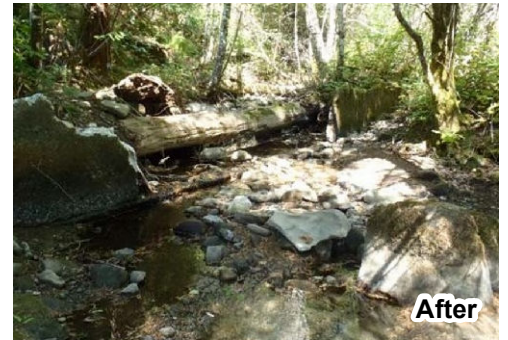
Notes: A concrete sill was removed to improve passage to juvenile and adult salmonids. It was a partial barrier. Coho, specifically YOY, were seen on Bridge creek for the first time during a snorkel survey on 9/13/2012 after this barrier was removed. Survey field note recommends improving instream shelter using available wood lying on riparian banks, and removing concrete and metal pieces from a house that washed away.
