Luckenbach Restoration: Shearwater Colony - Taiaroa Head Project, NZ

Update 11-07-12 H.M. Nevins

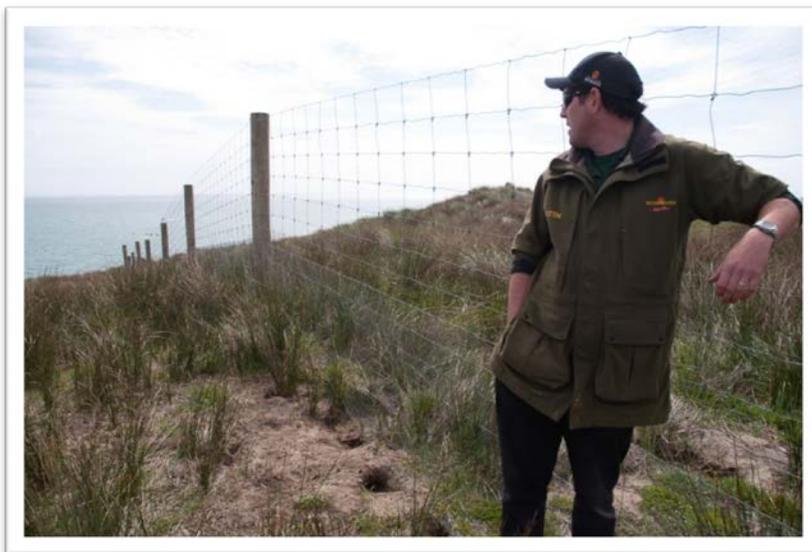
Photo 1. Martin Reid (landowner's son) looking along the new fence at a completed section. Note the rabbit digging at the edge of the mesh. The landowners patrol the fence line often checking for signs of entry and collapse any rabbit holes. The mesh 'footing' at the bottom seems

to be deterring most rabbits from getting through before they get detected. (Photo: Jaime Newman)

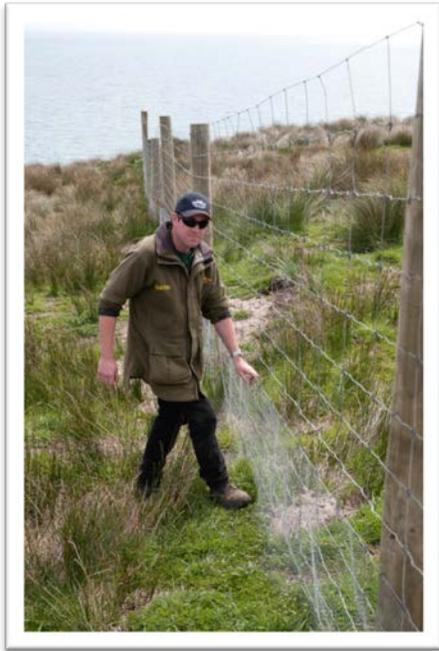
Photo 2. Martin showing me the fine mesh base complete with 'footing'. Note how the plants are binding into this and apparently helping to keep it pegged down and deter rabbits digging through. The height of the fine mesh is about 500mm - high enough to stop bunnies jumping through. (photo: Jaime Newman)

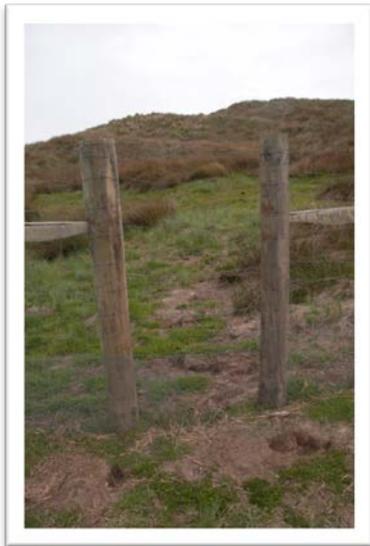
Photo 3. Temporary fencing at site of the planned gate for entrance to the titi colony. (photo: Jaime Newman)

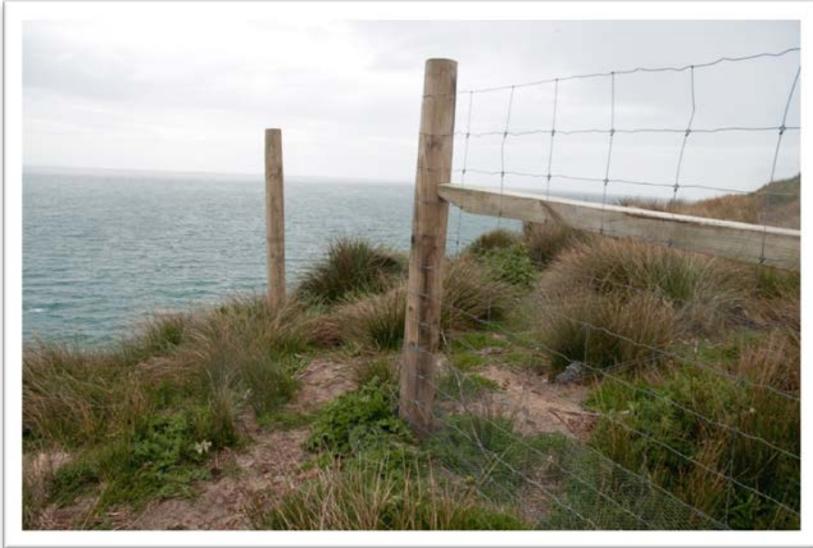
Photo 4. Current end of the fence at the cliff side. They plan to build a spiral fence system here to deter and confuse rabbits and possibly even other species such as hedgehogs getting through. (photo: Jaime Newman)

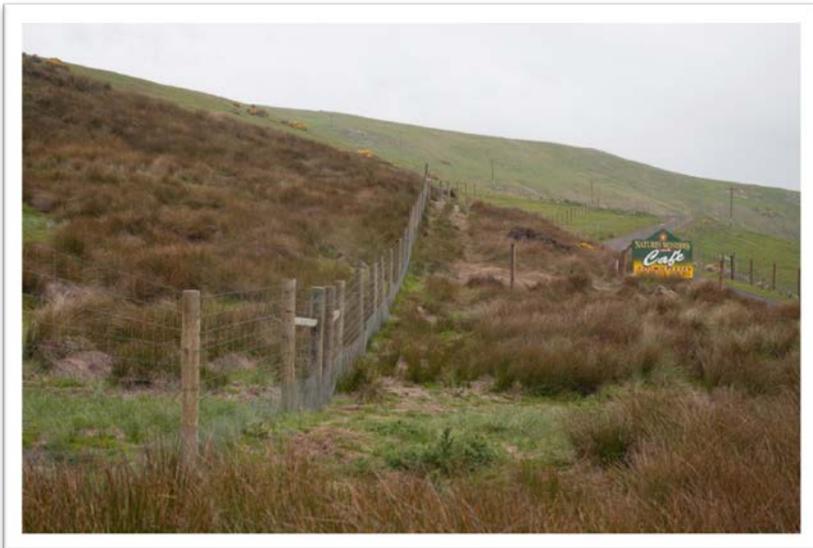
Photo 5. Looking up the completed section past Perry's entrance gate - note the start of his rabbit-proof fence in front of his sign - heading off to the right. Within Perry's eco-farm, they continue to control introduced mammals including possums, rabbits and hedgehogs. (photo: Jaime Newman)

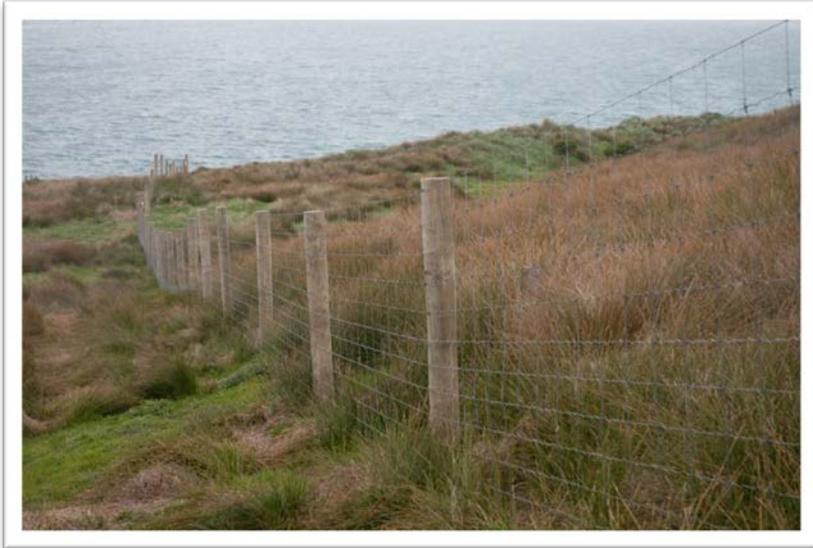
Photo 6. Partially completed section - note there is no fine mesh at the base until some way along. (photo: Jaime Newman)

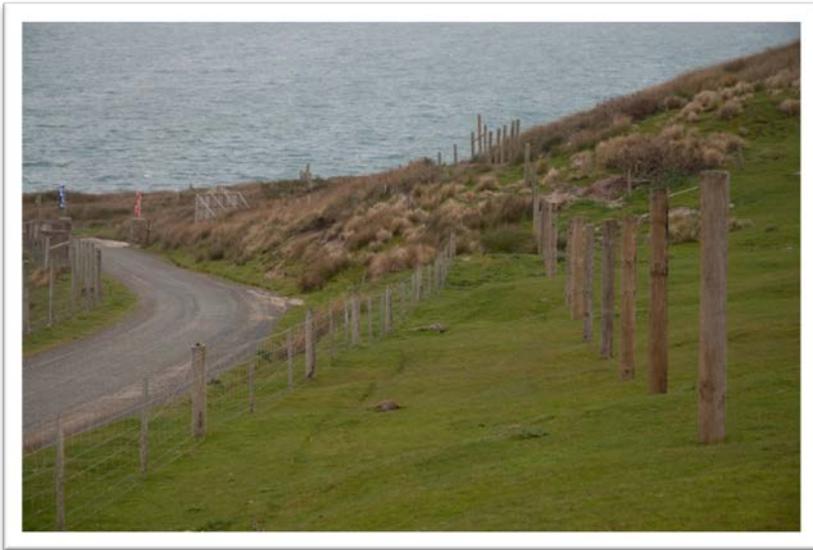
Photo 7. Posts only along secondary fencing wall within the Reid's fenced and predator-controlled area. (photo: Jaime Newman)

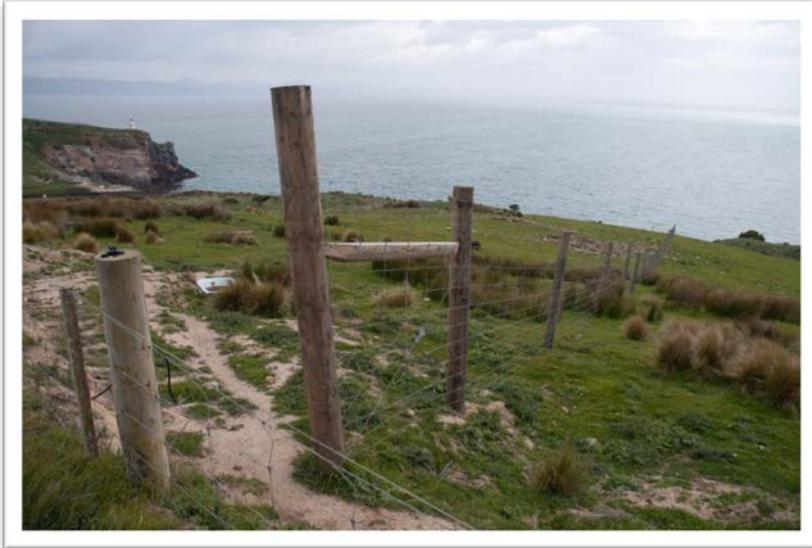
Photo 8. Looking down the section of fence that divides the block Perry owns and the "Maori" Block (to the right). This section still requires fine mesh to be added to the base. (photo: Jaime Newman)
