**YEAR THREE  
CREATED POND MONITORING REPORT  
EAST CONTRA COSTA COUNTY  
HABITAT CONSERVANCY  
VASCO SOUZA I, HCP POND  
VASCO CAVES REGIONAL PARK,  
BYRON, CALIFORNIA**

**PROJECT APN #: 005-160-005**

December 13, 2011

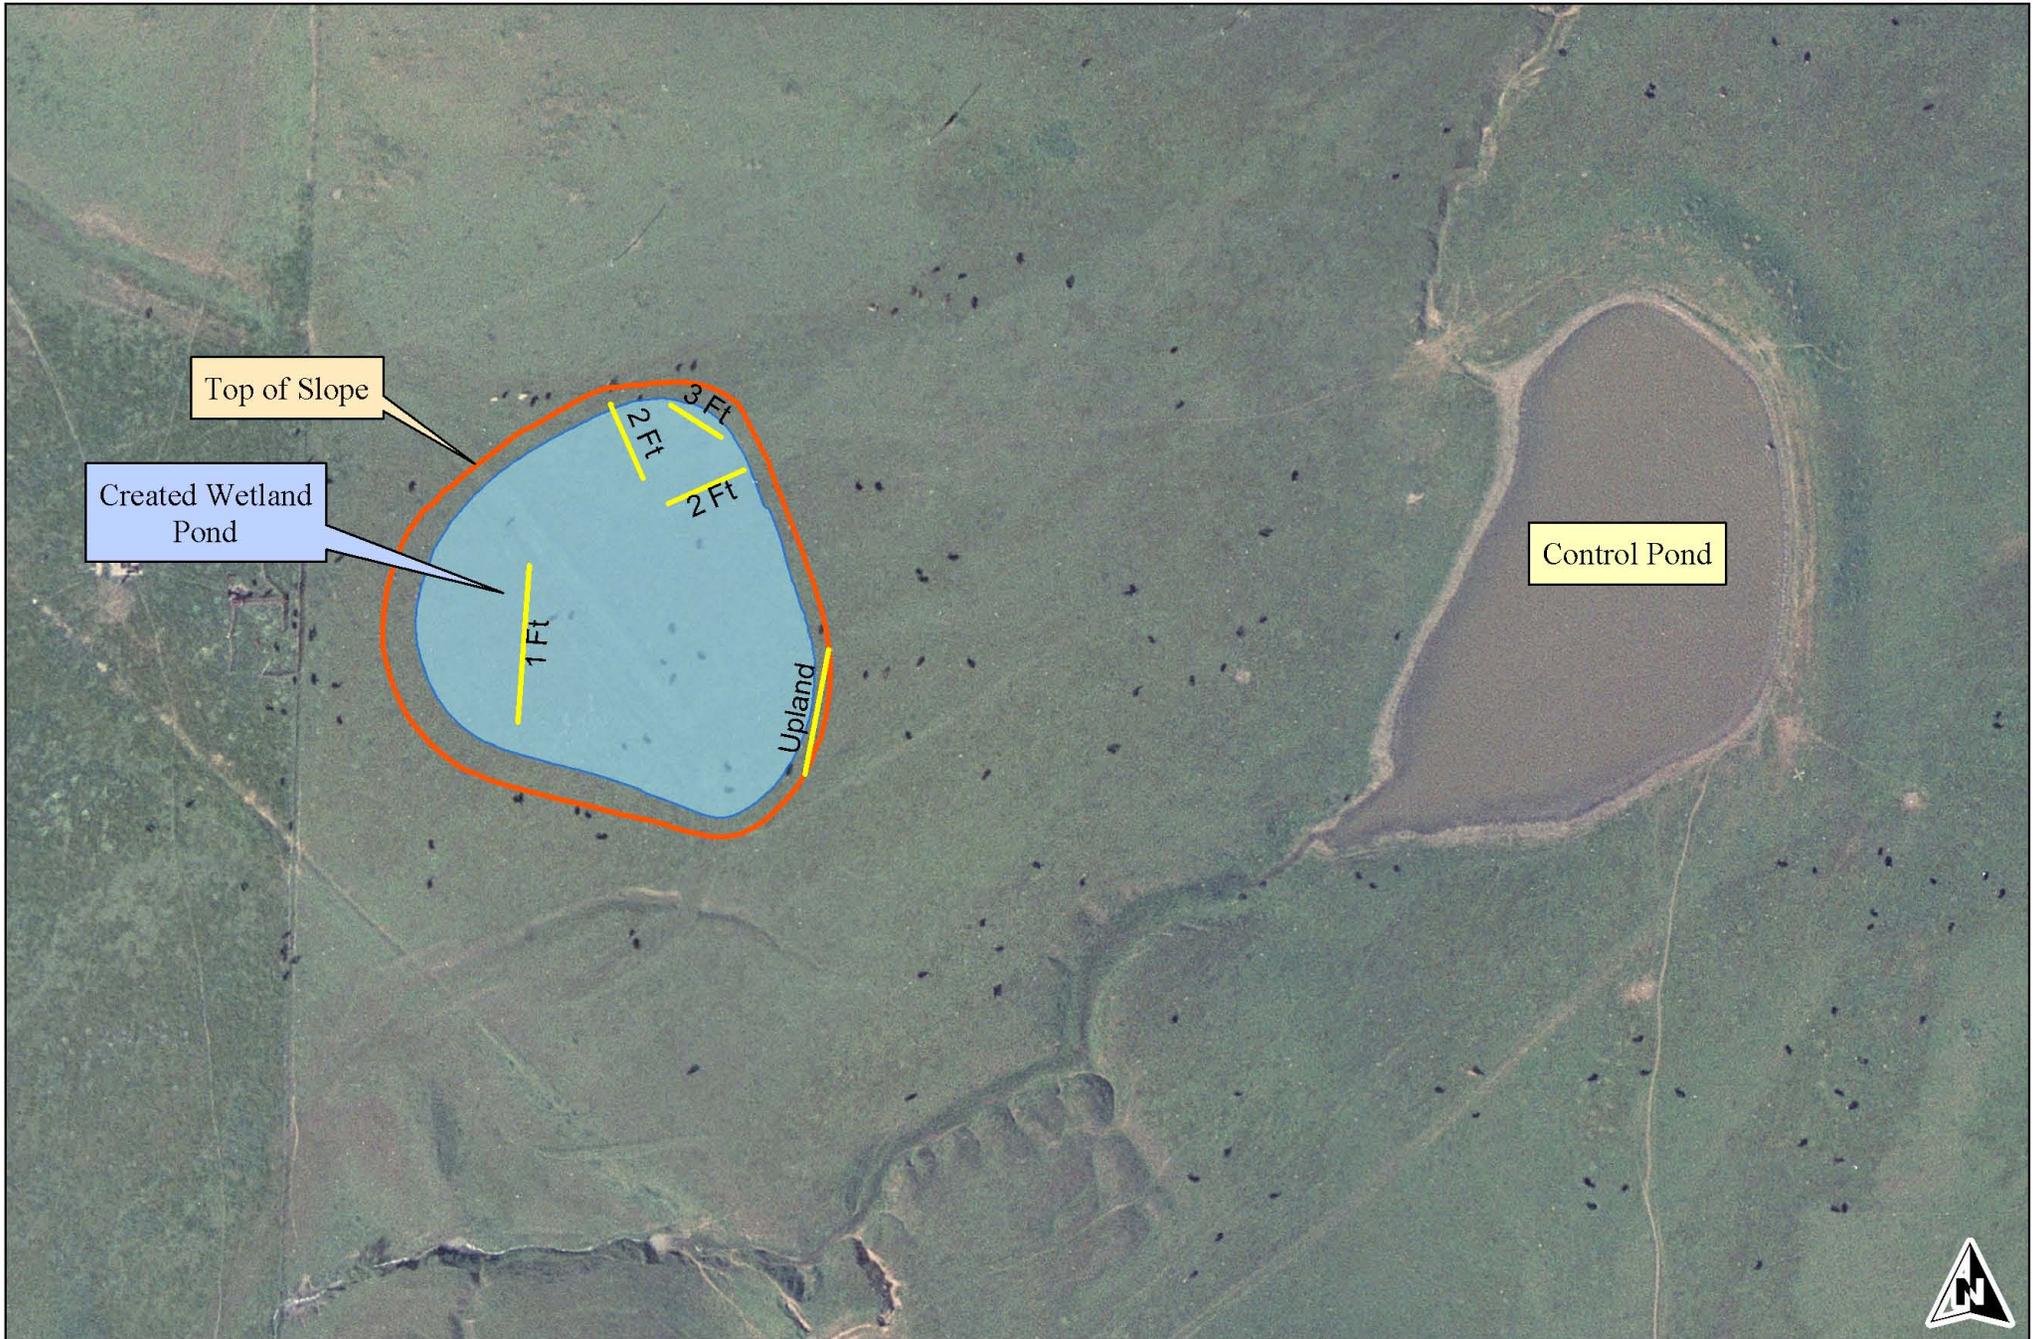
Figure 3. Aerial Photograph of  
Vasco Souza I, HCP Pond Project Site  
Byron, California

established in the pond (see Figure 3 for transect locations). These transects are as follows: one permanent 100-foot long transect was established in the one-foot section of the pond. A second 100-foot transect was established on the upland berm adjacent to the one-foot section. In the two-foot deep portion of the pond one, 50-foot long transect was established along one edge of the pond bottom and one, 100-foot long transect was established at a 90 degree angle from the other transect along another edge of the pond bottom. Finally, a 38-foot transect was established in the three-foot portion of the pond. The transect declinations and locations were permanently recorded using a GPS with submeter accuracy so that the exact locations could be found in subsequent years (Figure 3).

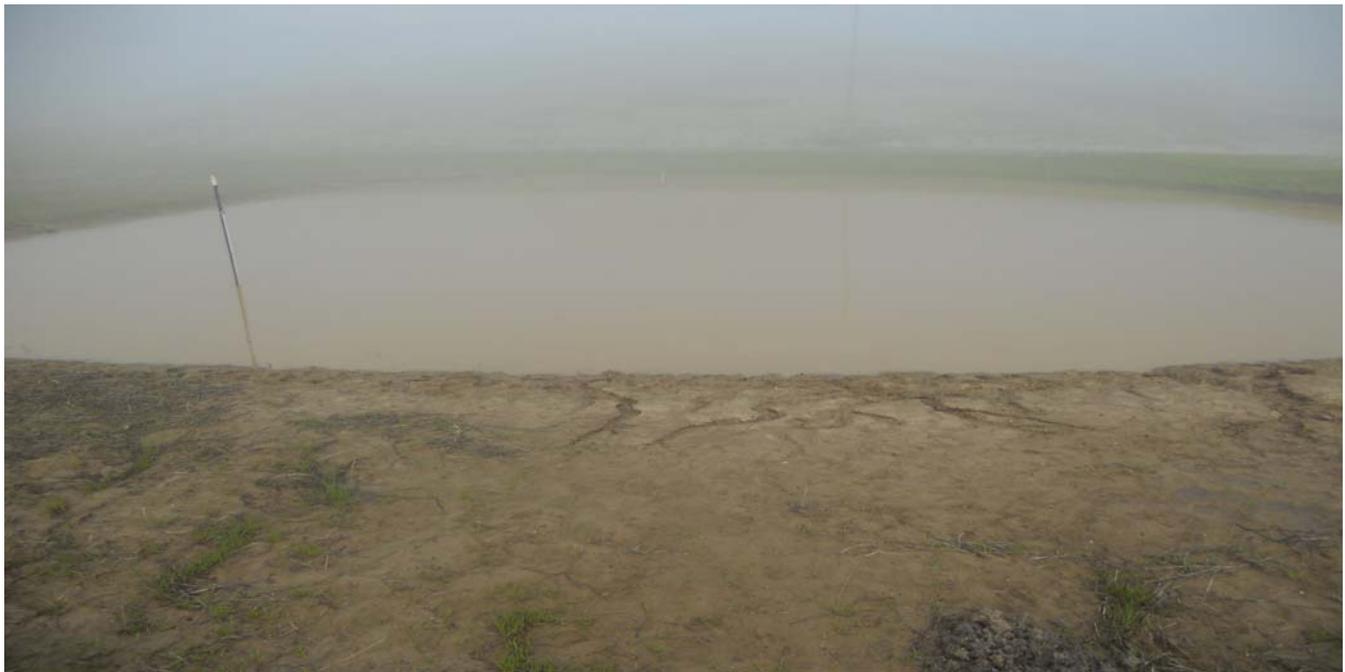
**Photograph #2.** Close up of the 2-foot section of the created pond on December 23, 2010. The 2-foot section held 3.6 inches of water; the 3-foot section held 15.6 inches of water on this date.

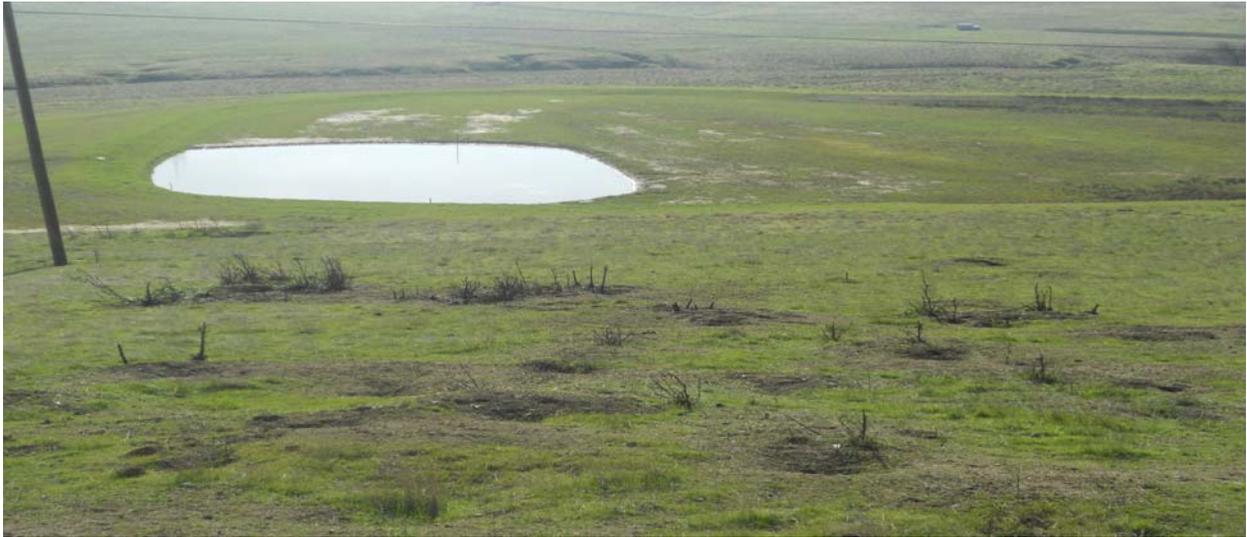
**Photograph #3.** Overview of created pond January 5, 2011. 1-foot section mostly dry.

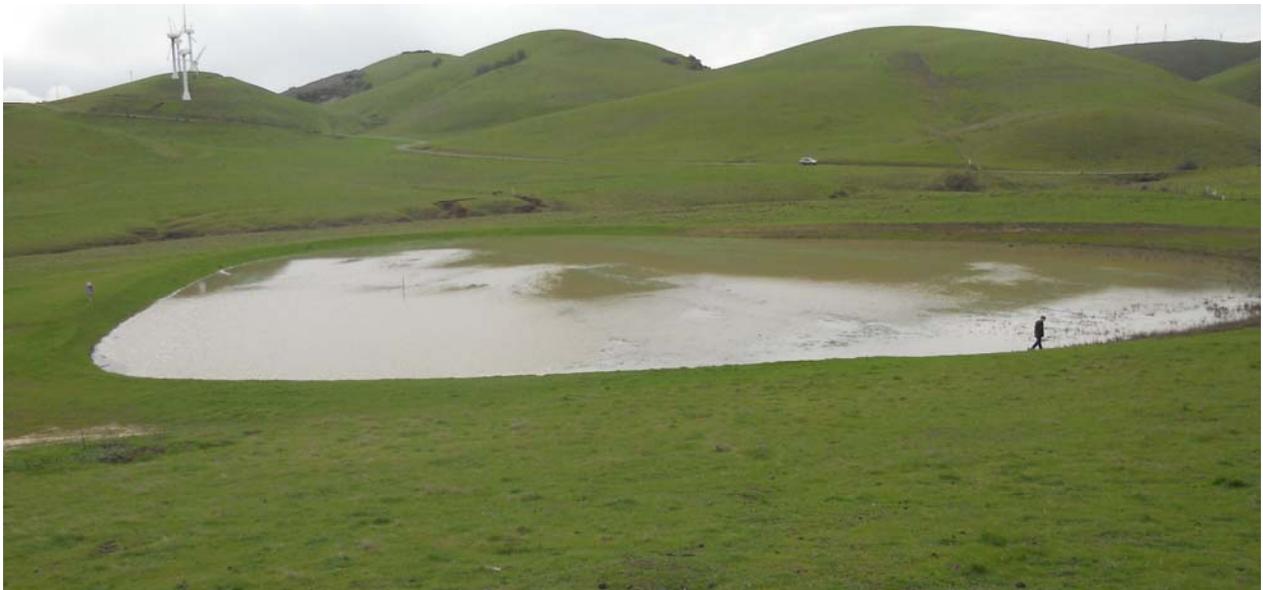
**Photograph #4.** Created pond on February 21, 2011 after a large storm event. All three sections of the pond inundated.

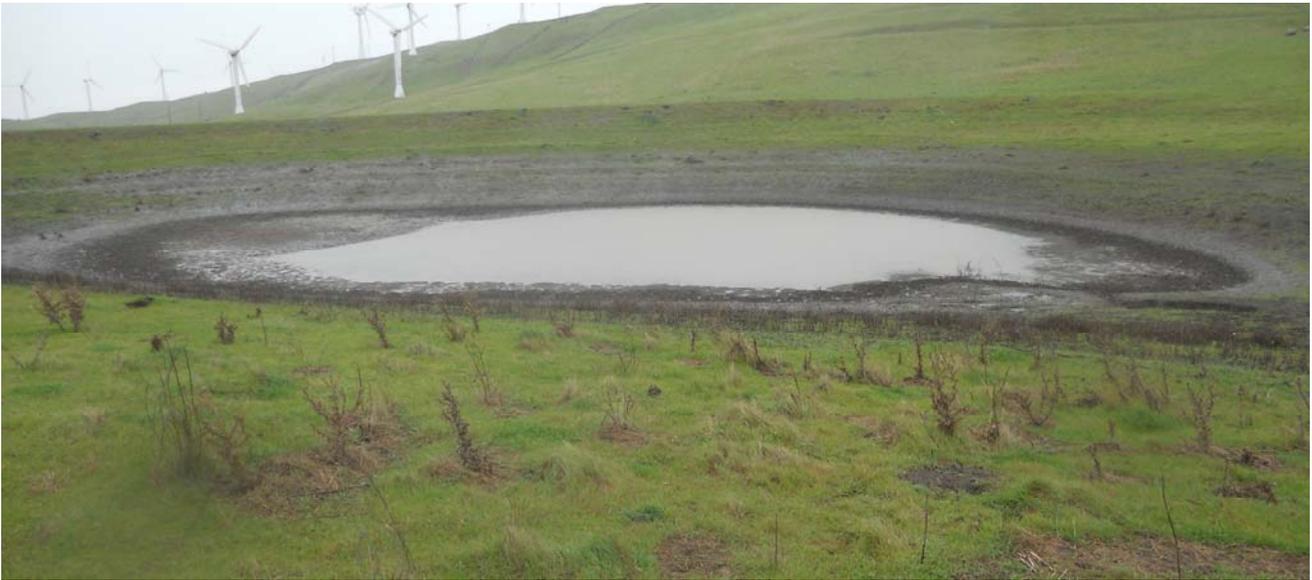
**Photograph #5.** Control pond. February 17, 2011, one day before a storm event brought 0.6-inch of rain to the area.

On February 17, 2011, the water in the control pond was turbid and only the bottom elevation of the pond was inundated. Turbid water during the filling stage is common; water flows over the ground into the pond and carries with it the surrounding sediments. The pond's southwestern corner was vegetated with cocklebur (*Xanthium strumarium*), a native but somewhat invasive wetland plant. There were also non-native bull thistle (*Cirsium vulgare*) and some non-native milk thistle (*Silybum marianum*) plants growing in this area.

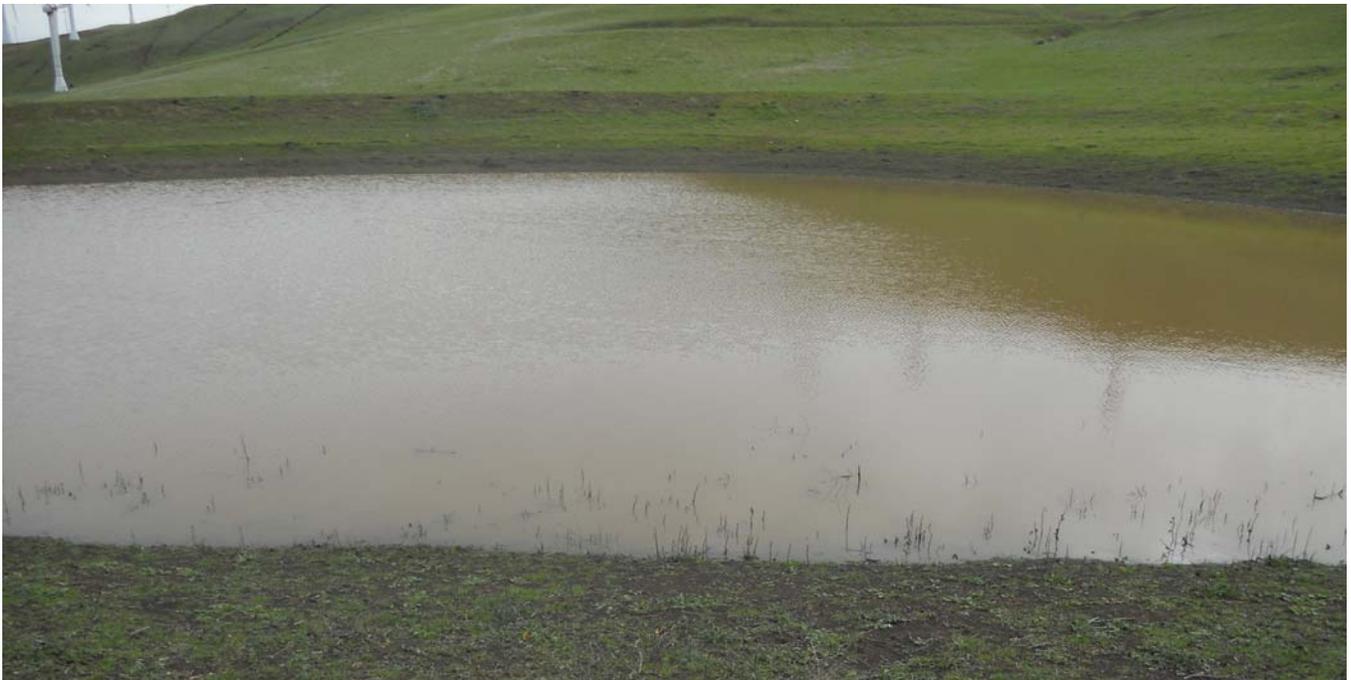
**Photograph #6.** Control pond on February 21, 2011 after rain storm reached the area.

On February 21, 2011, the water level had risen due to heavy rains over the past two days. The water level on this date covered the entire bottom of the pond, and the cocklebur plants were submerged. Killdeer (*Charadrius vociferus*) were observed along the shoreline.

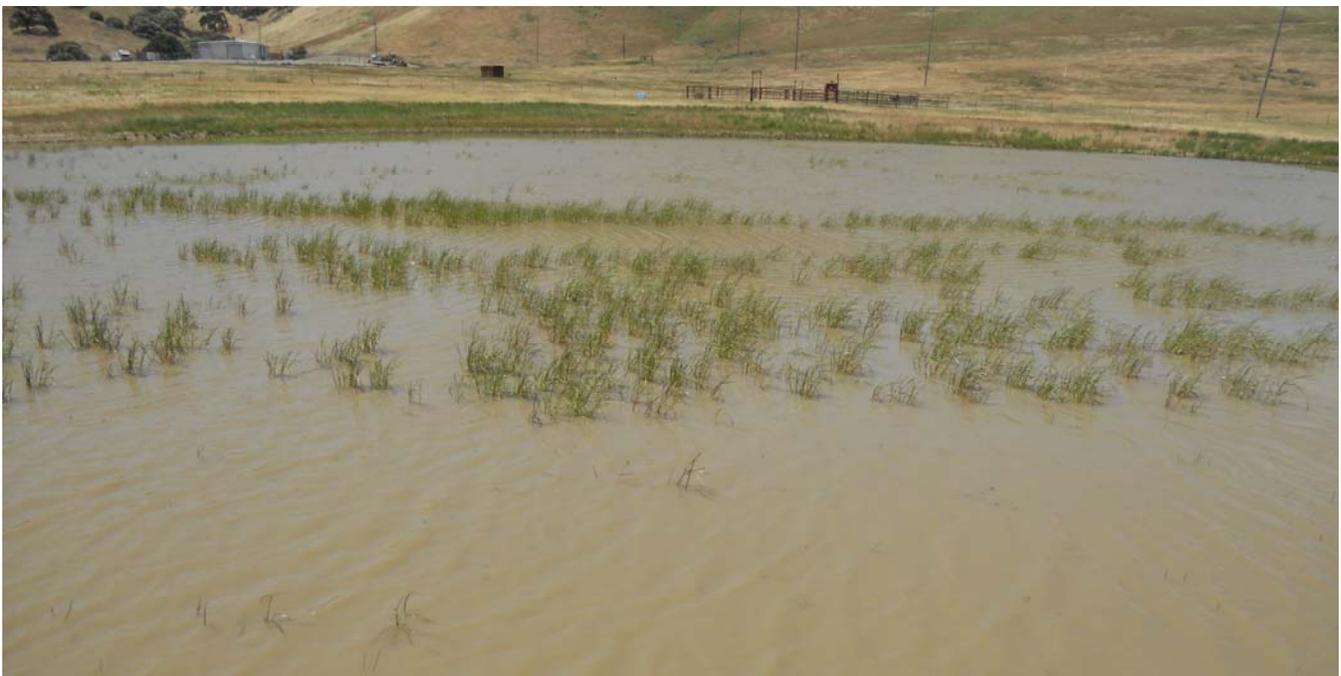
**Photograph #8.** California semaphore grass (*Pleuropogon californicus*) growing in created pond; May 22, 2011.

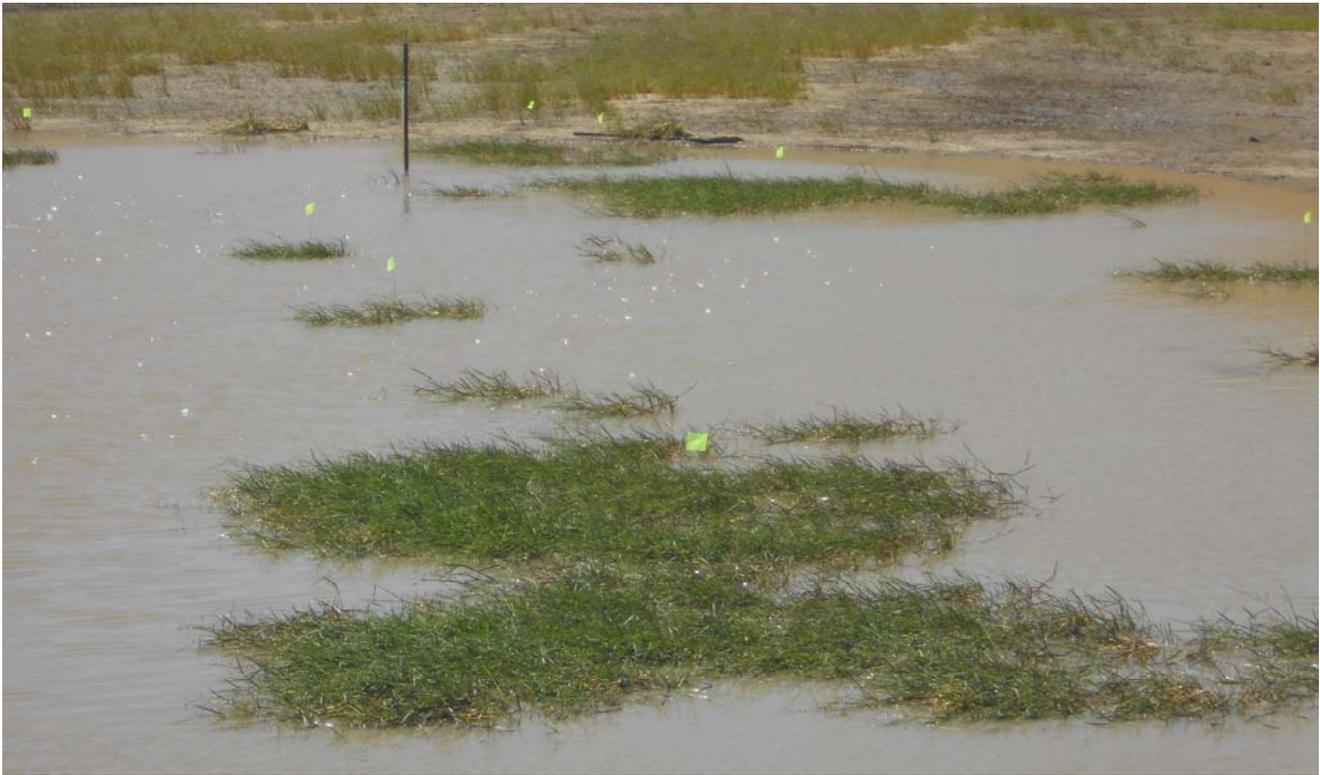
Unfortunately, European manna grass (*Glyceria declinata*) appeared in the pond this year. Approximately 20 clumps of the plant were distributed throughout the three-foot section. M&A immediately notified the Conservancy of the presence of this invasive grass and a landscape contractor was hired to hand-pull the plants and haul them away. This work was completed in July 2011. M&A will look for this plant at the pond again during the 2011-2012 monitoring season, will hand-pull any observed and notify the Conservancy.

**Photograph #9.** Showing European manna grass (*Glyceria occidentalis*) flagged for removal. This invasive grass was found in the 2- and 3-foot sections of the created pond; June 11, 2011 photo.

In June 2011, M&A hand pulled or flagged European manna grass plants emerging from the created pond's 2- and 3-foot sections. Due to standing water in the 3-foot section at that time, M&A was unable to reach all the plants and remove them without trampling over the inundated bottom and potentially mucking up the inundated habitat or stepping on a CTS, so the remaining plants were flagged with pin flags and left for Pacific Open Space to remove after the pond dried down completely. In July, Pacific Open Space hand pulled all the remaining plants and hauled them away. The created pond and surrounding area will be carefully checked in 2011-2012 for sign of invasive plants and the Conservancy will be notified if any are observed.

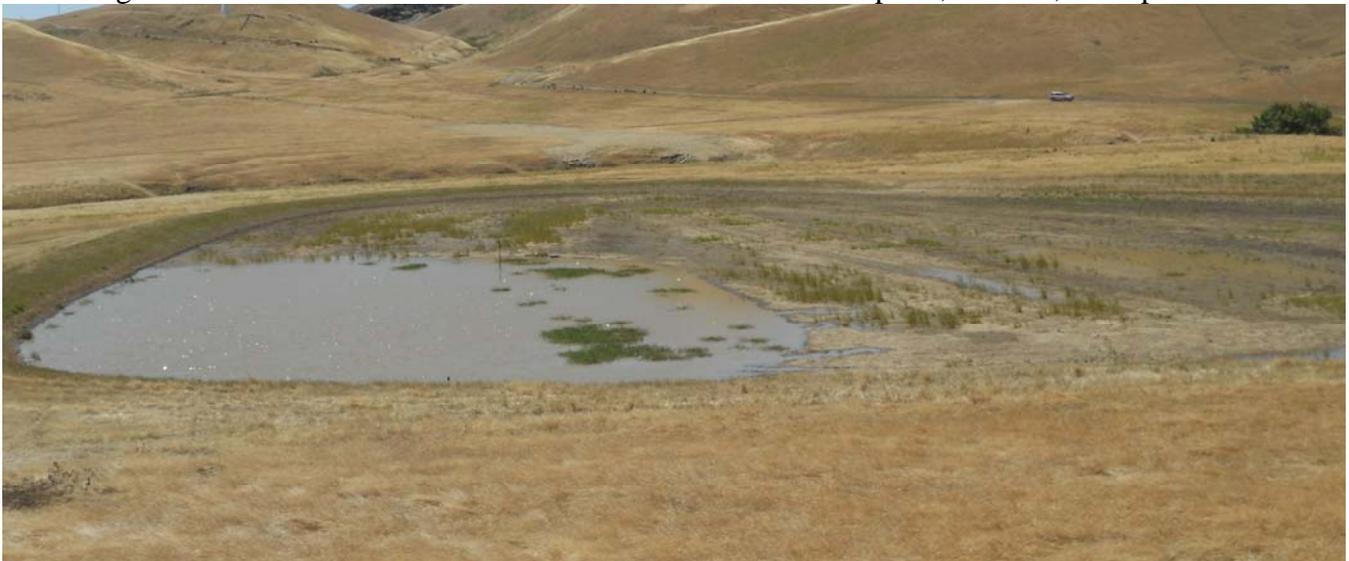
**Photograph #10.** Overview of the created pond showing drying conditions and flagged European manna grass plants.
