FOURTH ANNUAL RESTORATION MONITORING REPORT

LENTZNER SPRING RESTORATION PROJECT
CONTRA COSTA COUNTY, CALIFORNIA

DECEMBER 2012

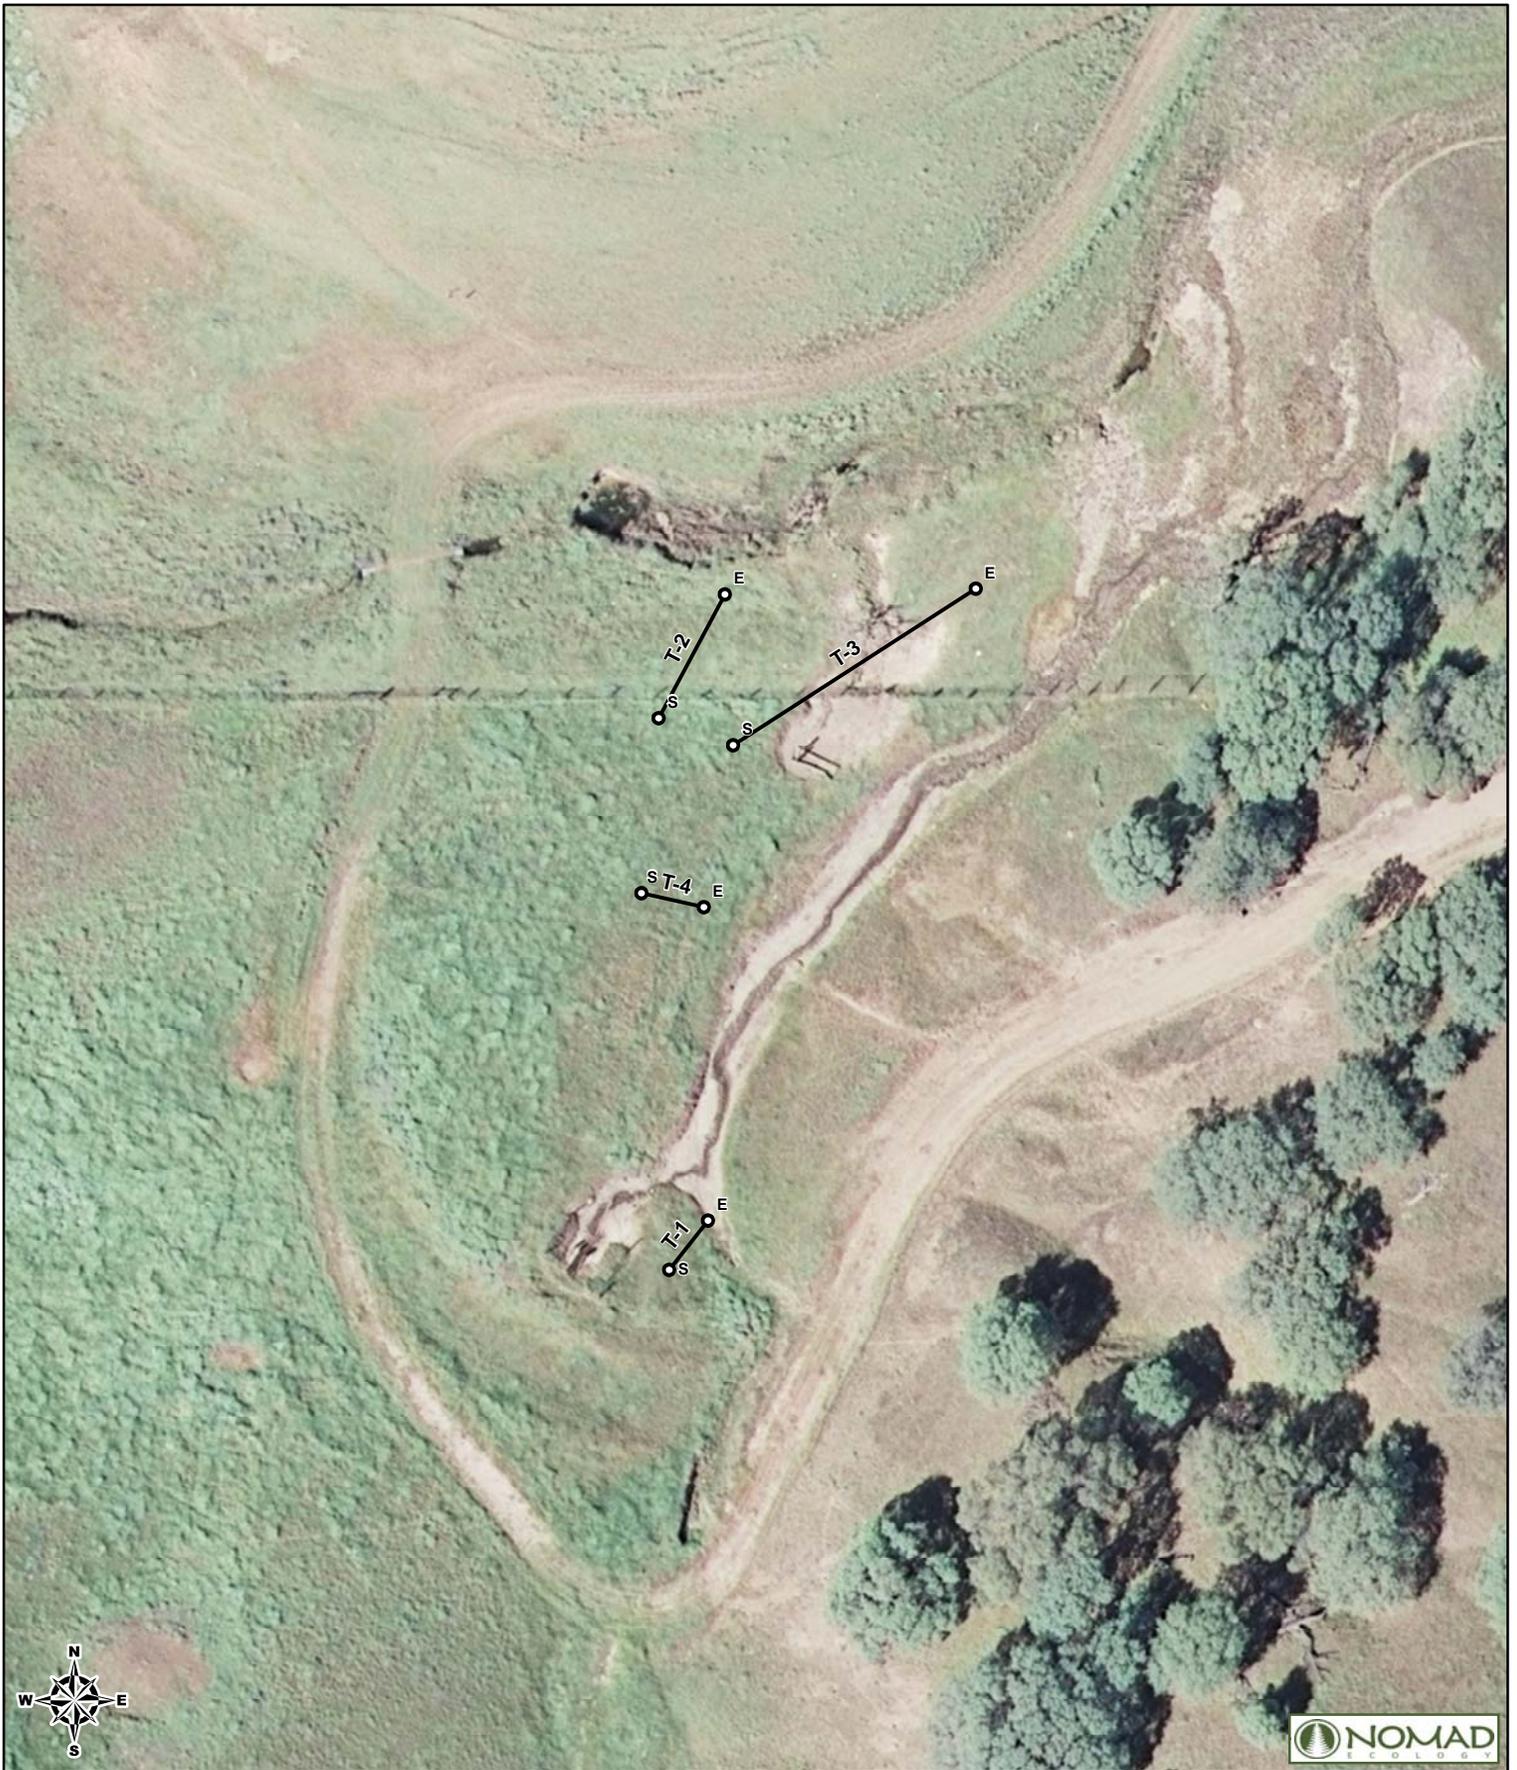
Figure 2

- Transect Start and End Locations*
- Transect Location and Number

Transect Locations

Transects were established in 2009 during the first year of monitoring (ICF Jones and Stokes 2009a). Three of the transects were placed in the larger wetland area, and one transect was placed in the smaller wetland area (Figure 2). The transects were positioned across the alkali wetlands in order to capture the hydrologic gradient. For the larger wetland, the transects started at the boundary with the grassland, and ran down-slope toward the unnamed tributary. These transects ended at the down-slope edge of the planted area. In the smaller wetland area, the transect was placed across the center of wetland (Figure 2).

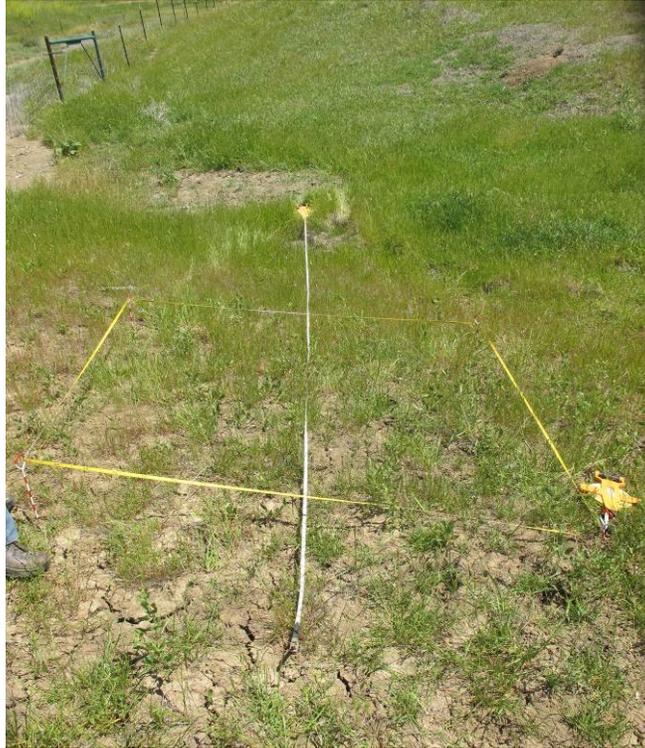
Photo 1. Transect 1. May 10, 2012.

Transects 1 and 2 continue to exhibit upland characteristics based on the current monitoring data. Within transects 1 and 2 the slope is steep and it is presumed that runoff is rapid. Observations in the field further suggest that the topography on site is too steep to support wetlands at this location that hold water for a duration characteristic of even a seasonal wetland. Although there is no evidence that the areas within transects 1 and 2 are currently wetland in character continued monitoring during year 5 will yield more data revealing whether this area will transition to wetland or not.

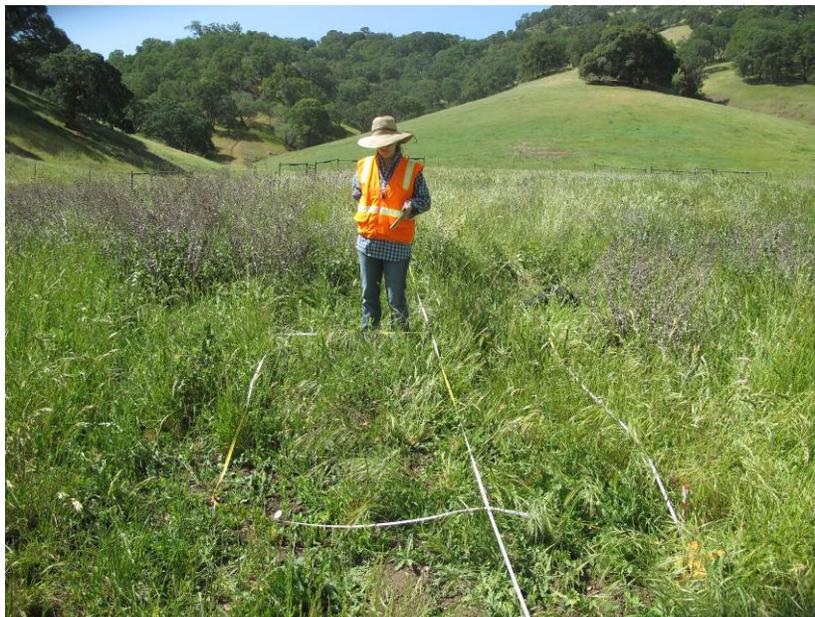
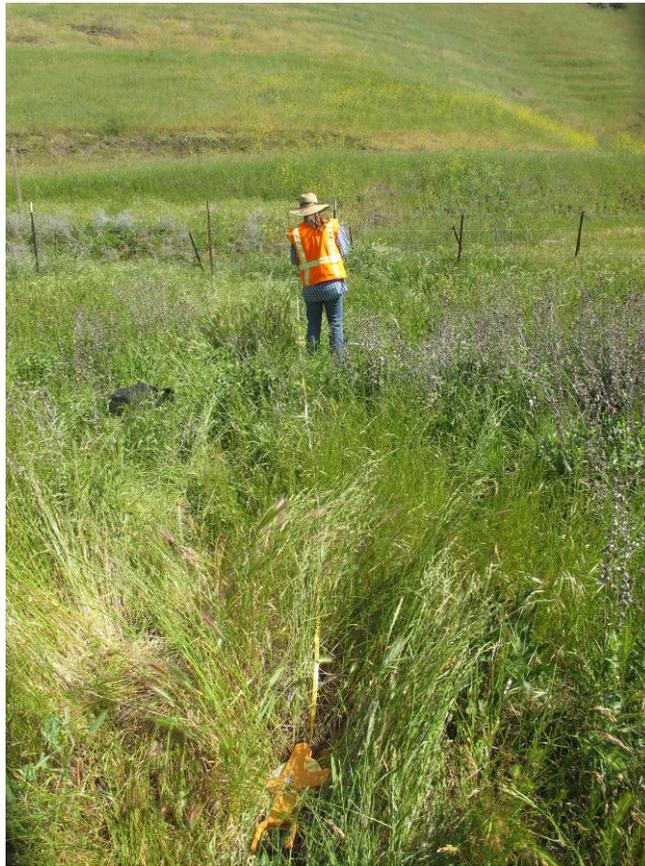
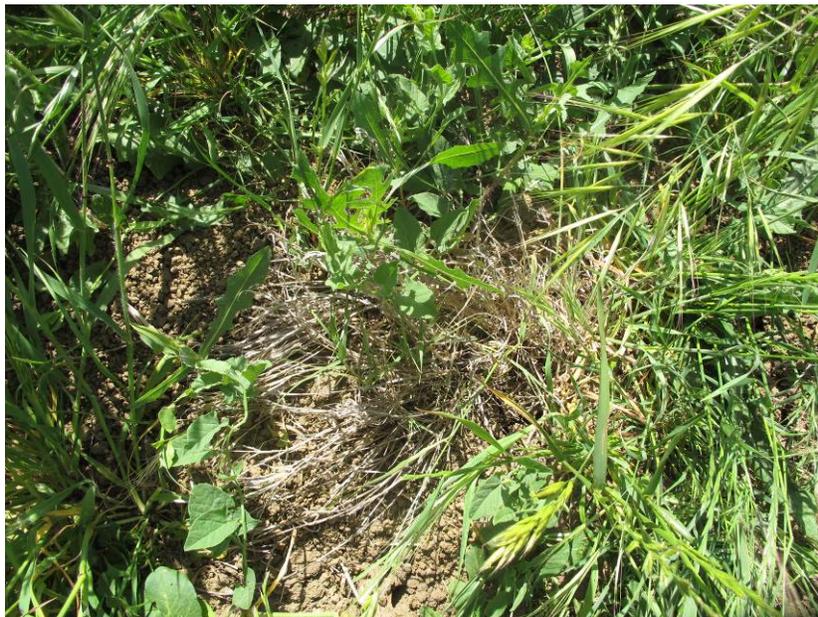
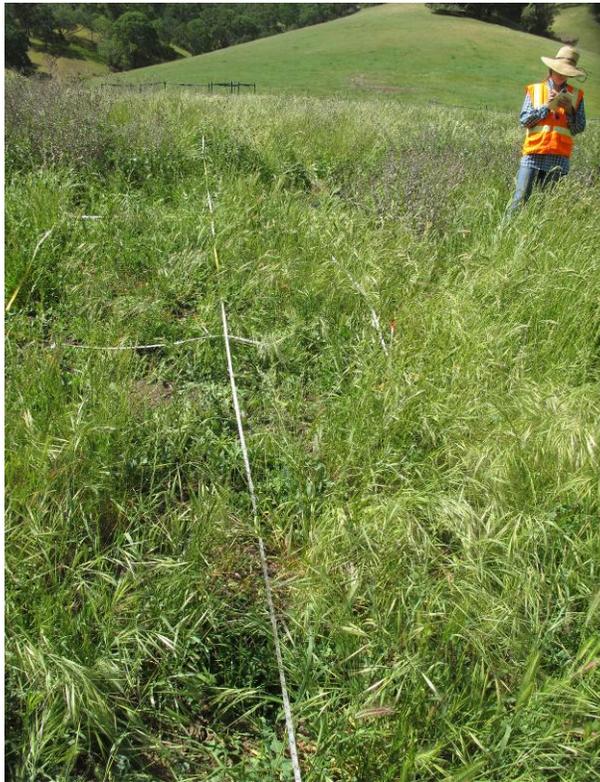
Photo 2. Transect 2. May 10, 2012.

Photo 3. Transect 2. May 10, 2012.

Photo 4. Transect 2. May 10, 2012.

Photo 5. Transect 2. May 10, 2012.

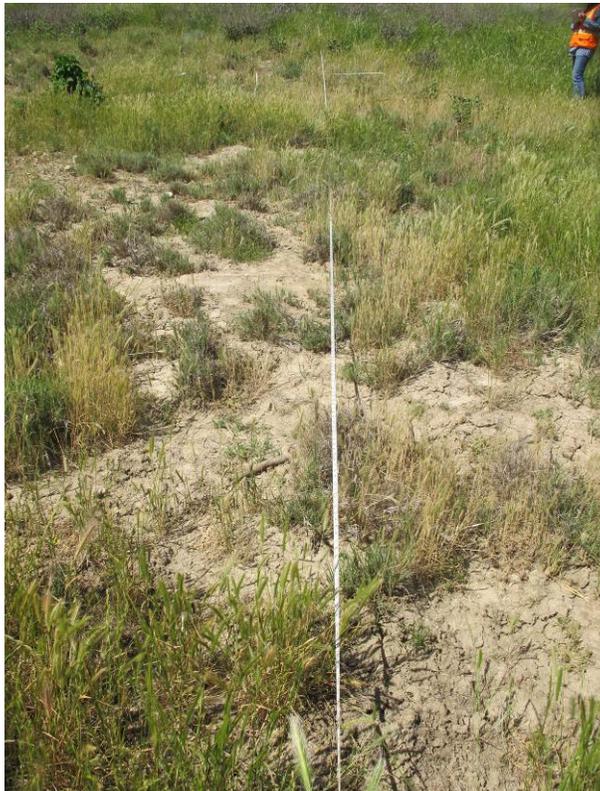
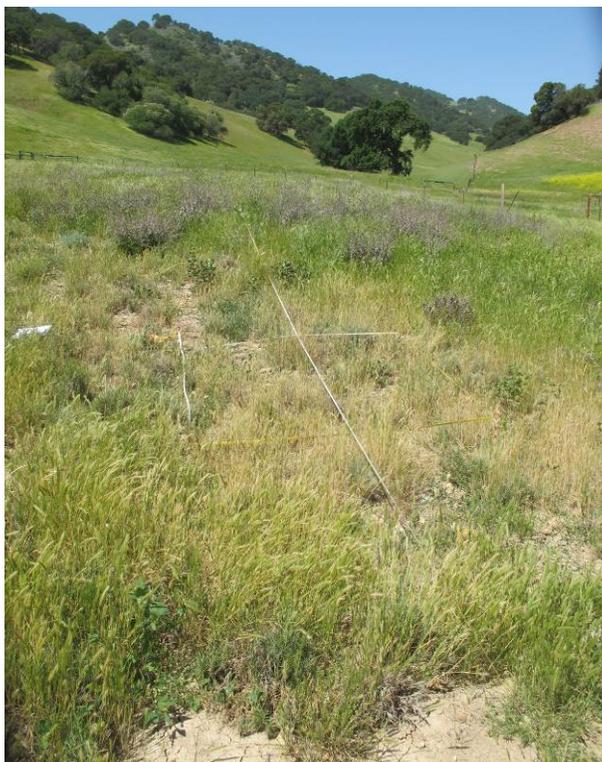
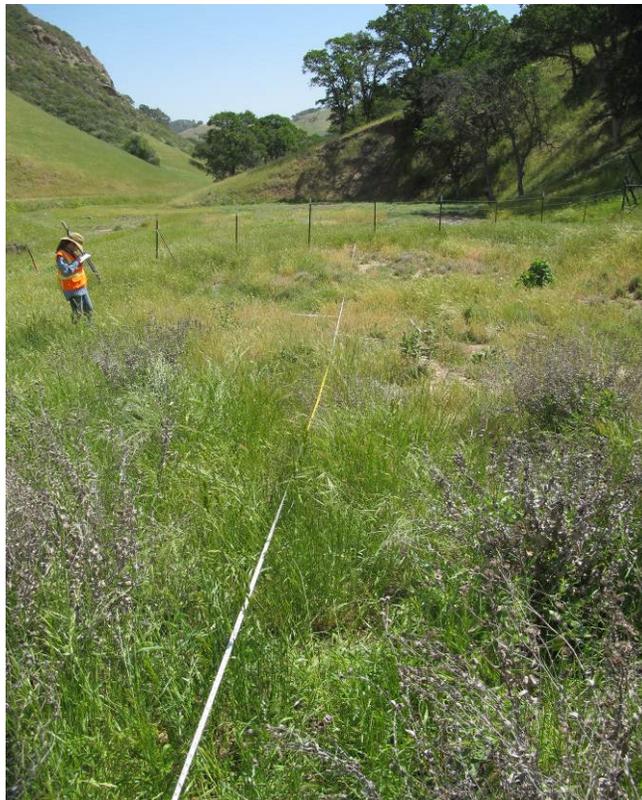
In addition, transect 4 has hydrological features that are present indicate alluvial sedimentation. Within transects 3 and 4 there was indication that water sheet flowed across the site but did not pond. These indicators include drift lines and matted vegetation. Therefore we expect that the areas that include transect 3 and 4 will continue to develop into wetlands, though they may require supplemental planting of wetland adapted native species.

Photo 6. Transect 3. May 10, 2012.

Photo 7. Transect 3. May 10, 2012.

Photo 8. Transect 3. May 10, 2012.

Photo 9. Transect 3. May 10, 2012.

Over the past years, results of monitoring have indicated that the Lentzner restoration is progressing toward becoming wetlands as is evidenced by the transition of the areas within transect 3 and 4 to alkali wetland. However, we recommend planting the areas of transect 3 and 4 with wetland adapted native plants such as saltgrass, meadow barley, and dwarf peppergrass (*Lepidium latipes*). Saltgrass and meadow barley may be sourced from downstream of the restoration site. This planting can be executed in the fall of 2013.

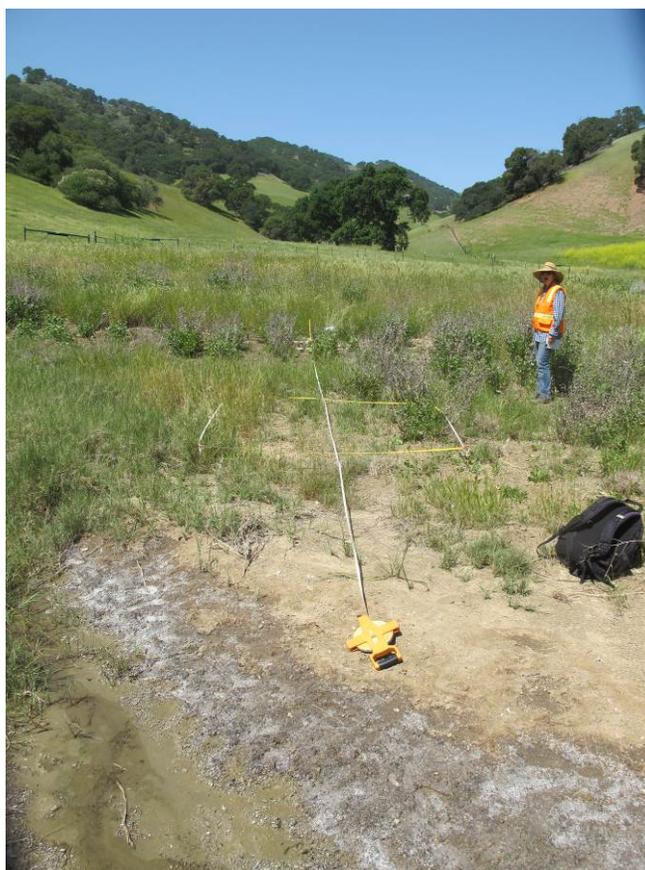
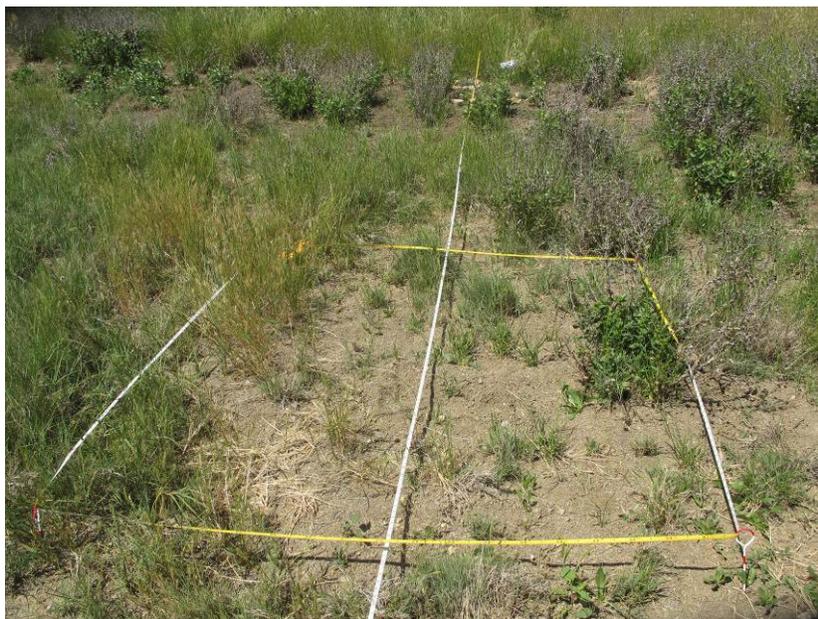
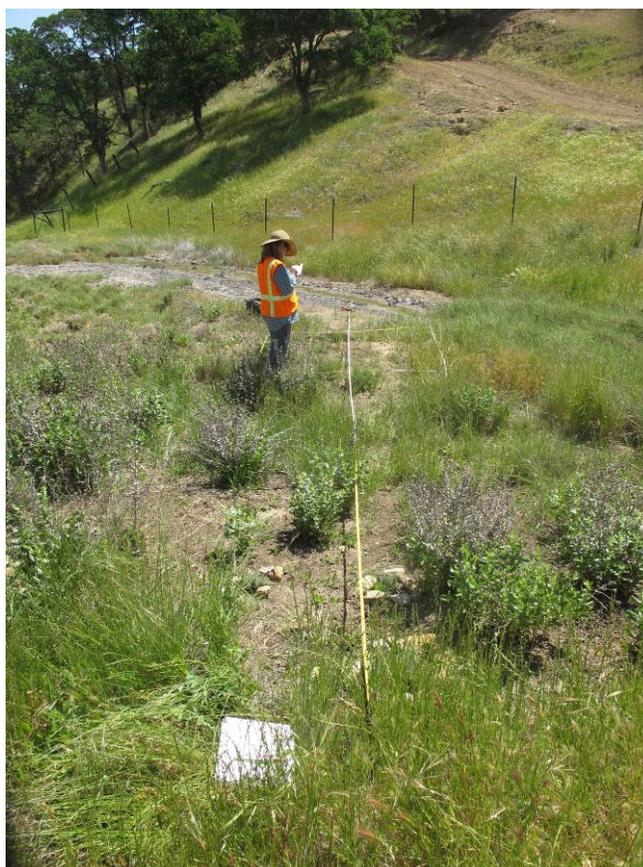
Photo 10. Transect 4. May 10, 2012.

Photo 11. Transect 4. May 10, 2012.

Photo 12. Transect 4. May 10, 2012.
