State of California
Department of Fish and Wildlife

Memorandum

Subject: Summary of Brush Shelter Habitat Placement in Camanche Reservoir

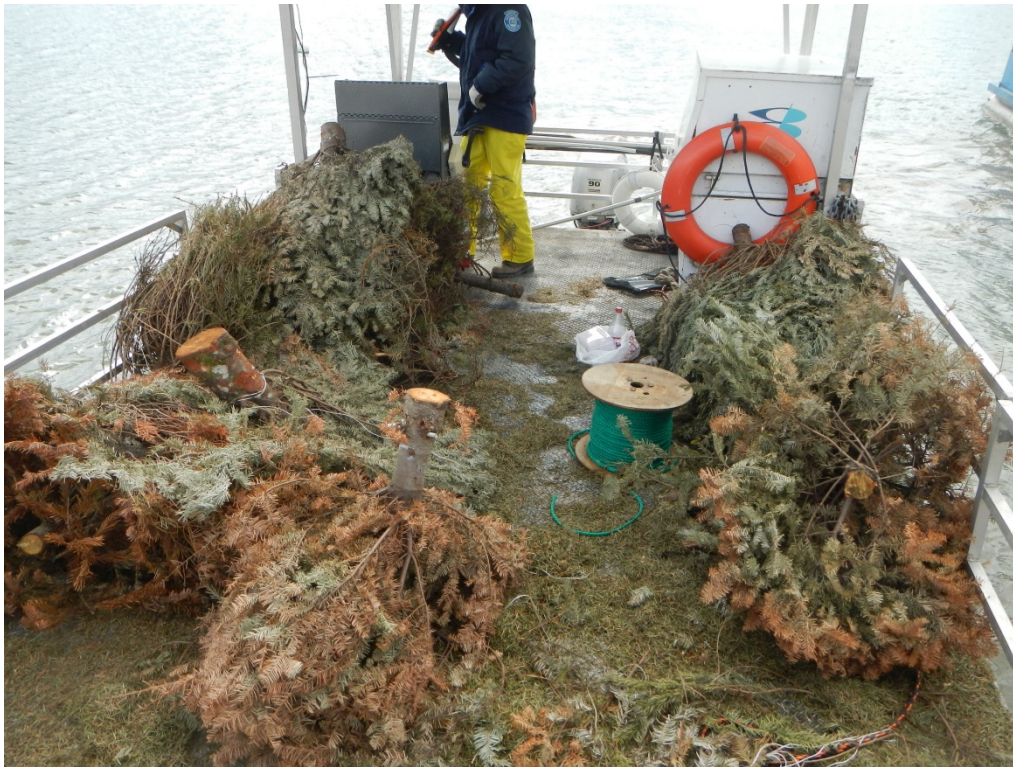
Figure 1. Christmas trees used for habitat at Camanche Reservoir (2/27/2014).

Brush shelter habitats were created by drilling a 9/16 inch hole into the trunk of each tree. Depending on the overall size of the brush shelter habitat, up to four concrete or solid round bar anchors were secured to each with ¼" polypropylene rope in order to sink them (Figure 1). The two types of solid round bar weights weighed 30 lb. or 50 lbs. each. The brush shelter habitats were then taken to various locations on Camanche Reservoir using two EBMUD pontoon boats (Figure 2).

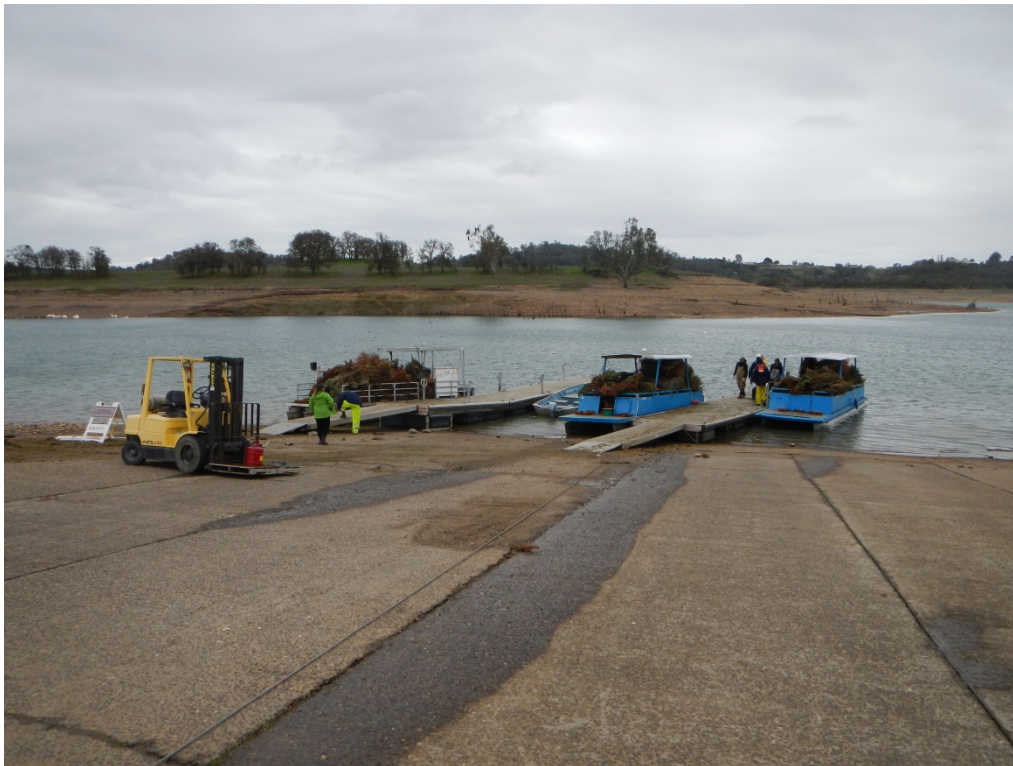
Figure 2. South Shore Ramp at Camanche Reservoir (2/27/2014).
