STREAM INVENTORY REPORT Big Rock Creek

A stream inventory was conducted from July 13 to July 22, 2009 on Big Rock Creek. The survey began at the confluence with Tenmile Creek and extended upstream 3.9 miles.

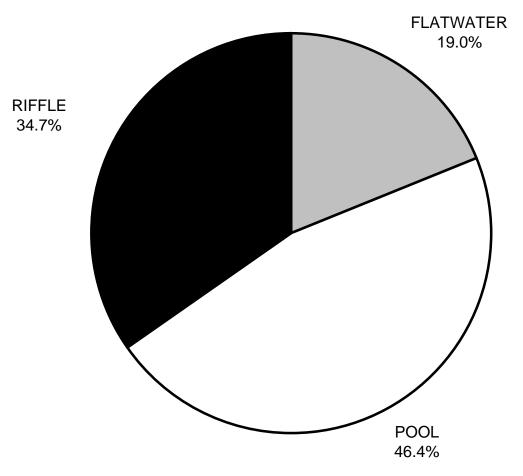
BIG ROCK CREEK 2009 HABITAT TYPES BY PERCENT OCCURRENCE

Table 1 summarizes the Level II riffle, flatwater, and pool habitat types. Based on frequency of occurrence there were 46% pool units, 35% riffle units, and 19% flatwater units (Graph 1). Based on total length of Level II habitat types there were 44% pool units, 32% riffle units, and 24% flatwater units (Graph 2).

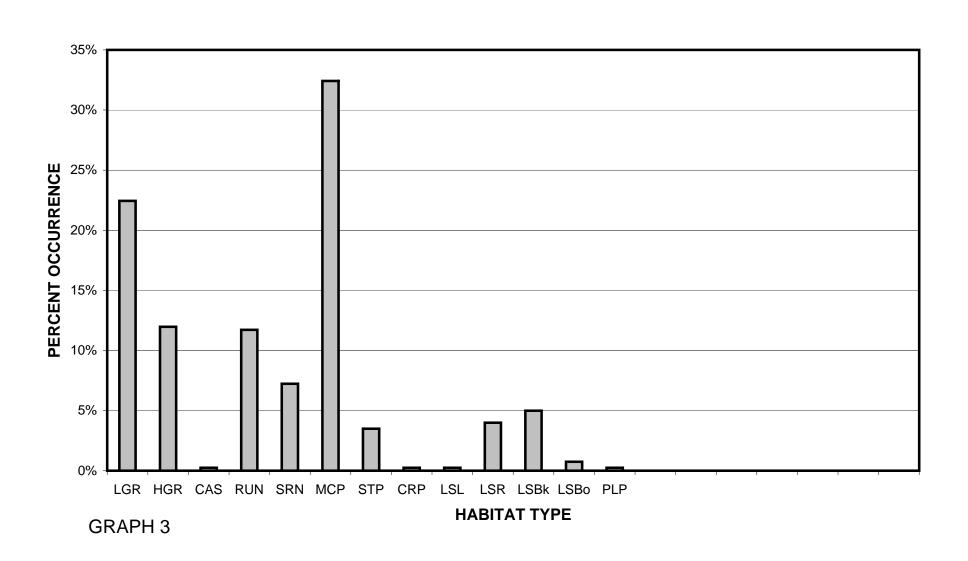
BIG ROCK CREEK 2009 HABITAT TYPES BY PERCENT OCCURRENCE

Thirteen Level IV habitat types were identified (Table 2). The most frequent habitat types by percent occurrence were mid-channel pool units, 32%; low gradient riffle units, 22%; run units, 12%; and high gradient riffle units, 12% (Graph 3). Based on percent total length, mid-channel pool units made up 29%, low gradient riffle units 19%, and step run units 13%.

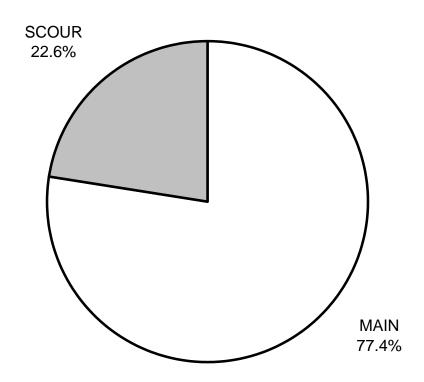
BIG ROCK CREEK 2009 POOL TYPES BY PERCENT OCCURRENCE

A total of 186 pools were identified (Table 3). Main channel pools were the most frequently encountered at 77% (Graph 4), and comprised 74% of the total length of all pools (Table 3).

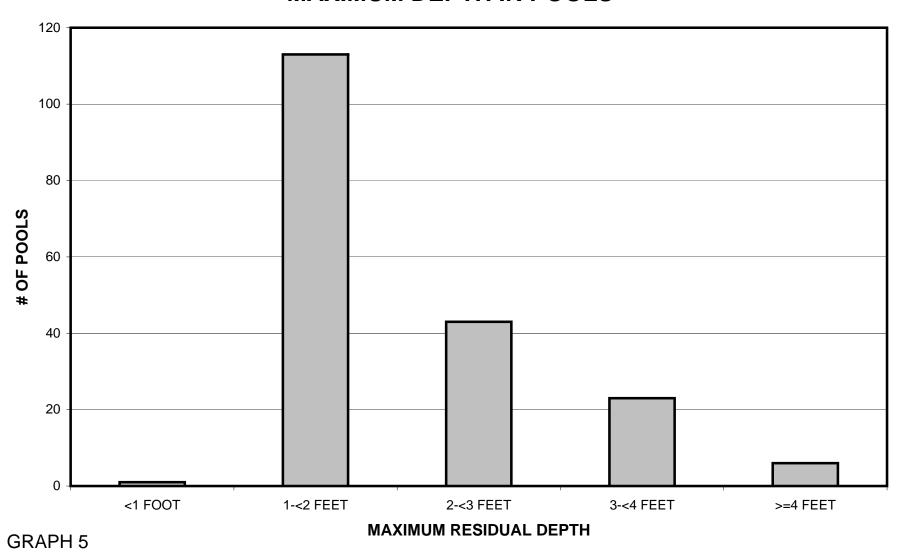
BIG ROCK CREEK 2009 MAXIMUM DEPTH IN POOLS

Table 4 is a summary of maximum residual pool depths by pool habitat types. Pool quality for salmonids increases with depth. Seventy-two of the 186 pools (39%) had a residual depth of two feet or greater (Graph 5).

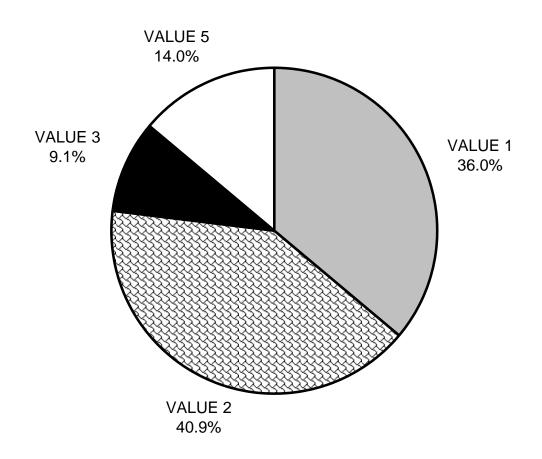
BIG ROCK CREEK 2009 PERCENT EMBEDDEDNESS

The depth of cobble embeddedness was estimated at pool tail-outs. Of the 186 pool tail-outs measured, 67 had a value of 1 (36%); 76 had a value of 2 (41%); 17 had a value of 3 (9%); 26 had a value of 5 (14%) (Graph 6). On this scale, a value of 1 indicates the best spawning conditions and a value of 4 the worst. Additionally, a value of 5 was assigned to tail-outs deemed unsuited for spawning due to inappropriate substrate such as bedrock, log sills, boulders, or other considerations.

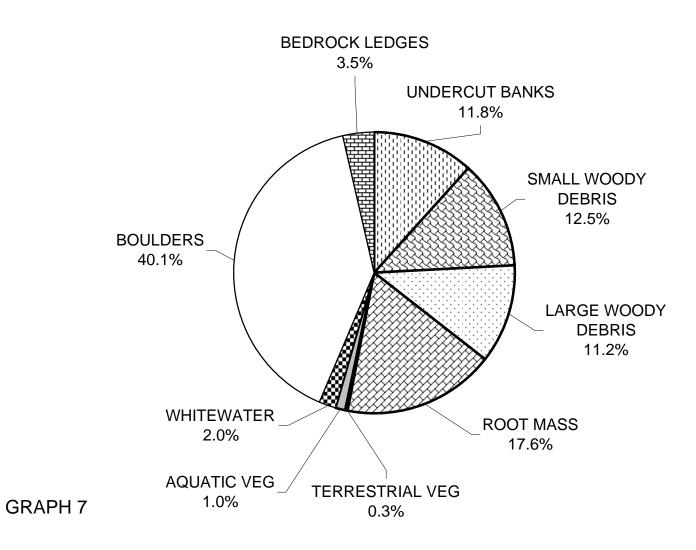
BIG ROCK CREEK 2009 MEAN PERCENT COVER TYPES IN POOLS

Table 5 summarizes mean percent cover by habitat type. Boulders are the dominant cover type in Big Rock Creek. Graph 7 describes the pool cover in Big Rock Creek. Boulders are the dominant pool cover type followed by root mass.

- 3) Increase woody cover in the pools and flatwater habitat units. Most of the existing cover in the pools is from boulders. Adding high quality complexity with woody cover in the pools is desirable.

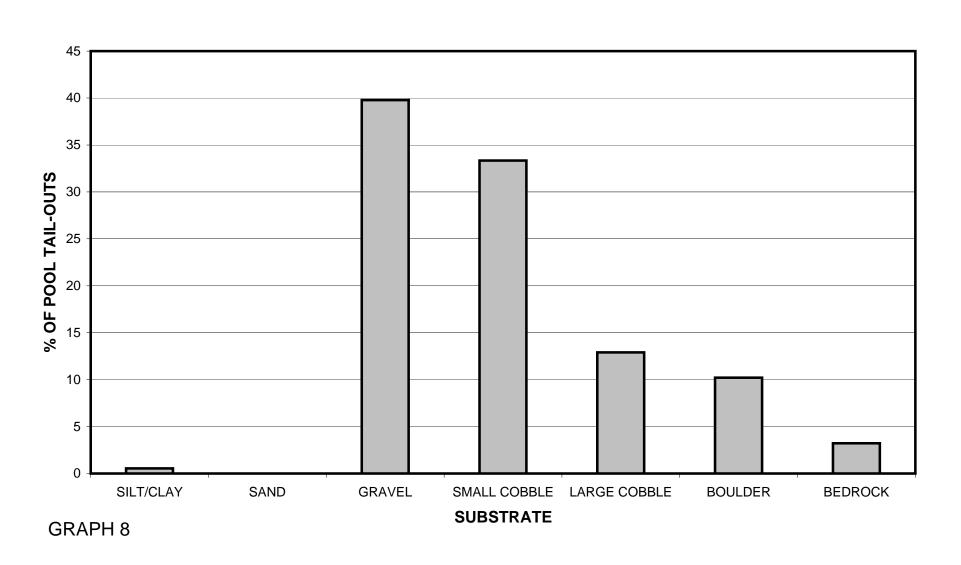
BIG ROCK CREEK 2009 SUBSTRATE COMPOSITION IN POOL TAIL-OUTS

Table 6 summarizes the dominant substrate by habitat type. Graph 8 depicts the dominant substrate observed in pool tail-outs. Gravel was the dominant substrate observed in 40% of the pool tail-outs. Small cobble was the next most frequently observed dominant substrate type and occurred in 33% of the pool tail-outs.

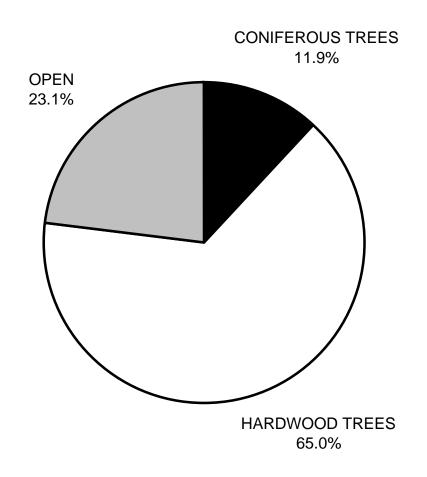
BIG ROCK CREEK 2009 MEAN PERCENT CANOPY

The mean percent canopy density for the surveyed length of Big Rock Creek was 77%. Twenty-three percent of the canopy was open. Of the canopy present, the mean percentages of hardwood and coniferous trees were 85% and 15%, respectively. Graph 9 describes the mean percent canopy in Big Rock Creek.

- Increase the canopy in Reach 1 on Big Rock Creek by planting appropriate native vegetation like willow, alder, redwood, and Douglas fir along the stream where shade canopy is not at acceptable levels. The reaches above this survey section should be inventoried and treated as well, since the water flowing here is affected from upstream. In many cases, planting will need to be coordinated to follow bank stabilization or upslope erosion control projects.

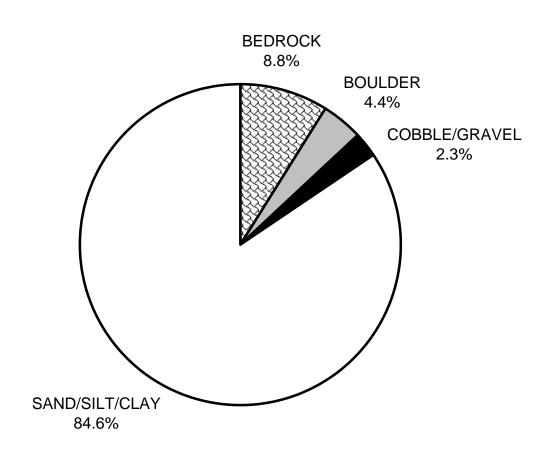
BIG ROCK CREEK 2009 DOMINANT BANK COMPOSITION IN SURVEY REACH

For the stream reach surveyed, the mean percent right bank vegetated was 84%. The mean percent left bank vegetated was 87%. The dominant elements composing the structure of the stream banks consisted of 85% sand/silt/clay, 9% bedrock, 4% boulder, and 2% cobble/gravel. (Graph 10). Deciduous trees were the dominant vegetation type observed in 78% of the units surveyed. Additionally, 12% of the units surveyed had coniferous trees as the dominant vegetation type, and 8% had grass as the dominant vegetation type (Graph 11).
