Site Name: NATOMAS BENNETT PLANT

Stream Name: Cross Canal

PAD ID: [702865](#)

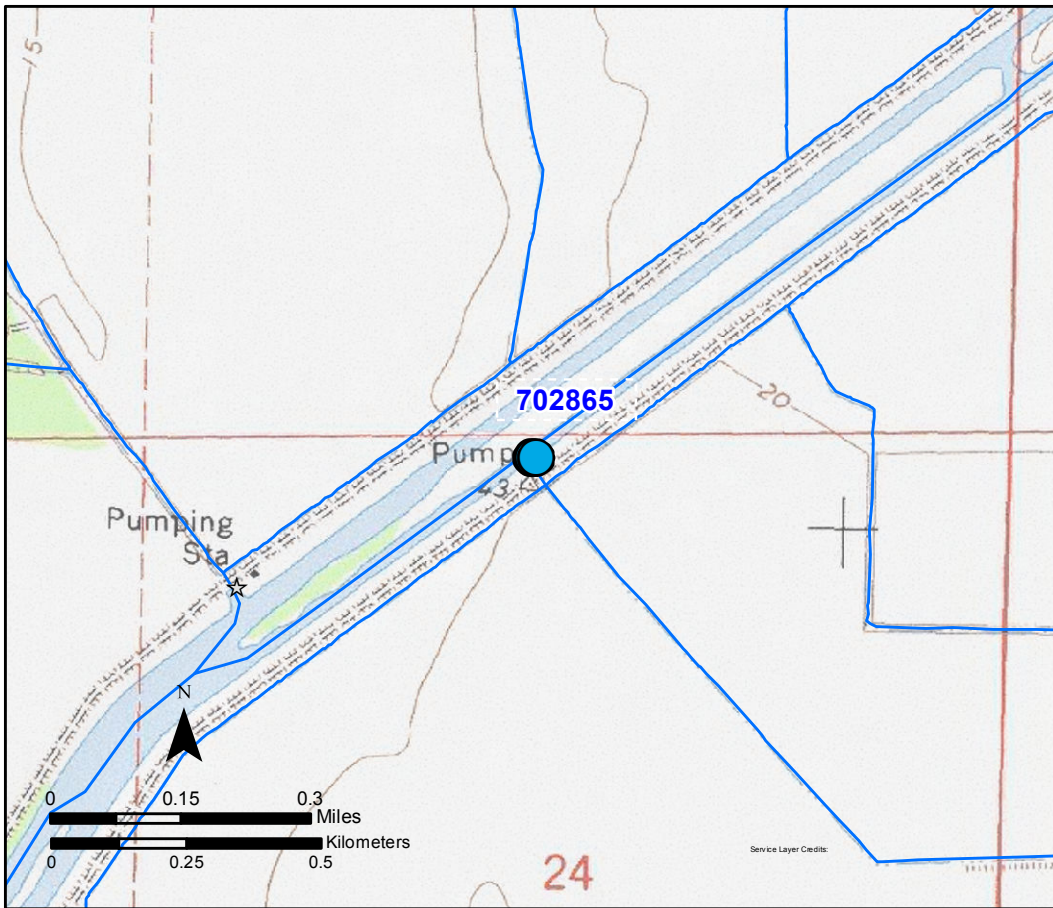
- Barrier Remediated
- Total Barrier
- Partial Barrier
- Not a Barrier
- Remediated, Fish Response Unconfirmed
- ▲ Natural Total Barrier
- ▲ Natural Partial Barrier
- ★ Screened Diversion
- ★ Unscreened Diversion
- Unknown Passage Status
- Unassessed
