Site Name: Grenada Irrigation District Dam (RM 30)

Stream Name: Shasta River

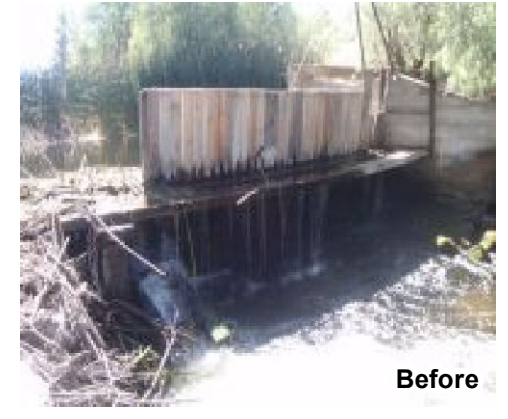
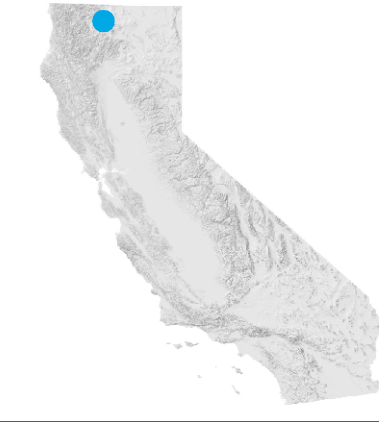
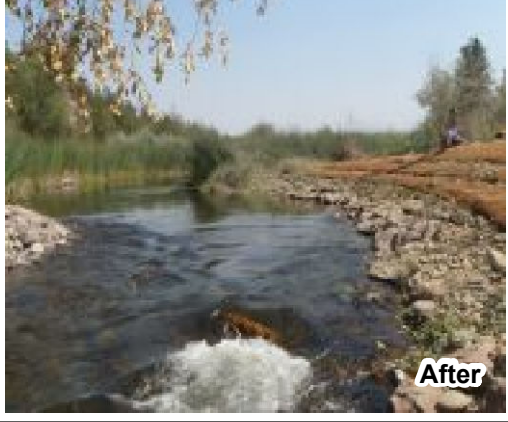
Notes: Dam was removed, and a new on channel fish screen is installed and operating. The new screen is about 1000ft downstream from the old dam replacing the the old screen facility associated with the stream and diversion channel. The river channel and right river bank at the dam site were reconstructed to meet fish passage criteria and natural hydraulic function. Adult passage is being monitored by site observation. Adult Chinook were witnessed navigating through the project area. Before: temporal barrier per professional judgement by Grenada Irrigation District. Diversion dam is the point of diversion for the GID (40 cfs water right) and the Huseman Ditch (11.9 cfs water right), blocks juvenile fish year round and adult passage during the irrigation season.
