Site Name: Water Gulch Dam and Stream Crossing

Stream Name: Freathy Creek (Water Gulch)

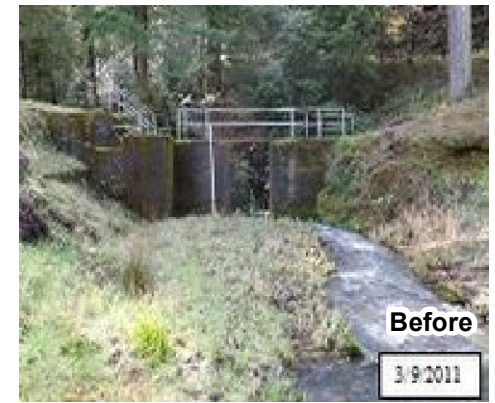
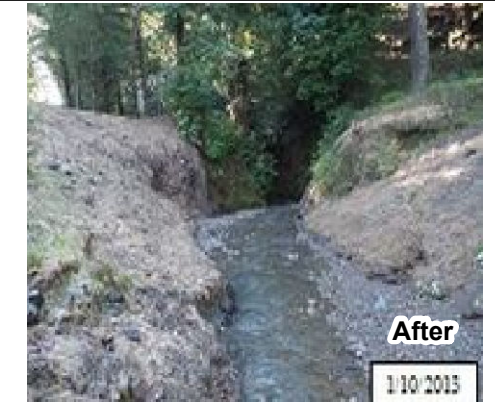
Notes: Sill was removed, and approximately 70 tons of concrete was broken into manageable sized pieces, removed from the crossing and exported to a concrete recycling facility in Willits, California. Before: Temporal barrier per professional judgment by Mendocino Land Trust, Inc. 12 ft tall concrete dam constructed in the late 1950's originally to create a summertime swimming hole, discontinued in the early 1990's. Currently, the dam is a barrier to all juvenile upstream movement.
