Site Name: LNF Big River concrete sill

Stream Name: Little North Fork Big River

PAD ID: [758257](#)

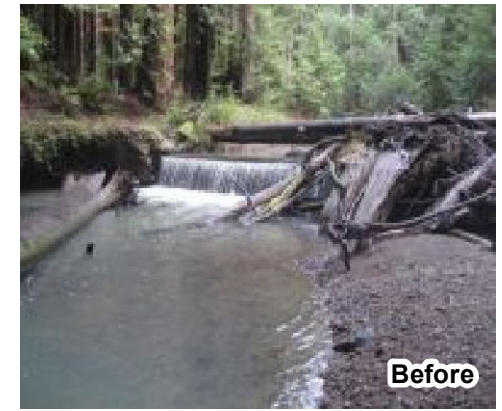
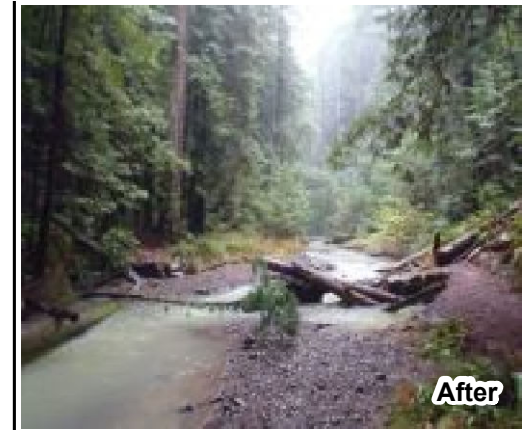
Notes: California Conservation Corps removed the unused diversion sill over a two-week period with jackhammers. The sill once spanned Little North Fork Big River and created a passage barrier, preventing emigration and immigration of juvenile/adult listed salmonids (e.g., coho and steelhead). This project opened 10 miles of stream to juvenile and adult salmonids (Coho and Steelhead) and other fishes. Funded by FRGP. There are no barriers below the project site to impede passage. Before: Partial barrier per professional judgment by CDFW. Was a 3ft x 45ft x 2ft (H, L, W) concrete sill. The structure prevented the migration of juvenile salmon upstream, according to presence/absence data of Coho "redds" collected by SONAR.
