OWCN 2010-2011 Final Report: *Validation of thermography to assess body temperature and waterproofing of captive and rehabilitated seabirds*

Hannah M. Nevins^{1,2}, Colleen Young³ and David A. Jessup⁴

FINAL REPORT

27 December 2012

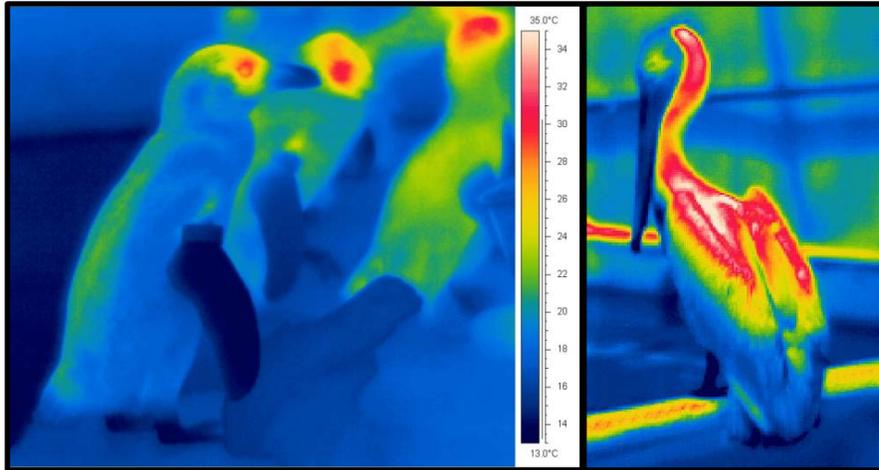
Cover Photos: Thermographs of captive and rehabilitated seabirds: a captive African Penguin at Monterey Bay Aquarium (left) and a Brown Pelican roosting at San Francisco Bird Rescue (right).

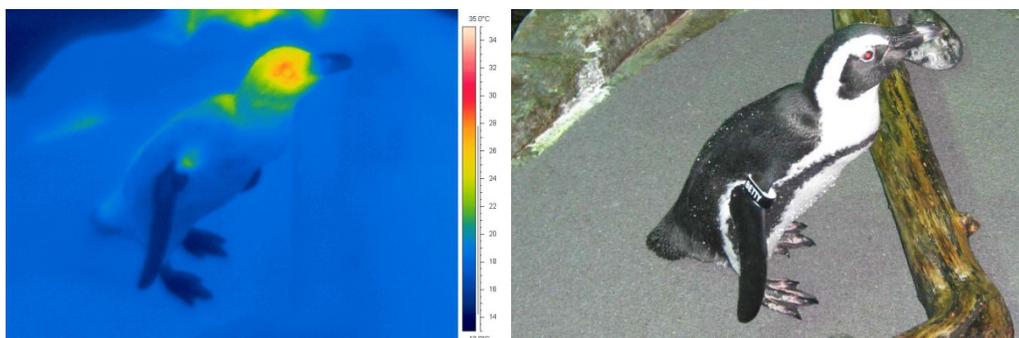
Figure 1. Infrared thermograph (left) and digital image (right) of “Betty”, an adult, 2.5 year-old African Penguin at the Monterey Bay Aquarium on 4/7/2011. Colors in the thermograph correspond to the temperatures (°C) on the scale on the right, which ranges from 13 to 35°C.

We quantified surface temperatures with thermography of 12 “normal” adult, non-molting AFPE on display during feeding events at 10:30 am and 3:00 pm. (Fig. 1). For this study, we assumed that these long-term captive animals represented thermally stable and healthy individuals and thus represented the “normal” thermal state.

Temperatures recorded by the thermograph represent *surface* body temperature, not necessarily *core* body temperature. On thermographs, areas with good insulation (feathers and/or subcutaneous fat), with poor blood perfusion, and/or that have cold water droplets on the surface (from swimming) will appear cool (blues). Areas with poor insulation, with abundant blood perfusion, and/or that have been out of the cold water for some time will appear warmer (reds and oranges). During this first trial, we learned that physiological, behavioral, and developmental variables may affect the normal thermographic signatures. Digital photographs were taken in tandem with infrared thermographs for later reference to verify individual identities and in identifying behaviors or other environmental conditions that might affect the interpretation of the thermographs (Fig. 1).

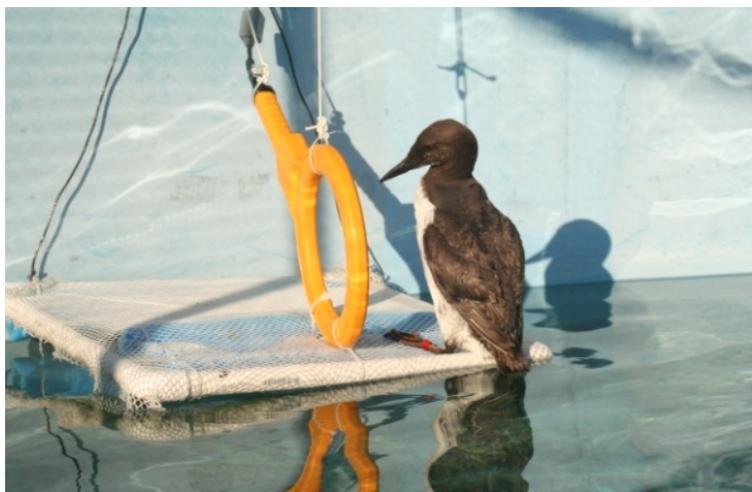
Figure 14. A Common Murre on a haul-out, checking out the microchip antenna (yellow racket-shaped object).

On 29 July, we implanted temperature-sensing microchips subcutaneously into three Common Murres (R172 [=P1031], B415, R1824) and on 5 August, we implanted a fourth bird (G938). We arranged to receive sample thermal microchips and a loaner microchip reader and antenna from Destron Fearing, a company specializing in animal identification products. In this trial, we mounted the antenna on a haul-out in the pool and set up a data logger (microchip reader) next to the pool (Fig. 14). The microchip reader logged the unique microchip number and the temperature of the tissue directly surrounding the microchip each time the bird was detected by the antenna. We obtained body temperature data for 3 of 4 birds and for 2 of the implanted murre over a 24 hour period (Fig. 15). We found that the read-range of this antenna was sufficient to detect birds sitting within 0 to 6 inches of the haul-out; but it was inadequate to detect birds swimming in the pool at a range >8 inches. Currently, we are in discussions with a representative from BioMark, a distributor for Destron Fearing, and a specialist in electronic identification to design and implement an improved antenna system with a better detection range. We hope to purchase a system this year and conduct more trials during the second year of this study.
