CALIFORNIA DEPARTMENT OF FISH AND GAME
STREAM INVENTORY REPORT

Atascadero Creek
Report Revised April 14, 2006
Report Completed 2000
Assessment Completed 1995

A stream inventory was conducted during the summer of 1995 on Atascadero Creek to assess habitat conditions for anadromous salmonids. The inventory was conducted in two parts: habitat inventory and biological inventory. The objective of the habitat inventory was to document the amount and condition of available habitat to fish, and other aquatic species with an emphasis on anadromous salmonids in Atascadero Creek. The objective of the biological inventory was to document the salmonid and other aquatic species present and their distribution. After analysis of historical information and data gathered recently, stream restoration and enhancement recommendations are presented.

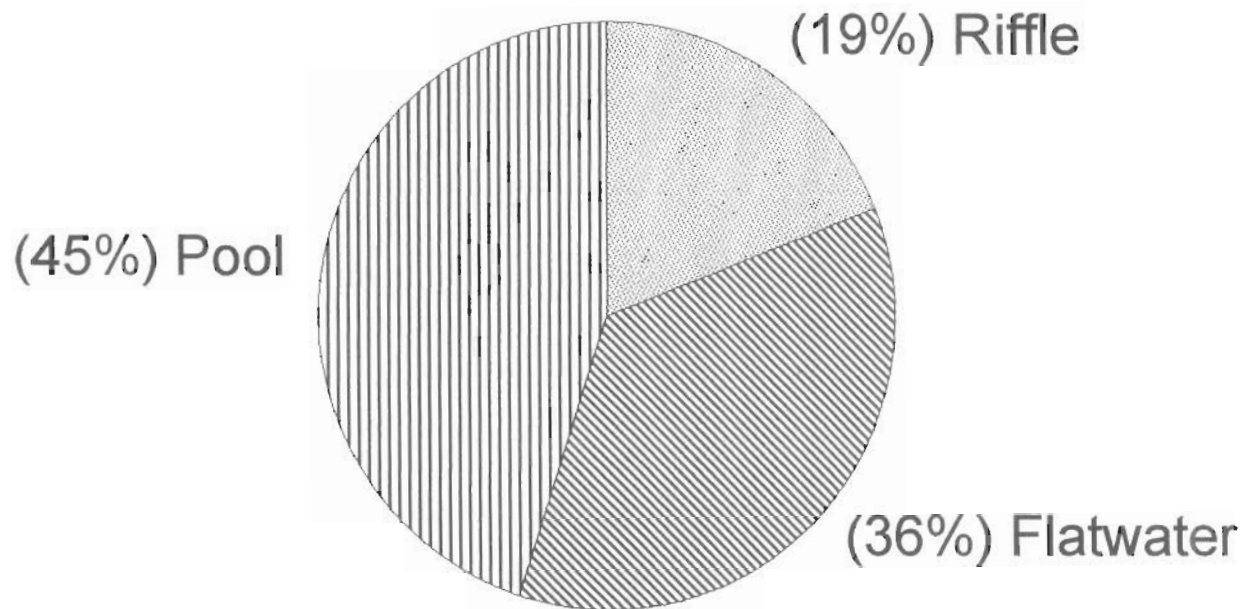
Graph 1

Table 1 summarizes the Level II riffle, flatwater, and pool habitat types. By percent occurrence, pools made up 45%, flatwater 36%, and riffles 19% (Graph 1). Flatwater habitat types made up 82% of the total survey length, pools 11%, and riffles 7%.

Level II Habitat Types by % Occurrence

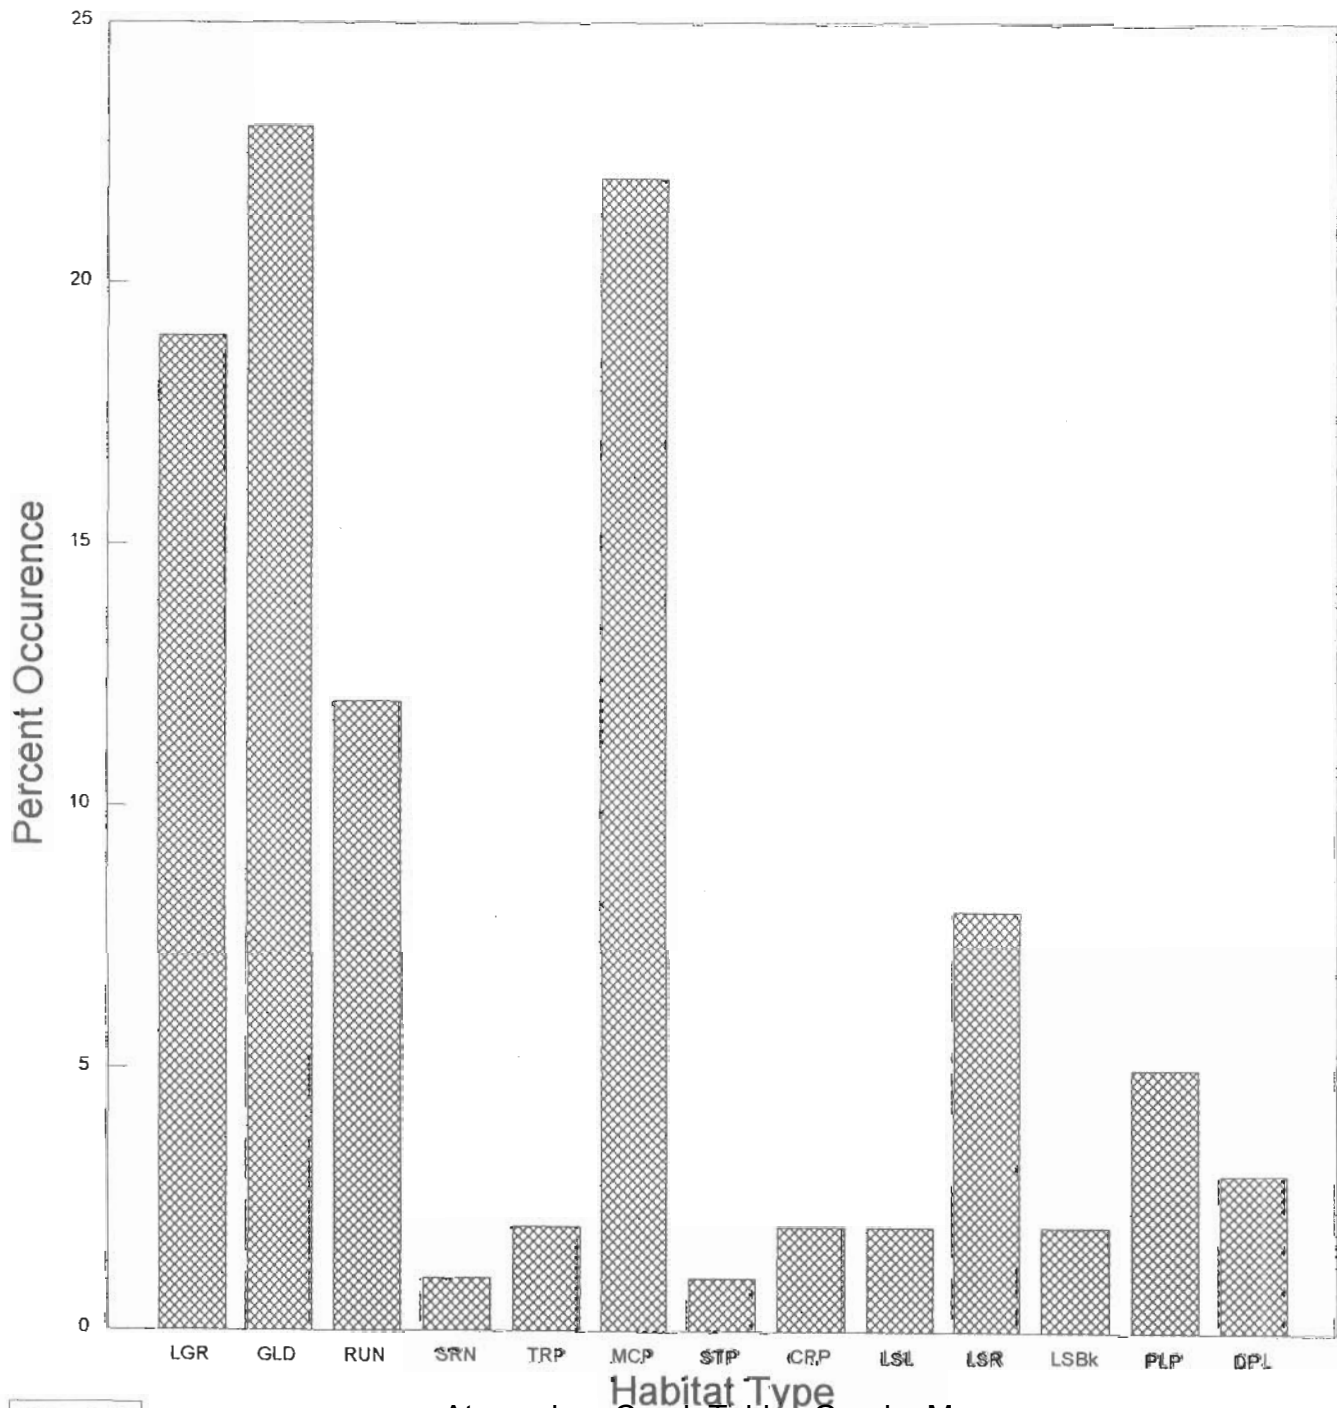
Graph 2

Thirteen Level IV habitat types were identified. The data are summarized in Table 2. The most frequent habitat types by percent occurrence were glides, 23%; mid-channel pools, 22%; and low gradient riffles, 19% (Graph 2). By percent total length, glides made up 77%, low gradient riffles 7%, and mid-channel pools 6%.

Level IV Habitat Types by Percent Occurrence

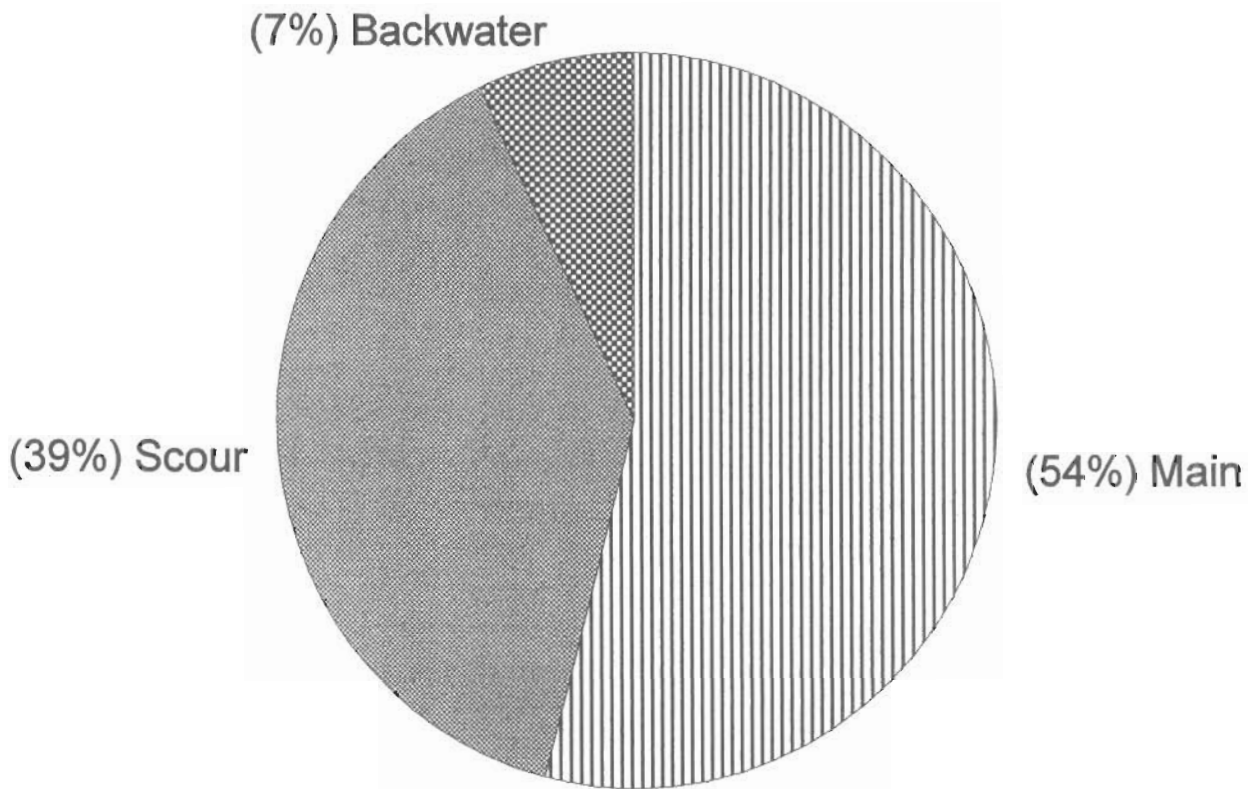
Graph 3

Fifty-six pools were identified (Table 3). Main channel pools were most often encountered at 54%, and comprised 62% of the total length of pools (Graph 3).

Pool Habitat Types by % Occurrence

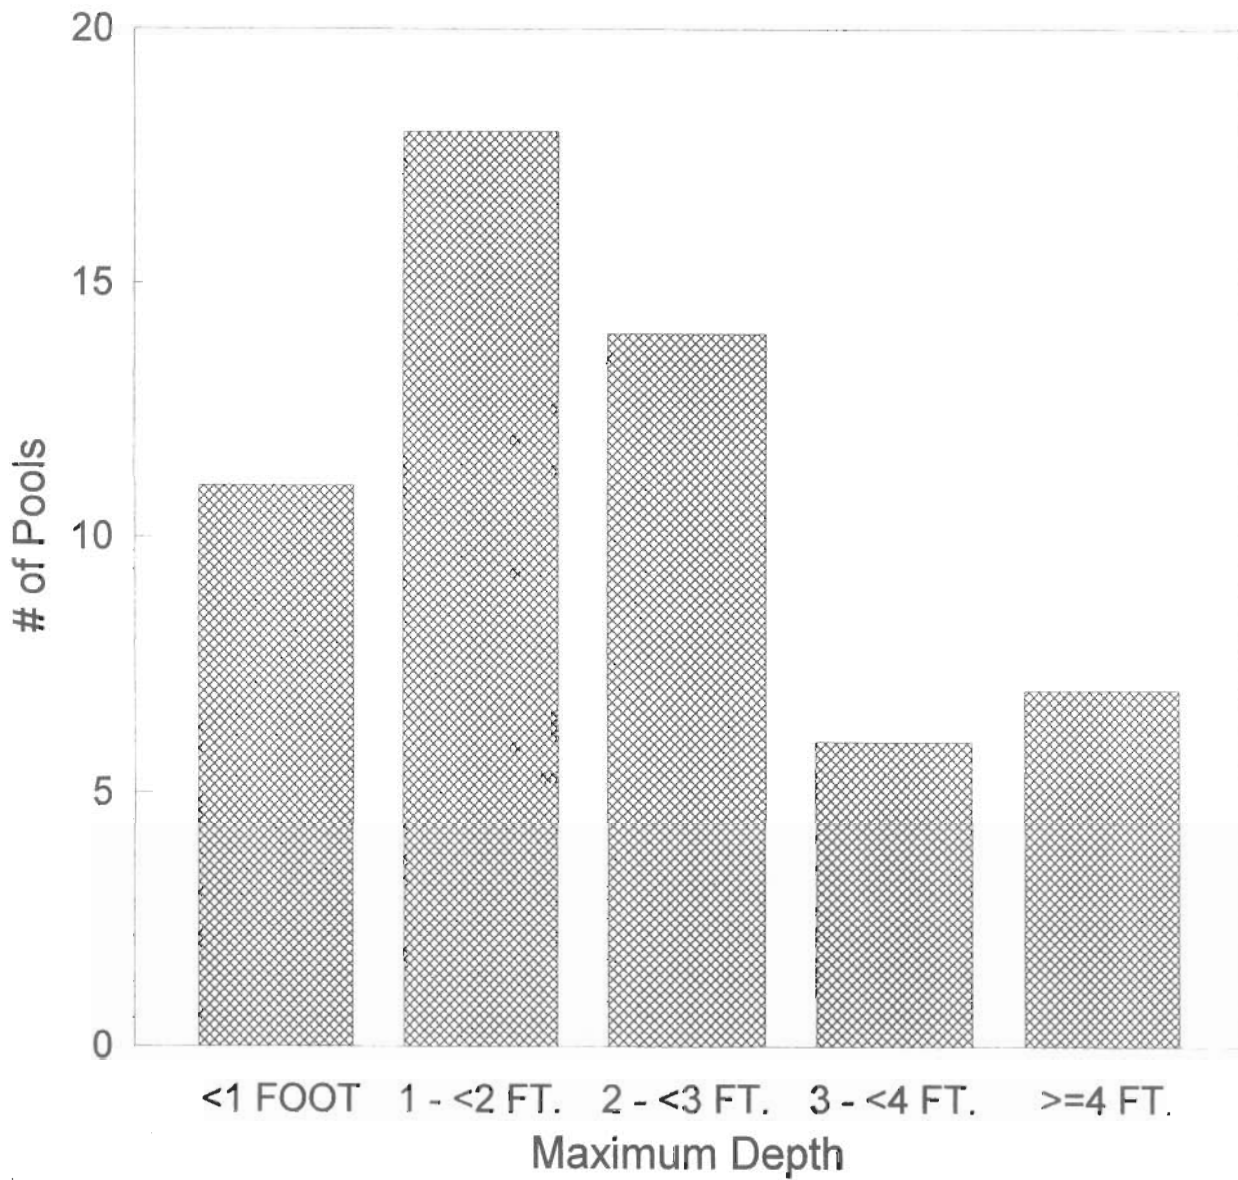
Graph 4

Table 4 is a summary of maximum pool depths by pool habitat types. Depth is an indicator of pool quality. Thirteen of the 56 pools (23%) had a depth of three feet or greater (Graph 4).

Maximum Depth in Pools

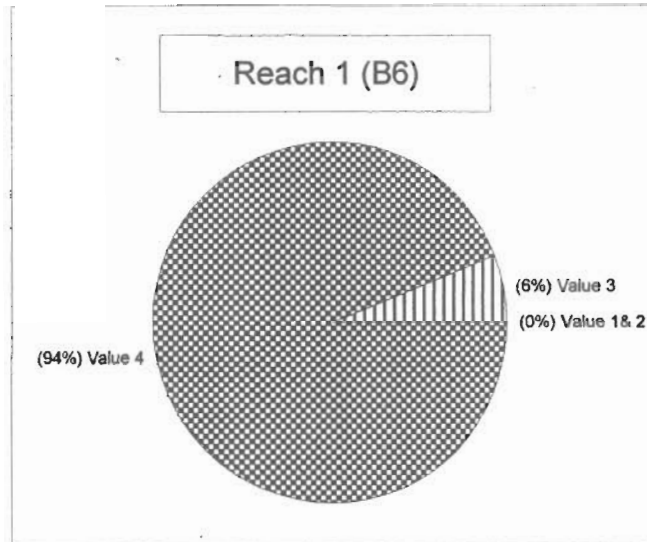
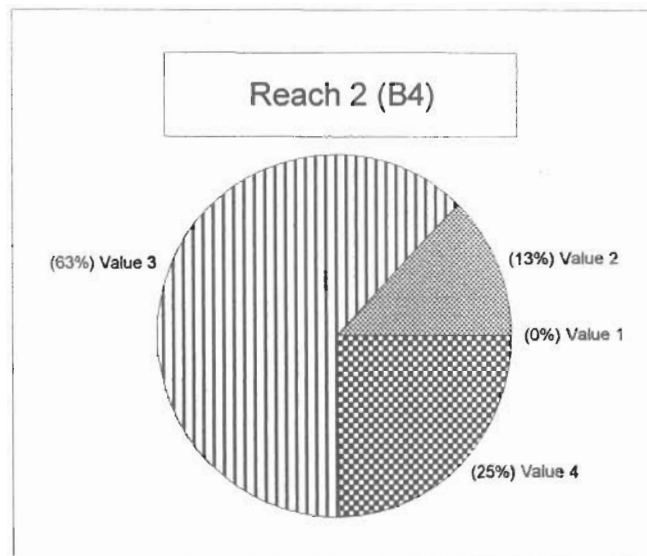
Graph 5

Pool tail embeddedness, is a measure of the suitability of spawning gravel. Reach 1 was found to be very embedded with 94% of the pools having a rating of 4 (75-100% embedded). Reach 2 was a little better, but still highly embedded with 25% of the pools with a rating of 4 and 63% with a rating of 3. A value of one is best for the needs of salmon and steelhead (Graph 5).

Percent Embeddedness by Reach

Value 1 = <25% Value 2 = 25-50% Value 3 = 51-75% Value 4 = >76%

Pool tail embeddedness, is a measure of the suitability of spawning gravel. Reach 1 was found to be highly embedded with 94% of the pools having a rating of 4 (75-100% embedded) and 6% with a rating of 3 (50-75% embedded). Reach 2 was only slightly better, but still highly embedded with 25% of the pools rating 4 and 63% rating 3.

A value of one is best for the needs of salmon and steelhead. Reach 2 contains 69% of the total length of riffle habitat. However, observations indicate the majority of riffles encountered to be poor habitat for spawning.

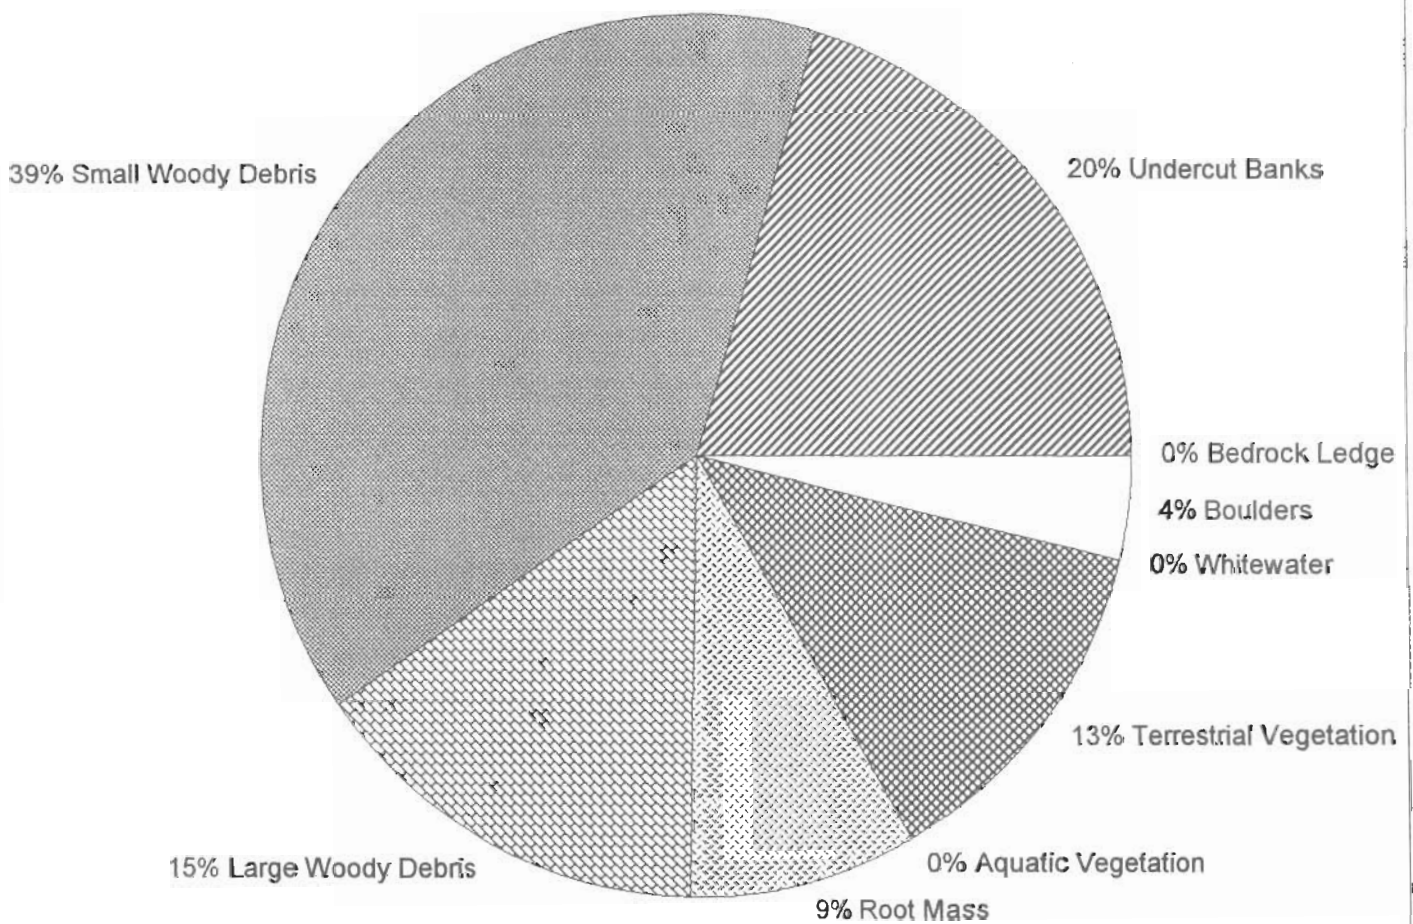
Table 10 summarizes total cover by habitat type. Small woody debris is the dominant cover type for pools in Atascadero Creek. Large woody debris and undercut banks are the next most common cover types.

Graph 6 describes the pool cover in Atascadero Creek.

Percent Cover Types in Pools

The mean shelter rating for pool habitat types was low at 44. A

pool shelter rating of approximately 80 is desirable. The relatively small amount of pool cover that now exists is being provided primarily by small woody debris. Log and root wad cover structures in the pool and flatwater habitats are needed to improve both summer and winter salmonid habitat. Log cover structure provides rearing fry with protection from predation, rest from water velocity, and also divides territorial units to reduce density related competition.

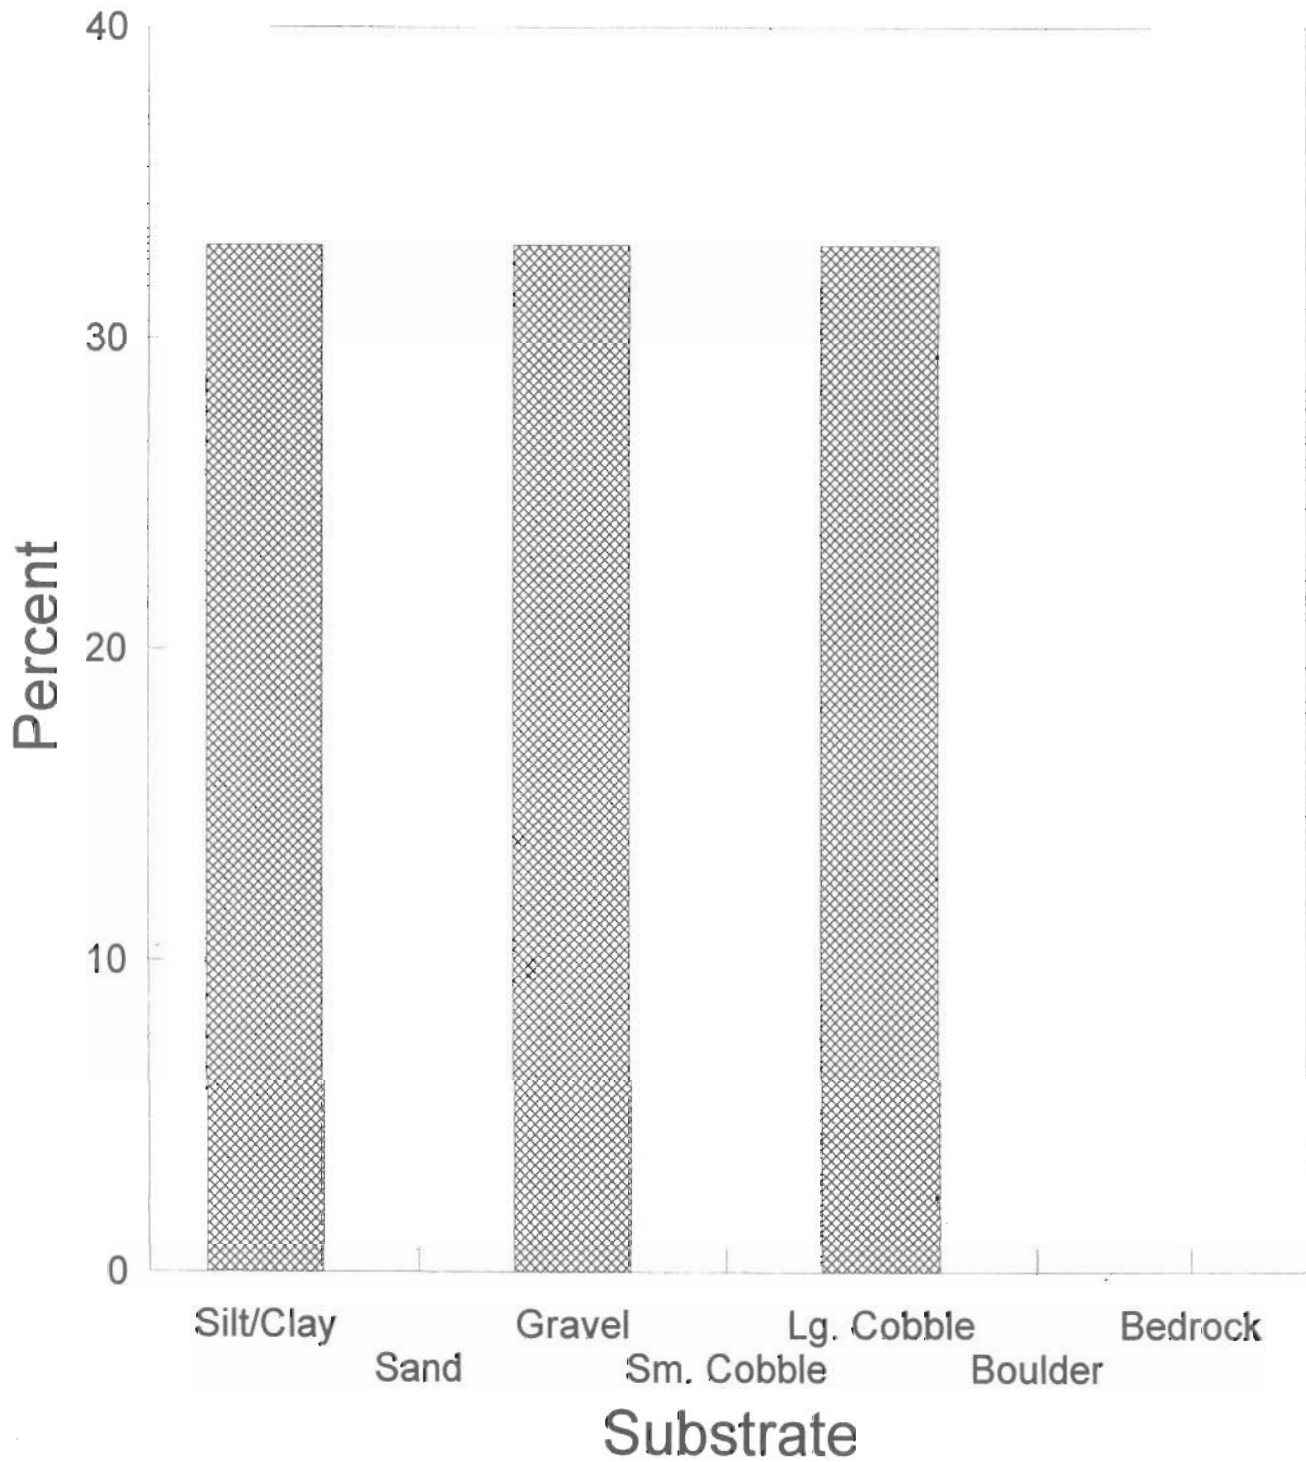
Graph 7

Gravel was the dominant substrate observed in 33% of the low gradient riffles measured (Graph 7). Large cobble and silt/clay were dominant substrates in the remaining low gradient riffles.

Substrate Composition in Low Gradient Riffles

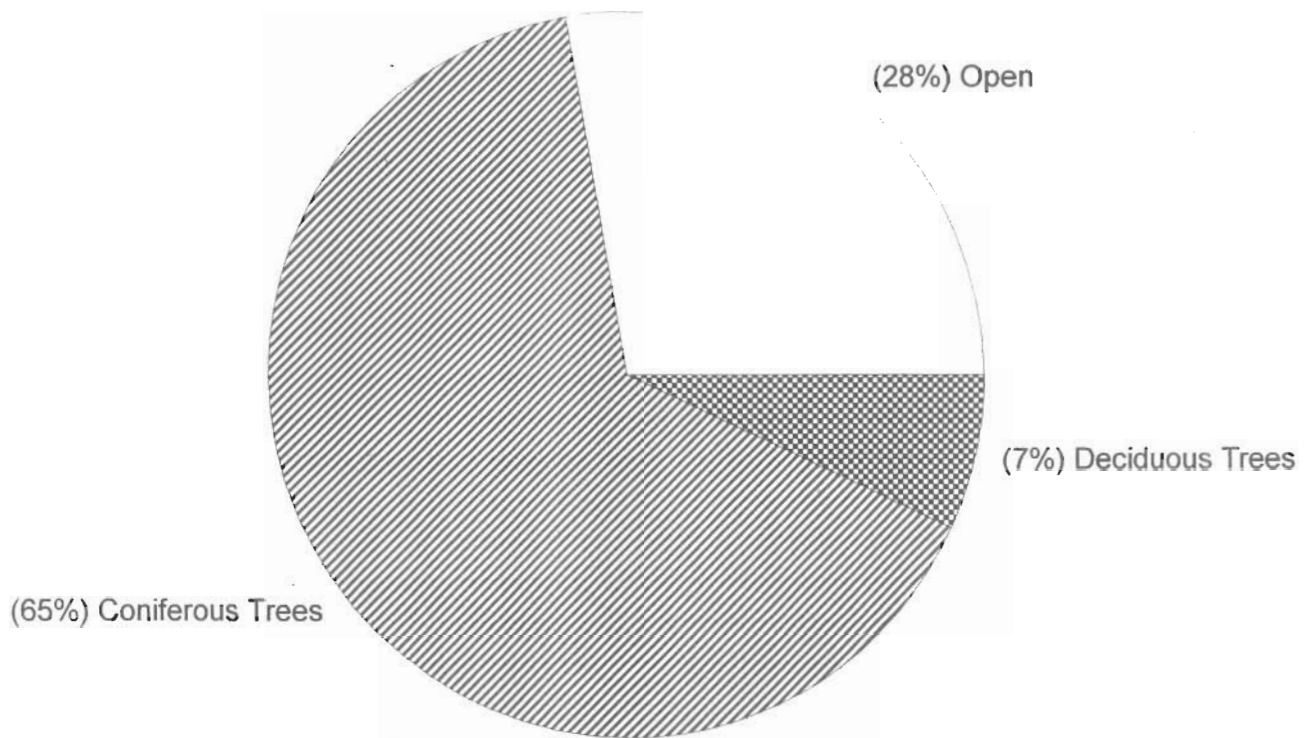
Only 28% of Atascadero Creek lacked shade canopy. Sixty-five percent of the stream had a canopy consisting of coniferous trees and 7% had a canopy of deciduous trees. Graph 8 describes the overall canopy in Atascadero Creek. On a reach by reach comparison, 26% of Reach 1 and 31% of Reach 2 lacked shade canopy (Graph 11).

Mean Percent Canopy

The mean percent canopy for the entire survey reach was 72%. This is a fair percentage of canopy since 80% is generally considered desirable. Large trees contribute shade, increase bank stability and eventually provide a long term source of large woody debris needed for instream structure.

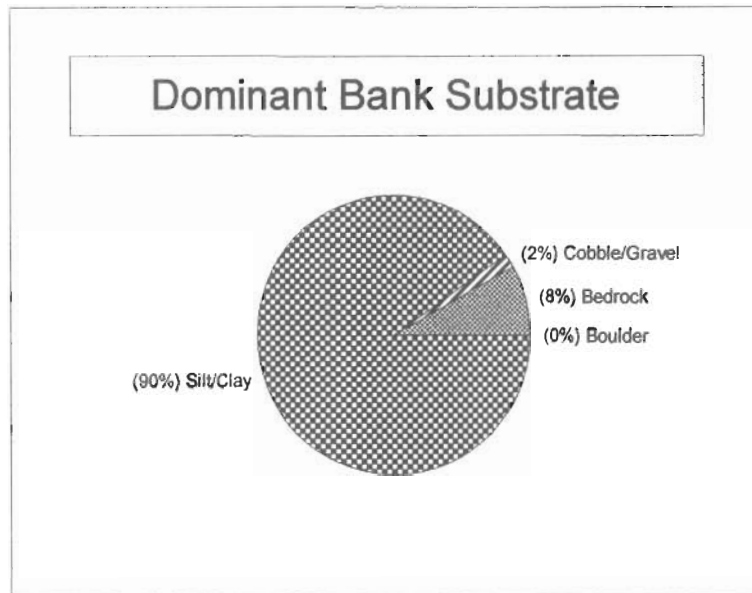
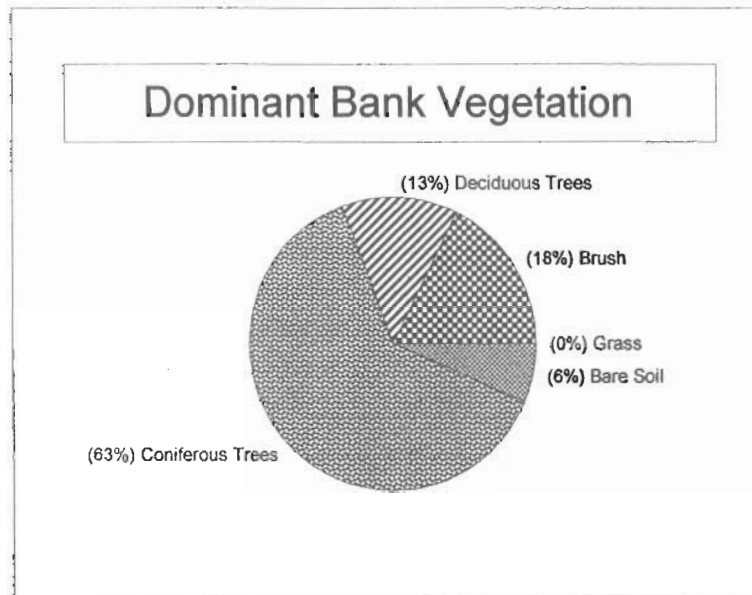
Graph 9

The mean percent right bank vegetated was 56% and the mean percent left bank vegetated was 54%. For the habitat units measured, the dominant vegetation types for the stream banks were: 63% coniferous trees, 18% brush, 13% deciduous trees and 6% bare soil. The dominant substrate for the stream banks were: 90% silt/clay, 8% bedrock and 2% cobble/gravel. The dominant vegetation types for the stream banks were: 63% coniferous trees, 18% brush, 13% deciduous trees and 6% bare soil (Graph 9).

Percent Bank Composition

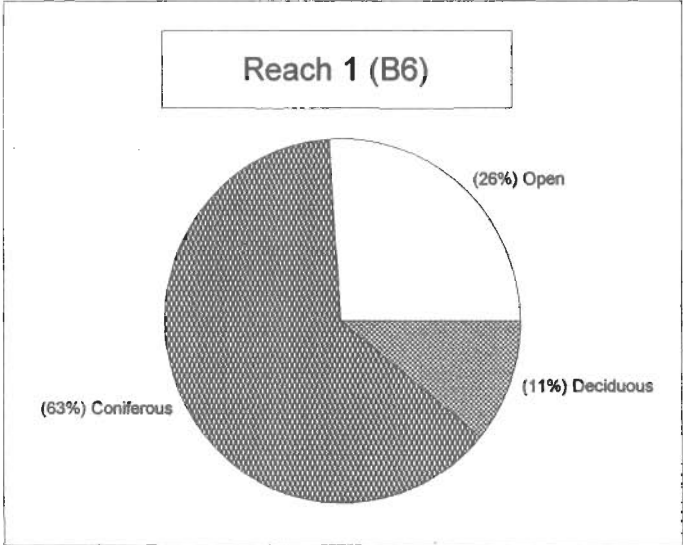
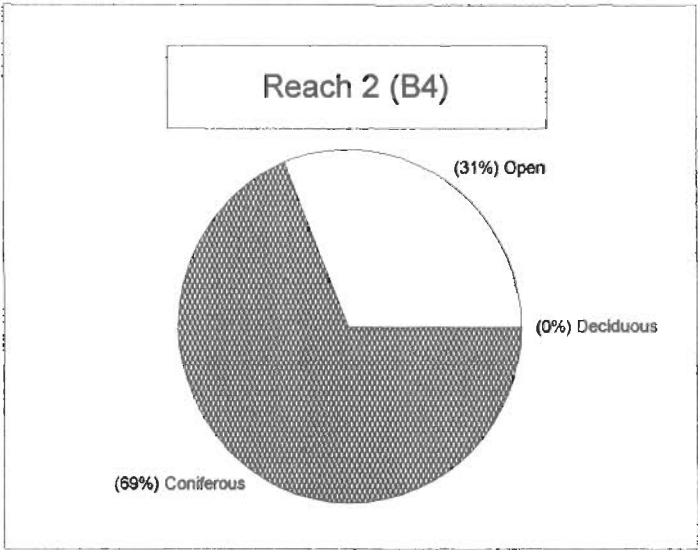
Graph 11

Percent Canopy by Reach

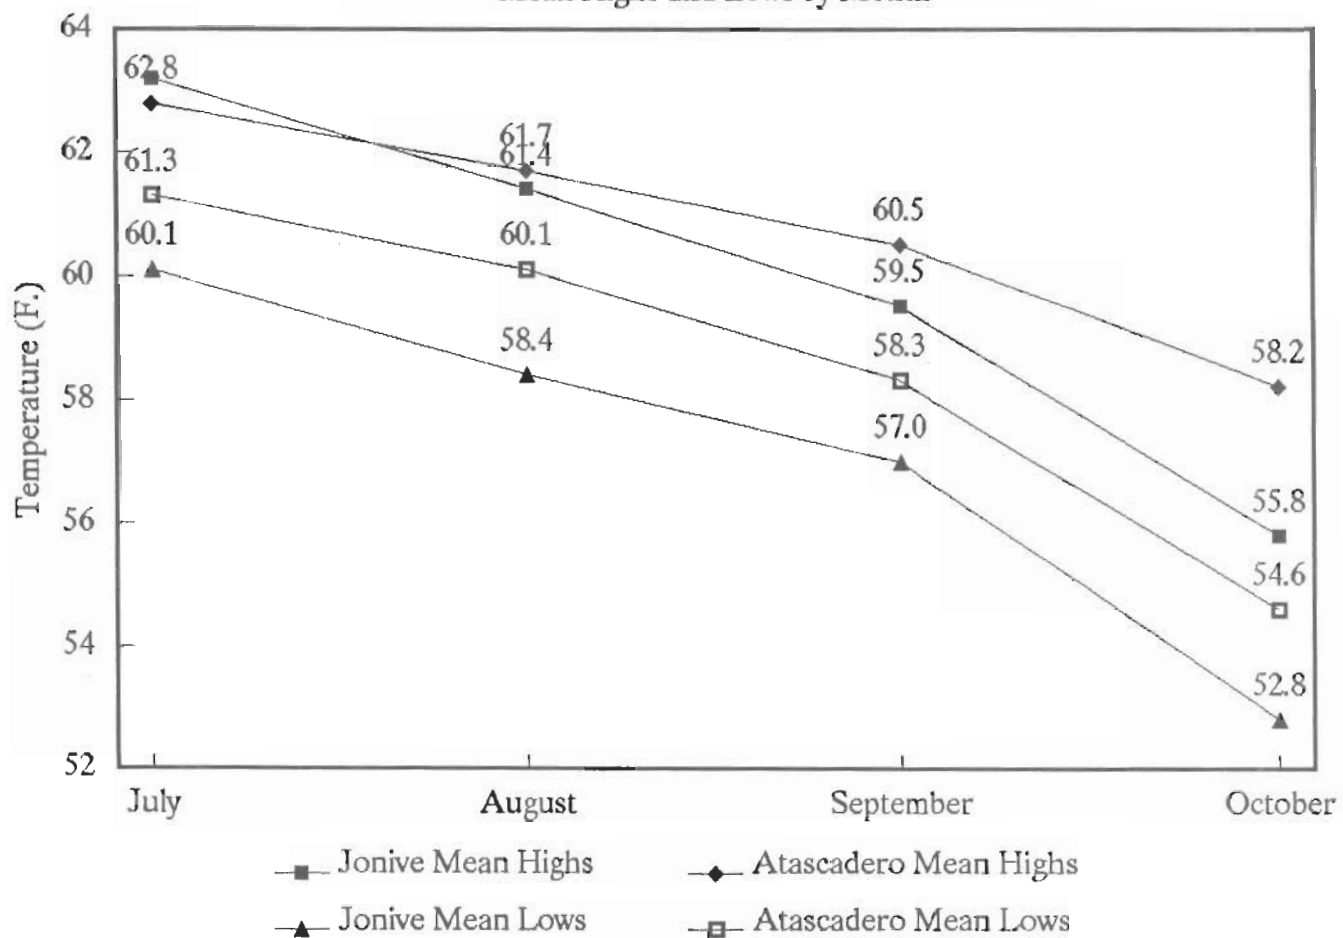
Water temperatures recorded by field observers ranged from 60°F to 65°F. Air temperatures ranged from 59°F to 85°F. A Ryan Tempmentor was placed in a pool near Mill Station Road and recorded temperatures every two hours from July 20 - October 10, 1995. The highest temperature recorded was 64.9°F. and the lowest was 53.1°F. The mean of the daily highs was 62.8°F for the last 11 days of July, 61.7°F. for August, 60.5°F. for September and 58.2°F. for the first 10 days of October (see Tempmentor summary graph).

Jonive and Atascadero Creek Tempentor Summary
 Mean Highs and Lows by Month

The water temperatures recorded daily by crew personnel ranged from 60°F to 65°F. The mean of the daily highs measured with remote

recorders for the month of July was 62.8°F, August 61.7°F, September 60.5°F and October 58.2°F.
