**California Department of Fish and Wildlife  
East Marin County  
San Francisco Bay Watersheds  
Stream Habitat Assessment Reports**

**Ross Creek**

# STREAM INVENTORY REPORT

*Survey complete October 2009*

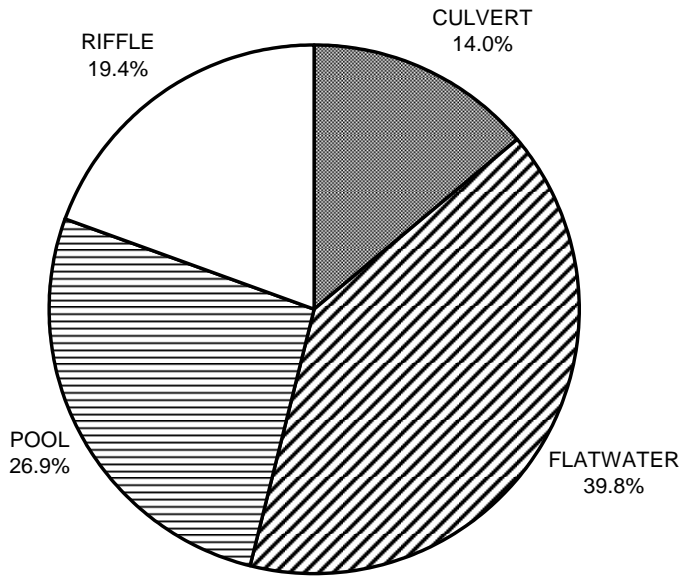
GRAPH 1

Table 1 summarizes the Level II riffle, flatwater, and pool habitat types. Based on frequency of occurrence there were 40% flatwater units, 19% riffle units, 27% pool units, and 14% culvert units (Graph 1). Based on total length of Level II habitat types there were 58% flatwater units, 23% riffle units, 17% pool units, 3% culvert units (Graph 2).

**ROSS CREEK 2009  
HABITAT TYPES BY PERCENT OCCURRENCE**

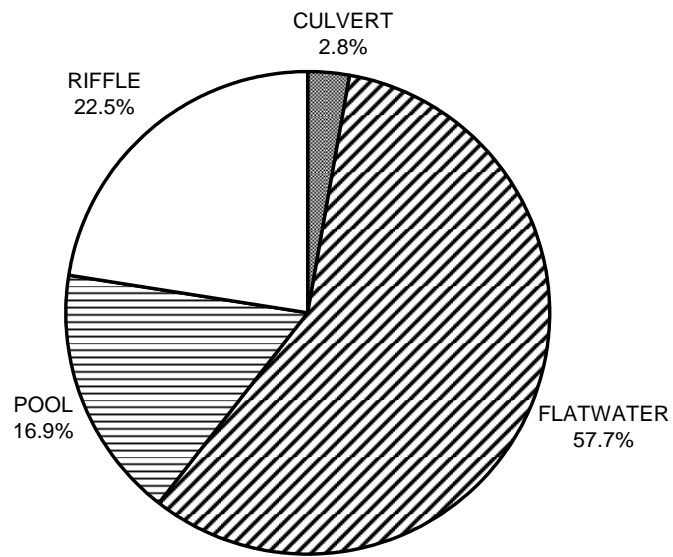
GRAPH 2

**ROSS CREEK 2009  
HABITAT TYPES BY PERCENT TOTAL LENGTH**

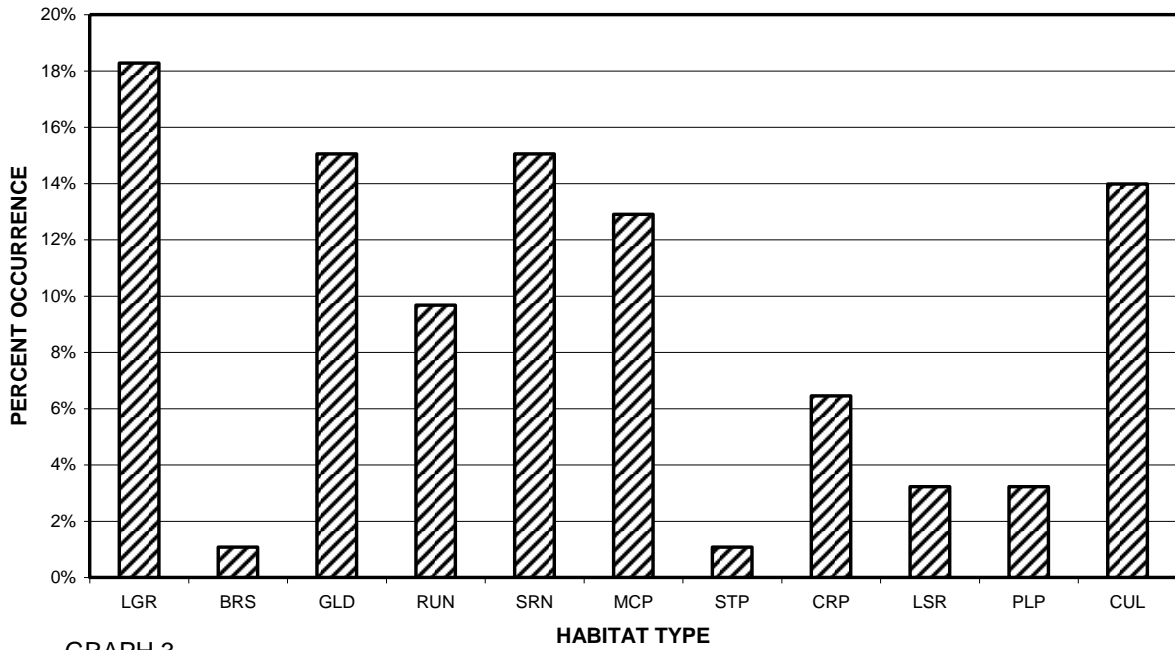
GRAPH 3

Eleven Level IV habitat types were identified (Table 2). The most frequent habitat types by percent occurrence were 15% Step Run units, 18% Low Gradient Riffle units, 15% Glide units (Graph 3). Based on percent total length of level II habitat types there were 35% Step Run units, 22% Low Gradient Riffle units, and 15% Glide units.

### ROSS CREEK 2009 HABITAT TYPES BY PERCENT OCCURRENCE

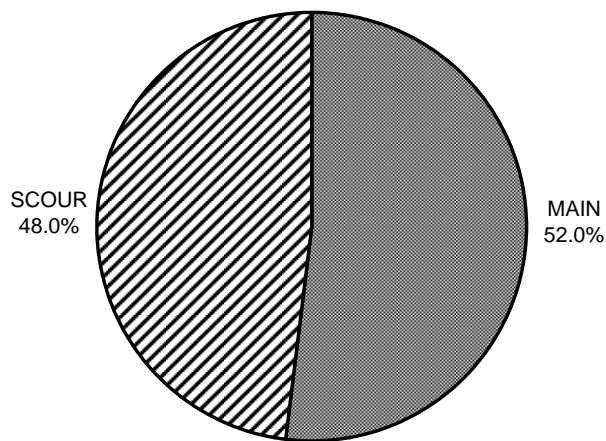
GRAPH 4

A total of 25 pools were identified (Table 3). Main Channel pools were the most frequently

encountered, at 52%, and comprised 59% of the total length of all pools (Graph 4).

### ROSS CREEK 2009 POOL TYPES BY PERCENT OCCURRENCE

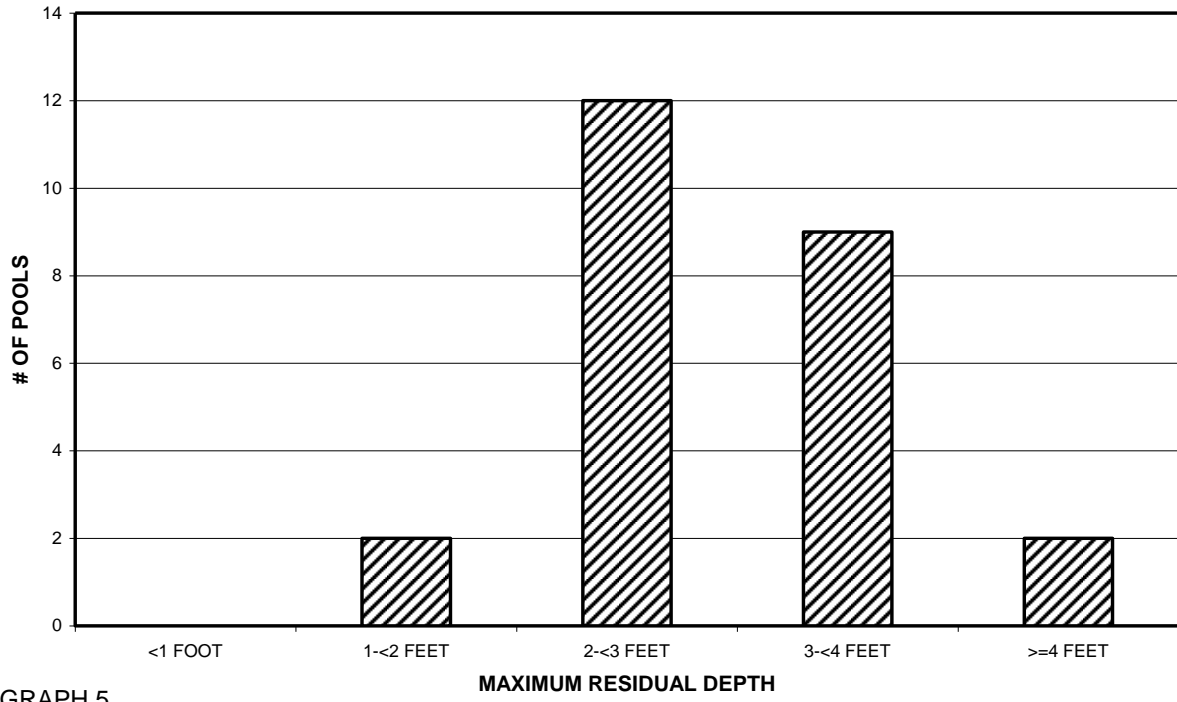
GRAPH 5

Table 4 is a summary of maximum residual pool depths by pool habitat types. Pool quality for salmonids increases with depth. Twenty-three of the 25 pools (92%) had a residual depth of two feet or greater (Graph 5).

**ROSS CREEK 2009  
MAXIMUM DEPTH IN POOLS**

- 5) Where feasible, design and engineer pool enhancement structures to increase the number of pools. This must be done where the banks are stable or in conjunction with stream bank armor to prevent erosion.

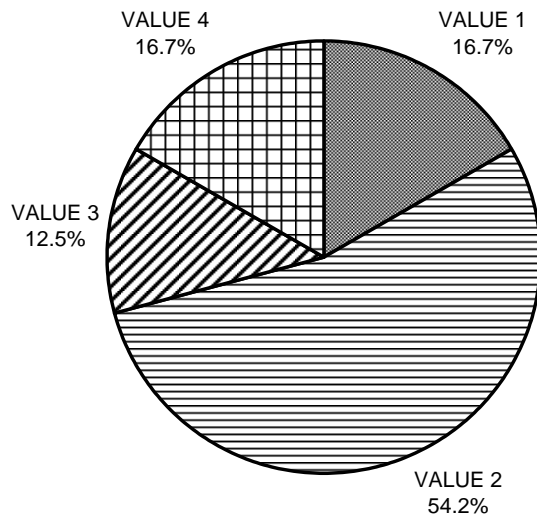
GRAPH 6

The depth of cobble embeddedness was estimated at pool tail-outs. Of the 24 pool tail-outs measured, 4 had a value of 1 (16.7%); 13 had a value of 2 (54.2%); 3 had a value of 3 (12.5%); 4 had a value of 4 (16.7%); (Graph 6). On this scale, a value of 1 indicates the best spawning conditions and a value of 4 the worst. Additionally, a value of 5 was assigned to tail-outs deemed unsuited for spawning due to inappropriate substrate such as bedrock, log sills, boulders, or other considerations.

Seventeen of the 24 pool tail-outs measured had embeddedness ratings of 1 or 2. Seven of the pool tail-outs had embeddedness ratings of 3 or 4. None of the pool tail-outs had a rating of 5, which is considered unsuitable for spawning. Cobble embeddedness measured to be 25% or less, a rating of 1, is considered to indicate good quality spawning substrate for salmon and steelhead. Sediment sources in Ross Creek should be mapped and rated according to their potential sediment yields, and control measures should be taken.

**ROSS CREEK 2009  
PERCENT EMBEDDEDNESS**

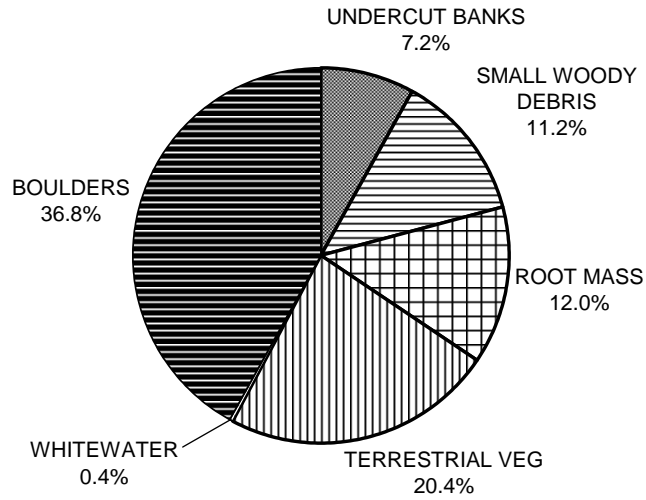
GRAPH 7

Table 5 summarizes mean percent cover by habitat type. Boulders are the dominant cover types in Ross Creek. Graph 7 describes the pool cover in Ross Creek. Boulders are the dominant pool cover type followed by terrestrial vegetation.

The mean shelter rating for pools was 11. The shelter rating in the flatwater habitats was 3. A pool shelter rating of approximately 100 is desirable. The amount of cover that now exists is being provided primarily by Boulders in Ross Creek. Boulders are the dominant cover type in pools followed by terrestrial vegetation. Log and root wad cover structures in the pool and flatwater habitats would enhance both summer and winter salmonid habitat. Log cover structure provides rearing fry with protection from predation, rest from water velocity, and also divides territorial units to reduce density related competition.

### ROSS CREEK 2009 MEAN PERCENT COVER TYPES IN POOLS

- 1) Increase woody cover in the pools and flatwater habitat units. Most of the existing cover in the pools is from Boulders. Adding high quality complexity with woody cover in the pools is desirable.

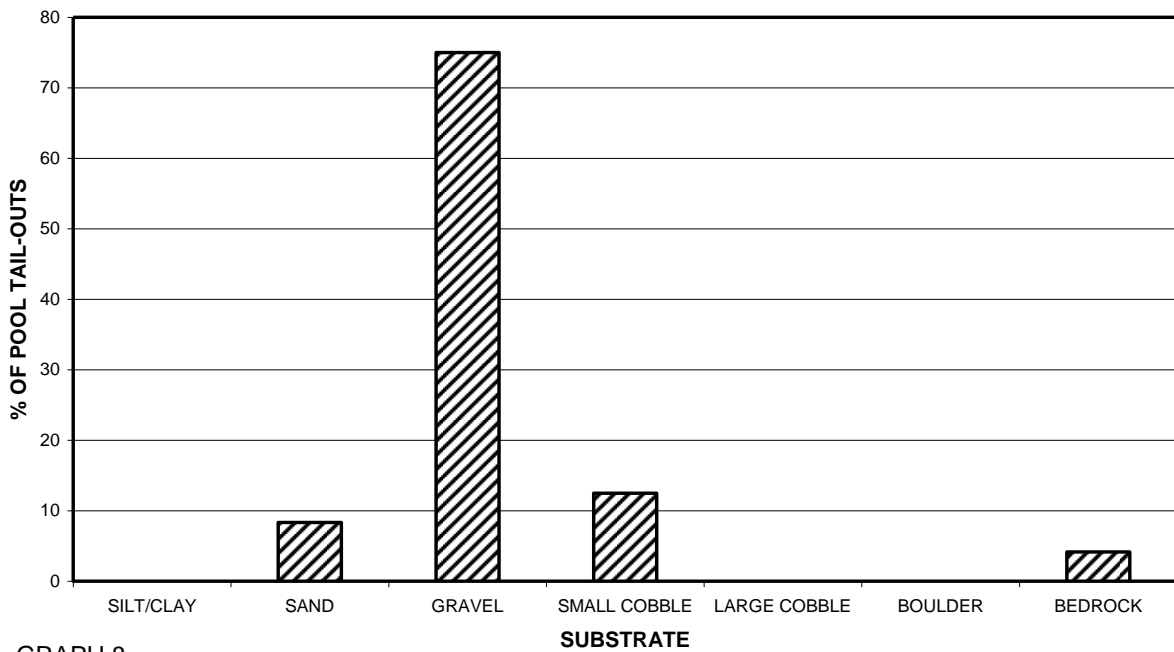
GRAPH 8

Table 6 summarizes the dominant substrate by habitat type. Graph 8 depicts the dominant substrate observed in pool tail-outs. Gravel dominance was observed in 75% of pool tail-outs, and small cobble dominance was observed in 12% of pool tail-outs.

Twenty-one of the 24 pool tail-outs measured had gravel or small cobble as the dominant substrate. This is generally considered good for spawning salmonids.

### ROSS CREEK 2009 SUBSTRATE COMPOSITION IN POOL TAIL-OUTS

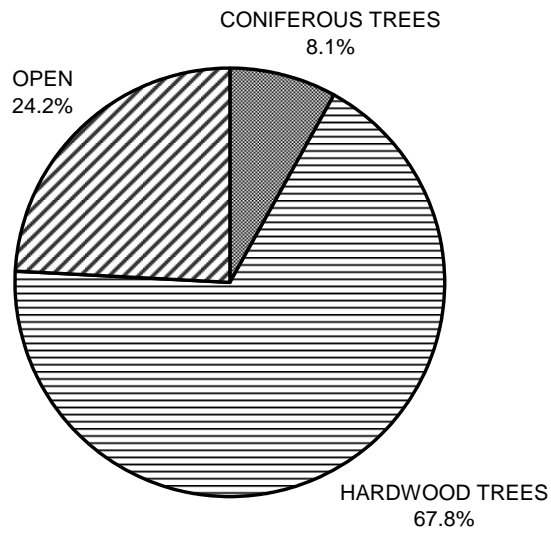
GRAPH 9

The mean percent canopy density for the surveyed length of Ross Creek was 76%. The mean percentages of hardwood and coniferous trees were 89% and 11%, respectively. Twenty-four percent of the canopy was open. Graph 9 describes the mean percent canopy in Ross Creek.

The mean percent canopy density for the stream was 76%. Reach 1 had a canopy density of 75.6%, Reach 2 had a canopy density of 77.1%. In general, revegetation projects are considered when canopy density is less than 80%.

**ROSS CREEK 2009  
MEAN PERCENT CANOPY**

- 2) Increase the canopy on Ross Creek by planting appropriate native vegetation like willow, alder, redwood, and Douglas fir along the stream where shade canopy is not at acceptable levels. The reaches above this survey section should be inventoried and treated as well, since the water flowing here is affected from upstream. In many cases, planting will need to be coordinated to follow bank stabilization or upslope erosion control projects.

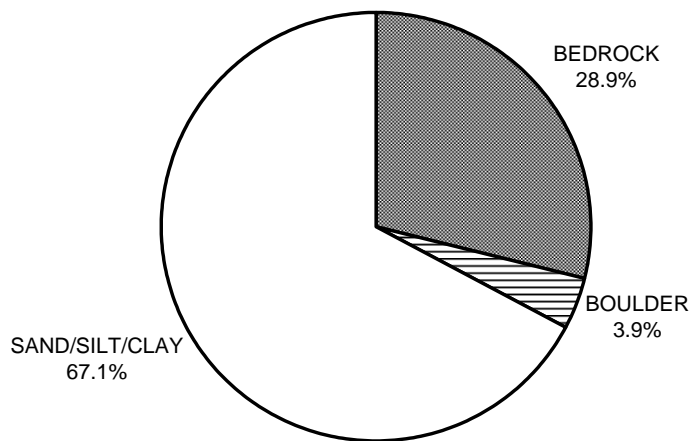
GRAPH 10

For the stream reach surveyed, the mean percent right bank vegetated was 46%. The mean percent left bank vegetated was 51%. The dominant elements composing the structure of the stream banks consisted of 29% bedrock, 4% boulder, 67% sand/silt/clay (Graph 10). Hardwood trees were the dominant vegetation type observed in 46% of the units surveyed. Additionally, 37% of the units surveyed had brush as the dominant vegetation type, and 8% had coniferous trees as the dominant vegetation (Graph 11).

**ROSS CREEK 2009  
DOMINANT BANK COMPOSITION IN SURVEY REACH**

In areas of stream bank erosion or where bank vegetation is sparse, planting endemic species of coniferous and hardwood trees, in conjunction with bank stabilization, is recommended.

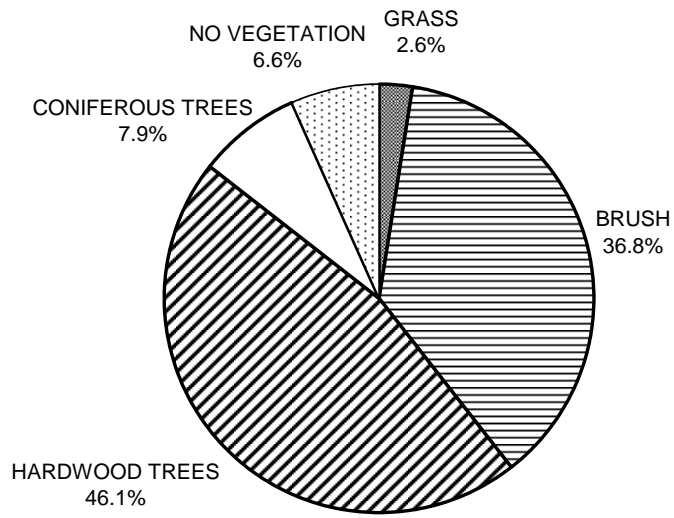
GRAPH 11

The percentage of right and left bank covered with vegetation was 46% and 51%, respectively.

**ROSS CREEK 2009  
DOMINANT BANK VEGETATION IN SURVEY REACH**
