Memorandum

Subject: Summary of Brush Shelter Habitat Placement in New Hogan Reservoir

The Department of Fish & Wildlife (Department), in cooperation with U.S. Army Corps of Engineers (Army Corps) placed 24 brush shelter habitats into New Hogan Reservoir (Calaveras County) on March 11, 2015. The brush shelter habitats were composed of repurposed Christmas trees and wood pallets received as a donation from a local Christmas tree farm in Citrus Heights, CA. The number of Christmas trees used for each brush shelter ranged from two to nine depending on the size of the trees.

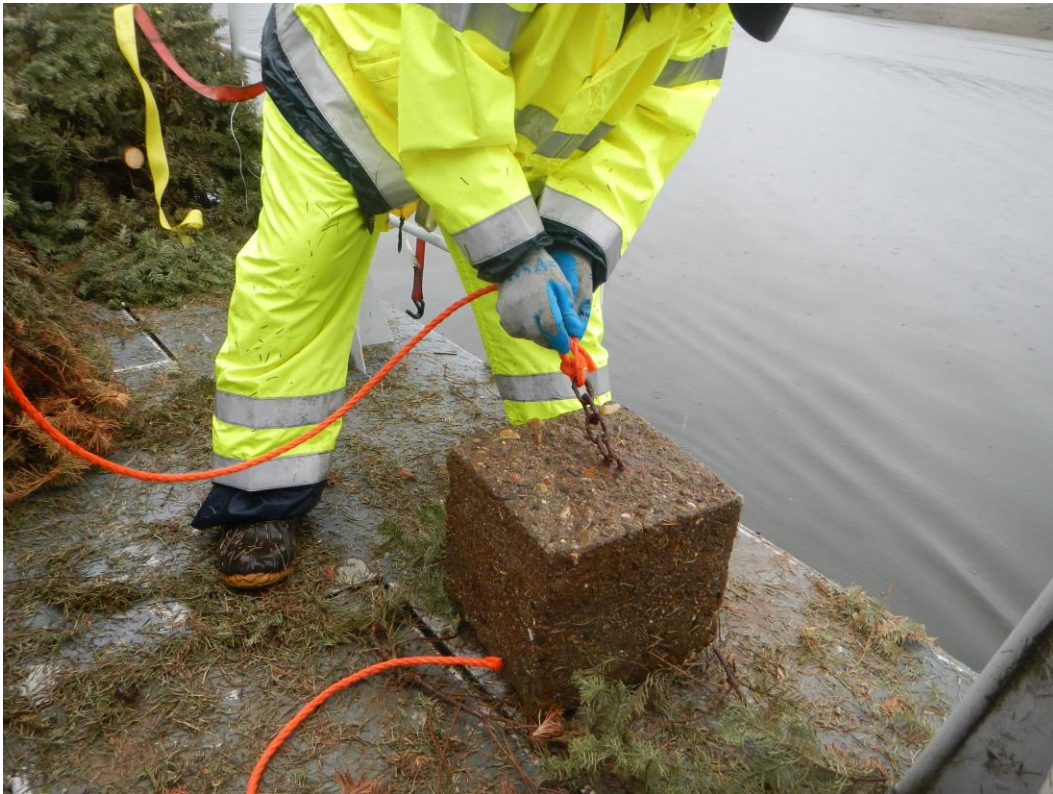
Figure 1. Christmas trees used for habitat at New Hogan Reservoir (3/11/2015).

Brush shelter habitats were created by drilling a 1/2 inch hole into the trunk of each tree. Wood pallets required no holes drilled. Depending on the overall size of the brush shelter habitat, up to three concrete or solid round bar anchors were secured to each with 3/8" polypropylene rope in order to sink them (Figure 1). The types of solid round bar weights weighed anywhere from 30 lb. to approximately 100 lbs. each. The brush shelter habitats were then taken to various locations on New Hogan Reservoir using a Department boat (Figure 2).

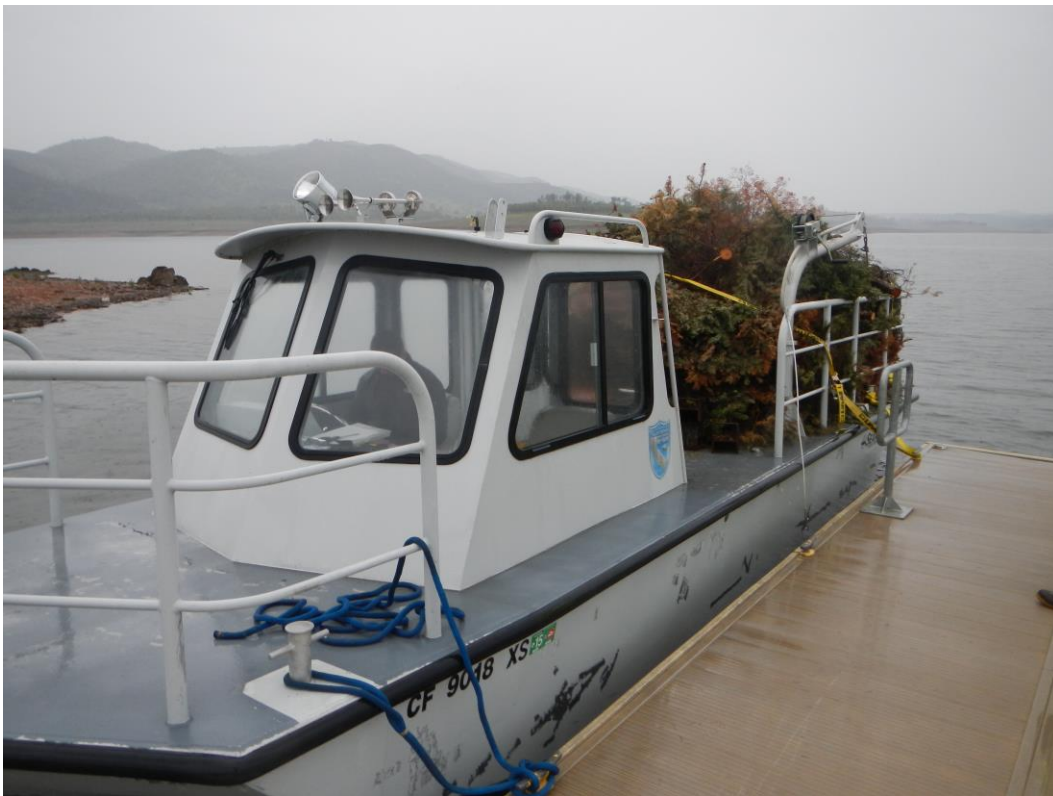
Figure 2. North Shore Ramp at New Hogan Reservoir (3/11/2015).
