# Draft Plans and Specifications

PLANS FOR CONSTRUCTION OF  
ANG POND RESTORATION

PREPARED BY  
UNITED STATES DEPARTMENT OF AGRICULTURE  
NATURAL RESOURCES CONSERVATION SERVICE

# DRAWINGS AND SPECIFICATIONS

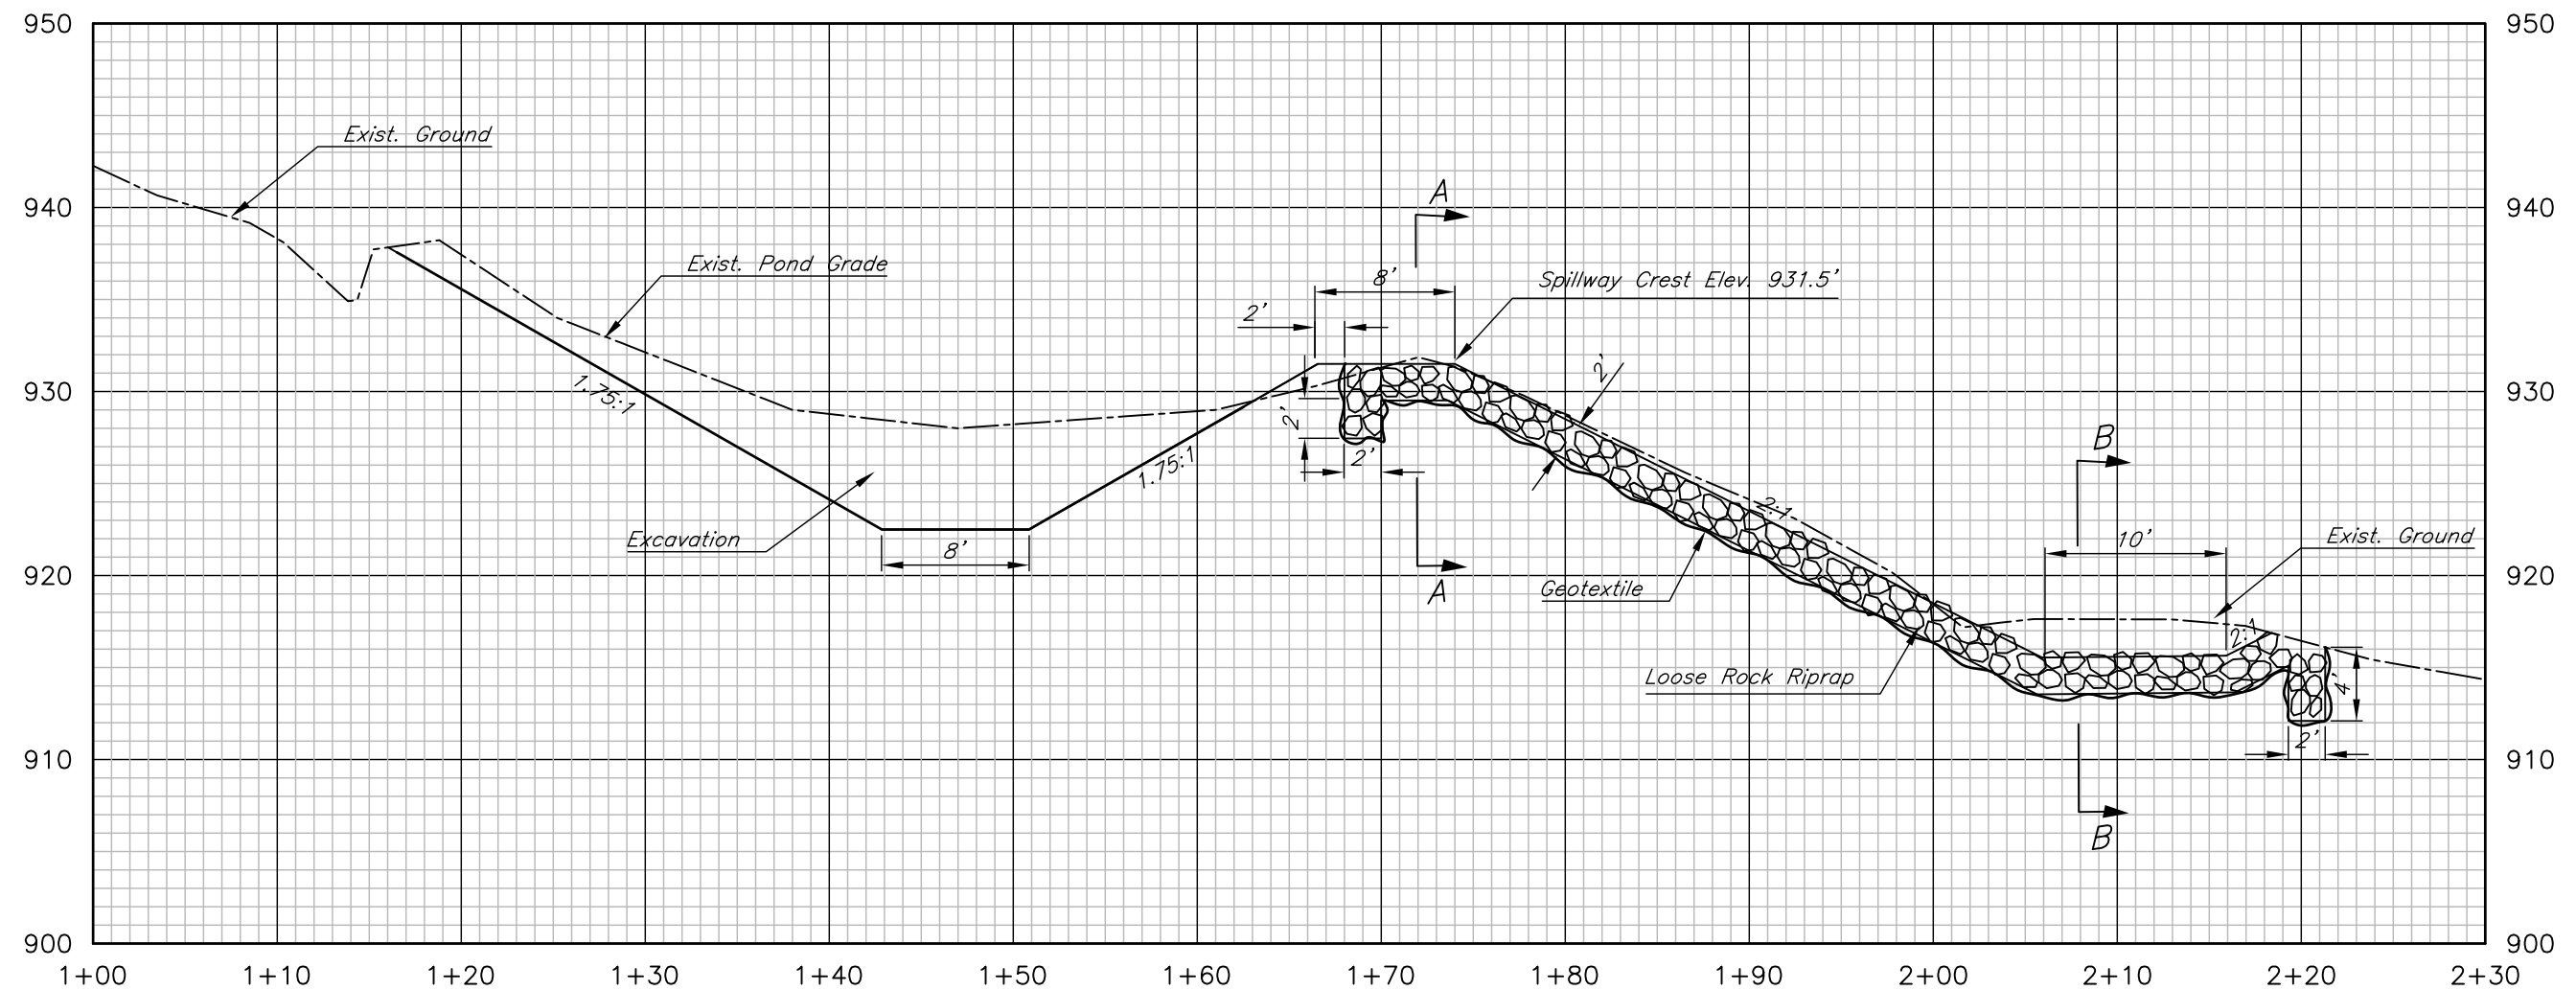
PROFILE AT CENTERLINE OF POND AND SPILLWAY

PROFILE AND CROSS SECTIONS  
ANG POND
