CALIFORNIA DEPARTMENT OF FISH AND WILDLIFE

STREAM INVENTORY REPORT

“Walton Gulch”

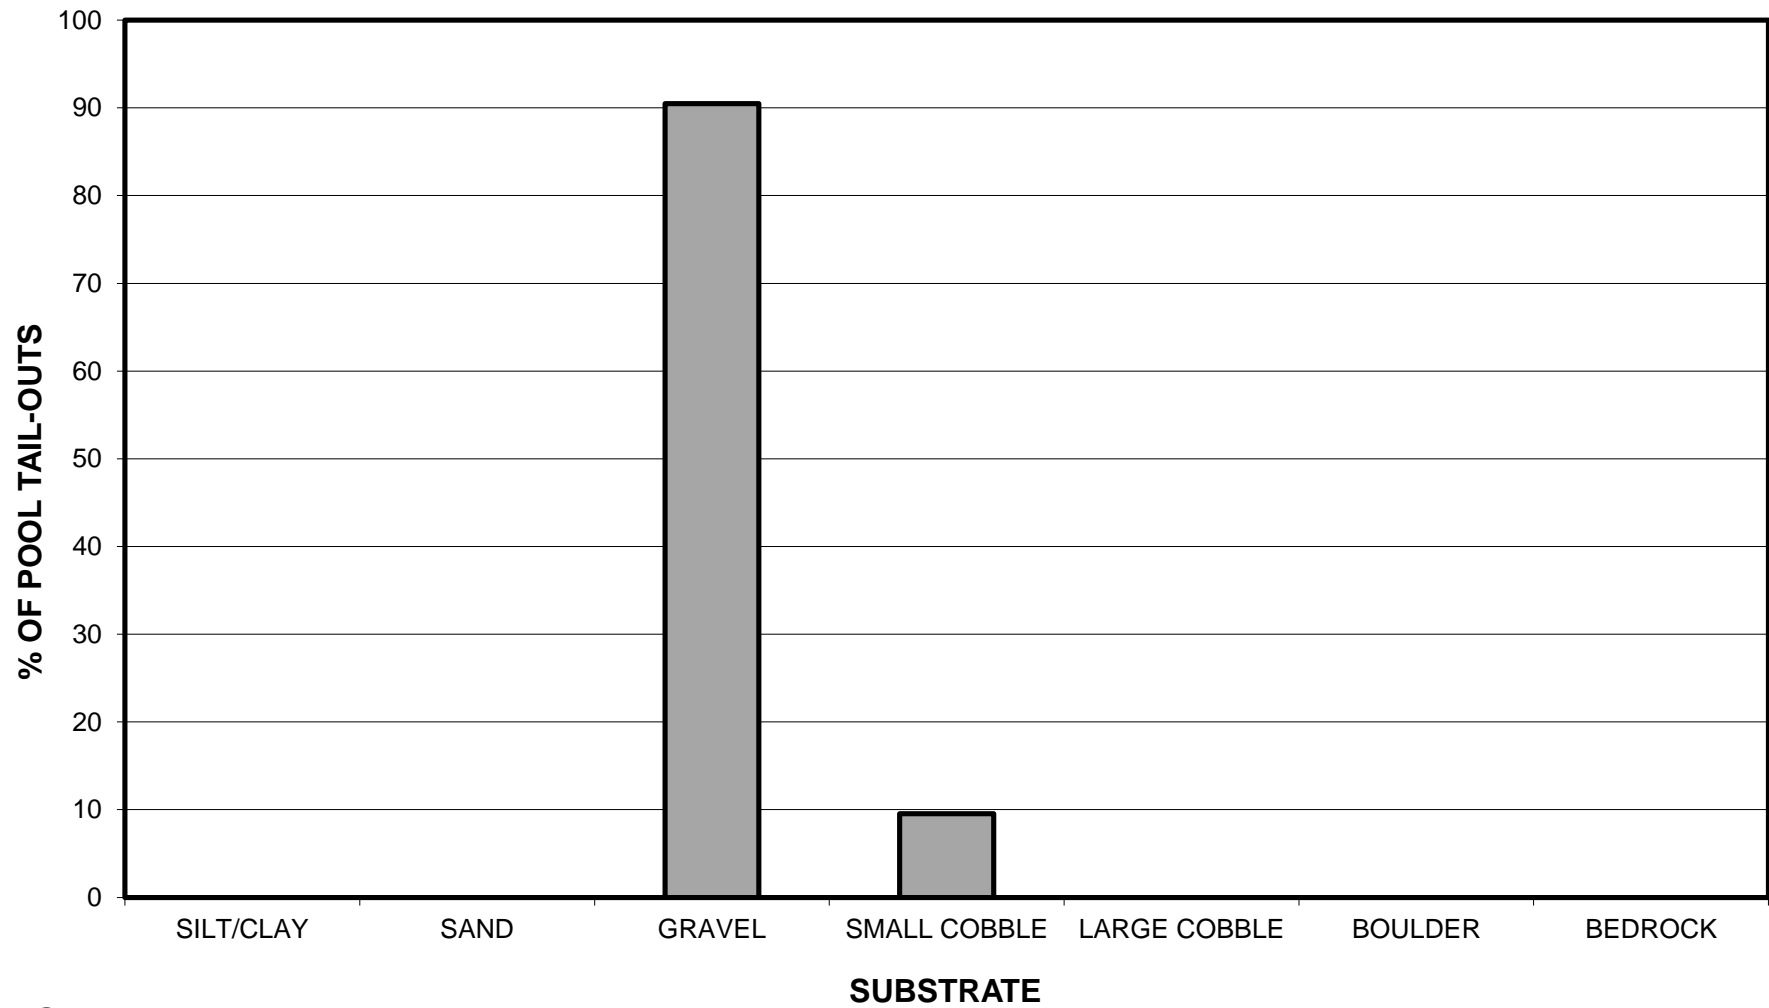
GRAPH 8

Table 6 summarizes the dominant substrate by habitat type. Graph 8 depicts the dominant substrate observed in pool tail-outs. Gravel was the most dominant substrate observed in 90% of pool tail-outs. Small cobble was the next most frequently observed substrate in 10% of pool tail-outs.

SUBSTRATE COMPOSITION IN POOL TAIL-OUTS
