## **CALIFORNIA DEPARTMENT OF FISH AND WILDLIFE**

### **STREAM INVENTORY REPORT**

#### **Price Creek**

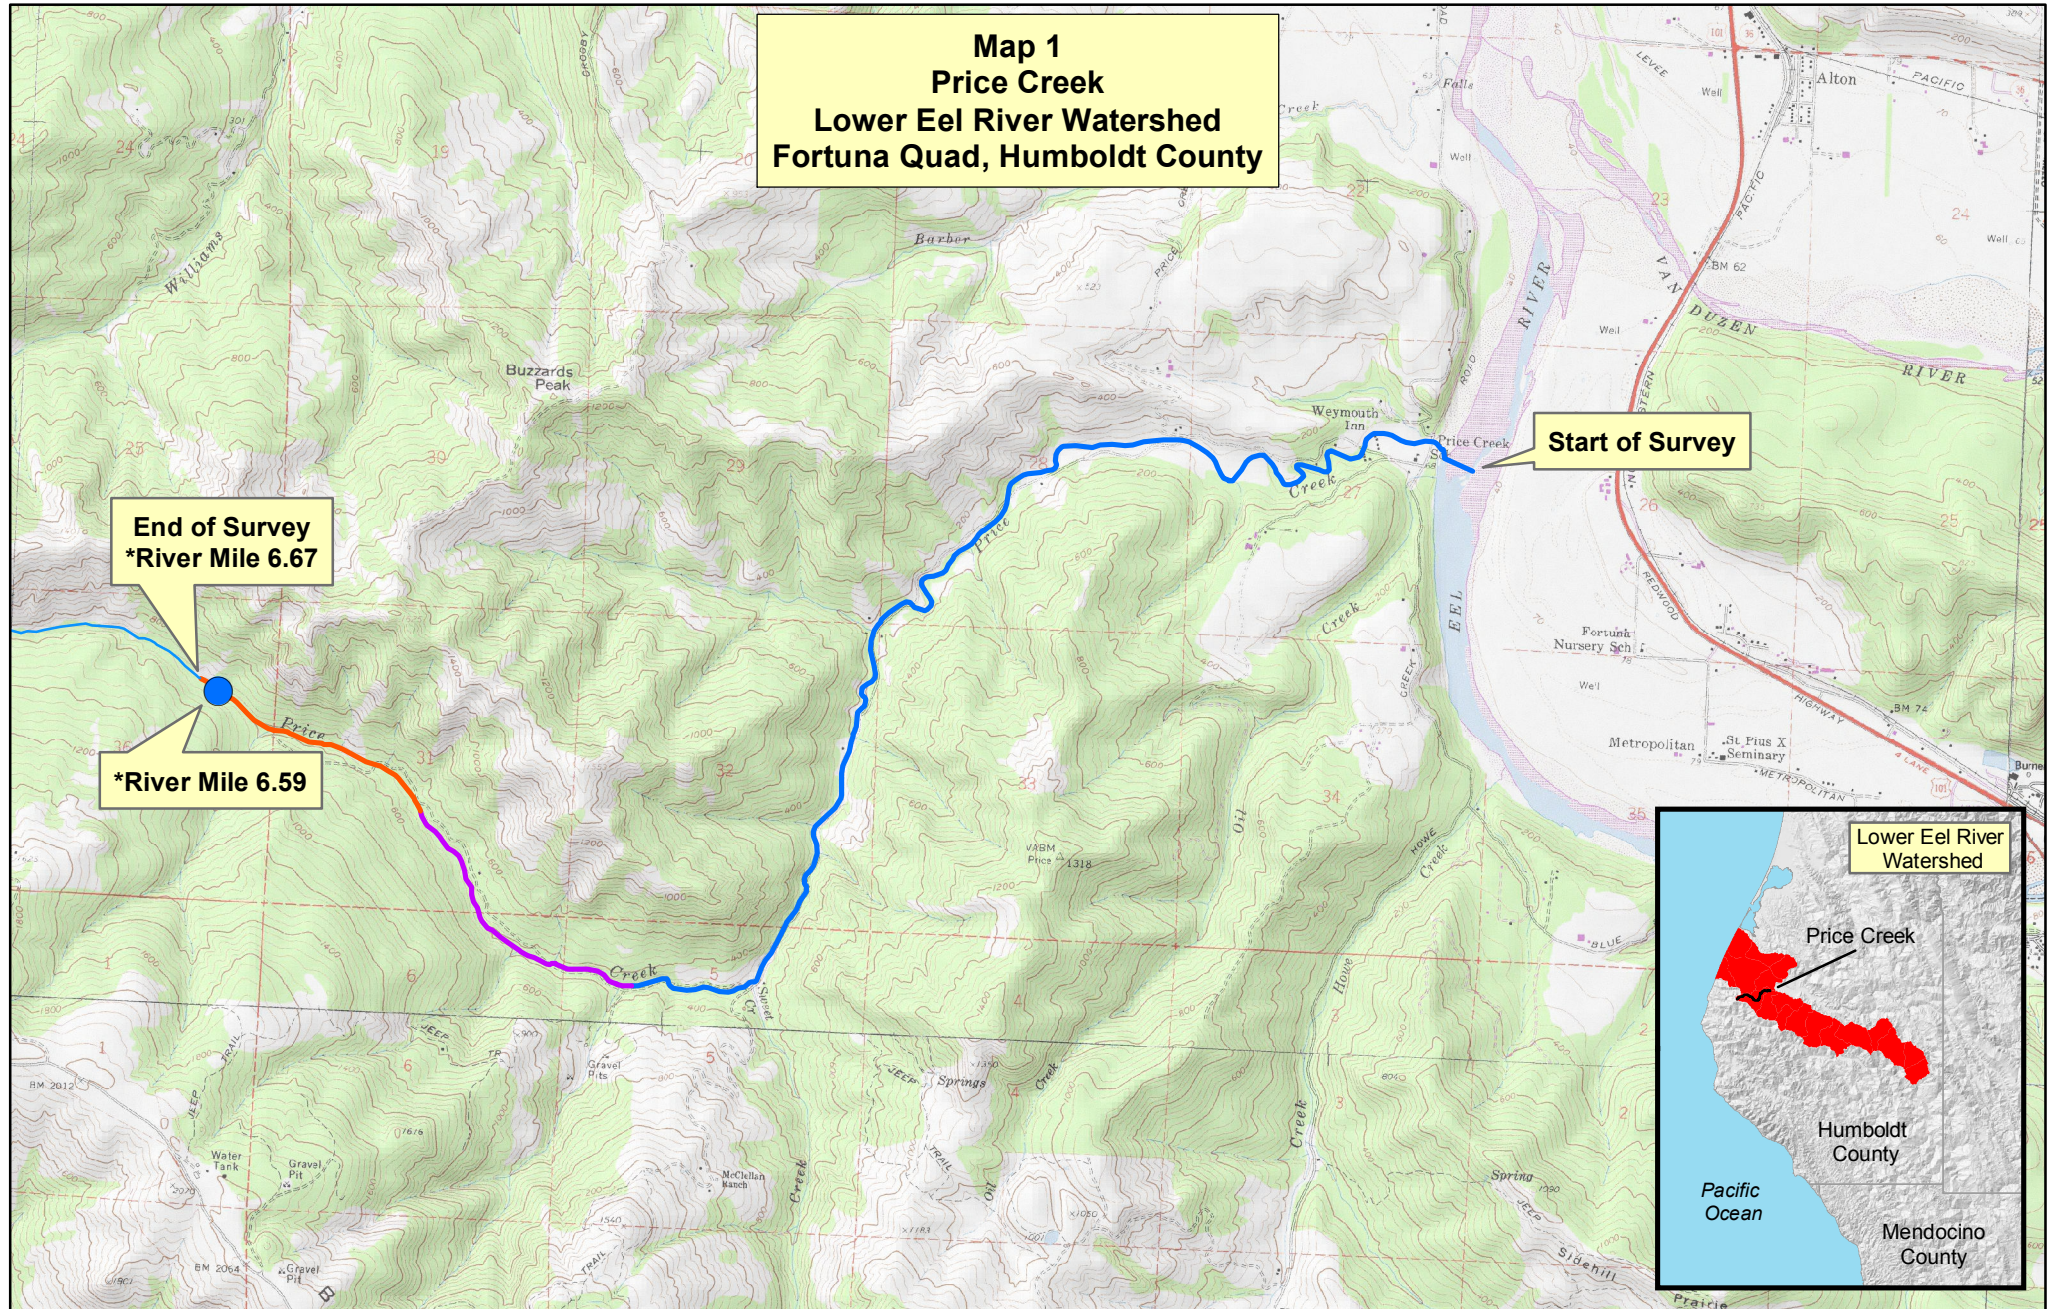
# **Map 1** **Price Creek** **Lower Eel River Watershed** **Fortuna Quad, Humboldt County**

During the survey, the upstream-most observation of juvenile steelhead trout occurred at 40.5150° northlatitude, -124.2385° west longitude, approximately 34,778 feet upstream from the confluence with Eel River (Map 1). No coho salmon (COHO) or Chinook salmon (CHIN) were observed during the biological inventory.

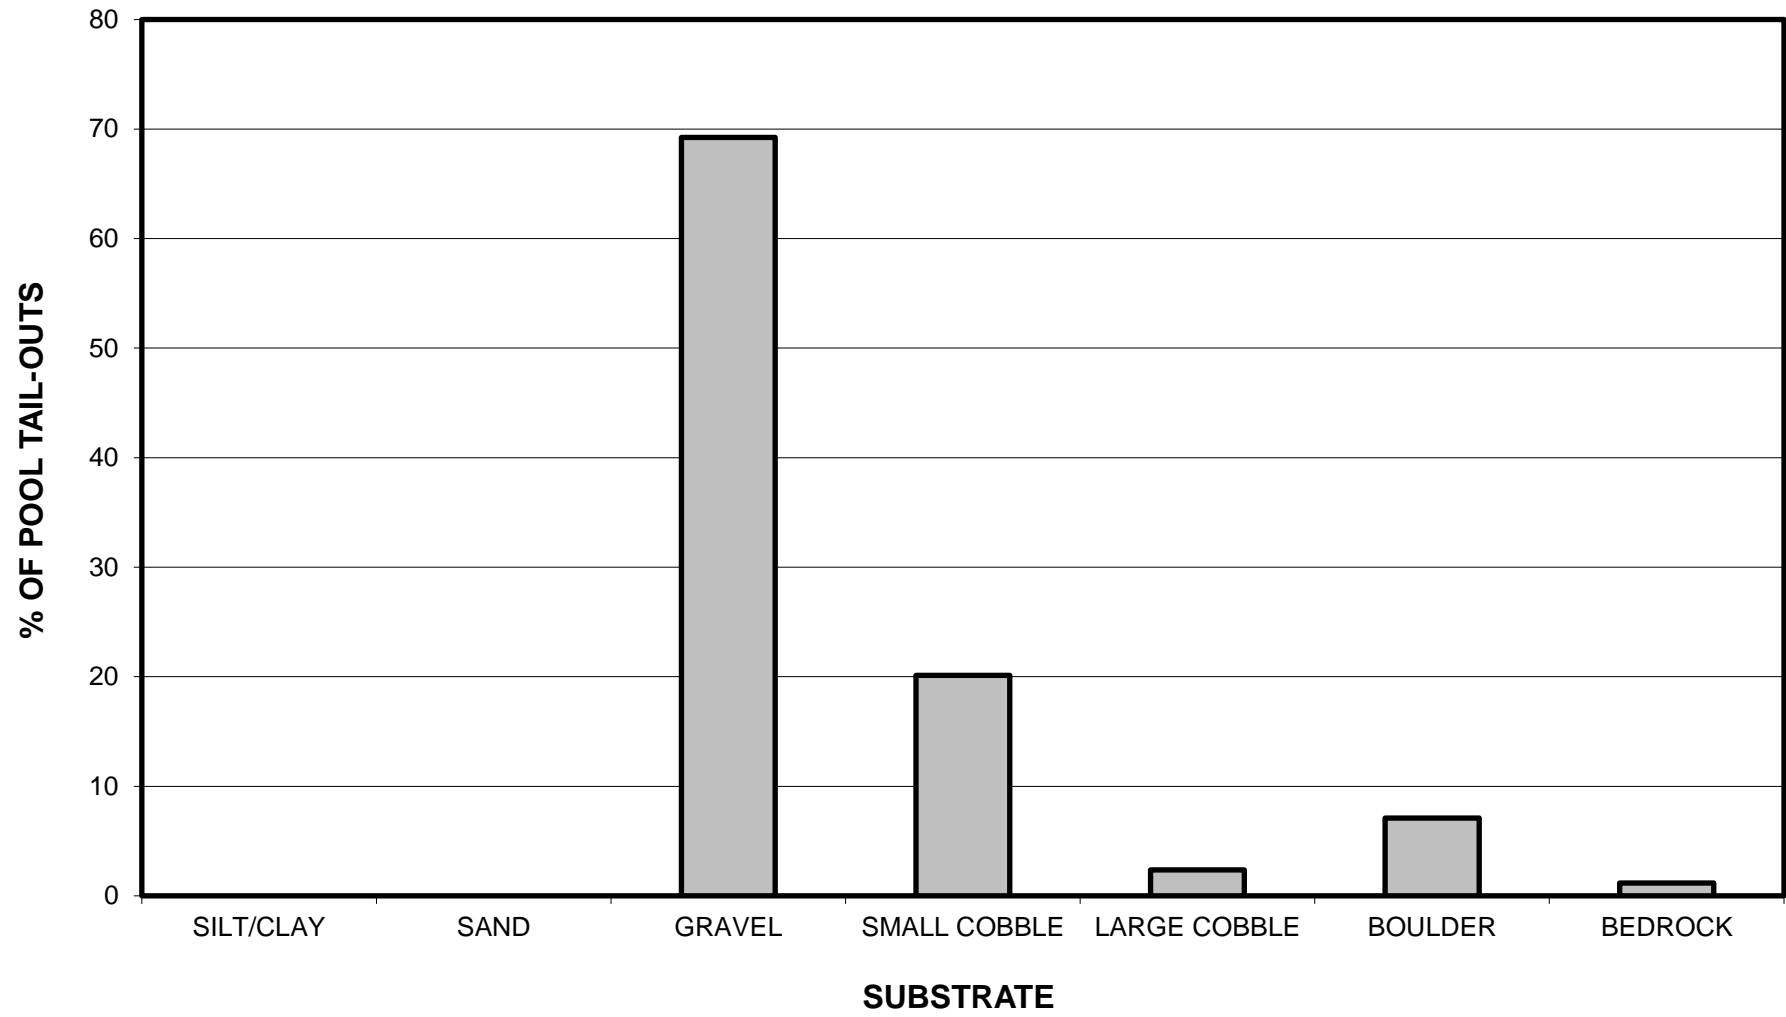
GRAPH 8

Table 6 summarizes the dominant substrate by habitat type. Graph 8 depicts the dominant substrate observed in pool tail-outs. Gravel was the dominant substrate, observed in 69% of pool tail-outs. Small cobble was the next most frequently observed dominant substrate type and occurred in 20% of pool tail-outs.

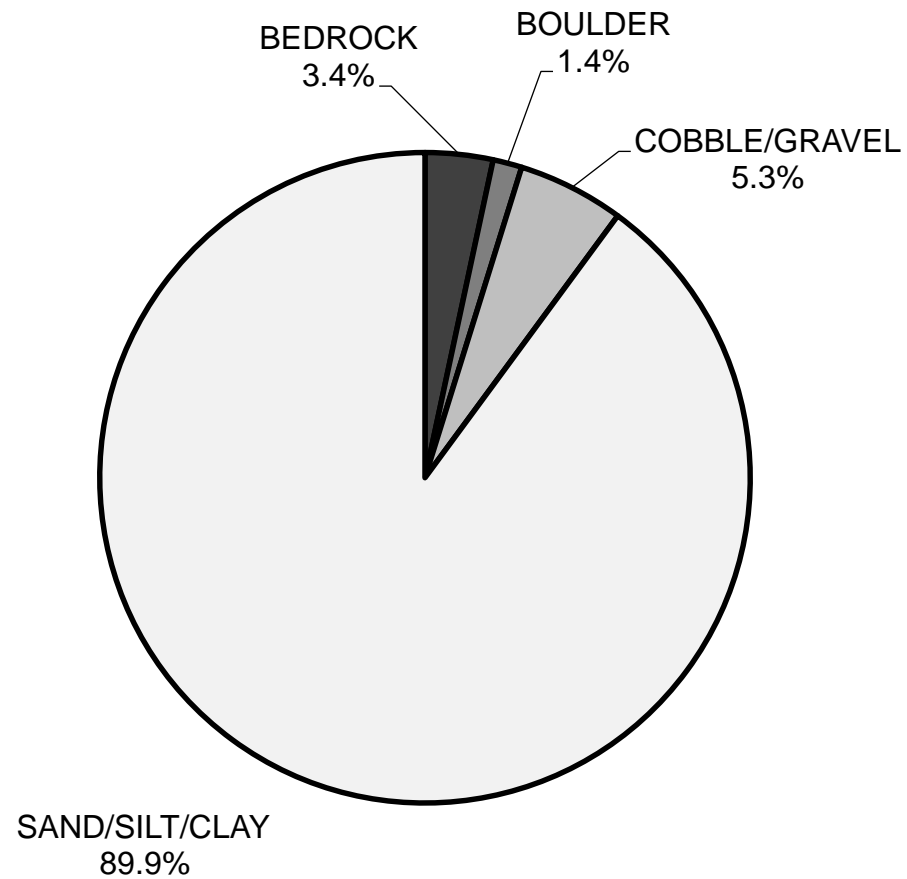
GRAPH 10

For the stream reach surveyed, the mean percent right bank vegetated was 97%. The mean percent left bank vegetated was 96%. The dominant elements composing the structure of the stream banks consisted of 90% sand/silt/clay, 5% cobble/gravel, 3% bedrock, and 1% boulder (Graph 10). Deciduous trees was the dominant vegetation type observed in 66% of the units surveyed. Additionally, 27% of the units surveyed had brush as the dominant vegetation type, and 4% had grass as the dominant vegetation type (Graph 11).

The percentage of right and left bank covered with vegetation was 97% and 96%, respectively. In areas of stream bank erosion or where bank vegetation is sparse, planting endemic species of coniferous and hardwood trees, in conjunction with bank stabilization, is recommended.
