## **CALIFORNIA DEPARTMENT OF FISH AND WILDLIFE**

### **STREAM INVENTORY REPORT**

#### **Grizzly Creek**

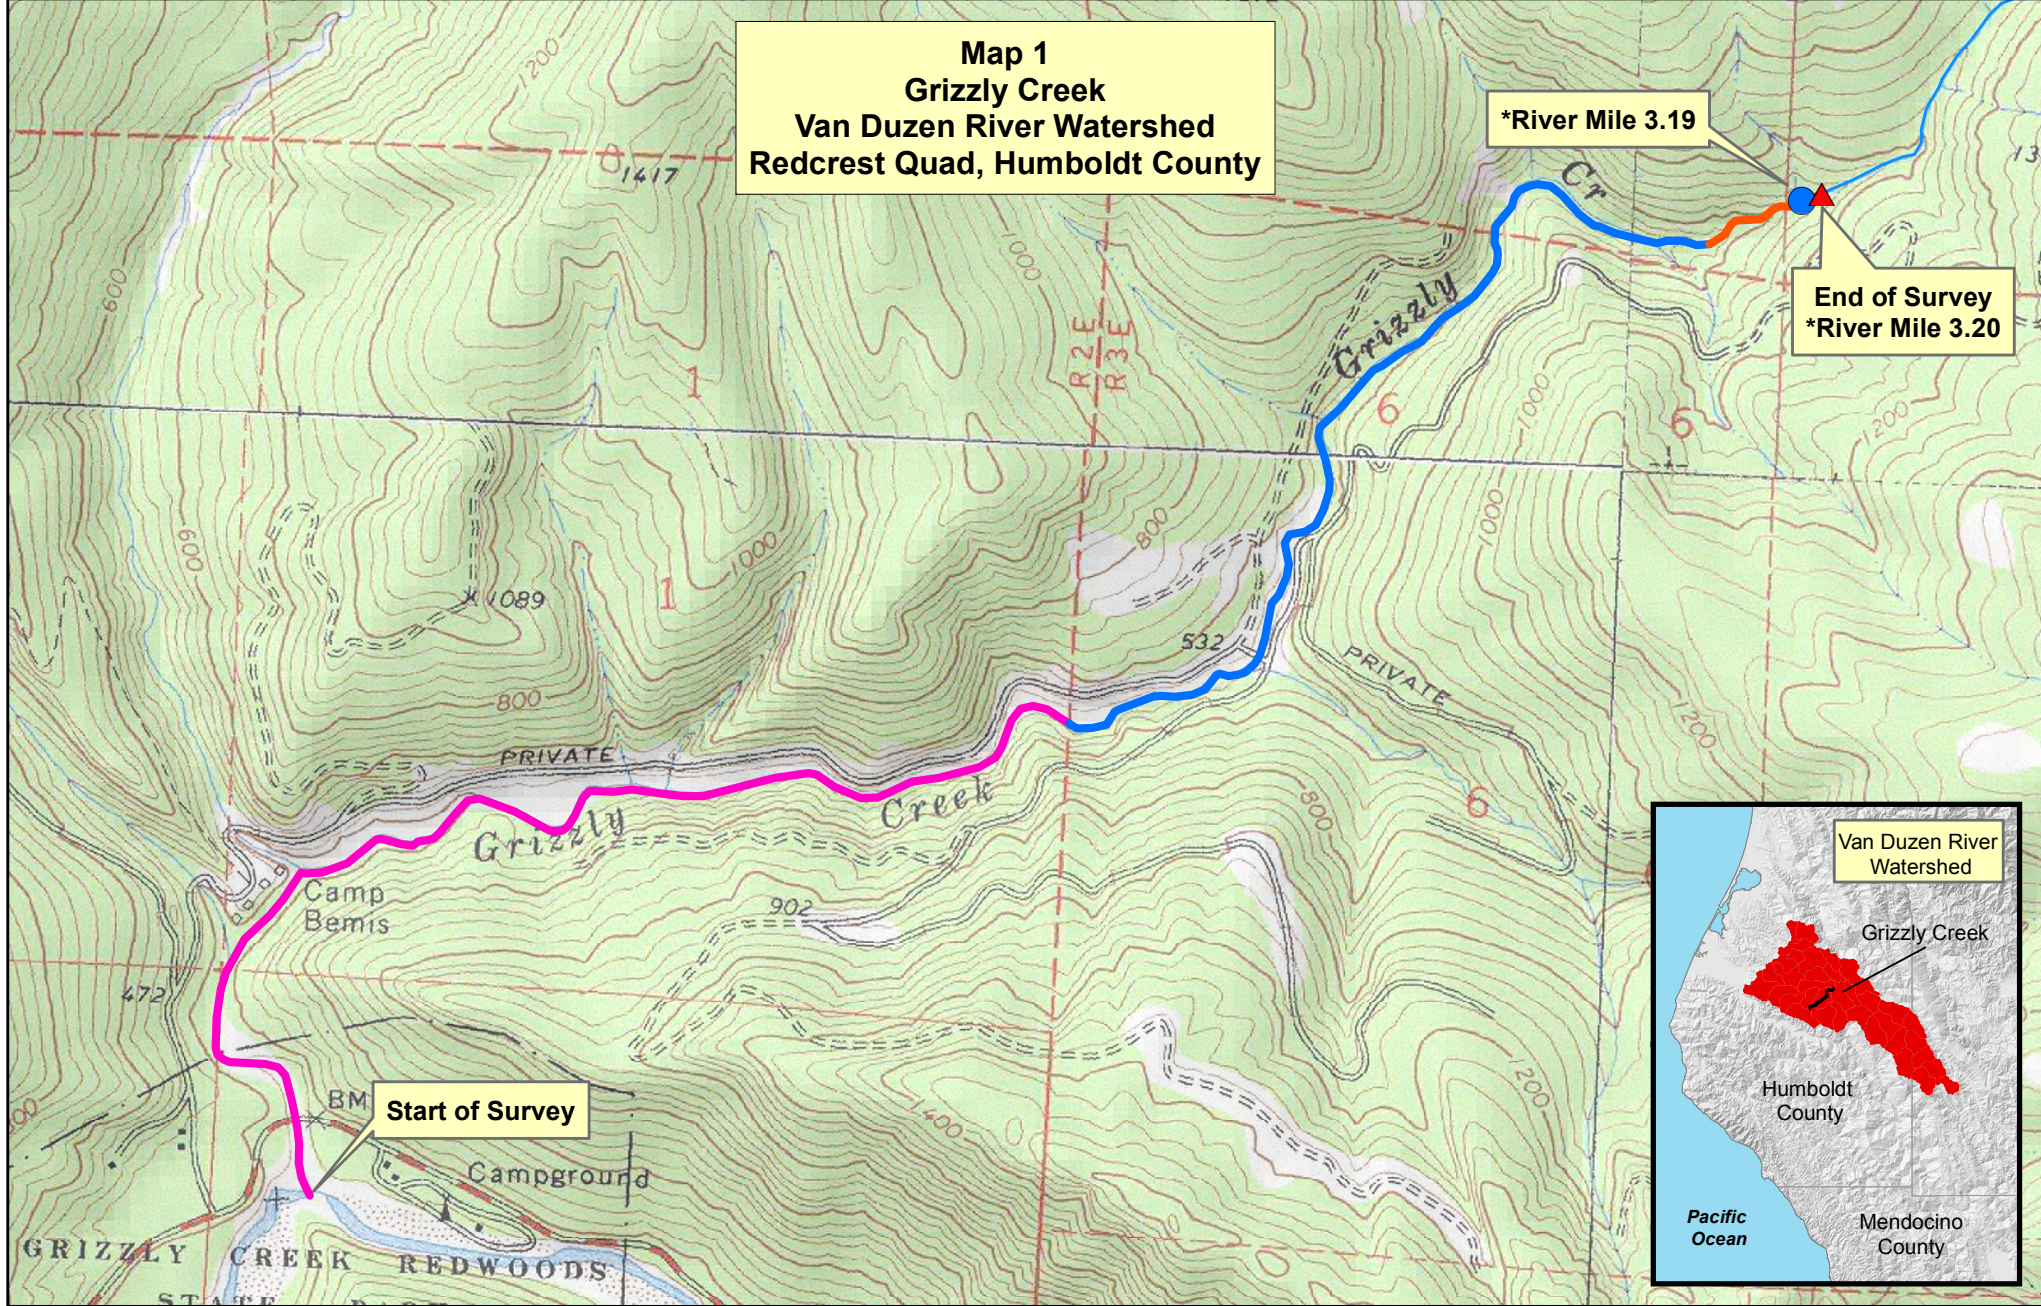
**Map 1**  
**Grizzly Creek**  
**Van Duzen River Watershed**  
**Redcrest Quad, Humboldt County**

During the survey, the upstream-most observation of steelhead trout occurred at 40.50483° north latitude, -123.87223° west longitude, approximately 16,793 feet upstream from the confluence with Van Duzen River (Map 1). No coho salmon were observed during the biological inventory. While not denoted in Table A, one California roach was observed during the stream inventory survey (see Comments and Landmarks section for observations and corresponding locations).

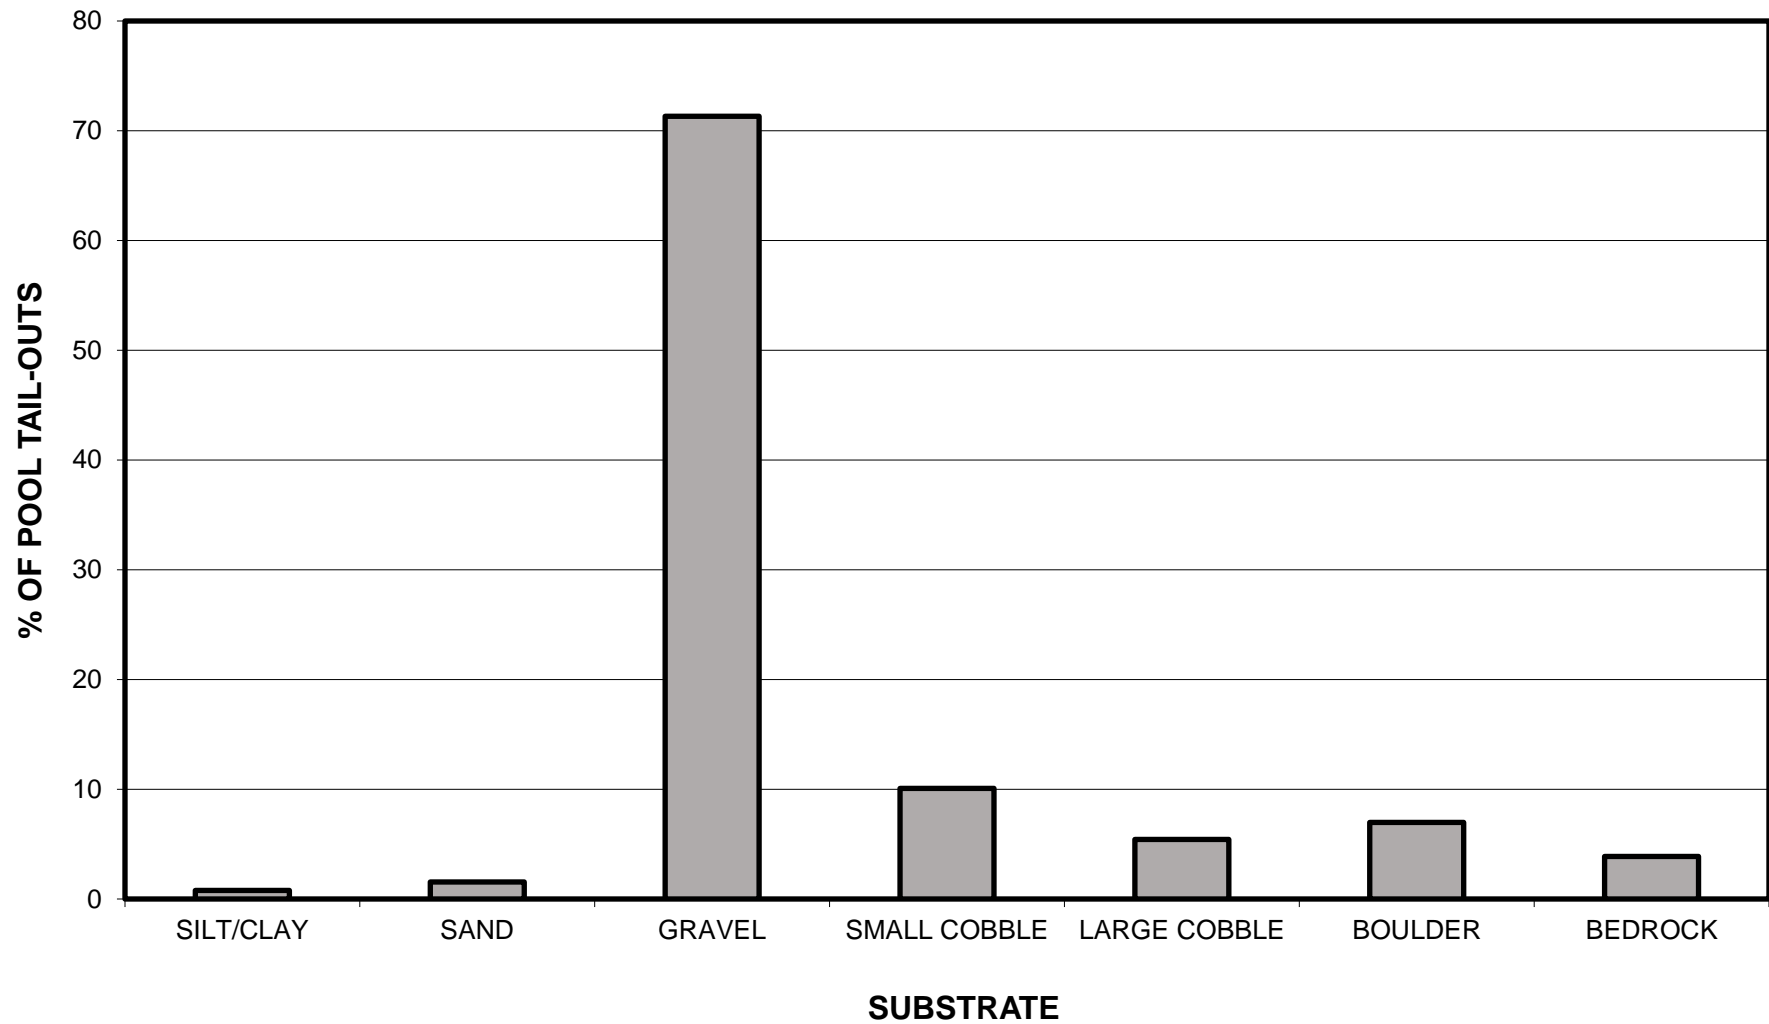
GRAPH 8

Table 6 summarizes the dominant substrate by habitat type. Graph 8 depicts the dominant substrate observed in pool tail-outs. Gravel was the dominant substrate observed in 71% of pool tail-outs. Small cobble was the next most frequently observed dominant substrate and occurred in 10% of pool tail-outs.
