#### FINAL REPORT: SHASTA AND TEHAMA COUNTIES STREAM BARRIER ASSESSMENT AND EVALUATION

#### Pacific States Marine Fisheries Commission and California Department of Fish and Game

April 15, 2011

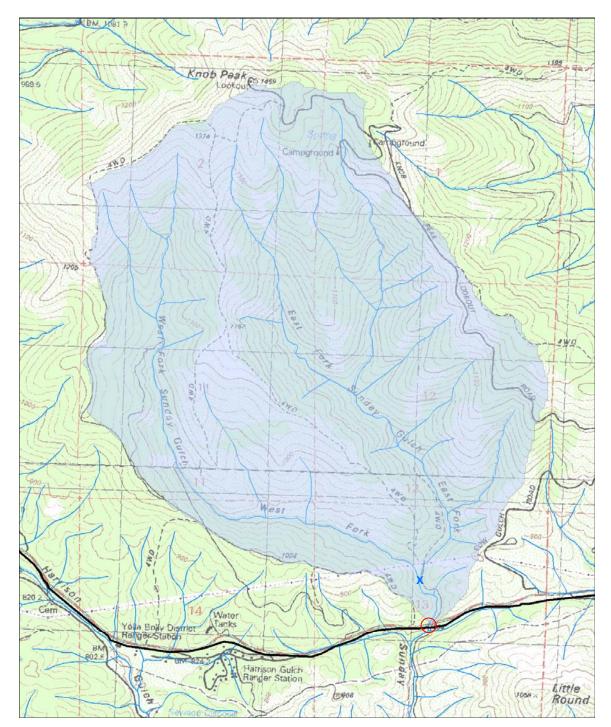
**Barrier Status: RED** due to the greater than 3% slope of the culvert as determined by the Green-Gray-Red first-phase evaluation filter. During FishXing analyses, adult salmonid passage was assessed for flows between 3 cfs and 68.28 cfs (50% of  $Q_2$  discharge). Only 11.5% (18.77 cfs to 26.27 cfs) of flows were passable to adult salmonids. A lack of depth occurred at flows less than 18.77 cfs and excessive velocities occurred above flows of 26.28 cfs. FishXing determined that the crossing did not meet passage criteria for resident trout or juvenile salmonids due to excessive velocities.

**Habitat:** <u>Quality</u> = Rated as "fair" due to the fairly small size of stream. Steelhead distribution moves past Sunday Gulch on the Middle Fork of Cottonwood Creek. Steelhead could be present if no barriers exist downstream. Riparian habitat is present but not dense. Steep gradient towards headwaters. Juvenile salmonids in the 3-6 inch size class were observed downstream of crossing during site visit. <u>Quantity</u> = ~1,372' of potential anadromous habitat upstream of road crossing based on channel slope sustaining <8%.

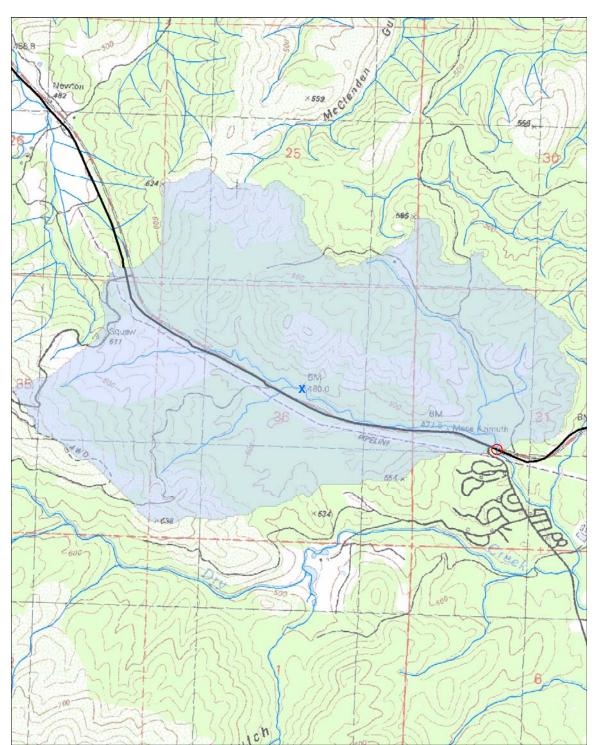
# Site # 3: Unnamed Tributary to Dry Creek/Hwy 36 West. Dry Creek; Cottonwood Creek; Sacramento River

**Barrier Status: GRAY** as determined by the Green-Gray-Red first-phase filter. During FishXing analyses, Adult Salmonid passage was assessed for flows between 3 cfs and 49.29 cfs (50% of  $Q_2$  discharge). An excessive outlet drop height resulted in 0% passable flows to adult, resident, and juvenile salmonids.

**Habitat:** <u>Quality</u> = rated as "poor". Small stream with poor riparian zone. Stream flows through pasture without riparian trees. Ideal spawning substrate in stream (cobble, pebble, gravel). There were no fish observed at time of survey. It is a tributary to Dry Creek which has no known steelhead distribution. <u>Quantity</u> = 4,699' of potential anadromous habitat upstream of road crossing based on channel slope sustaining <8%.

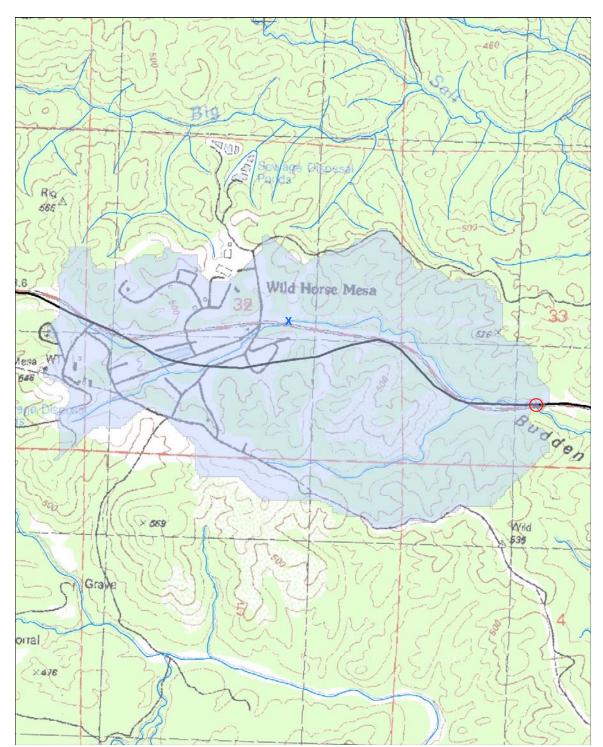
# Site # 4: Budden Canyon Creek/Hwy 36 West, Dry Creek; Cottonwood Creek; Sacramento River

**Barrier Status: GRAY** as determined by the Green-Gray-Red first-phase filter. During FishXing analyses, adult salmonid passage was assessed for flows between 3 cfs and 30.36 cfs (50% of  $Q_2$  discharge). Only 9.5% of flows were passable to adult salmonids. A lack of depth occurred during flows below 11.32 cfs and excessive velocities occurred at flows above 13.89 cfs. FishXing determined that the crossing did not meet passage criteria for resident trout or juvenile salmonids due to excessive velocities.

**Habitat:** <u>Quality</u> = Rated as "fair" due to its small size and very dense riparian zone. Substrate composed of cobble, aquatic vegetation, and pebble. This stream is a tributary to Dry Creek which has no known distribution of steelhead. There were no fish observed at time of survey. <u>Quantity</u> =  $\sim$  4,963' of potential anadromous habitat upstream of road crossing based on channel slope sustaining <8%.

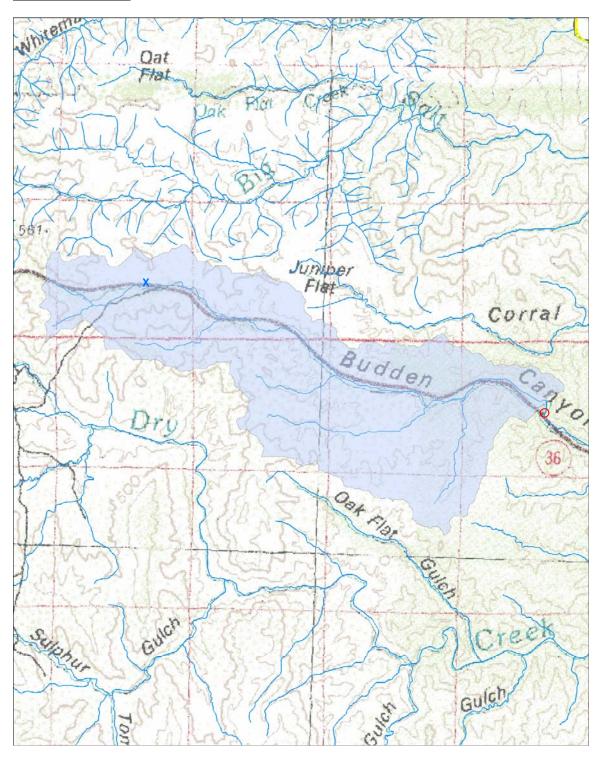
Site # 5: Budden Canyon Creek/Hwy 36 West, Dry Creek; Cottonwood Creek; Sacramento River

**Habitat:** <u>Quality</u> = rated as "fair" due to moderate riparian zone. Substrate is composed of cobble, pebble, and gravel. This stream is a tributary to Dry Creek which as no known steelhead distribution. Unknown juvenile fish in the 3-6 inch size class were observed downstream of crossing during survey. <u>Quantity</u> = ~18,163' of potential anadromous habitat upstream of crossing based on channel slope sustaining <8%.

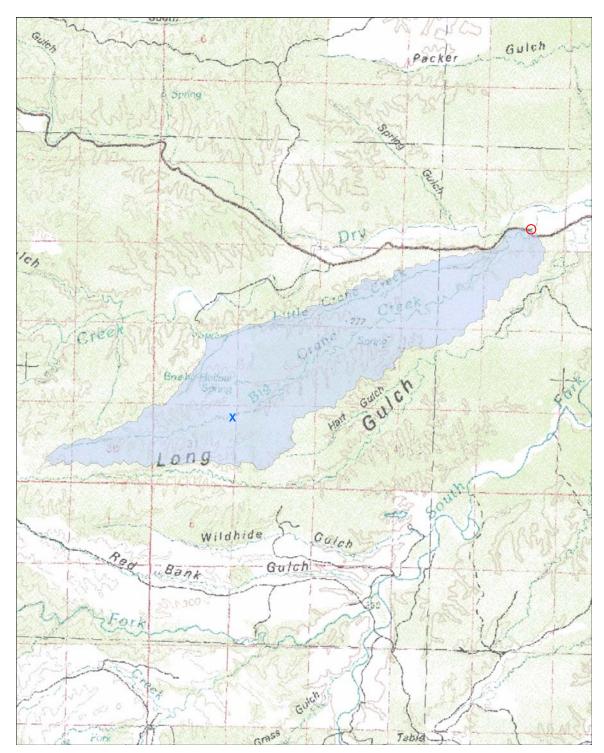
Site # 7: Little/Big Crane Creek/Hwy 36 West, Dry Creek; Cottonwood Creek; Sacramento River

**Barrier Status: GRAY** as determined by the Green-Gray-Red first-phase filter. During FishXing analyses, adult salmonid passage was assessed for flows between 3 cfs and 203.4 cfs (50% of  $Q_2$  discharge). Only 32% (52.2 cfs to 115.9 cfs) of flows were passable to adult salmonids. The lack of depth occurred at flows less than 51.2 cfs and excessive velocities occurred at flows above 116 cfs. FishXing determined that the crossing did not meet passage criteria for resident trout or juvenile salmonids due to excessive velocities and excessive outlet drop height.

**Habitat:** <u>Quality</u> = Rated as "fair" due to lack of water during warmer months and fairly dense riparian zone. Stream has a wide but shallow channel with an average wetted upstream width = 13.9 feet. Stream is a tributary to Dry Creek which has no known steelhead distribution. No fish were observed during survey. <u>Quantity</u> = 30,096' of potential anadromous habitat upstream of crossing based on channel slope sustaining <8%.

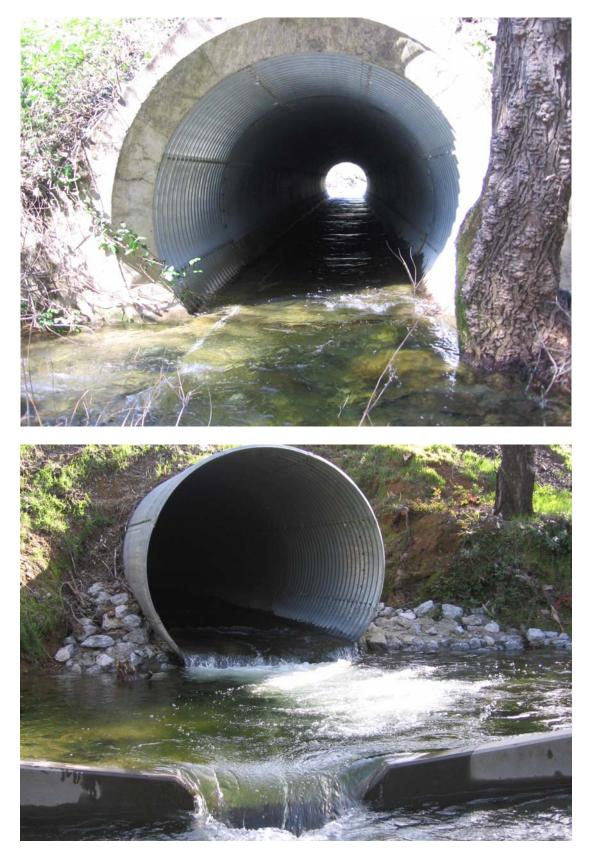
Site # 10- Salt Creek/PM 20.75; Hwy 299 Sha.

**Comments:** This culvert has been retrofitted in the past with steel corner baffles and two concrete outlet weirs. FishXing software does not account for these corrections which would explain the depth and velocity barriers associated with this crossing. Adult and juvenile salmonids have been observed upstream of the stream crossing post retrofitting.

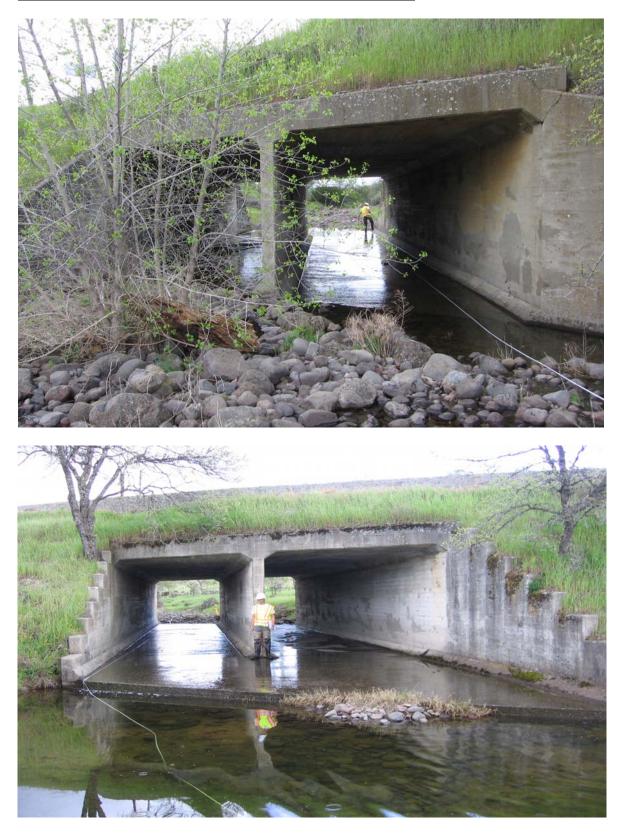
Site # 13- Seven Mile Creek/PM 48.60; Hwy 36 E Teh.

**Barrier Status: GRAY** as determined by the Green-Gray-Red first-phase filter. During FishXing analyses, adult salmonid passage was assessed for flows between 3 cfs and 72.3 cfs (50% of  $Q_2$  discharge). A lack of depth and excessive velocities through the culvert resulted in 0% passable to adult, resident, and juvenile salmonids.

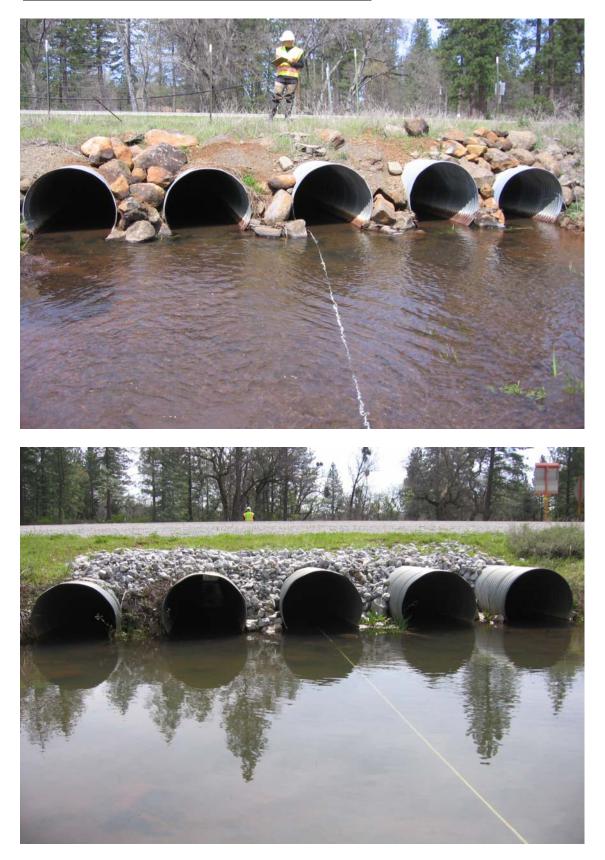
Site # 14- Shingle Creek/PM 22.4; Hwy 44 Sha.

**Barrier Status: GRAY** as determined by the Green-Gray-Red first-phase filter. During FishXing analyses, adult salmonid passage was assessed for flows between 3 cfs and 52.6 cfs (50% of  $Q_2$ ). Only 2.3% (51.51 cfs to 52.65 cfs) of flows were passable to adult salmonids. A lack of depth occurred at all flows through all culverts. Only 46.2% of flows were passable to resident trout and 65.8% percent were passable to juvenile salmonids. During higher flows, water depth is not an issue and resident and juvenile salmonids are able to swim through.

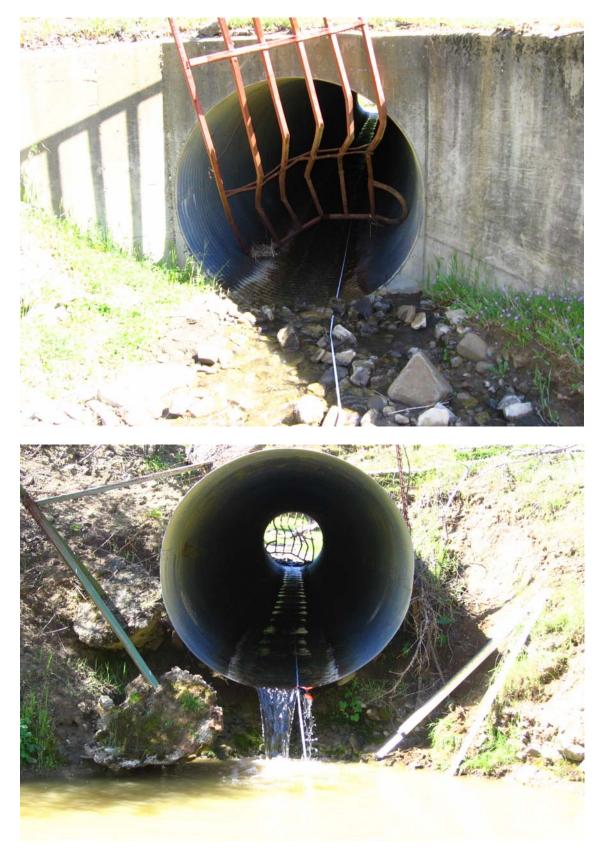
Site # 15- Unnamed Tributary to Dry Creek/PM 10.73; Hwy 36 W Teh.

**Barrier Status: RED** as determined by the Green-Gray-Red first-phase filter. During FishXing analyses, adult salmonid passage was assessed for flows between 3 cfs and 40 cfs (50% of  $Q_2$  discharge). Only 28.1% (11 cfs to 21.11 cfs) of flows were passable to adult salmonids. A lack of depth occurred below flows of 11 cfs and excessive velocities occurred above flows of 21 cfs. Excessive velocities and outlet drop height resulted in 0% passage for both resident and juvenile salmonids.

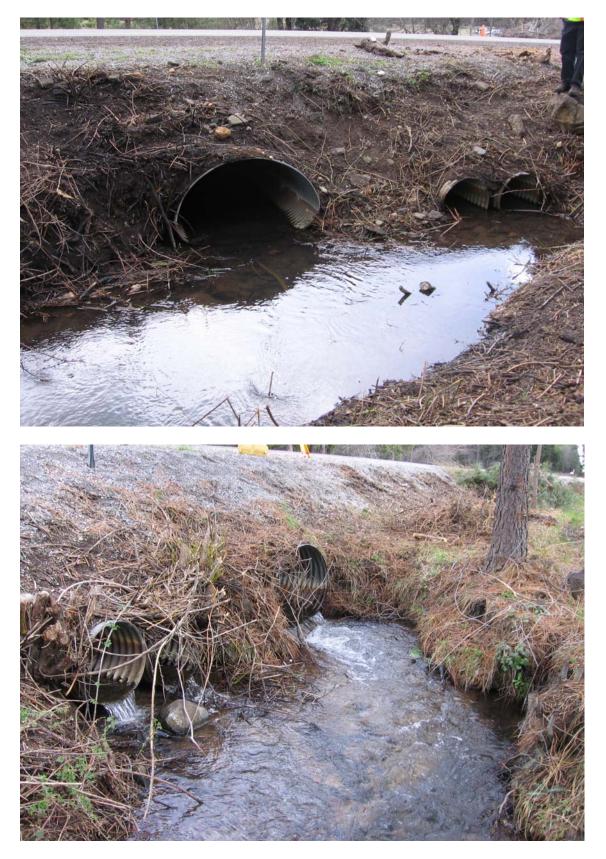
Site #17- Ash Creek/PM 28.05; Hwy 44 Sha.

**Barrier Status: GRAY** as determined by the Green-Gray-Red first-phase filter. During FishXing analyses, adult salmonid passage was assessed for flows between 3 cfs and 25.61 cfs (50% of  $Q_2$  discharge). Only 44.4% (15.5 cfs to 25.6 cfs) of flows were passable to adult salmonids. A lack of depth through the culvert occurred at flows below 15.5 cfs. Excessive velocities and outlet drop height resulted in 0% passage for both resident and juvenile salmonids.

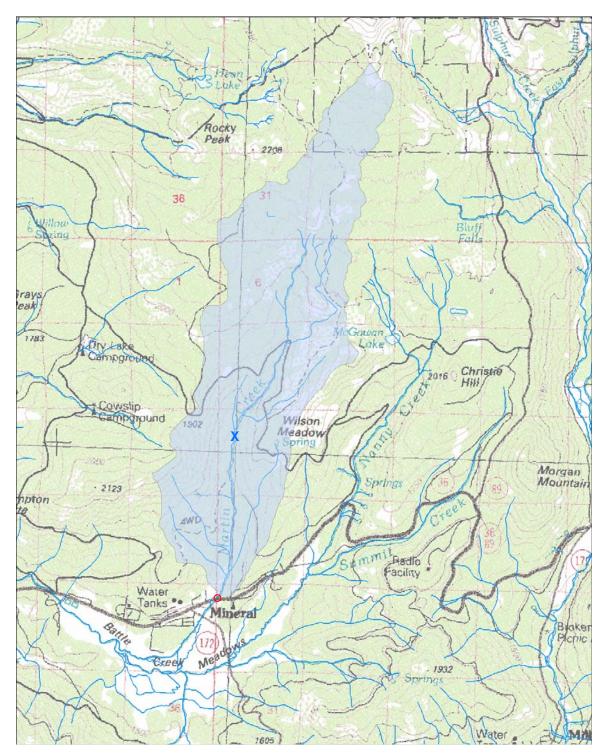
Site # 23: Martin Creek/Hwy 36 East; South Fork Battle Creek; Sacramento River

**Comments:** Known barrier 1 mile upstream of Hwy. 36 road crossing on a Forest Service road. There are several known barriers downstream of Hwy. 36 road crossing on South Fork Battle Creek, which prevent further upstream migration.

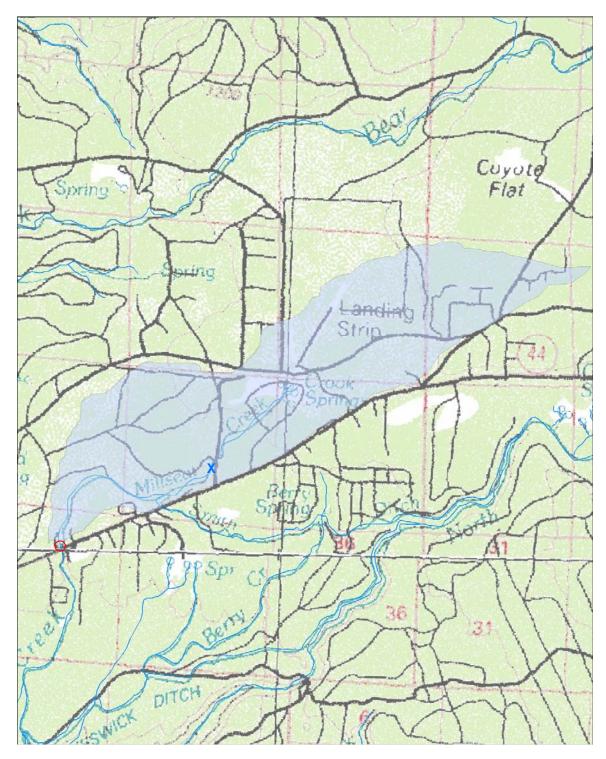
Site # 24: Millseat Creek/Hwy 44 East; North Fork Battle Creek; Sacramento River

Culvert Information: Type: Circular pipe, SSP Dimensions: 6' diameter Length: 113.2' Slope: 2.26 % Overall conditions: Poor Modifications: None Fill Estimate: 4,709 cubic yards Substrate at cross section: 1) Boulder 2) Cobble 3) Pebble Average Channel Width: 40.4' (man-made rock dams influence upstream width)

**Habitat:** <u>Quality</u> = rated as "fair". The average upstream channel width= 40.4 feet but is influenced by a series of man-made rock check dams upstream of culvert. The riparian zone has dense mature tree cover. <u>Quantity</u> = 10,401' of potential anadromous habitat upstream of crossing based on channel slope sustaining <8%.

**Comments:** Downstream dam located at the Volta Power House is a known barrier to salmonids and prevents upstream migration. Another dam is located ~0.12 miles downstream of Hwy. 44 road crossing.

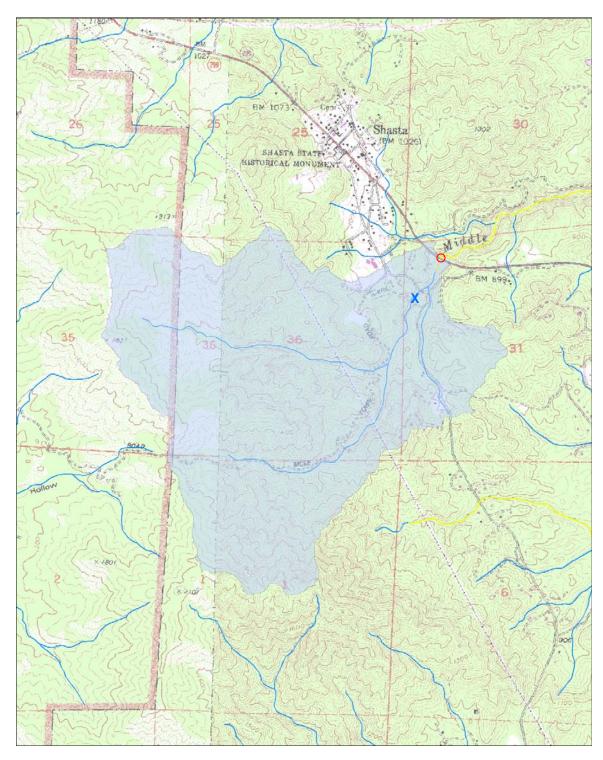
Site #25: Middle Creek/PM 19.14; Hwy. 299 W; Sacramento River

Culvert Information: Type: Circular, SSP Corrugations: 6 X 1.5" Dimensions: 7.5' diameter Length: 180' Slope: 2.24% Overall Conditions: Poor Modifications: None Fill Estimate: Not available Average Channel Width: 10.7' Substrate at Cross section: 1) Cobble 2) Gravel 3) Boulder

**Barrier Status: RED** as determined by the Green-Gray-Red first-phase filter. During FishXing analyses, adult salmonid passage was assessed for flows between 3 cfs and 173.2 cfs (50% of  $Q_2$  discharge). An excessive outlet drop, velocities, and a lack of depth through the culvert resulted in 0% passable to adult, resident, and juvenile salmonids at all flows.

**Habitat:** <u>Quality</u> = rated as "good". Riparian zone has mature tree cover. The current steelhead distribution stops just above the Hwy. 299 road crossing. <u>Quantity</u> = 1,260' of potential anadromous habitat located upstream of crossing based on channel slope sustaining <8%. An old road and concrete dam are located 1,260' above highway crossing and constitute a total barrier to anadromous fish.

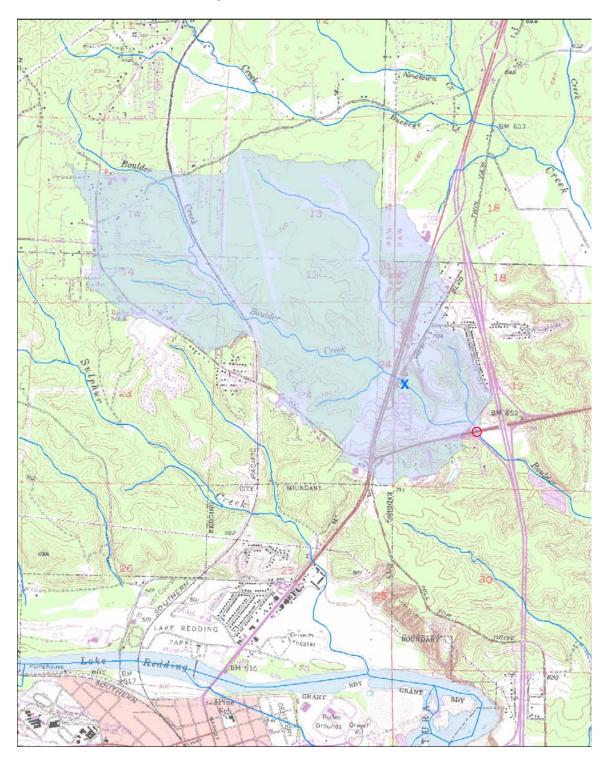
Site #26: Boulder Creek/Hwy. 299; Churn Creek; Sacramento River

**Culvert Information: Type:** 2-sided box **Dimensions:** 8'3" x 10' **Length:** 323.9' **Slope:** 0.28% **Overall conditions:** Good **Modifications:** None **Fill Estimate:** 2,845 cubic yards **Average Channel Width:** 20.8'

**Barrier Status: GRAY** as determined by the Green-Gray-Red first-phase filter. During FishXing analyses, adult salmonid passage was assessed for flows between 3 cfs and 342 cfs (50% of  $Q_2$  discharge). Only 23.8% (73.9 cfs to 154.5 cfs) of flows were passable to adult salmonids. A lack of depth occurred during flows below 73.9 cfs and excessive velocity occurred during flows of 154.5 cfs to 342 cfs. Only 2.6% of flows were passable to resident trout. A lack of depth and excessive velocities resulted in 0% passable to juvenile salmonids.

**Habitat:** <u>Quality</u> = rated as "poor" due to the lack of riparian vegetation. The upstream channel has been straightened in the past. <u>Quantity</u> = 2,927' of potential anadromous habitat upstream of crossing based on channel slope sustaining <8%. Upstream habitat is limited due to the known barrier on Twin View Blvd. road crossing.

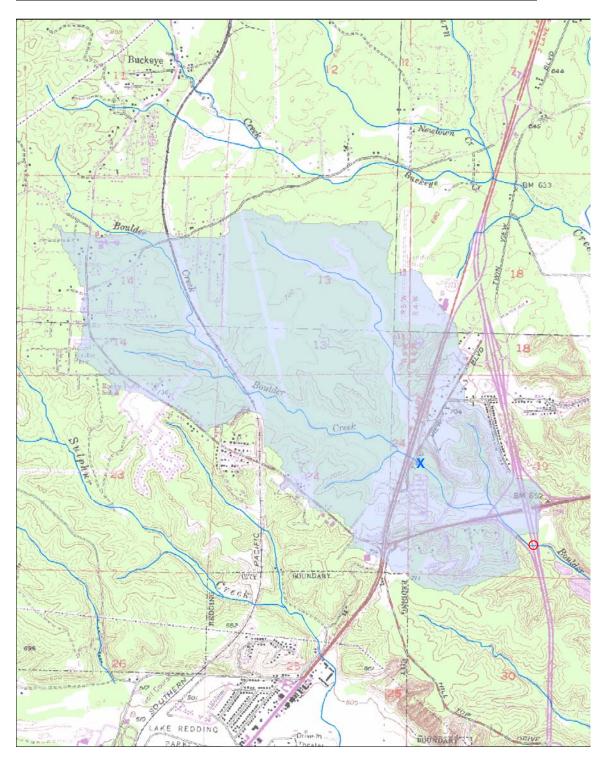
Site #27: Boulder Creek/Interstate 5; Churn Creek; Sacramento River

Culvert Information: Type: Concrete box (2-sides) Dimensions: 8'3" x 10' Length: 254' Slope: 0.27% Overall conditions: Good Modifications: None Fill Estimate: 4,022 cubic yards Average Channel Width: 19.8'

**Barrier Status: GREEN** as determined by the Green-Gray-Red first-phase filter. During FishXing Analyses, adult salmonid passage was assessed for flows between 3 cfs and 361 cfs (50% of  $Q_2$  discharge). Only 52.1% (3 cfs to 189.8 cfs) of flows were passable to adult salmonids. Excessive velocity occurred above 189.8 cfs. Excessive velocities resulted in only 54.4% passage to resident and juvenile salmonids.

**Habitat:** <u>Quality</u> = rated as "poor" due to the series of culvert road crossings immediately upstream of the I-5 crossing. Stream channel has been straightened in the past. <u>Quantity</u> = 4,168' of potential anadromous habitat upstream of crossing based on channel slope sustaining <8%.

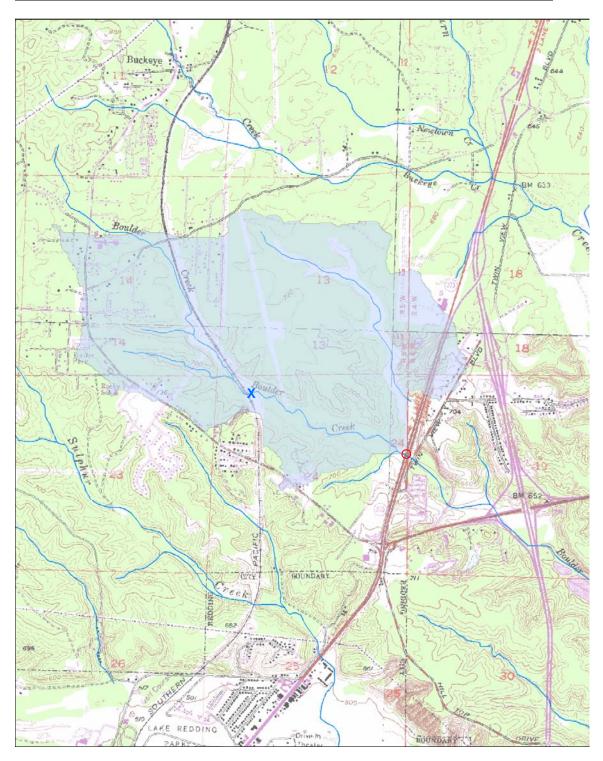
Site #28: Boulder Creek/Hwy. 273 Sha; Churn Creek; Sacramento River

Culvert Information: Type: Concrete box (2 sided) Dimensions: 7' x 10' Length: 120' Slope: 0.46% Overall Conditions: Good Fill Estimate: 1,256 cubic yards. Average Channel Width: 11.7'

**Barrier Status: GRAY** as determined by the Green-Gray-Red first-phase filter. During FishXing analyses, adult salmonid passage was assessed for flows between 3 cfs and 277.3 cfs (50% of  $Q_2$  discharge). There is a 0% passage for adult, resident, and juvenile salmonids due to excessive velocities and a lack of depth through culvert.

**Habitat:** <u>Quality</u> = rated as "fair" due to the good in-stream habitat and limited mature trees in riparian zone. <u>Quantity</u> = 5,016' of potential anadromous habitat upstream of crossing based on channel slope sustaining <8%. Road crossing on Redwood Blvd. immediately upstream of Hwy. 273 crossing.

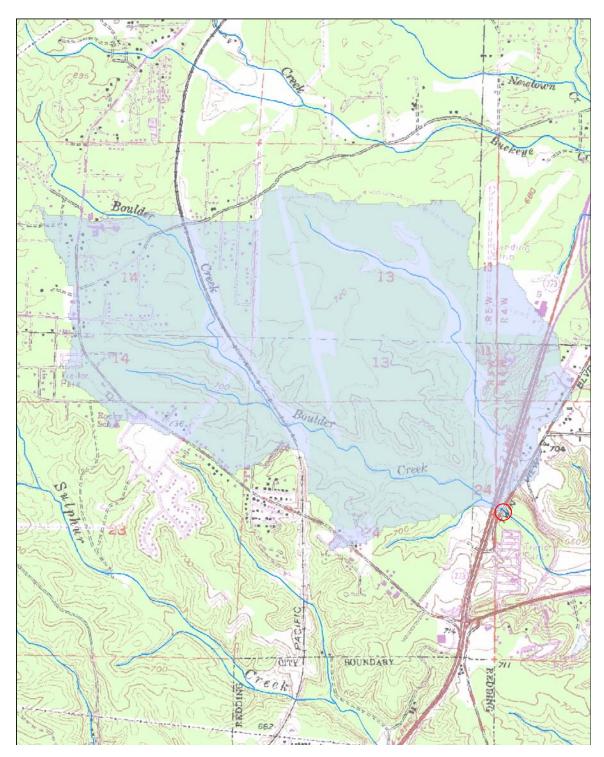
Site #29: Boulder Creek/Twin View Blvd.; Churn Creek; Sacramento River

Culvert Information: Type: Concrete box (2-sided) Dimensions: 7' x 10' Length: 86.2' Slope: 1.12% Overall Conditions: Good Fill Estimate: 1,072 cubic yards. Average Channel Width: 21.2'

**Barrier Status: RED** as determined by the Green-Gray-Red first-phase filter. During FishXing analyses, adult salmonid passage was assessed for flows between 3 cfs and 282.8 cfs (50% of  $Q_2$  discharge). Due to excessive leap heights, outlet drop, and velocities, there is a 0% passage to adult, resident, and juvenile salmonids.

**Habitat:** <u>Quality</u> = rated as "poor" due to the lack of riparian vegetation and the immediate upstream road crossing. <u>Quantity</u> = 90' of potential anadromous habitat upstream of crossing based on channel slope sustaining <8%. Immediate upstream road crossing at State Route 273 was determined a barrier by FishXing.
