# STREAM INVENTORY REPORT

## Julias Creek

A stream inventory was conducted June 6, 2006 to July 12, 2006 on Julias Creek. The survey began at the confluence with South Fork Usal Creek and extended upstream 1.4 miles.

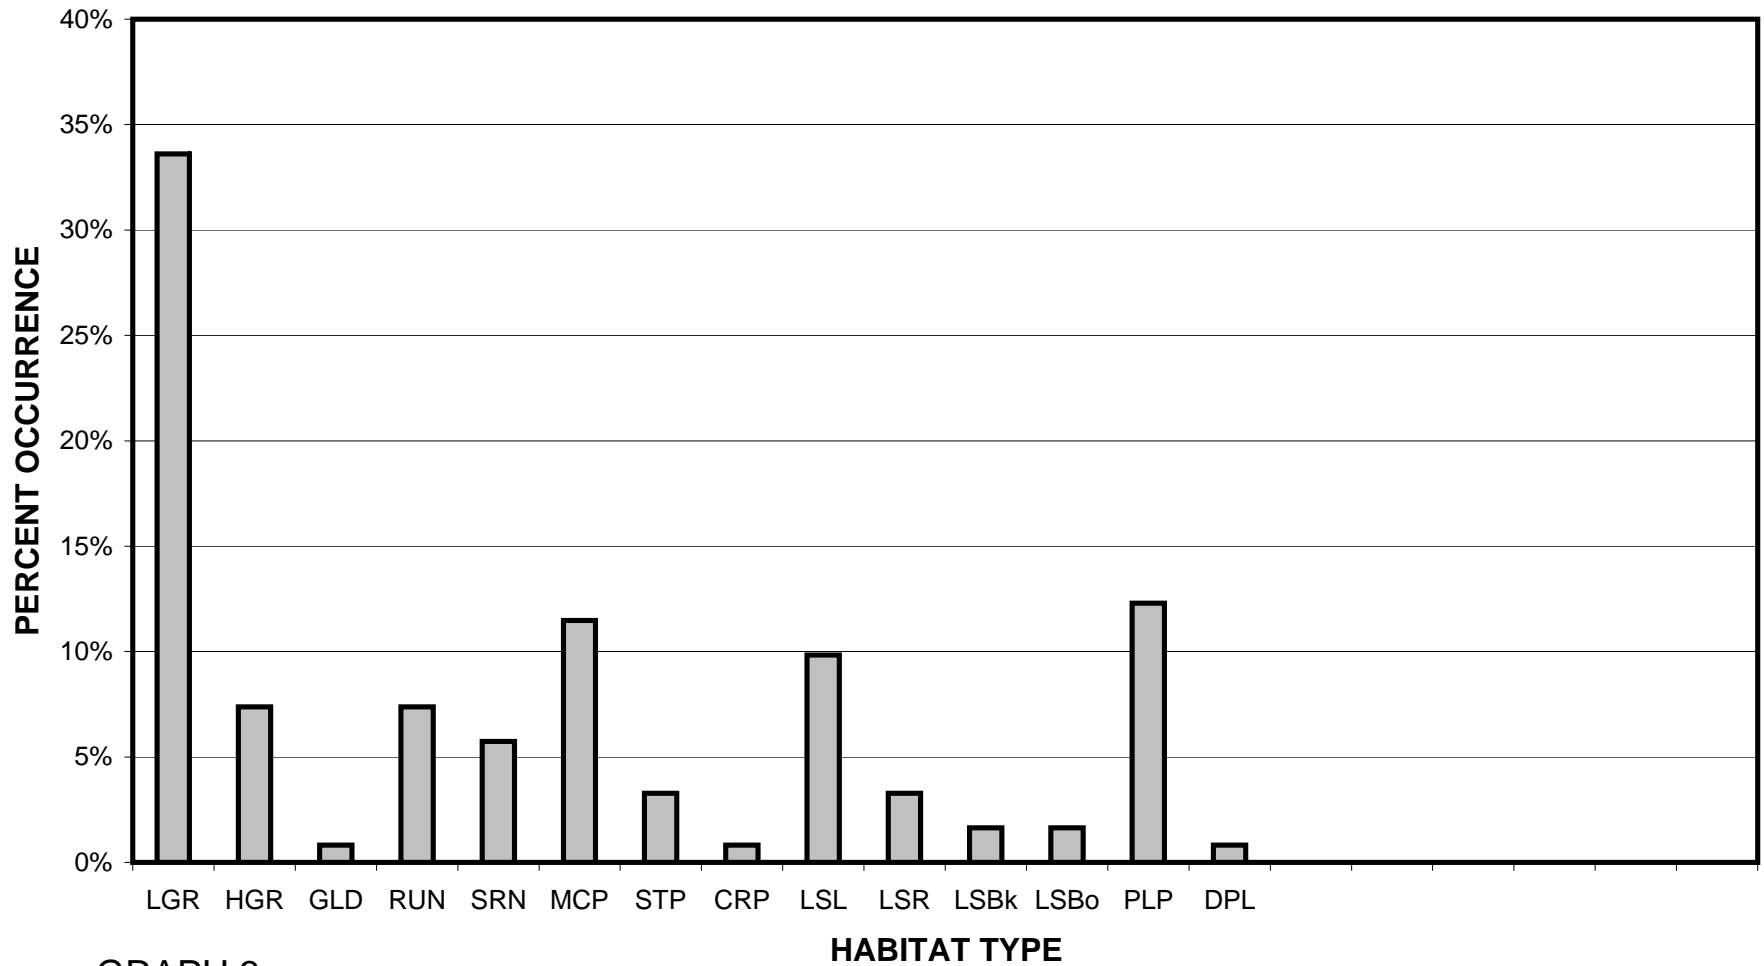
GRAPH 2

# **JULIAS CREEK 2006** **HABITAT TYPES BY PERCENT OCCURRENCE**

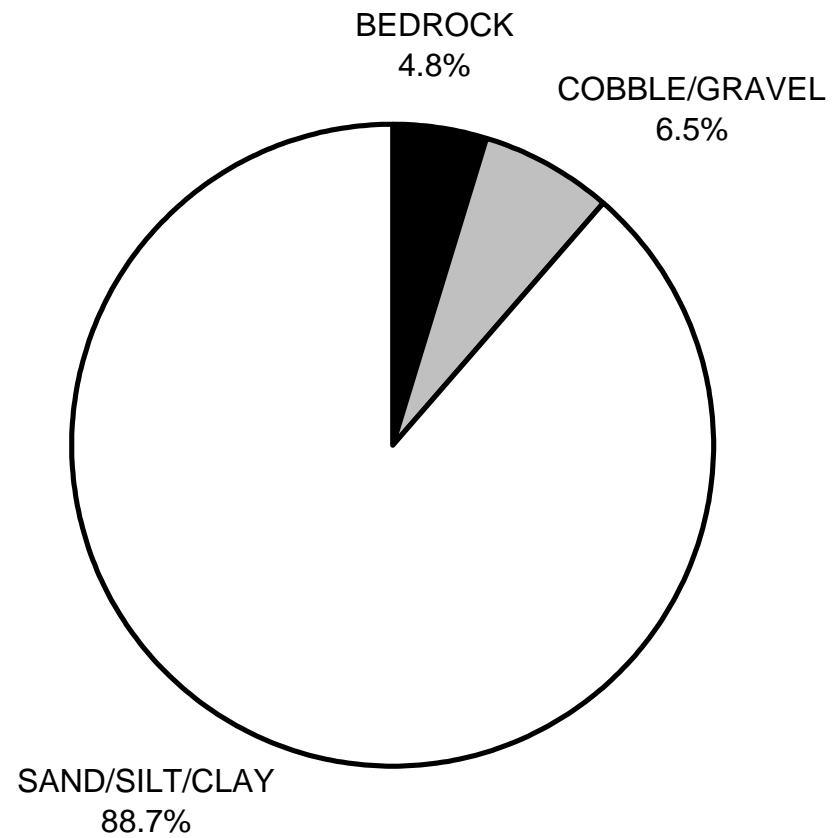
GRAPH 9

For the stream reach surveyed, the mean percent right bank vegetated was 95%. The mean percent left bank vegetated was 90%. The dominant elements composing the structure of the stream banks consisted of 89% sand/silt/clay, 6% cobble/gravel, and 5% bedrock (Graph 10). Hardwood trees were the dominant vegetation type observed in 52.4% of the units surveyed. Additionally, 33.1% of the units surveyed had coniferous trees as the dominant vegetation type (Graph 11). Hardwood trees were the dominant vegetation type observed in 52.4% of the units surveyed. Additionally, 33.1% of the units surveyed had coniferous trees as the dominant vegetation type (Graph 11).

**JULIAS CREEK 2006**  
**DOMINANT BANK COMPOSITION IN SURVEY REACH**

The percentage of right and left bank covered with vegetation was 95% and 90%, respectively. In areas of stream bank erosion or where bank vegetation is sparse, planting endemic species of coniferous and hardwood trees, in conjunction with bank stabilization, is recommended.
