Site Name: Abandoned Stream Crossing (Removed)

Stream Name: Tajiguas Creek

Year Remediated: 2014

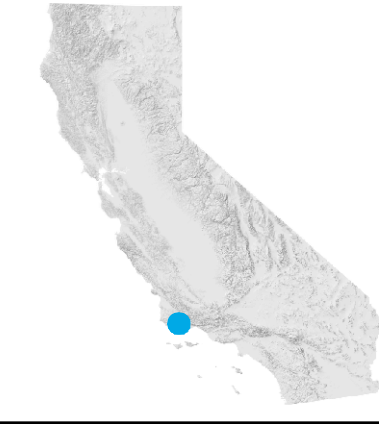
Before

Barrier Description Prior to Remediation: Total

Notes: Structure was removed in late Summer 2014 opening up over six miles of historic steelhead habitat. The project was funded by CDFW FRGP. After barrier removal, the channel was regraded and three large pools were created, the stream banks were restored and re-vegetated. Before: Recorded as unknown passage status in the PAD per professional judgement by Stoecker Ecological per a 2002 survey/site visit. In 2010, Stoecker assessed passage using DFG's Restoration Manual Passage Filter which determined that passage was "red" (total/non-passable). The crossing failed to meet CDFW and NOAA passage criteria for steelhead/rainbow trout for all life stages due to the excessive jump height. The draft assessment report was cited in FRGP proposal but not found online or elsewhere. Per the 2010 assessment: The barrier is an abandoned stream crossing - a 12 to 18 inch thick concrete curb that spans the channel and is attached to boulders at each bank. A steeply sloped grouted rock apron extends downstream of the concrete curb for a distance of approximately 7 feet. The crossing has created a vertical drop approximately 3.5 feet high, as measured from the top of the concrete curb to riffle control at the downstream end of the scour pool.
