Site Name: Diversion Dam (Removed)

Stream Name: Tajiguas Creek

PAD ID: 706364

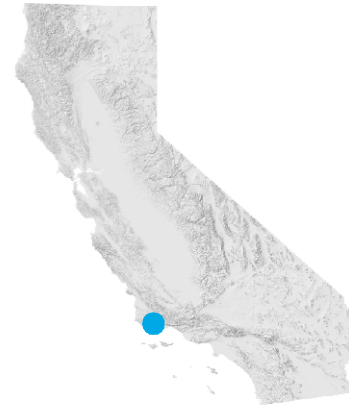
Before

Barrier Description Prior to Remediation: Total

Notes: Structure was removed in late Summer 2014 opening up over six miles of historic steelhead habitat. The project was funded by CDFW FRGP. After barrier removal, the channel was regraded and three large pools were created, the stream banks were restored and re-vegetated. Before: Total barrier per professional judgement by Stoecker Ecological per a 2002 survey/site visit. In 2010 there was an assessment using DFG's Restoration Manual Passage Filter which determined that passage was "red" (total/non-passable). The draft assessment report was cited in FRGP proposal but not found online or elsewhere. Due to the significant drop on the downstream side of the structure it is likely that upstream migration would not be possible. Depending on the downstream pool depth and vertical height of the structure, upstream passage may be possible although highly unlikely.
