Site Name: Parks Creek #5 culvert (removed)
Stream Name: Parks Creek
Structure Owner:
Year Remediated: 2014
Site Type: Road crossing
Site Status After Remediation: Remediated, fish response unconfirmed
Species Benefited After Remediation:
Immediate Downstream barrier PAD ID: 737360

PAD ID: 758585
Tributary To: Shasta River
Barrier Remediation By:
Barrier Description Prior to Remediation: Temporal & Partial
Count of Barriers Downstream: 3
Count of Barriers Upstream: 0
Distance Upstream to Next Barrier or Limit of Anadromy : 45.81923 Miles

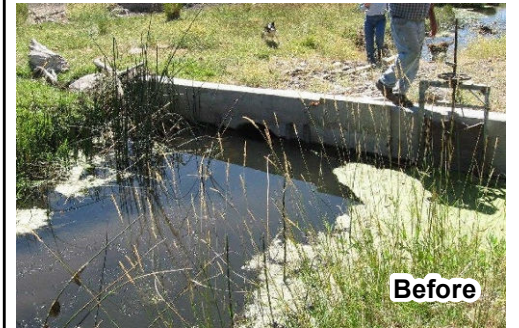
Notes: In September 2014, the entire structure (culvert) was removed from the creek, and a headgate and pipe were installed in its place. This was a Coho Help Act project. Before: Temporal & Partial barrier per professional judgement by CDFW. Twin culvert (36 in (diameter)) road crossing/point of diversion for agriculture irrigation. The upstream side of the culverts have board slots, fitted with boards to create head to direct flow into headgate. The structure creates a temporal and partial barrier due to stream flow combined and/or with how the diversion is being operated. The barrier may be due to velocities, or from blockage. Previously updated on 5/10/2013. On 5/22/2015, updated the passage status to not a barrier per a ppx by Catelin Bean at Coho TRT and per CDFW coho help webpage.
