**Site Name:** Rock and mortar dam with spillway (removed)

**Stream Name:** Arroyo Trabuco

**PAD ID:** 758698

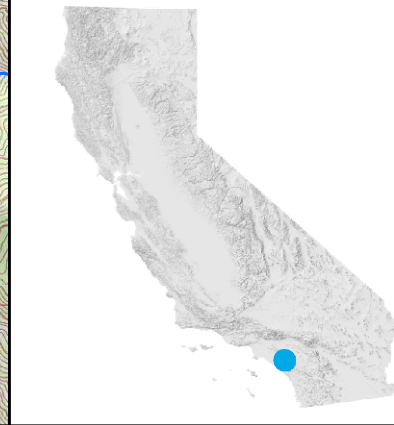
**Notes:** In December 2014, the Cleveland National Forest in conjunction with the Tahoe Mine Reclamation Crew removed this dam. Before: Unknown passage status per field survey conducted by U.S. Forest Service. 2013 USFS survey comments: Rock and mortar dam (6.5' h x 2' w x 40' l) with spillway, condition: Good. Juvenile barrier Undercut at base/pool area, eroded at spillway, but largely intact
