CATALOG OF SONOMA COUNTY STREAM CROSSINGS WITH CULVERTS LOCATED ON FISH-BEARING STREAM REACHES WITHIN THE RUSSIAN RIVER BASIN

By
Ross Taylor and Associates

Site ID# S-001: Unnamed Tributary/Willow Creek Road; Willow Creek; Russian River **Road Ownership** County

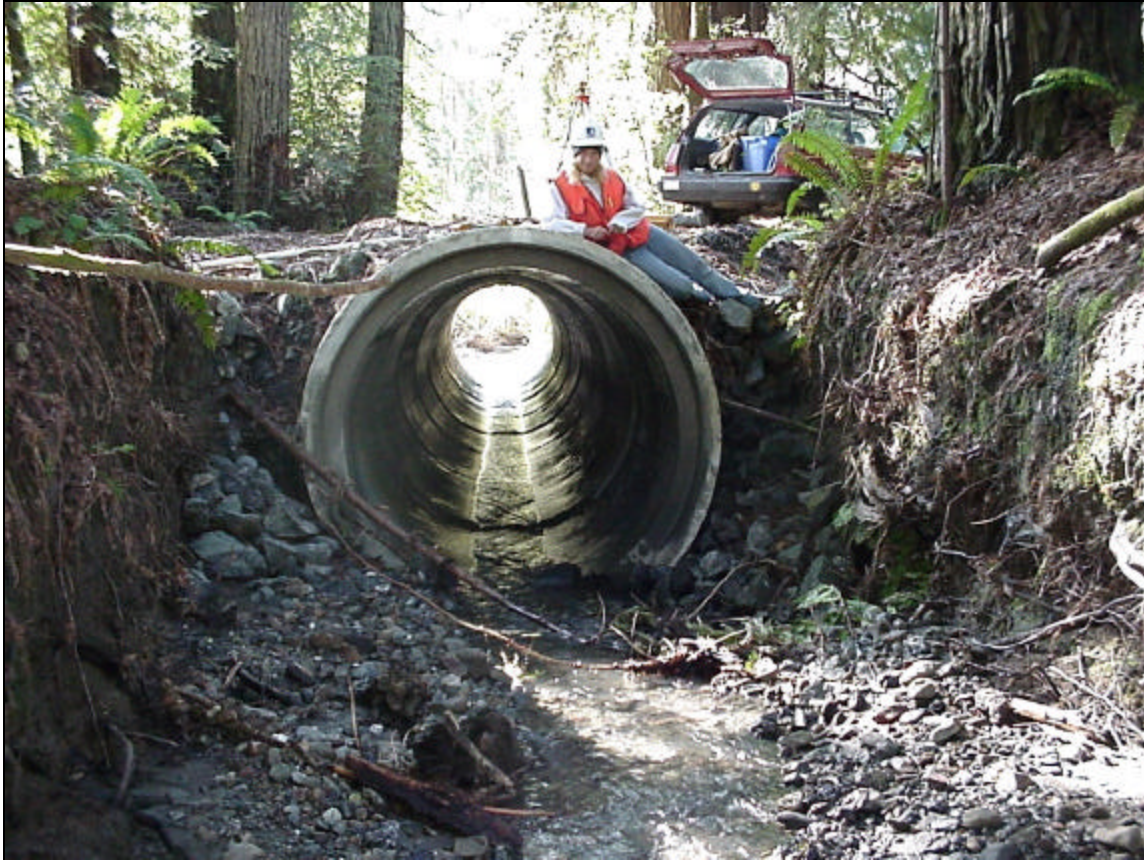
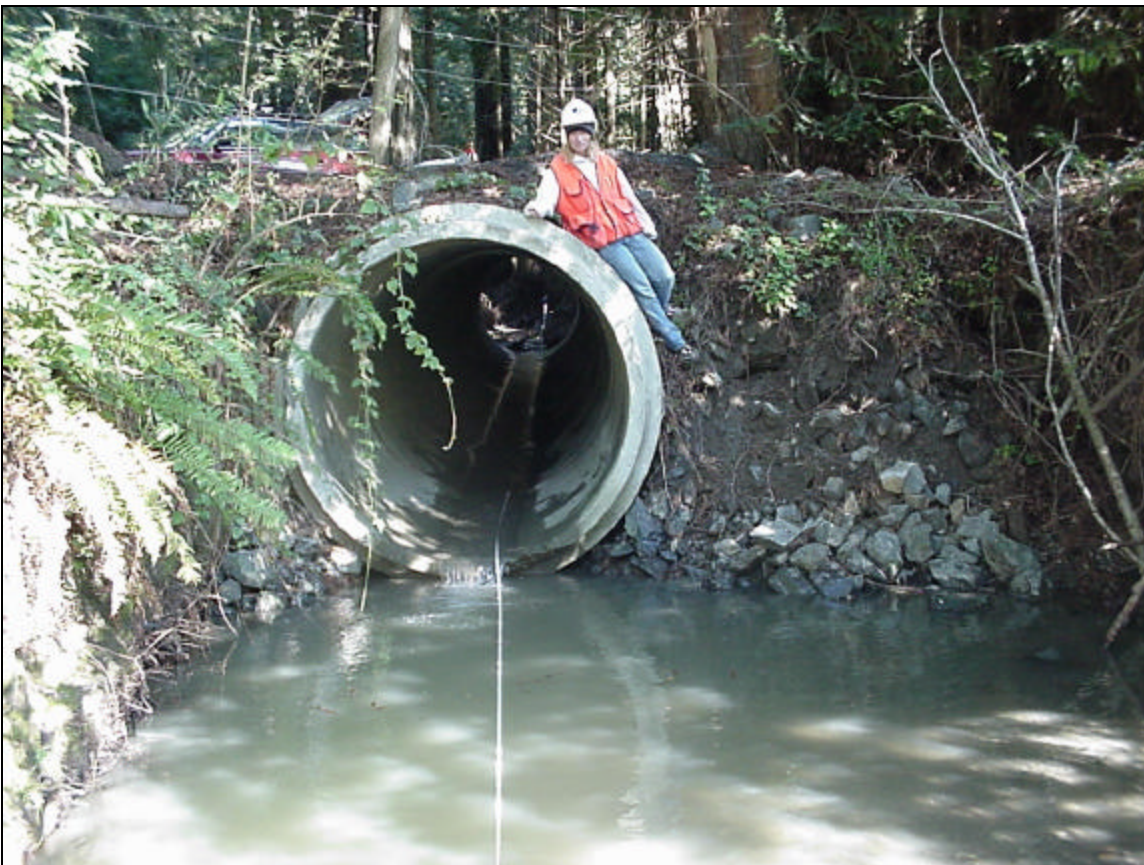
Fill Estimate: 253 cubic yards. **Overall Condition:** Good.

Sizing: Adequately sized; HW/D = 1 on a storm flow with approximately an 84-year recurrence interval. Willow Creek Road is overtopped on more than a 250-year storm flow.

Barrier Status: **GRAY:** FishXing estimated this crossing meets the 8-16-16 passage criteria for adult steelhead on 35% of the range of migration flows and fails to meet criteria for all age classes of juveniles. There is a lack-of-depth for adults on lower migration flows and also excessive velocities on most flows for juveniles.

Preferred Treatment: When needed, replace with a properly-sized open-bottom arch or a bridge.

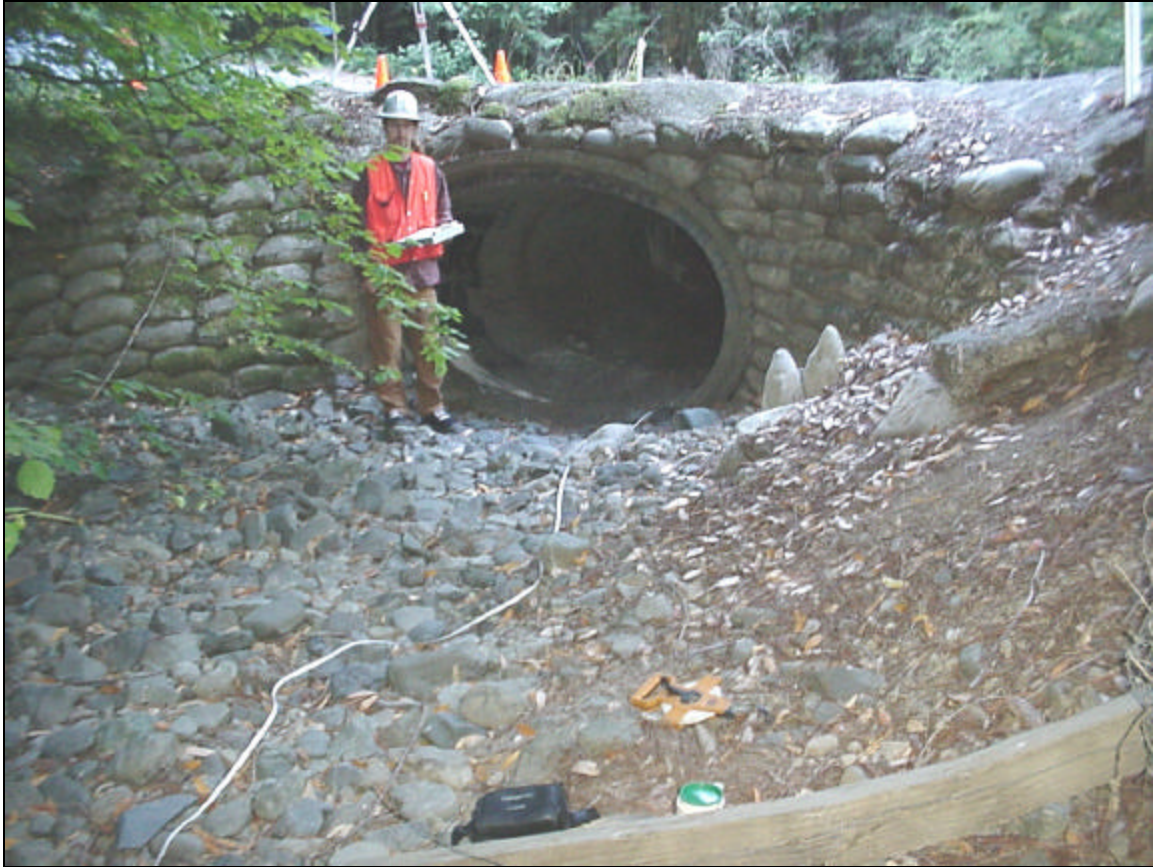
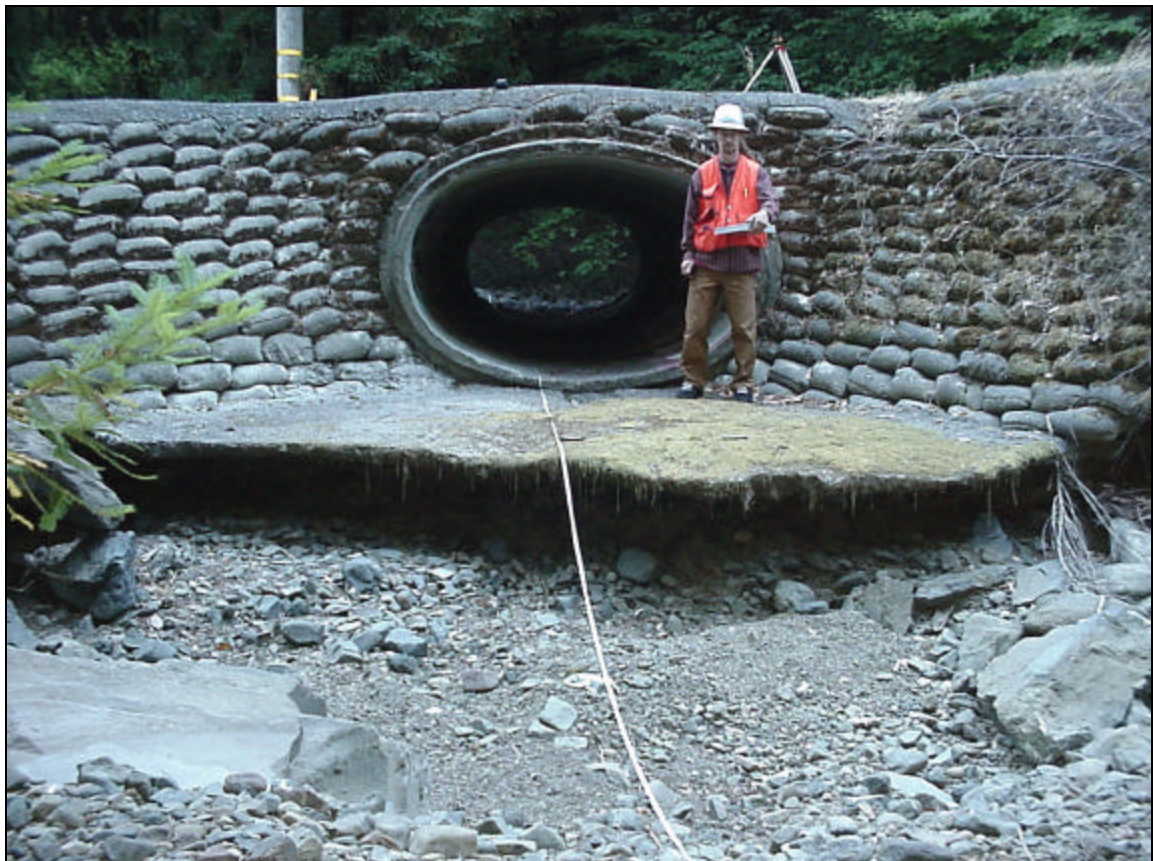
Site ID# S-002: Kohute Gulch/Austin Creek Road; Austin Creek; Russian River **Road Ownership:** County

Fill Estimate: 221 cubic yards. **Overall Condition:** Good.

Barrier Status: **GRAY:** FishXing determined this crossing meets the 8-16-16 ft/sec passage criteria for adult steelhead on 18% of the range of migration flows and fails to meet criteria for all age classes of juveniles. There is a lack-of-depth for adults on lower migration flows and also excessive velocities on most flows for juveniles.

Preferred Treatment: Because the current culvert is extremely undersized a full replacement is the only option to improve fish passage and increase storm flow conveyance. Replace with a properly sized open-bottom arch on concrete footings or with a bridge.

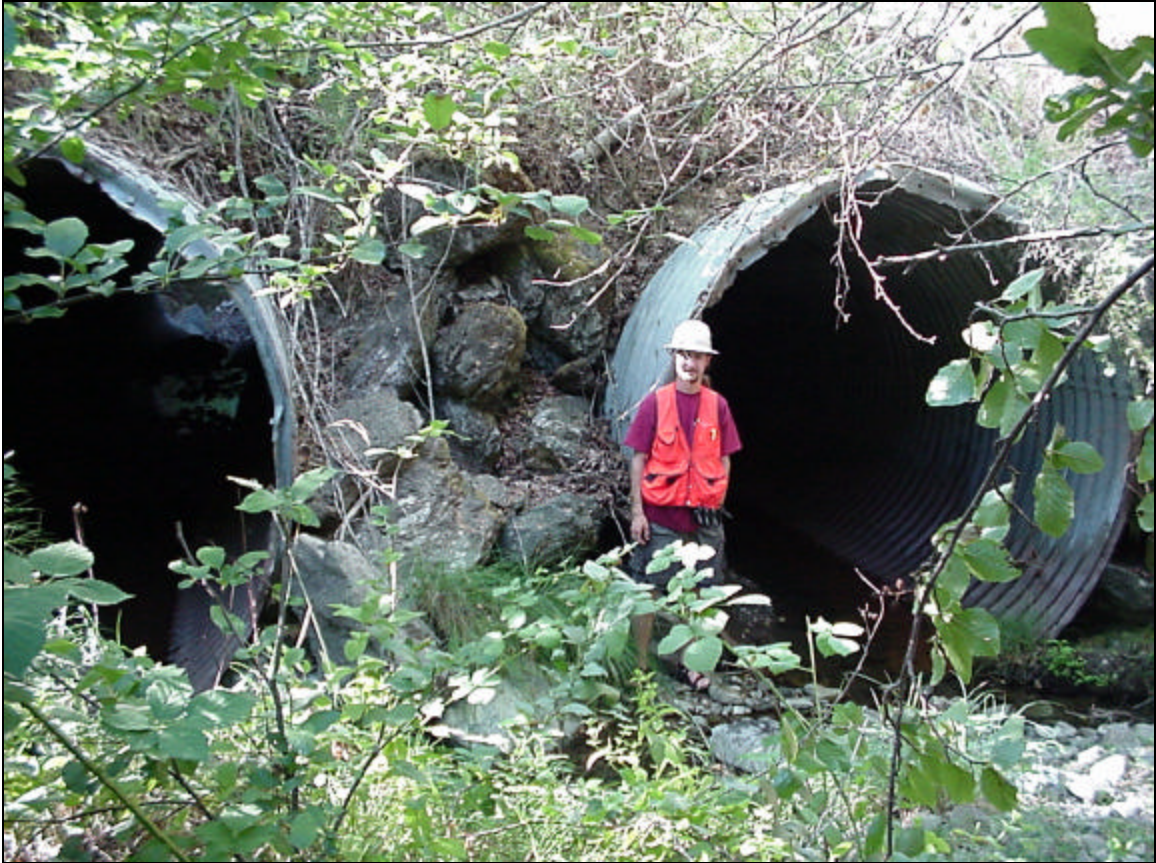
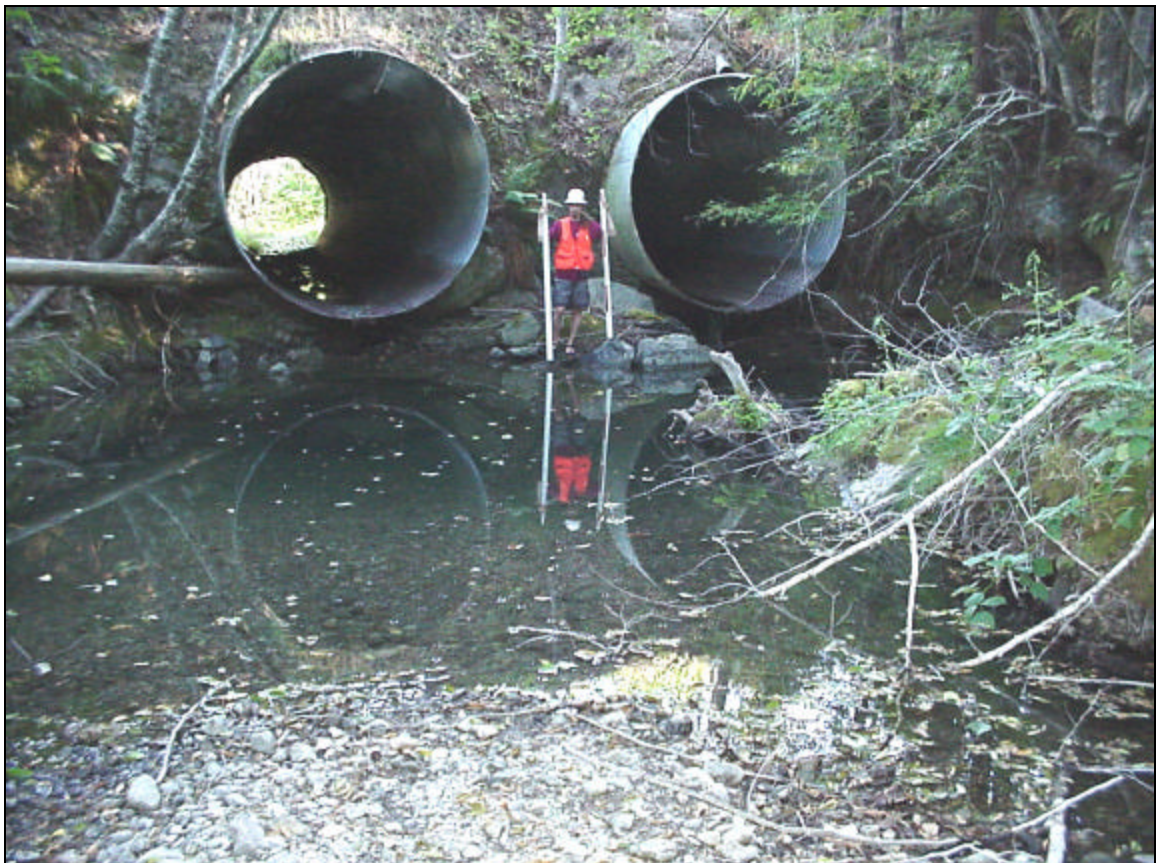
Site ID #S-003: Pole Mountain Creek/Fort Ross Road; Ward Creek; Austin Creek; Russian River

Culvert Type: Two Circular Pipes, SSP. **Corrugations:** 6" x 2" **Dimensions:** diameters = 9.0' **Lengths:** 76.6'
Slopes: LB pipe = 0.05%; RB pipe = 0.38% **Modifications:** None. **Rustline Height:** LB = 2.2'; RB = 2.0'
Average Active Channel Width: 12.4' **Fill Estimate:** 1,037 cubic yards. **Overall Condition:** Rusted through.
Sizing: Undersized; HW/D = 1 on a storm flow with approximately a 32-year recurrence interval. Fort Ross Road is overtopped on more than a 250-year storm flow.

Barrier Status: Both pipes =**GRAY**: FishXing determined this crossing meets the 8-16-16 ft/sec passage criteria for adult steelhead on 50% of the range of estimated migration flows and fails to meet passage criteria all age classes of juveniles. For adults, the perched outlets are leap barriers until stream discharge is greater than 50 c.f.s.

Preferred Treatment: Because both culverts are in poor condition with completed rusted-through inverts, a full replacement is the best long-term option to improve fish passage. Replace with a properly sized open-bottom arch on concrete footings or with a bridge.

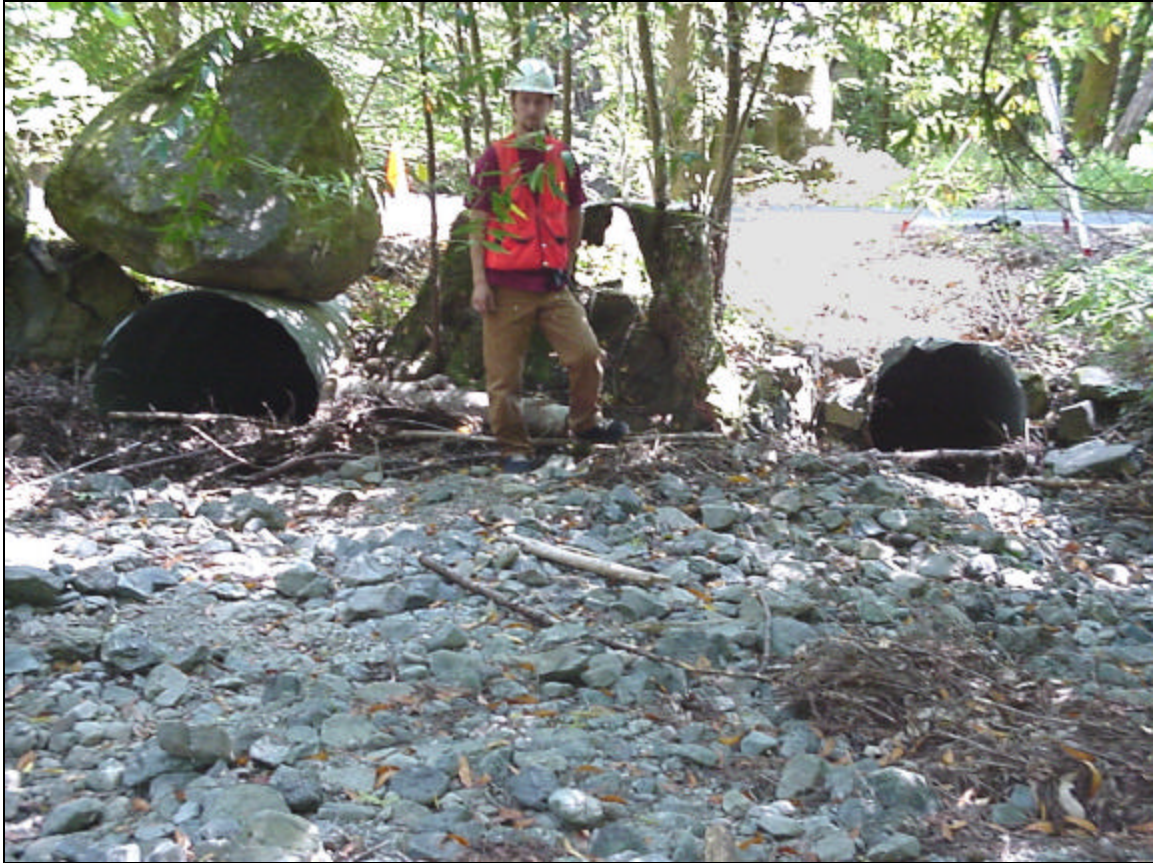
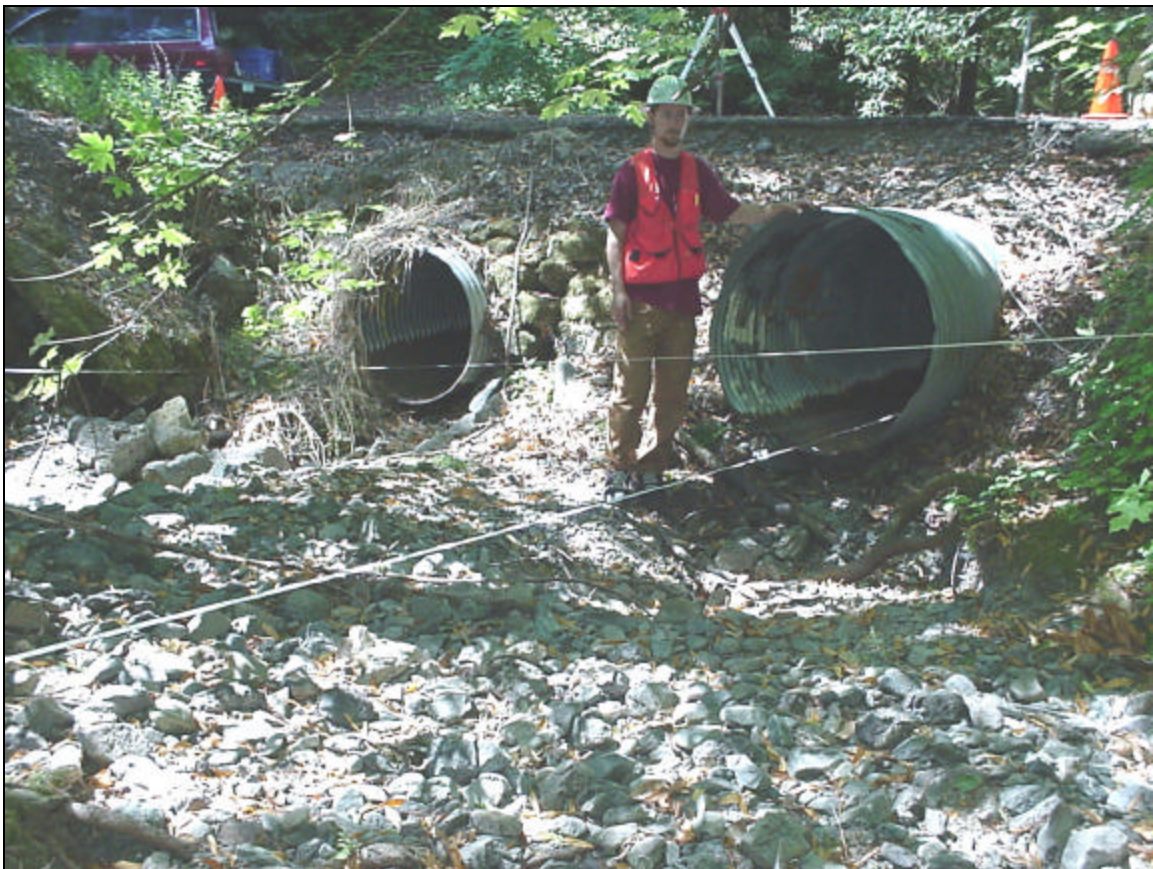
Site ID #S-004: Tyrone Gulch/Tyrone Road; Dutch Bill Creek; Russian River **Road Ownership:** County

Culvert Type: Two Circular Pipes, CSP. **Corrugations:** 2-2/3" x 1/2" **Dimensions:** LB pipe diameter = 3.5'; RB pipe diameter = 3.0' **Lengths:** LB pipe = 40.2'; RB pipe = 30.3' **Slopes:** LB pipe = 4.60%; RB pipe = 5.12% **Modifications:** None. **Rustline Height:** LB = 0.6'; RB = 1.2' **Average Active Channel Width:** 7.5' **Fill Estimate:** 111 cubic yards. **Overall Condition:** Abraded. **Sizing:** Extremely undersized; HW/D = 1 on a storm flow with approximately a two-year recurrence interval. Tyrone Road is overtopped on approximately a five-year storm flow.

Barrier Status: **RED:** the Green-Gray-Red filter determined the RB culvert fails to meet passage criteria for adult steelhead and all age classes of juveniles due to the steep slope. **GRAY:** FishXing determined the LB culvert meets the 8-16-16 ft/sec passage criteria for adult steelhead on 89% of the range of estimated migration flows and fails to meet passage criteria all age classes of juveniles.

Preferred Treatment: Because both culverts are extremely undersized and the inverts are starting to rust-through, this crossing is probably due for a full replacement. Replace with a properly sized open-bottom arch on concrete footings or with a bridge. The limited reach of upstream salmonid habitat makes this site a poor candidate for treatment with fisheries restoration funding.

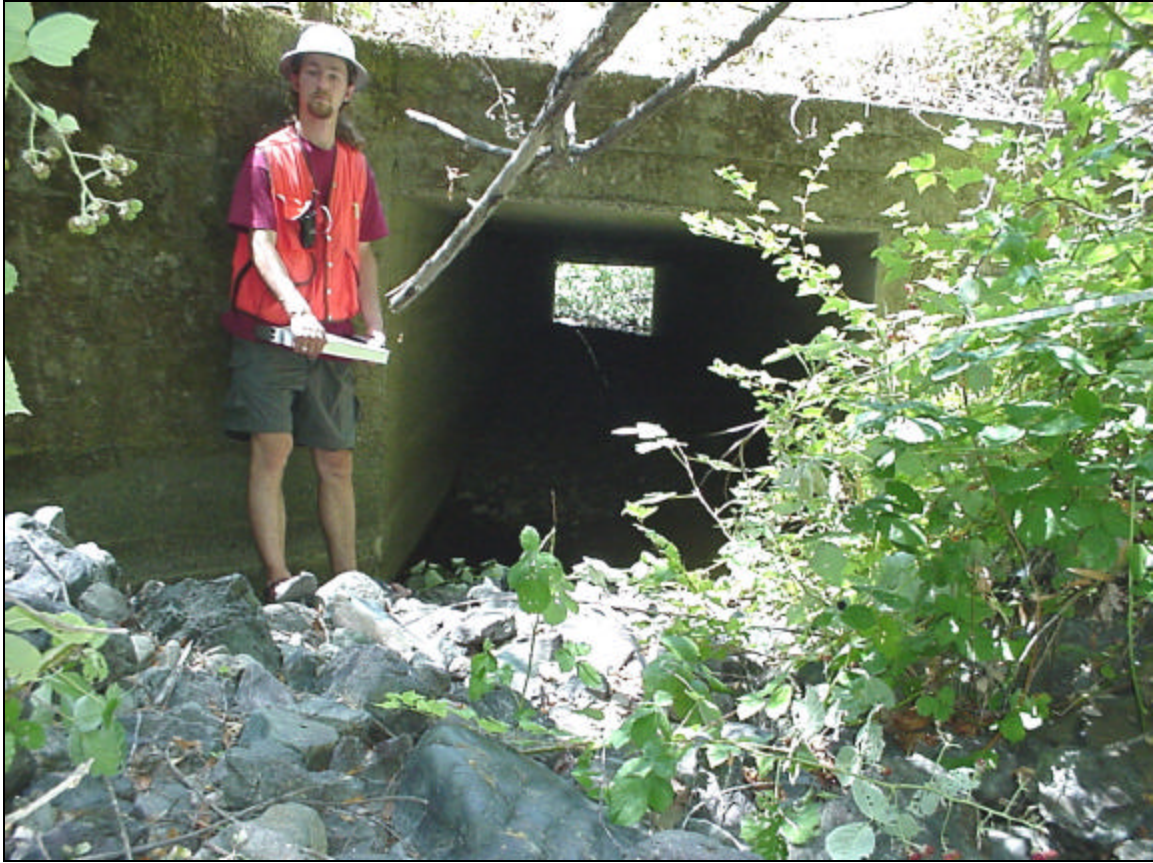
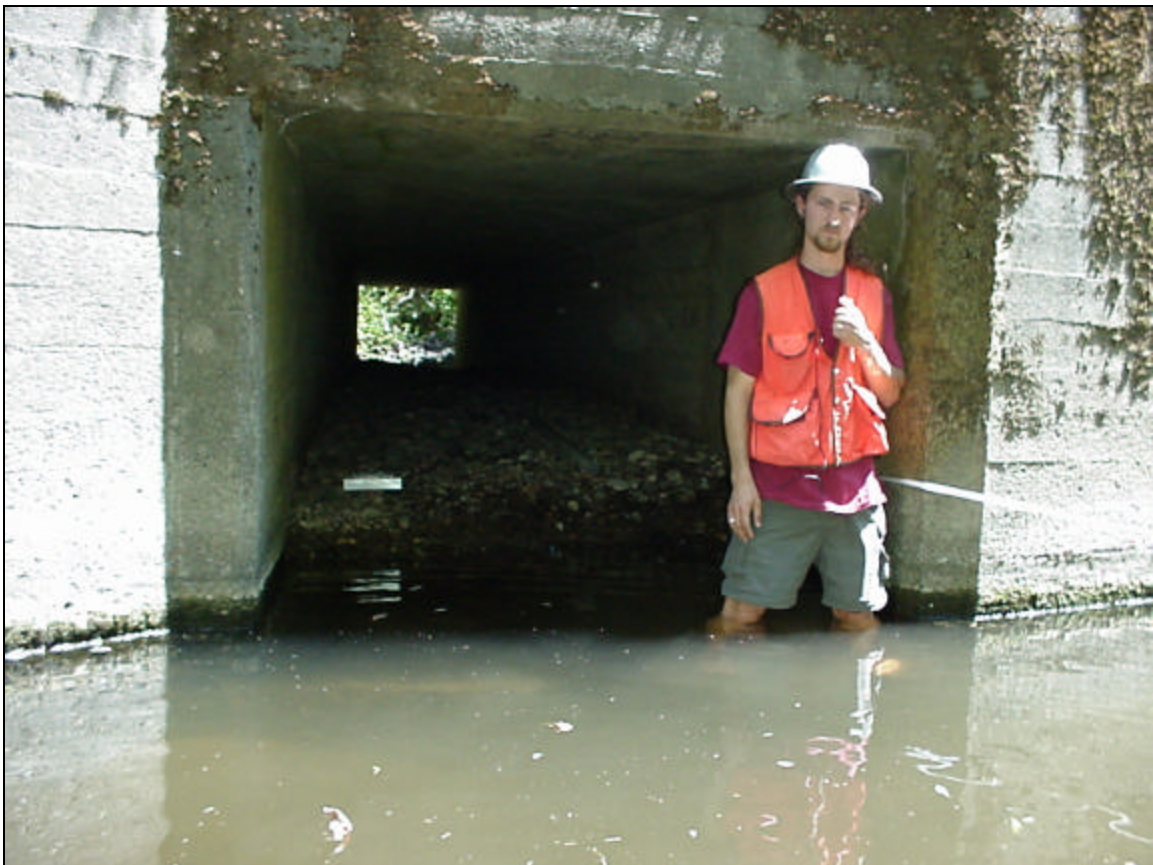
Site ID #S-005: Devoul Creek/Bohemian Highway; Dutch Bill Creek; Russian River **Road Ownership:** County

Culvert Type: Box, Concrete. **Corrugations:** None. **Dimensions:** 6.1' height x 6.0' width **Length:** 66.8'
Slope: 3.10% **Modifications:** None. **Rustline Height:** N/A **Average Active Channel Width:** 7.9'
Fill Estimate: 867 cubic yards. **Overall Condition:** Good. **Sizing:** Undersized; HW/D = 1 on a storm flow with approximately a seven-year recurrence interval. The Bohemian Highway is overtopped on more than a 250-year flow.

Barrier Status: **GRAY:** FishXing determined this crossing meets the 8-16-16 ft/sec passage criteria for adult steelhead on 80% of the range of estimated migration flows, meets passage criteria for resident/2+ juveniles on 20% of the range of estimated migration flows, and fails to meet passage criteria for 1+/young-of-year juveniles. Actual passage of adults and older juveniles may be higher than predicted because the main violation was lack-of-depth.

Preferred Treatment: None recommended because the current box culvert provides adequate passage. However, the crossing is sized to overtop on less than a 10-year storm flow. Periodically inspect for condition and maintenance. When needed, replace with a properly sized open-bottom arch or a bridge.

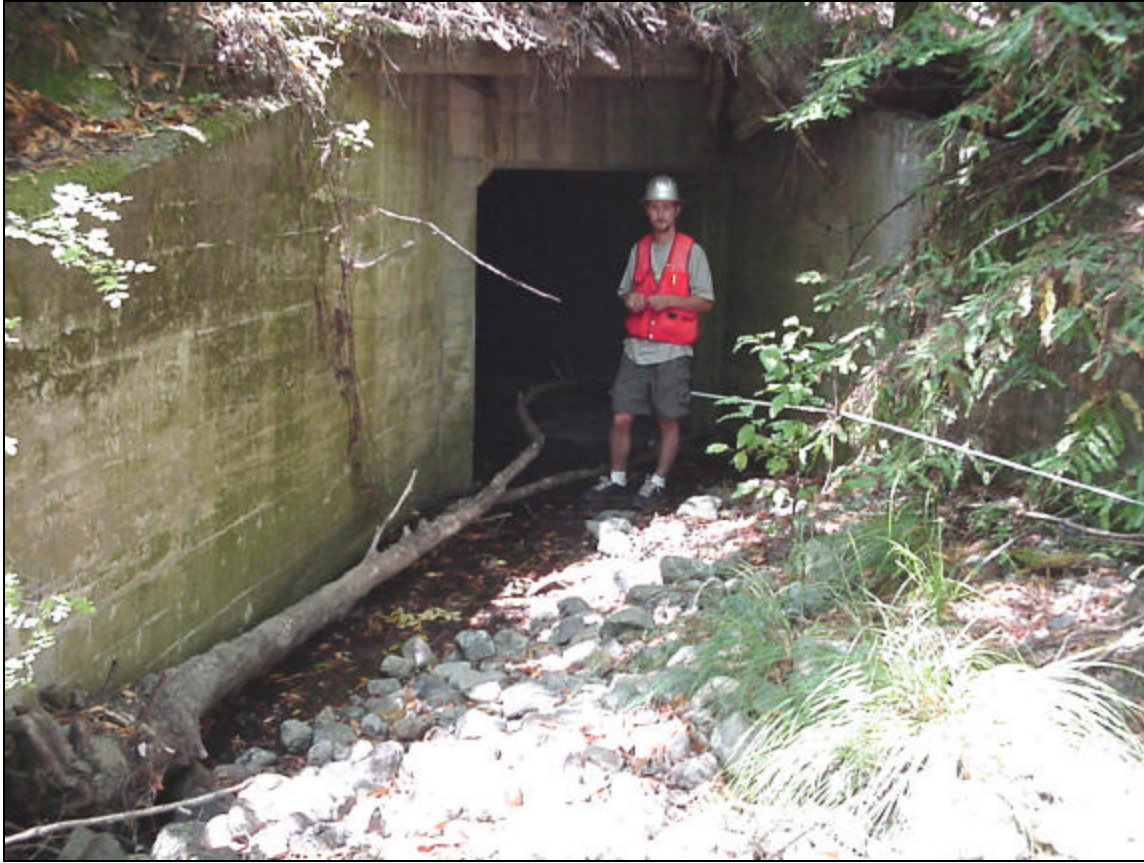
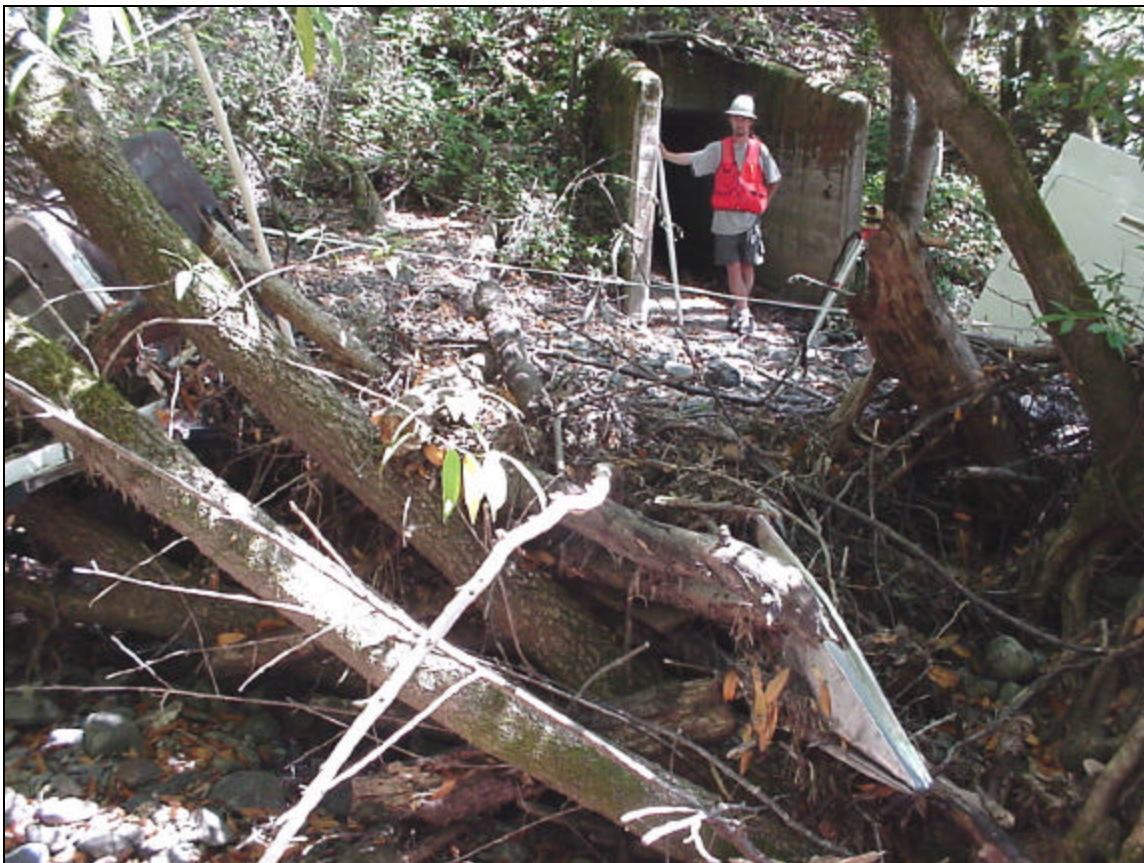
Site ID #S-006: Grub Creek/Bohemian Highway; Dutch Bill Creek; Russian River **Road Ownership:** County

Culvert Type: Box, Concrete. **Corrugations:** None. **Dimensions:** 6.0' height x 6.0' width **Length:** 85.2'
Slope: 1.36% **Modifications:** None. **Rustline Height:** N/A **Average Active Channel Width:** 11.6'
Fill Estimate: 1,108 cubic yards. **Overall Condition:** Good. **Sizing:** Properly sized; HW/D = 1 on a storm flow with approximately a 135-year recurrence interval. The Bohemian Highway is overtopped on more than a 250-year storm flow.

Barrier Status: **GRAY:** FishXing determined this crossing meets the 8-16-16 ft/sec passage criteria for adult steelhead on 43% of the range of estimated migration flows and fails to meet passage criteria for all age classes of juveniles. Actual passage of adults and older juveniles may be higher than predicted because the main violation was lack-of-depth.

Preferred Treatment: Because the current box culvert is sized to pass more than a 100-year storm flow, a retrofit is recommended to improve fish passage. Two or three boulder weirs downstream of the crossing will raise tail-water elevation and corner baffles within the box culvert will increase depths and decrease velocities.

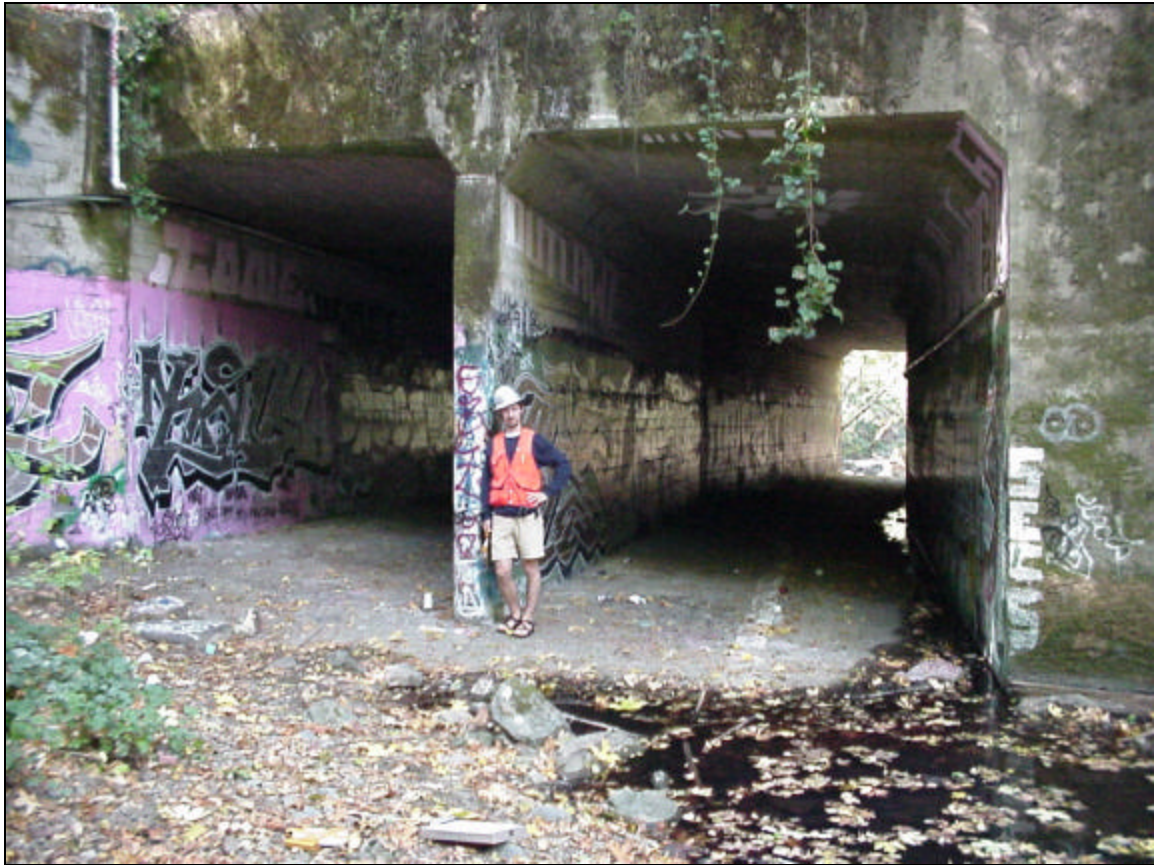
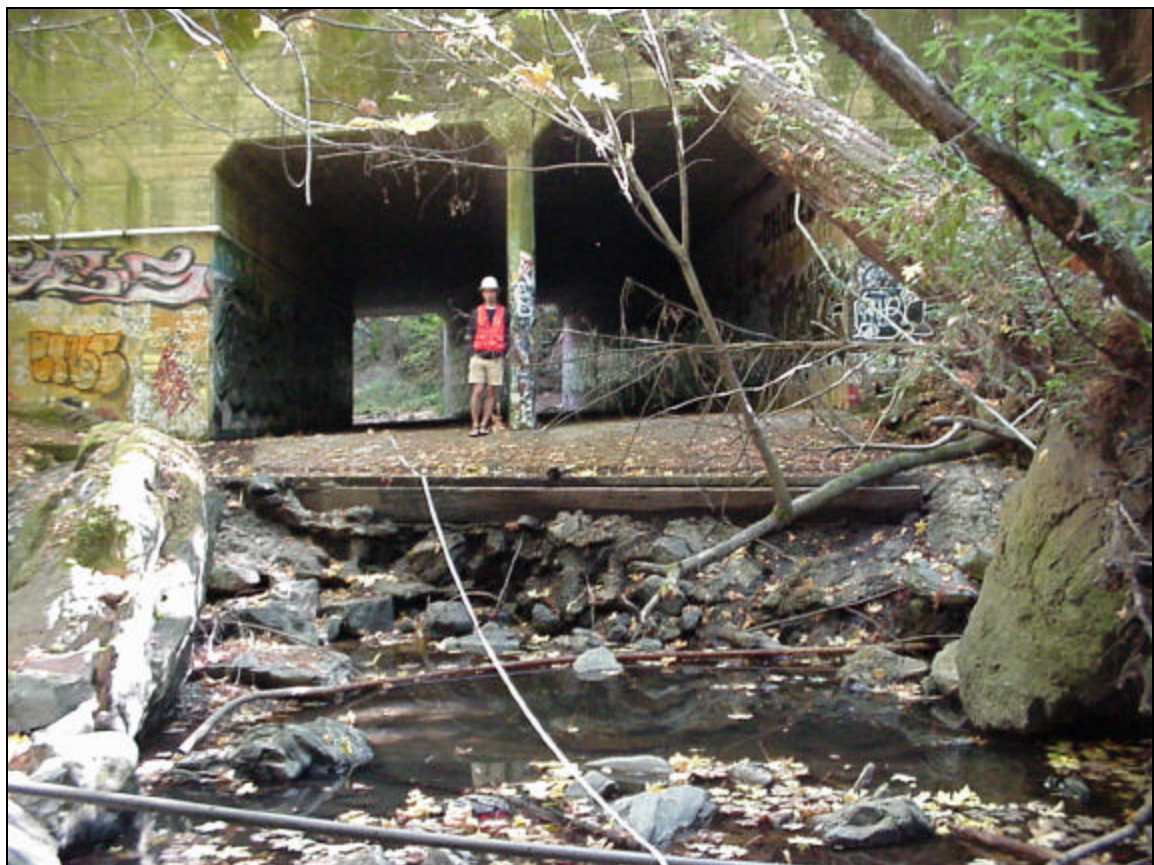
Site ID #S-007: Dutch Bill Creek #1/Market Street; Russian River **Road Ownership:** County

Culvert Type: Two Bay Box, Concrete. **Corrugations:** None. **Dimensions:** 12.1' height x 25.0' width
Length: 98.5' **Slope:** 1.37% **Modifications:** None. **Rustline Height:** N/A **Average Active Channel Width:** 12.1'
Fill Estimate: 4,783 cubic yards. **Overall Condition:** Good. **Sizing:** Properly sized; HW/D = 1 on a storm flow with more than a 250-year recurrence interval. Market Street is overtopped on more than a 250-year storm flow.

Barrier Status: **RED:** the Green-Gray-Red filter determined this crossing fails to meet passage criteria for all species of adult salmonids and all age classes of juveniles due to the extremely perched outlet (~ 5 feet).

Preferred Treatment: Because the current box culvert is sized to pass more than a 250-year storm flow, a retrofit is recommended to improve fish passage. Consider the feasibility of constructing a series of eight to ten concrete weirs attached to the culvert's outlet, designed to function as a fishway. It may be appropriate to divert lower flows into one of the bays with a weir across the inlet of one of the bays. Concrete weirs (sloped with v-notch) within the box culvert will increase depths and decrease velocities. Due to the complexity of the project, the County should consult with CDFG and NMFS hydraulic engineers with assistance in the retrofit's design.

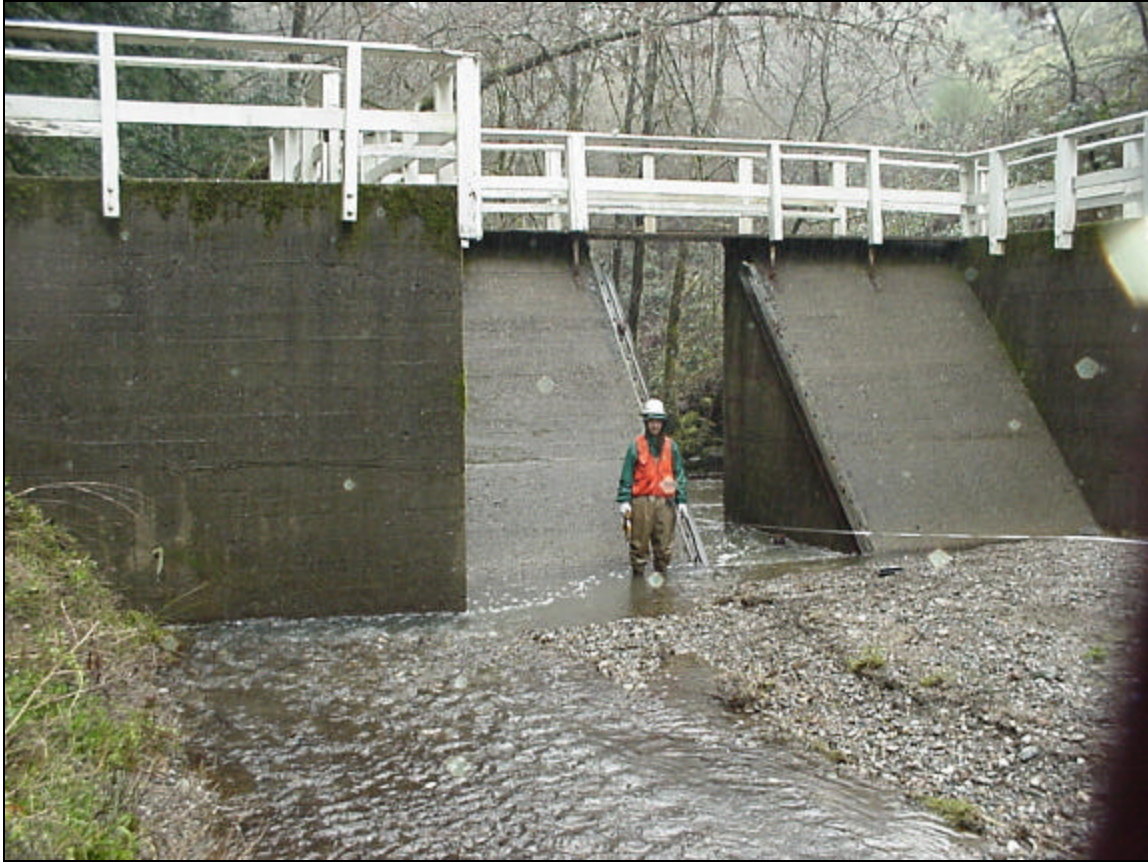
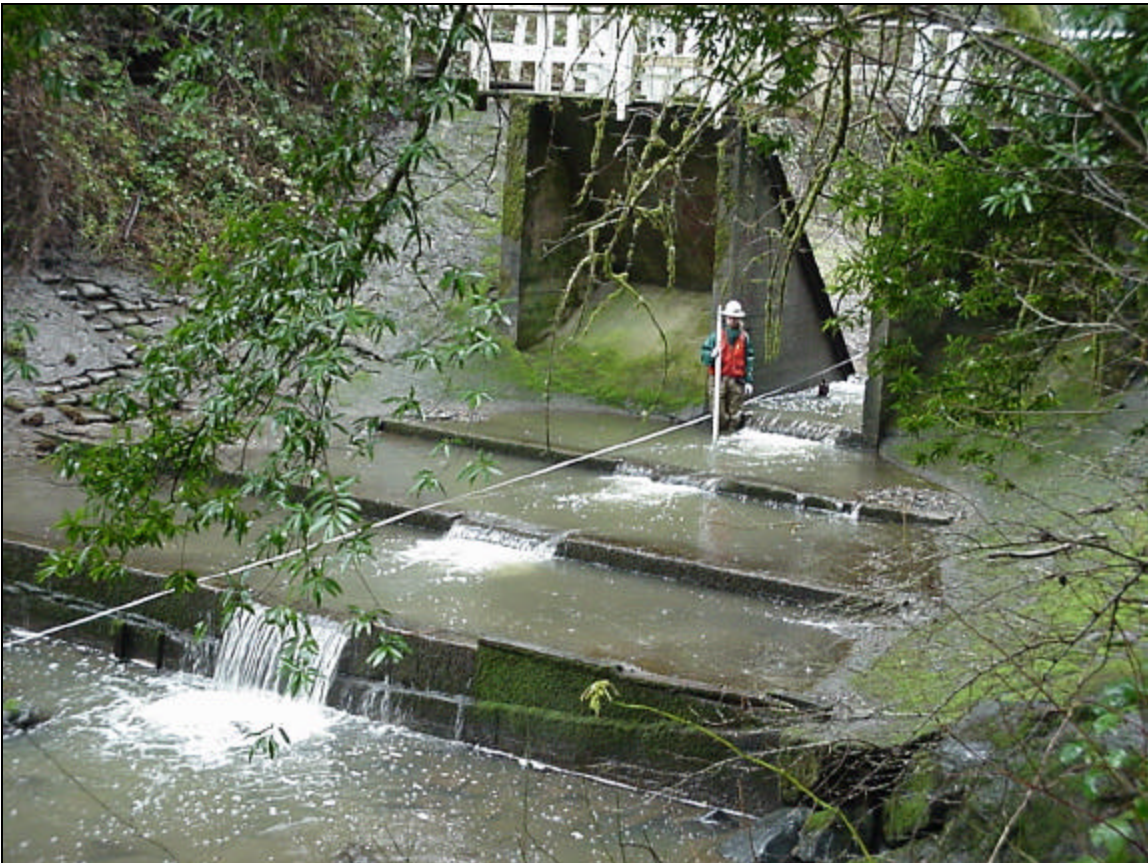
Site ID #S-008: Dutch Bill Creek #2/Footbridge over Dam; Russian River

Culvert Type: Splashboard Dam, Concrete. **Corrugations:** None. **Dimensions:** 11.8' height x 6.0' width
Length: 11.6' **Slope:** 3.71% **Modifications:** Four notched concrete weirs after outlet. **Rustline Height:** N/A
Average Active Channel Width: 25.8' **Fill Estimate:** 1,097 cubic yards. **Overall Condition:** Good.
Sizing: Undersized; HW/D = 1 on a storm flow with approximately a 10-year recurrence interval. The dam is overtopped on approximately an 18-year storm flow.

Barrier Status: **RED:** the Green-Gray-Red filter determined this crossing fails to meet passage criteria for all species of adult salmonids and all age classes of juveniles due to the perched outlet. It is probable that some adult steelhead and coho are able to negotiate the three-foot high leap over the lowermost weir.

Preferred Treatment: The interim treatment should be the construction of two more concrete weirs below the third existing weir so that all leaps are no more than one foot in height. County should consider removal of the dam as the best long-term solution to provide unimpeded fish passage. Consider treatment of Dutch Bill #1 prior to treating this splashboard dam.

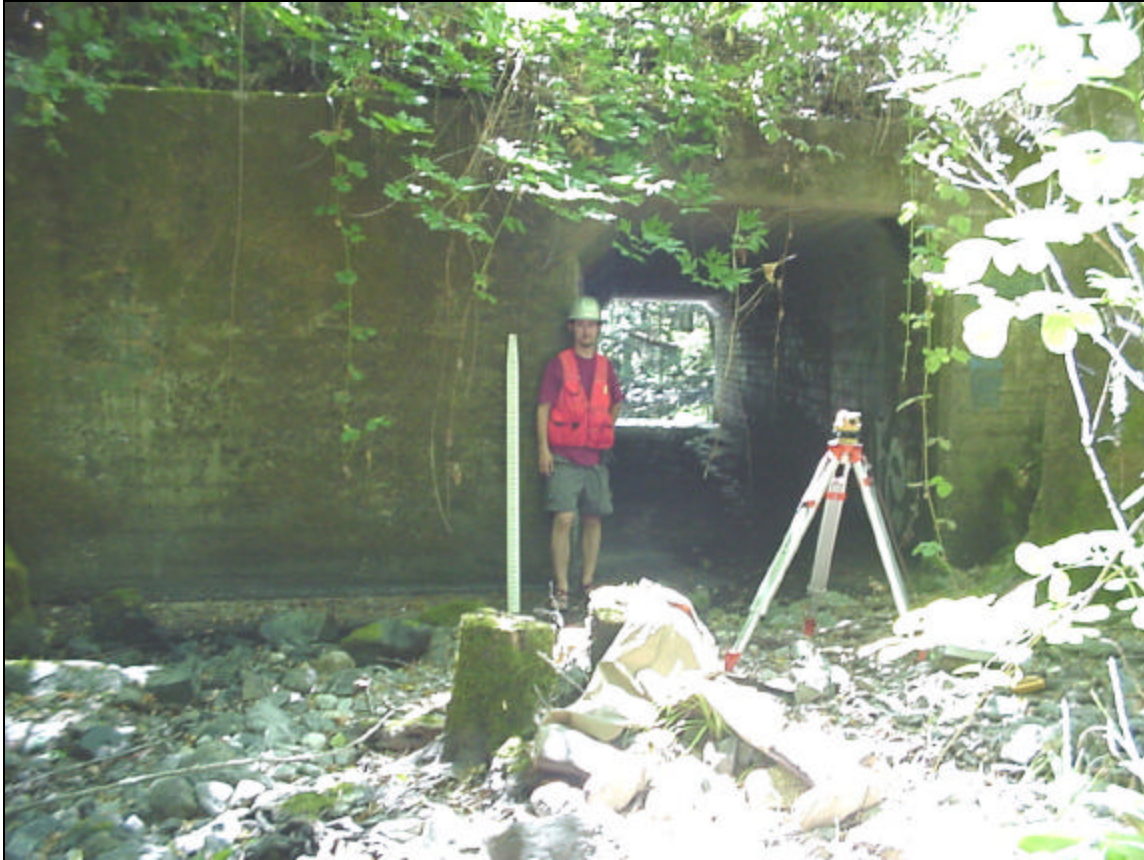
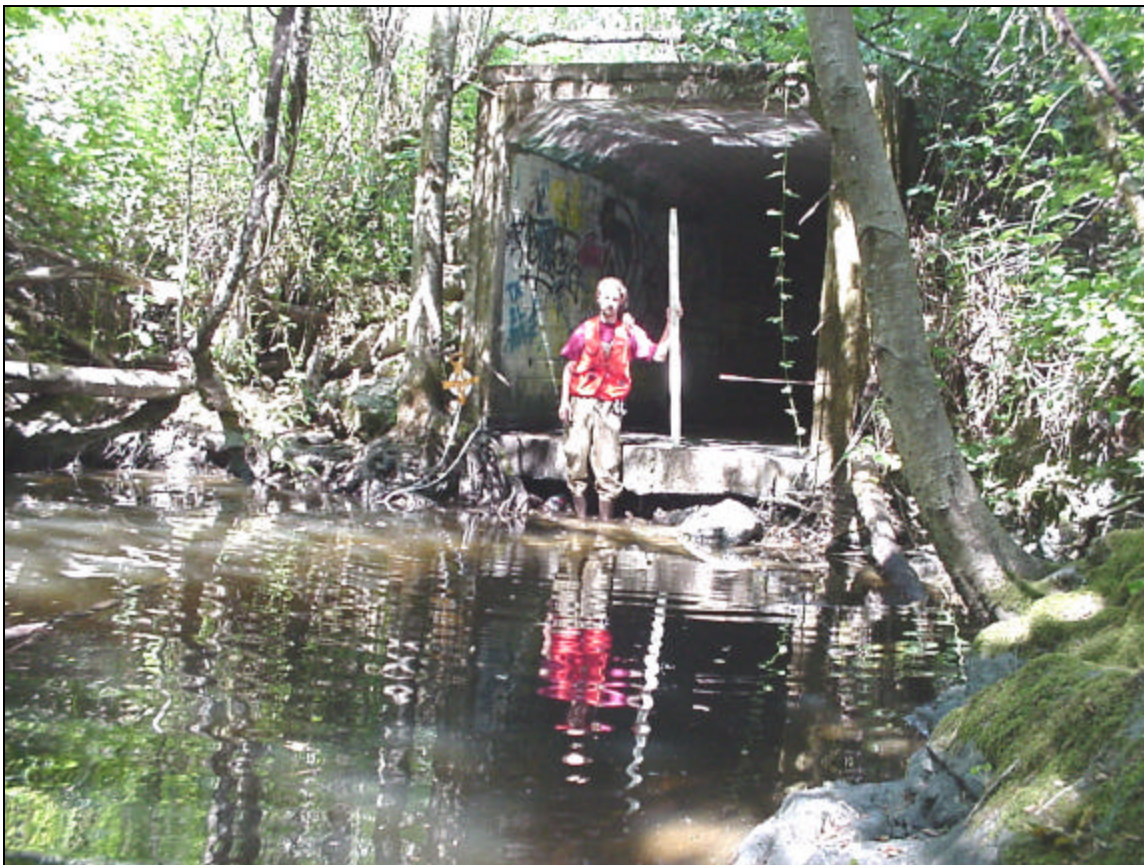
Site ID #S-009: Lancel Creek/Occidental Camp -Meeker Road; Dutch Bill Creek; Russian River **Road Ownership:** County

Culvert Type: Box, Concrete. **Corrugations:** None. **Dimensions:** 8.0' height x 8.0' width **Length:** 63.7' **Slope:** 1.84% **Modifications:** None. **Rustline Height:** N/A **Average Active Channel Width:** 12.8' **Fill Estimate:** 799 cubic yards. **Overall Condition:** Good. **Sizing:** Undersized; HW/D = 1 on a storm flow with approximately a 29-year recurrence interval. Occidental Camp -Meeker Road is overtopped on more than a 250-year storm flow.

Barrier Status: GRAY: FishXing determined this crossing meets the 8-16-16 ft/sec passage criteria for adult steelhead on 13% of the range of estimated migration flows and fails to meet passage criteria for all age classes of juveniles. For adults, lack-of-depth is the only violation of the passage criteria, whereas for all age classes of juveniles the primary violation of the criteria is excessive velocities.

Preferred Treatment: Consider the construction of two downstream boulder weirs to raise tail-water elevation. Corner baffles within the culvert would increase depths and decrease velocities, however consider the potential impacts of the reduction of storm flow conveyance through a moderately undersized culvert. Consider treatment of the two sites located downstream of Lancel Creek - Dutch Bill #1 and #2 prior to treating this site.
