CATALOG OF SONOMA COUNTY STREAM CROSSINGS WITH CULVERTS LOCATED ON FISH-BEARING STREAM REACHES WITHIN THE RUSSIAN RIVER BASIN

By
Ross Taylor and Associates

Site ID# S-001: Unnamed Tributary/Willow Creek Road; Willow Creek; Russian River **Road Ownership** County

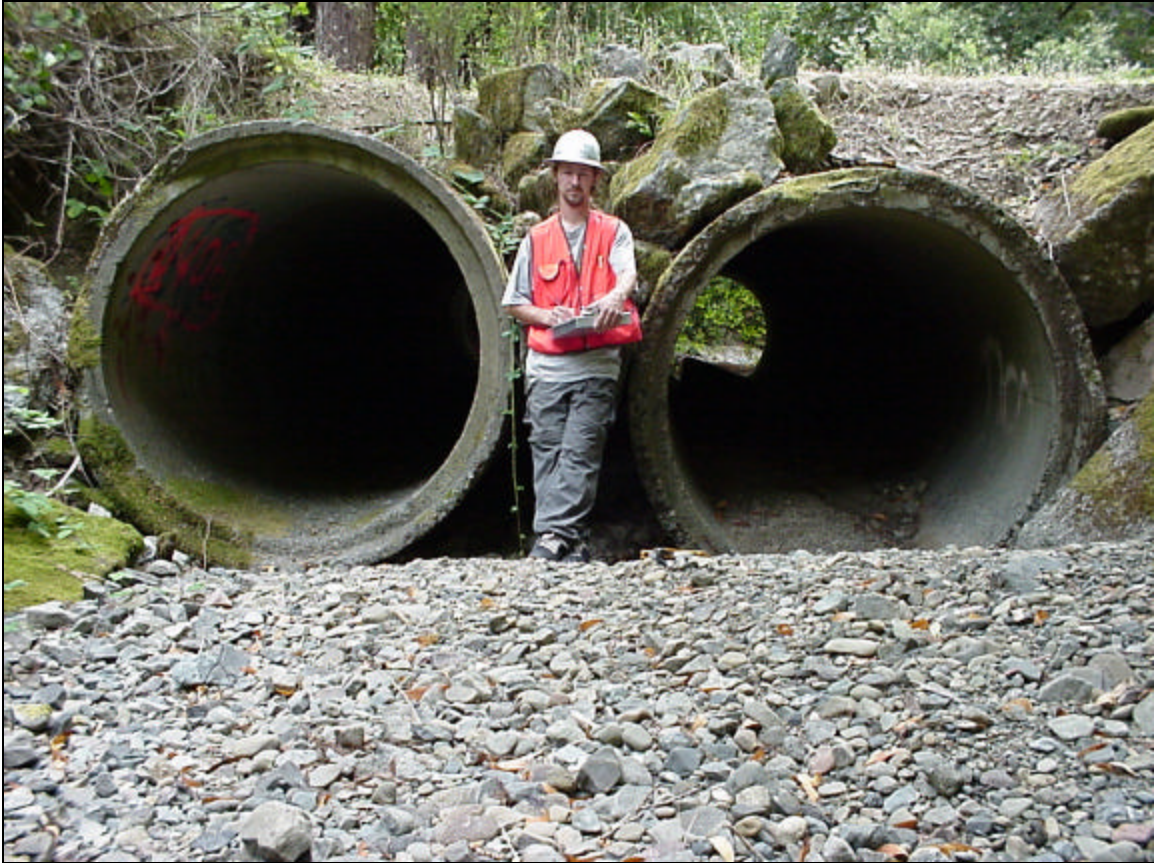
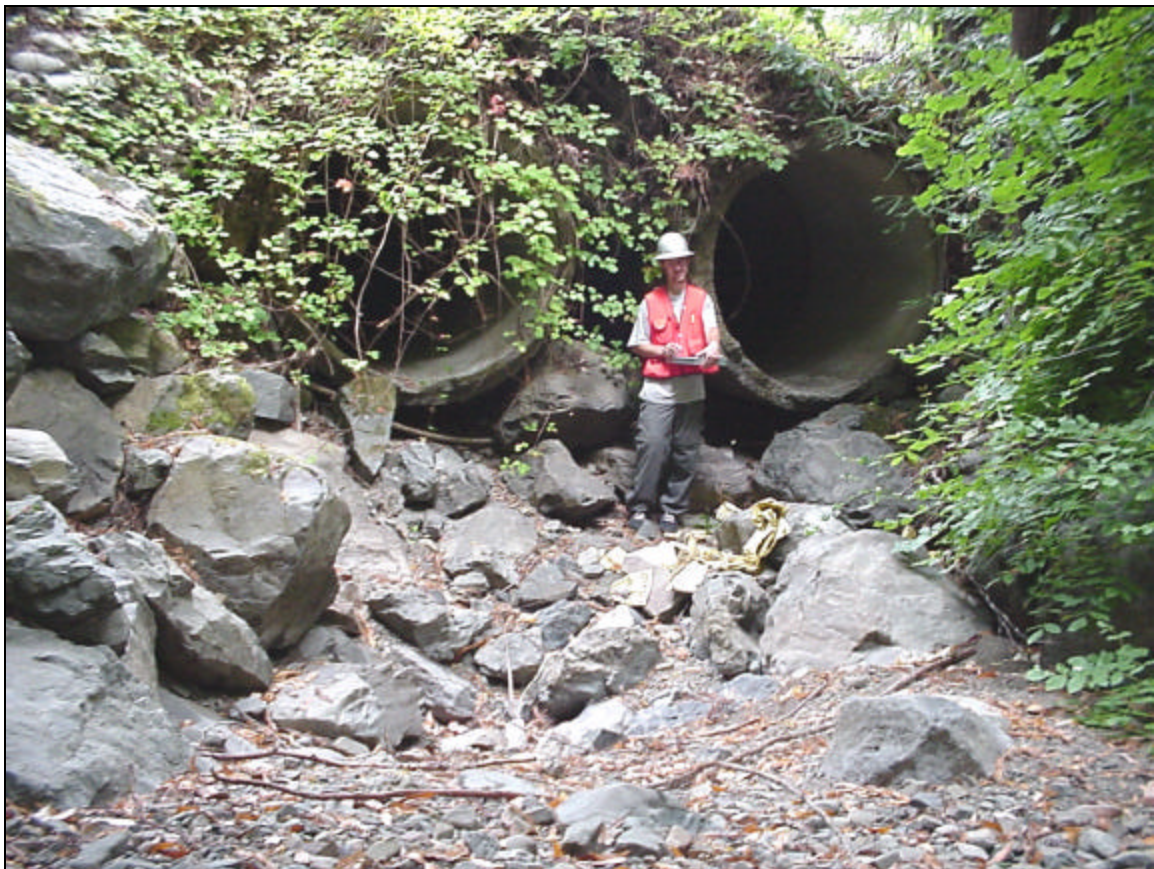
Site ID #S-010: Mission Creek #1/Camino Del Arroyo; Hubert Creek; Russian River **Road Ownership:** Private

Culvert Type: Circular, Concrete. **Corrugations:** None. **Dimensions:** diameter = 5.4' **Length:** 48.1' **Slope:** 1.60% **Modifications:** None. **Rustline Height:** N/A **Average Active Channel Width:** 11.0' **Fill Estimate:** 384 cubic yards. **Overall Condition:** Abraded.

Barrier Status: **GRAY:** FishXing determined this crossing meets the 8-16-16 ft/sec passage criteria for all species of adult salmonids on 42% of the range of estimated migration flows and fails to meet passage criteria for all age classes of juveniles. The main violation in passage criteria for all age classes of salmonids is excessive velocities.

Preferred Treatment: A full replacement with an open-bottom arch or a bridge is the only feasible option for improving fish passage at this site because the current crossing is extremely undersized. Due to the potential effects of headwall cutting when the new crossing is installed, the County should consider the use of grade control weirs to minimize the impacts of potentially rapid and severe downcutting of the upstream channel.

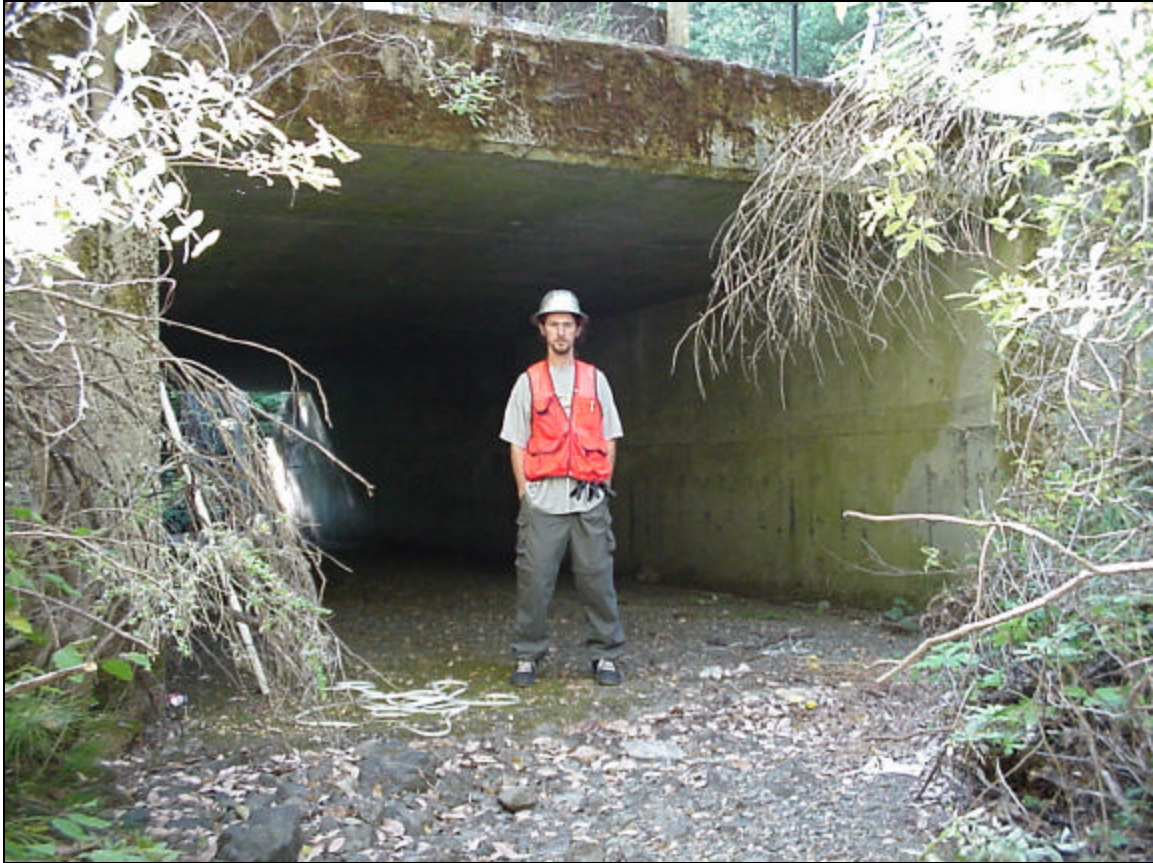
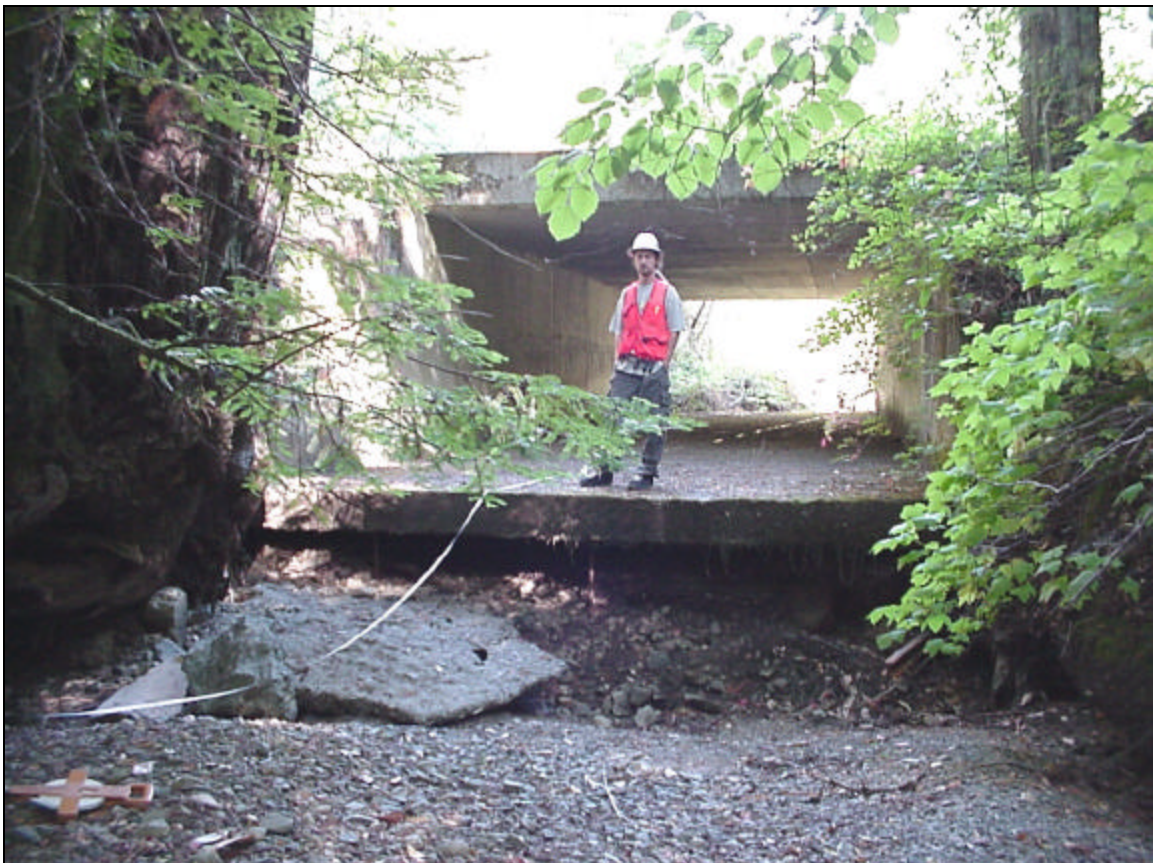
Site ID #S-011: Mission Creek #2/Old Cazadero Road; Hubert Creek; Russian River **Road Ownership:** County

Culvert Type: Box, Concrete. **Corrugations:** None. **Dimensions:** 8.0' height x 16.1' width **Length:** 66.9'
Slope: 1.27% **Modifications:** None. **Rustline Height:** N/A **Average Active Channel Width:** 9.3'
Fill Estimate: 311 cubic yards. **Overall Condition:** Good.

Barrier Status: **RED:** the Green-Gray-Red filter determined this crossing fails to meet passage criteria for all species of adult salmonids and all age classes of juveniles due to the extremely perched outlet. Although not evaluated with FishXing, if an adult salmonid were able to enter the culvert there would be impediments to migration caused by lack-of-depth and, depending on amount of flow, possibly excessive velocities too.

Preferred Treatment: Because the current box culvert is sized for more than a 250-year discharge, the construction of three or four downstream boulder weirs to raise tail-water elevation is a feasible treatment option. Corner baffles or sloped, v-notched concrete weirs within the culvert would also increase depths and decrease velocities. Treatment of Site ID #S-010 should occur prior to treating this site.

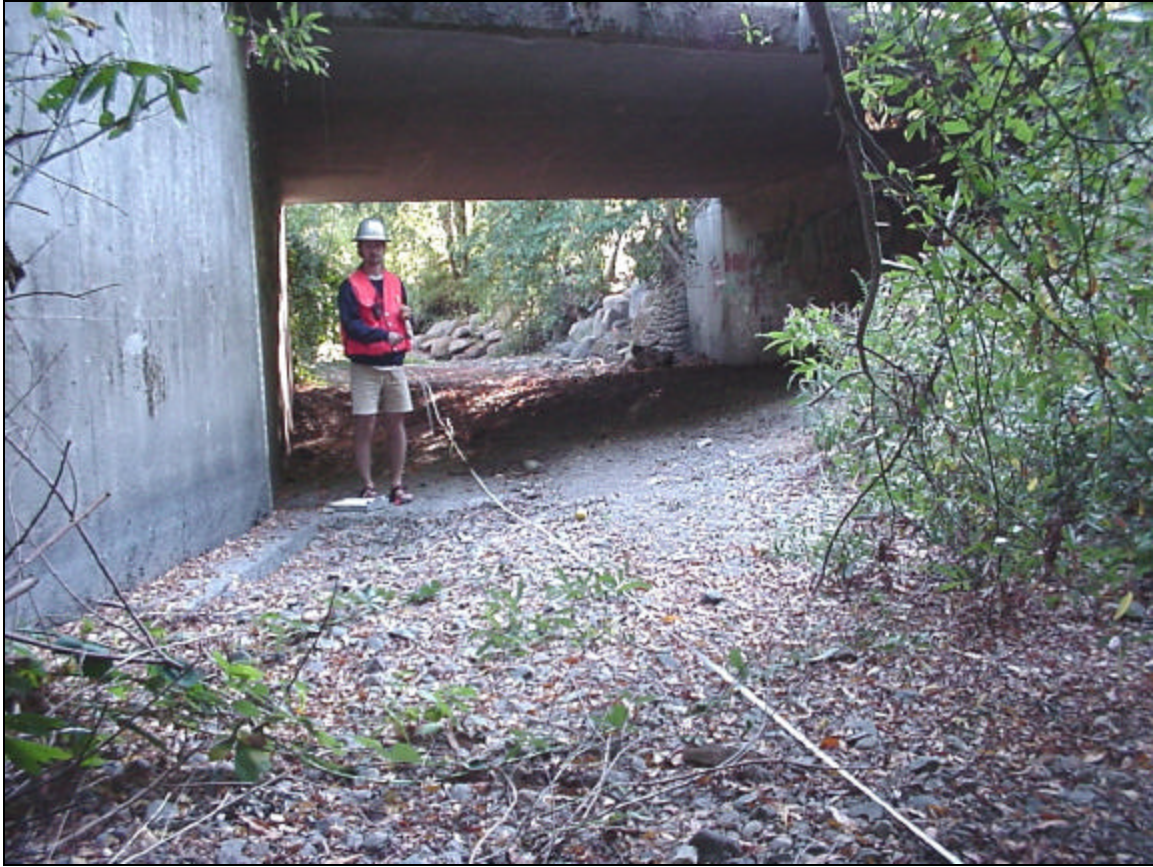
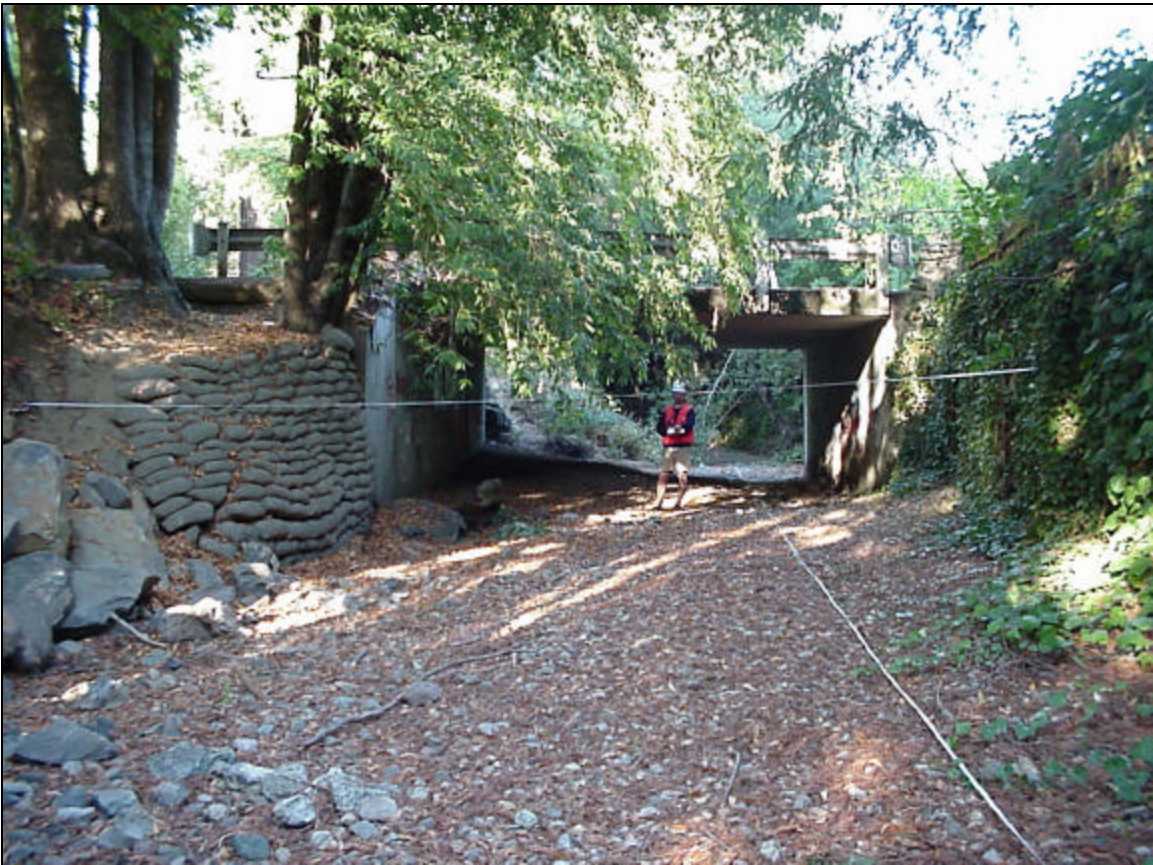
Site ID #S-012: Fife Creek/Watson Road; Russian River **Road Ownership:** County

Culvert Type: Box, Concrete. **Corrugations:** None. **Dimensions:** 10.0' height x 23.6' width **Length:** 36.3'
Slope: -1.57% **Modifications:** None. **Rustline Height:** N/A **Average Active Channel Width:** 20.4
Fill Estimate: 221 cubic yards. **Overall Condition:** Good.

Preferred Treatment: No treatment is required because the current box culvert provides unimpeded passage, is in good condition, and is properly sized. Recommend periodic inspection for condition and maintenance.

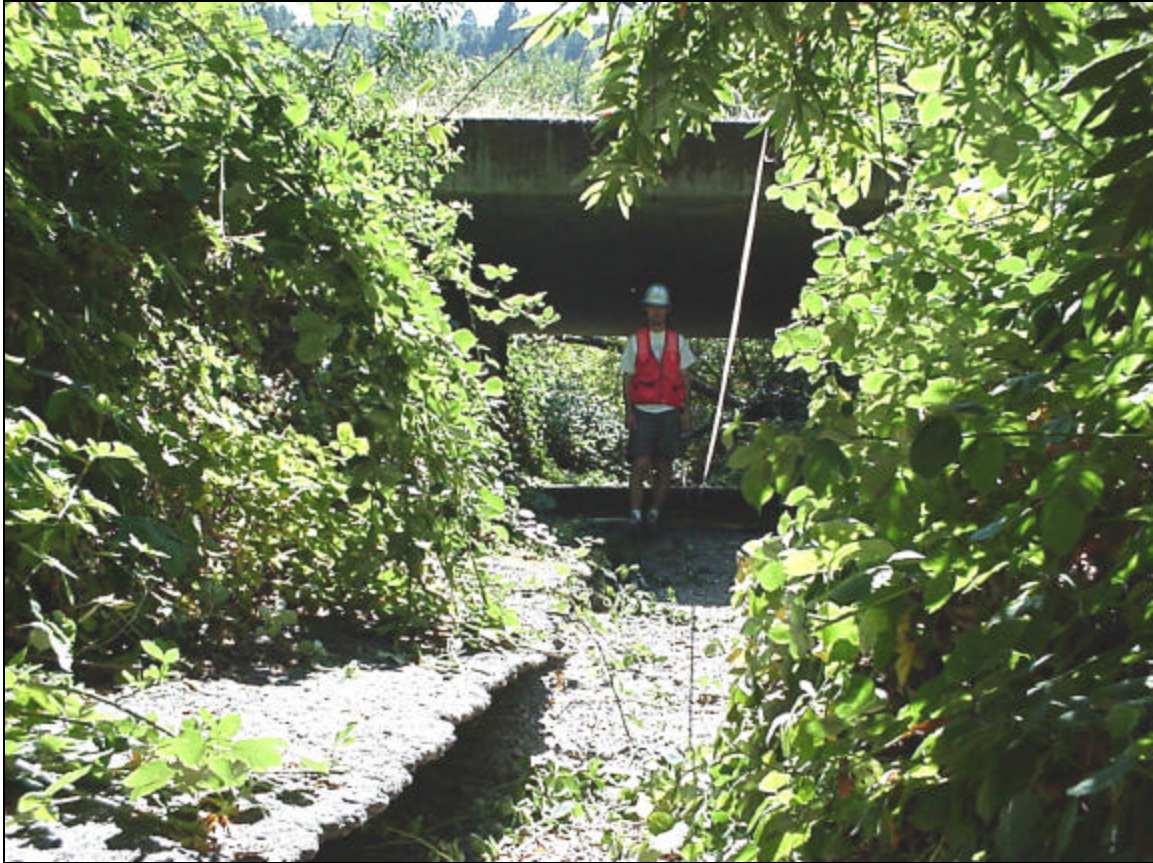
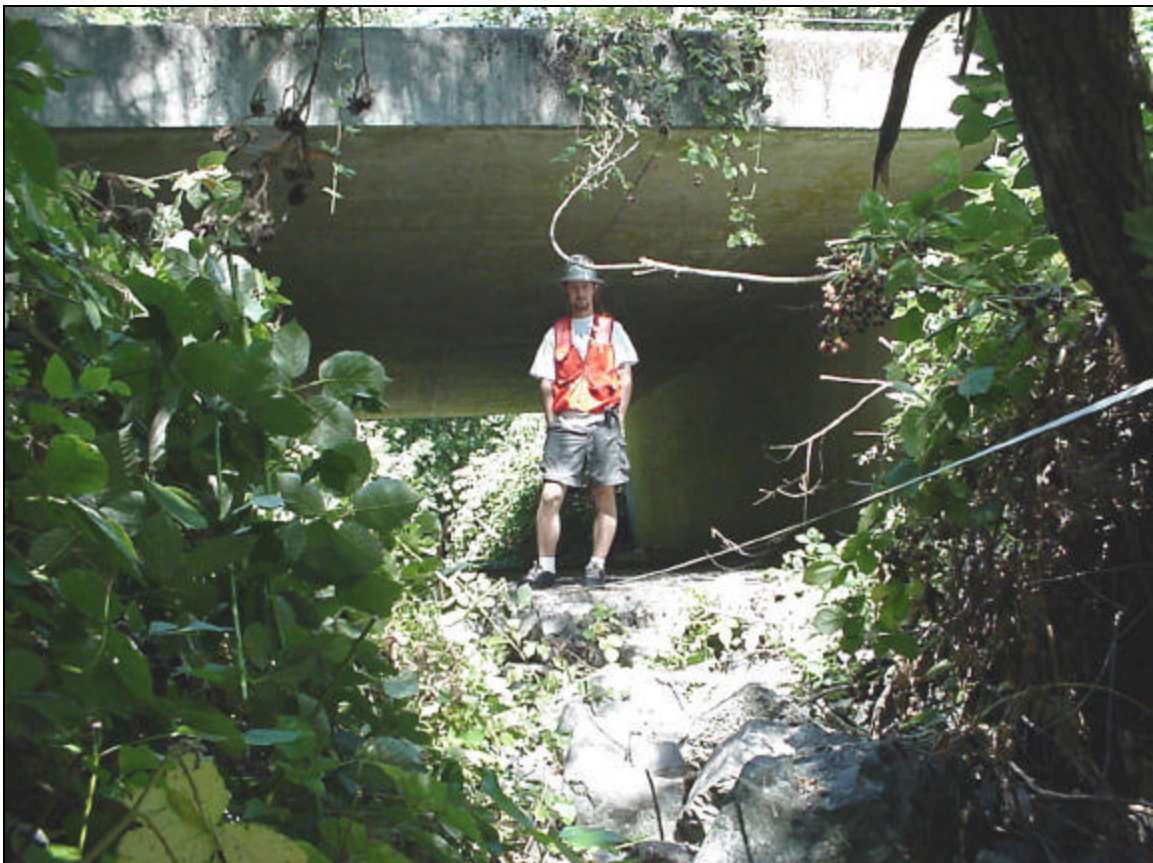
Site ID #S-013: Redwood Creek/Armstrong Woods Road; Fife Creek; Russian River **Road Ownership:** County

Culvert Type: Box, Concrete. **Corrugations:** None. **Dimensions:** 8.0' height x 24.0' width **Length:** 45.9'
Slope: 0.41% **Modifications:** None. **Rustline Height:** N/A **Average Active Channel Width:** 13.5'
Fill Estimate: 437 cubic yards. **Overall Condition:** Good. **Sizing:** Properly sized; HW/D = 1 on a storm flow with more than a 250-year recurrence interval. Armstrong Woods Road is overtopped with more than a 250-year storm flow.

Barrier Status: **RED:** the Green-Gray-Red filter determined this crossing fails to meet passage criteria for all species of adult salmonids and all age classes of juveniles due to the perched outlet and the riprap placed below the outlet. Although not evaluated with FishXing, if an adult salmonid were able to enter the culvert there would be impediments to migration caused by lack-of-depth and, depending on amount of flow, possibly excessive velocities too.

Preferred Treatment: Because the current box culvert is sized for more than a 250-year discharge, the construction of three or four downstream boulder weirs to raise tail-water elevation is a feasible treatment option. Corner baffles or sloped, v-notched concrete weirs within the culvert would also increase depths and decrease velocities.

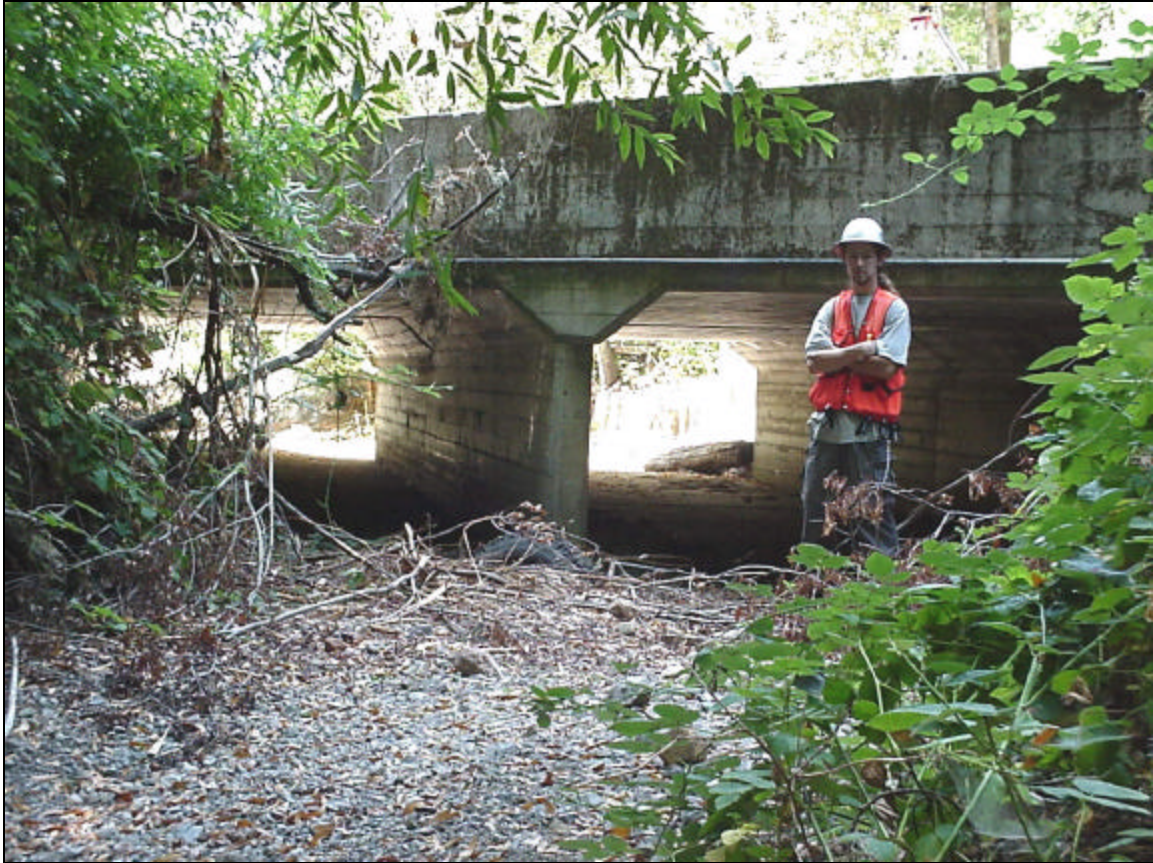
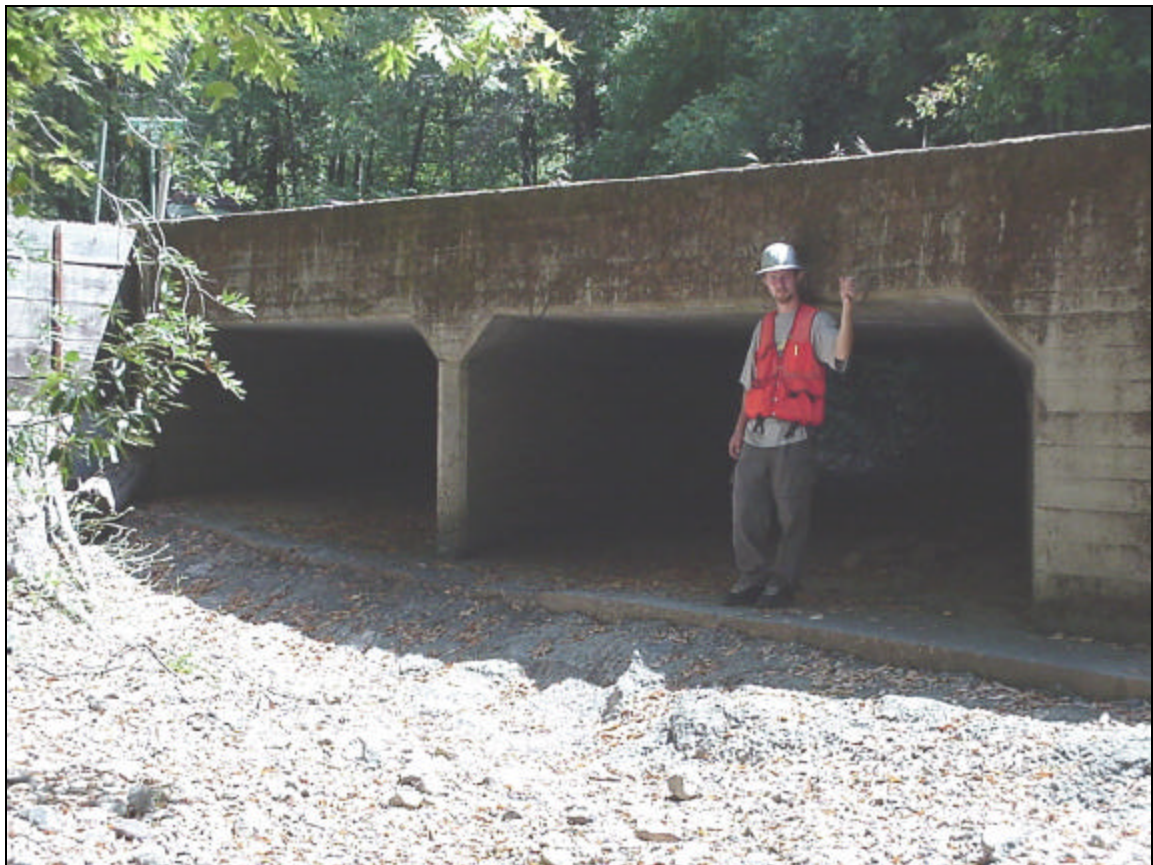
Site ID #S-014: Sweetwater Creek/Sweetwater Springs Road; Redwood Ck; Fife Creek; Russian River
Road Ownership: County

Culvert Type: Two Bay Box, Concrete. **Corrugations:** None. **Dimensions:** 5.2' height x 36.5' width
Length: 59.0' **Slope:** -0.19% **Modifications:** None. **Rustline Height:** N/A **Average Active Channel Width:** 10.5'
Fill Estimate: 89 cubic yards. **Overall Condition:** Good. **Sizing:** Properly sized; HW/D = 1 on a storm flow with more than a 250-year recurrence interval. Sweetwater Springs Road is overtopped on more than a 250-year storm flow.

Preferred Treatment: Because the current box culvert is sized for more than a 250-year discharge, the construction of three or four downstream boulder weirs to raise tail-water elevation is a feasible treatment option. Corner baffles or sloped, v-notched concrete weirs within the culvert would also increase depths and decrease velocities. A thorough assessment of the three private crossings on Sweetwater Creek is recommended prior to treating Site ID #S-014.

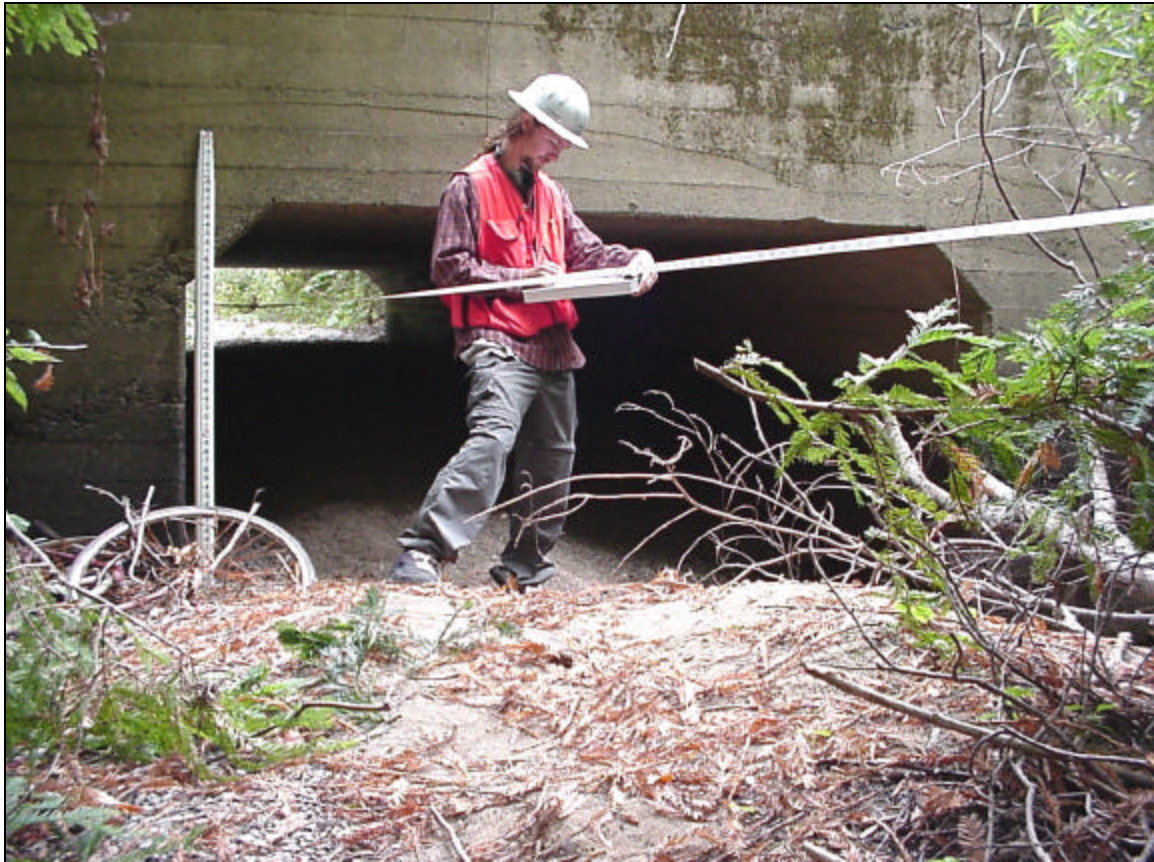
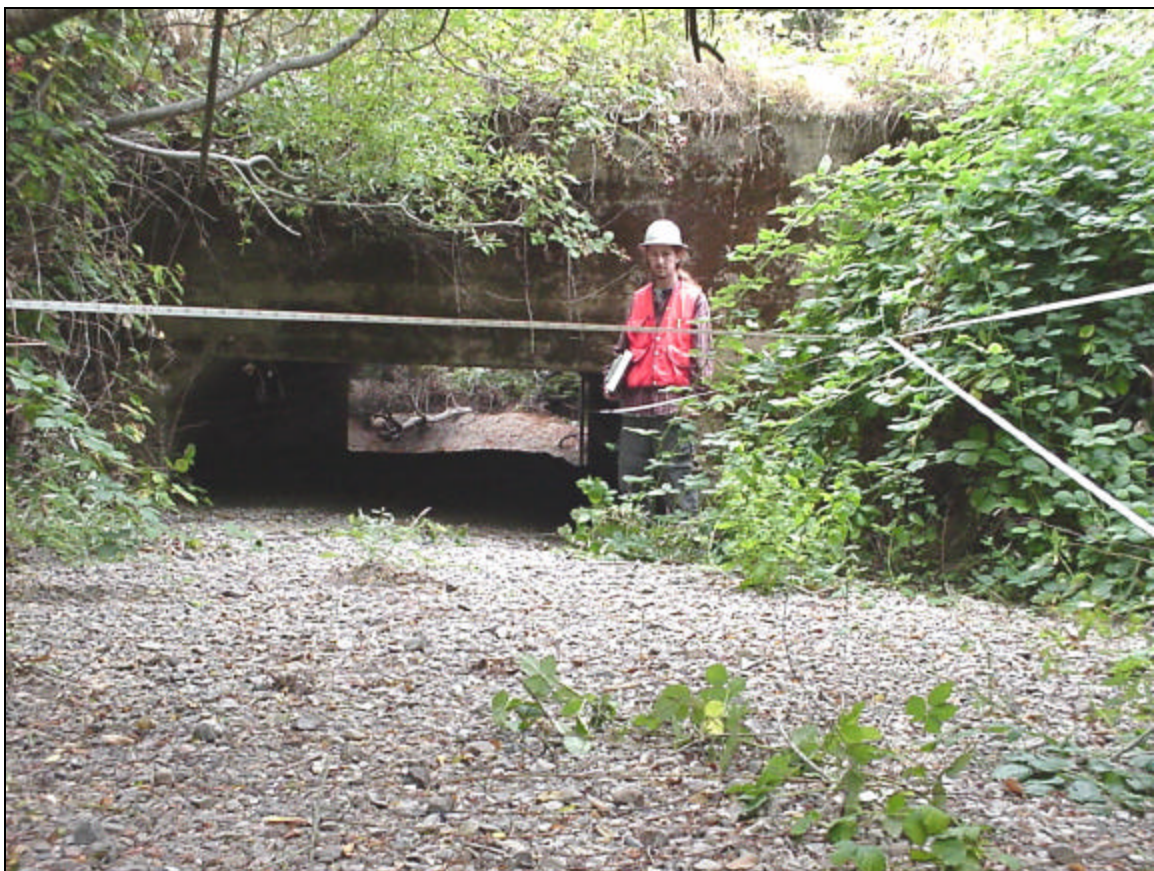
Site ID #S-017: Korbel Tributary/River Road; Russian River

Culvert Type: Box, Concrete. **Corrugations:** None. **Dimensions:** 9.35' height x 14.05' width **Length:** 49.2'
Slope: -0.28% **Modifications:** None. **Rustline Height:** N/A **Average Active Channel Width:** 6.4'
Fill Estimate: 149 cubic yards. **Overall Condition:** Good.

Barrier Status: **GRAY:** FishXing determined this crossing meets the 8-16-16 ft/sec passage criteria for adult steelhead on 79% of the range of estimated migration flows, meets passage criteria for resident/2+ age classes on 61% of the range of estimated migration flows, and meets criteria for 1+/young-of-year juvenile salmonids on 86% of the estimated migration flows. At some flows there is a lack-of-depth violation for adults and older juveniles.

Habitat: Quantity = approximately 9,350' of potential fish-bearing habitat upstream of Site ID# S-017. Quality = rated as “fair” for the ranking matrix by CDFG’s professional judgment (Coey, pers. comm.). The crossing was surveyed by Taylor and Assoc. on 8/14/01 and there was continuous flow in the channel. At 9:00AM the air temp = 13°C and the water temp = 14°C. The culvert survey crew described the habitat as “fair” and noted a sparse riparian canopy of hardwoods and a highly aggraded channel surrounded by vineyards. The culvert survey crew also noted that the winery was using the creek bed and culvert as a wet ford – that is, they were driving through the culvert (note truck tracks in inlet photo).

Preferred Treatment: None recommended because current box culvert provides adequate passage, is in good condition, and is properly sized.

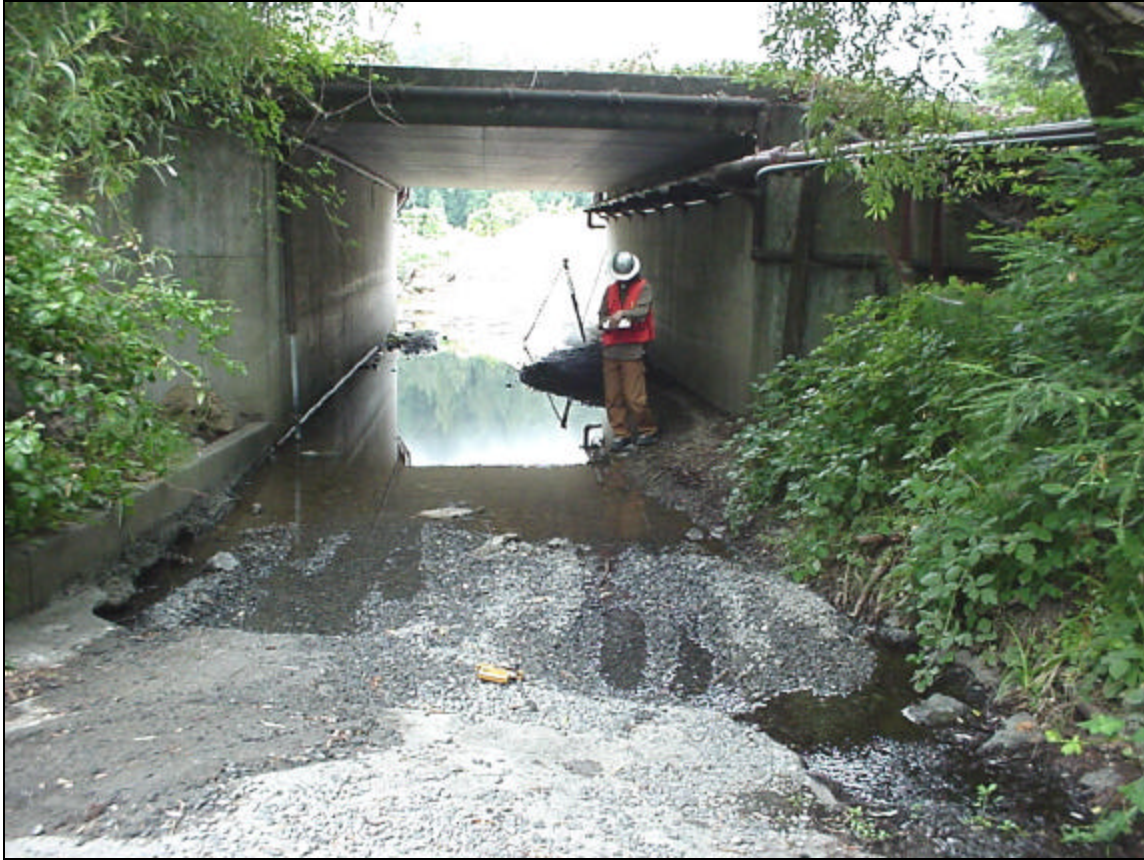
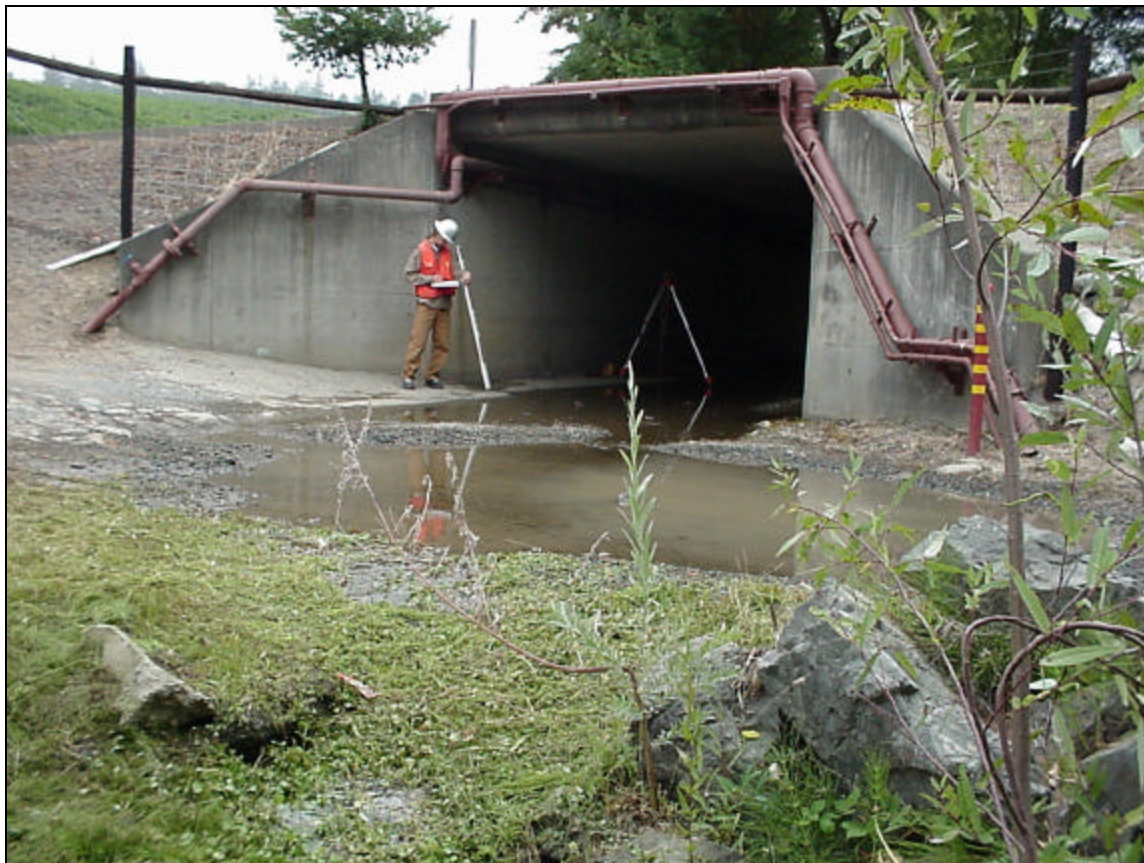
Site ID #S-018: Hobson Creek/Westside Road; Russian River

Culvert Type: Box, Concrete. **Corrugations:** None. **Dimensions:** 11.5' height x 12.0' width **Length:** 53.0'
Slope: 0.60% **Modifications:** None. **Rustline Height:** N/A **Average Active Channel Width:** 13.1'
Fill Estimate: 1,724 cubic yards. **Overall Condition:** Good.

Barrier Status: **GRAY:** FishXing determined this crossing meets the 8-16-16 ft/sec passage criteria for adult steelhead on 67% of the range of estimated migration flows and fails to meet passage criteria all age classes of juvenile salmonids. Actual adult passage may be higher than the FishXing estimate because the only violation of the criteria is lack-of-depth. However, for all juvenile age classes the primary violation of the passage criteria is excessive velocities.

Habitat: Quantity = approximately 10,750' of potential fish-bearing habitat upstream of Site ID# S-018. Quality = rated as “fair” for the ranking matrix by CDFG’s professional judgment (Coe, pers. comm.). The crossing was surveyed by Taylor and Assoc. on 10/10/01 and the channel was dry. The culvert survey crew described the habitat as “pretty good” and noted a moderately dense riparian canopy of hardwoods and redwoods.

Preferred Treatment: None recommended because current box culvert provides adequate adult passage, is in good condition, and is properly sized. One or two downstream boulder weirs and corner baffles within the culvert would cost-effectively improve passage conditions for juveniles if CDFG deemed this a vital concern.

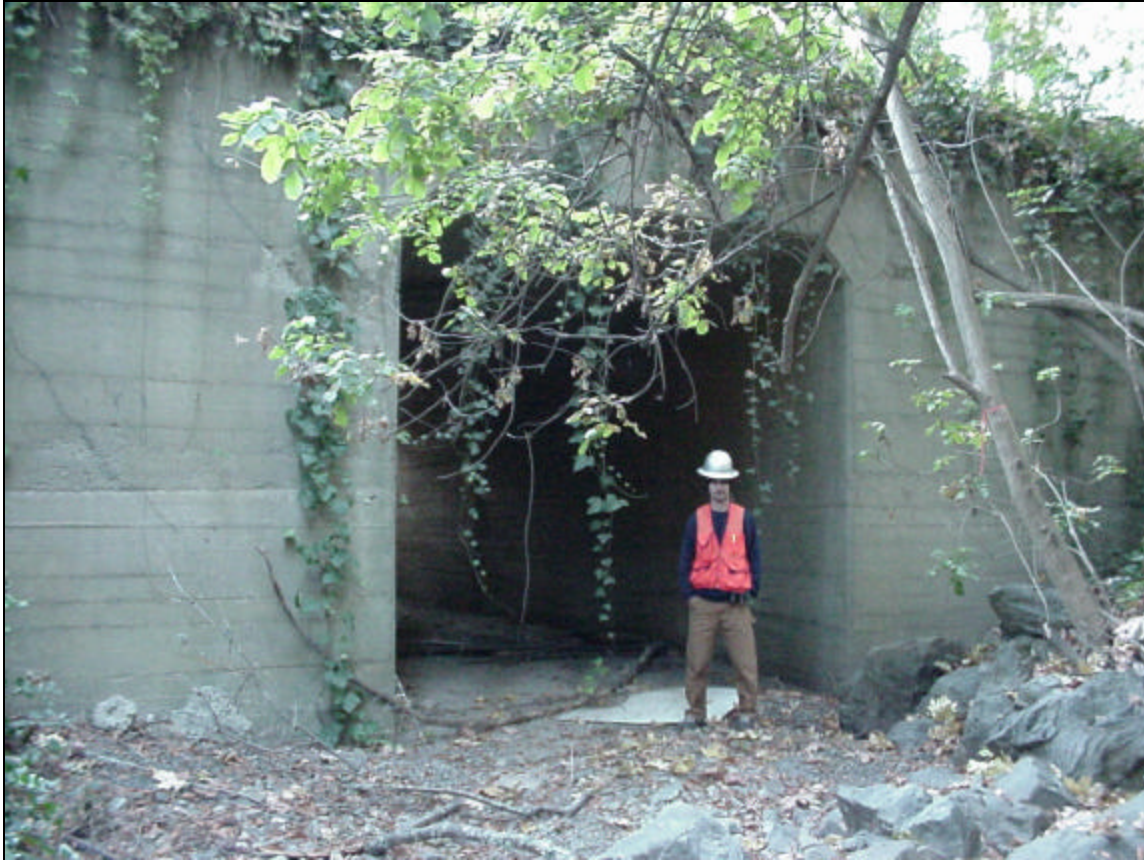
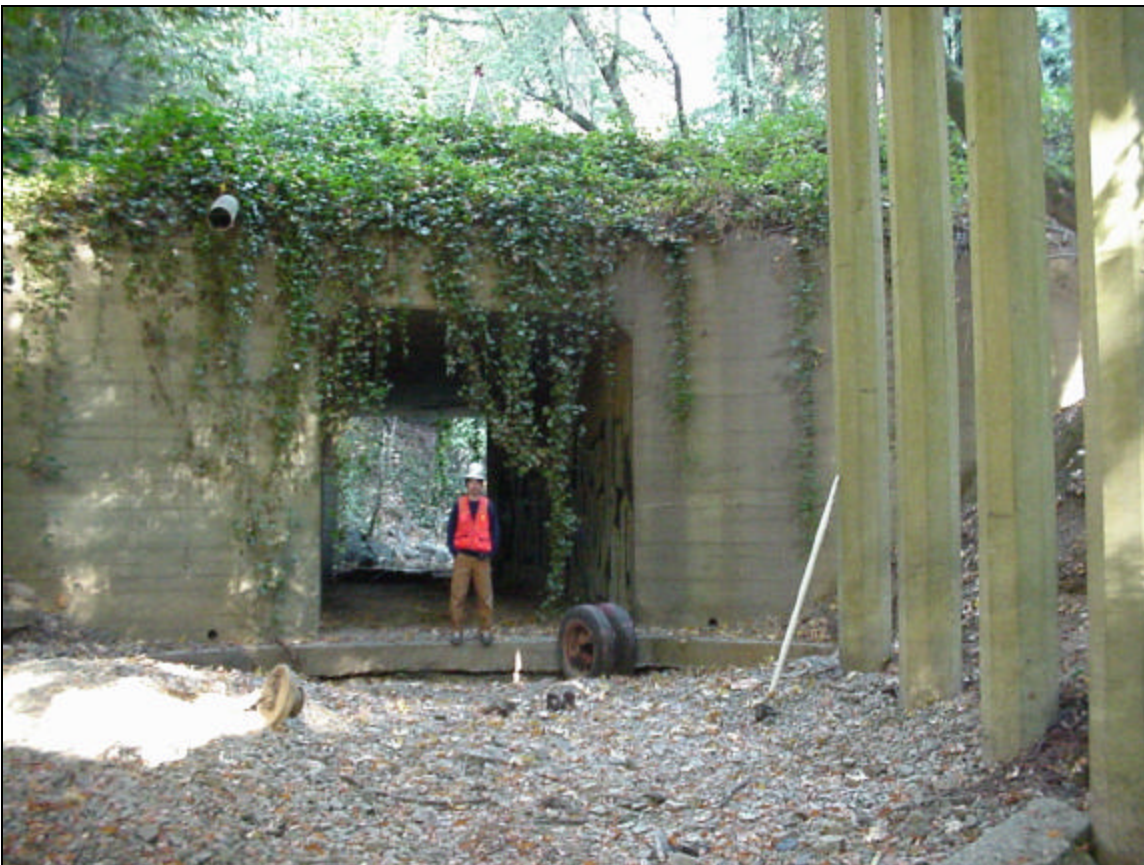
Site ID #S-019: Jonive Creek #1/Bodega Highway; Atascadero Creek; Green Valley Creek; Russian River

Culvert Type: Box, Concrete. **Corrugations:** None. **Dimensions:** 11.0' height x 23.9' width **Length:** 34.5' **Slope:** -0.46% **Modifications:** None. **Rustline Height:** N/A **Average Active Channel Width:** 9.2' **Fill Estimate:** 160 cubic yards. **Overall Condition:** Abraded. **Sizing:** Properly sized; HW/D = 1 on a storm flow with more than a 250-year recurrence interval. Bodega Highway is overtopped on more than a 250-year storm flow.

Habitat: Quantity = approximately 28,850' of potential fish-bearing habitat upstream of Site ID# S-019. Quality = rated as "fair" for the ranking matrix by CDFG's professional judgment (Coey, pers. comm.). The crossing was surveyed by Taylor and Assoc. on 9/24/01 and there was continuous flow in the channel. At 1:45PM the air temp = 20°C and the water temp = 13°C. The culvert survey crew described the habitat as "good" and noted a moderately dense riparian canopy of hardwoods and redwoods. Two young-of-year salmonids were observed in a pool upstream of Site ID #S-019.

Preferred Treatment: None recommended because current boxculvert provides adequate passage, is in good condition, and is properly sized.

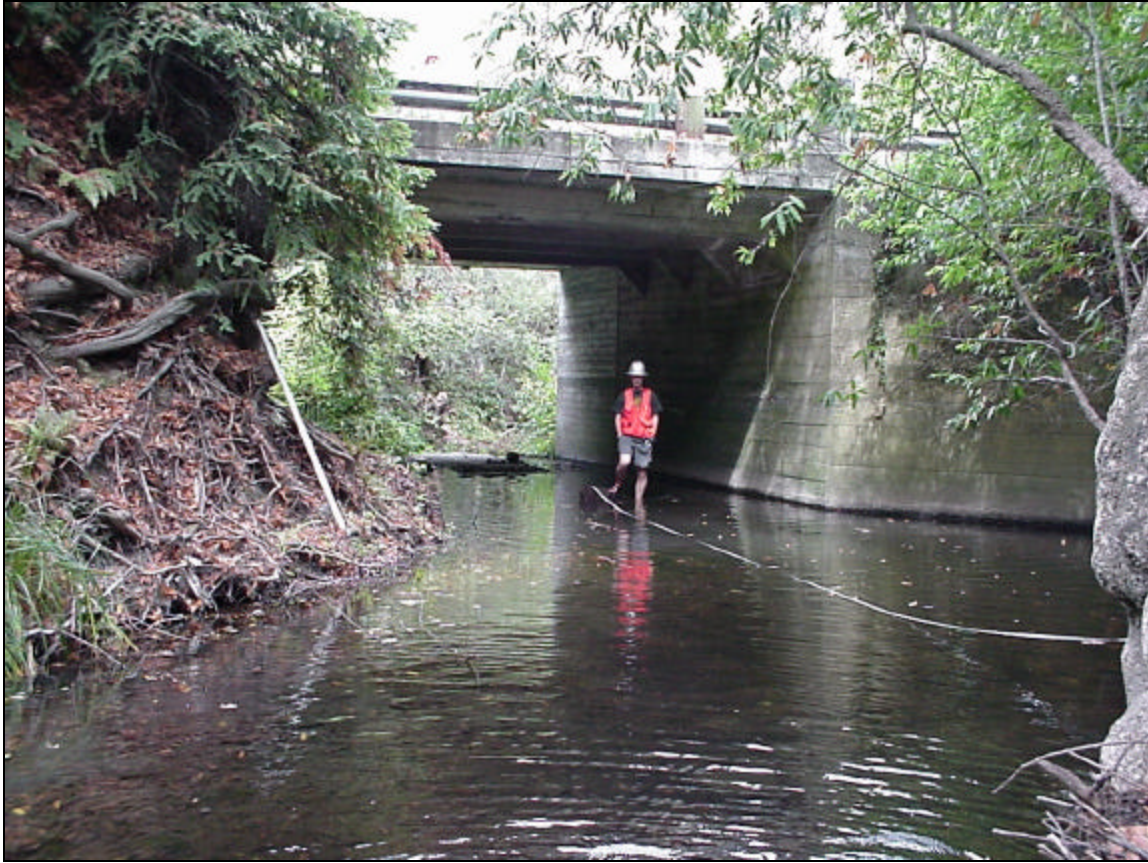
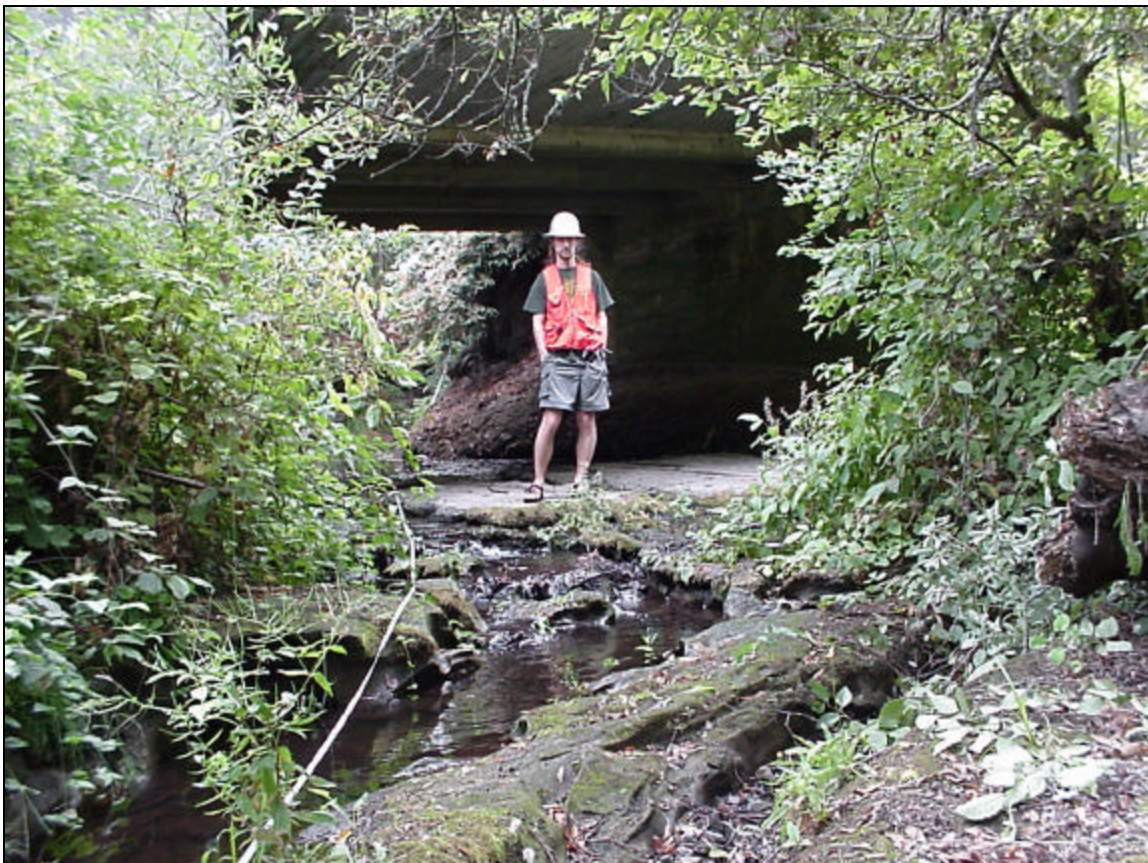
Site ID #S-020: Jonive Creek #2/Bodega Highway; Atascadero Creek; Green Valley Creek; Russian River

Culvert Type: Box, Concrete. **Corrugations:** None. **Dimensions:** 10.6' height x 24.0' width **Length:** 35.9' **Slope:** -0.81% **Modifications:** None. **Rustline Height:** N/A **Average Active Channel Width:** 15.7' **Fill Estimate:** 481 cubic yards. **Overall Condition:** Good. **Sizing:** Properly sized; HW/D = 1 on a storm flow with more than a 250-year recurrence interval. Bodega Highway is overtopped on more than a 250-year storm flow.

Habitat: Quantity = approximately 16,000' of potential fish-bearing habitat upstream of Site ID# S-020. Quality = rated as “fair” for the ranking matrix by CDFG’s professional judgment (Coey, pers. comm.). The crossing was surveyed by Taylor and Assoc. on 9/24/01 and there was continuous flow in the channel. At 4:00PM the air temp = 14°C and the water temp = 13°C. The culvert survey crew described the habitat as “good” and noted several deep pools near the crossing and a moderately dense riparian canopy of mostly hardwoods. No fish were observed.

Preferred Treatment: None recommended because current box culvert provides unimpeded passage, is in good condition, and is properly sized.
