CATALOG OF SONOMA COUNTY STREAM CROSSINGS WITH CULVERTS LOCATED ON FISH-BEARING STREAM REACHES WITHIN THE RUSSIAN RIVER BASIN

By
Ross Taylor and Associates

Site ID# S-001: Unnamed Tributary/Willow Creek Road; Willow Creek; Russian River **Road Ownership** County

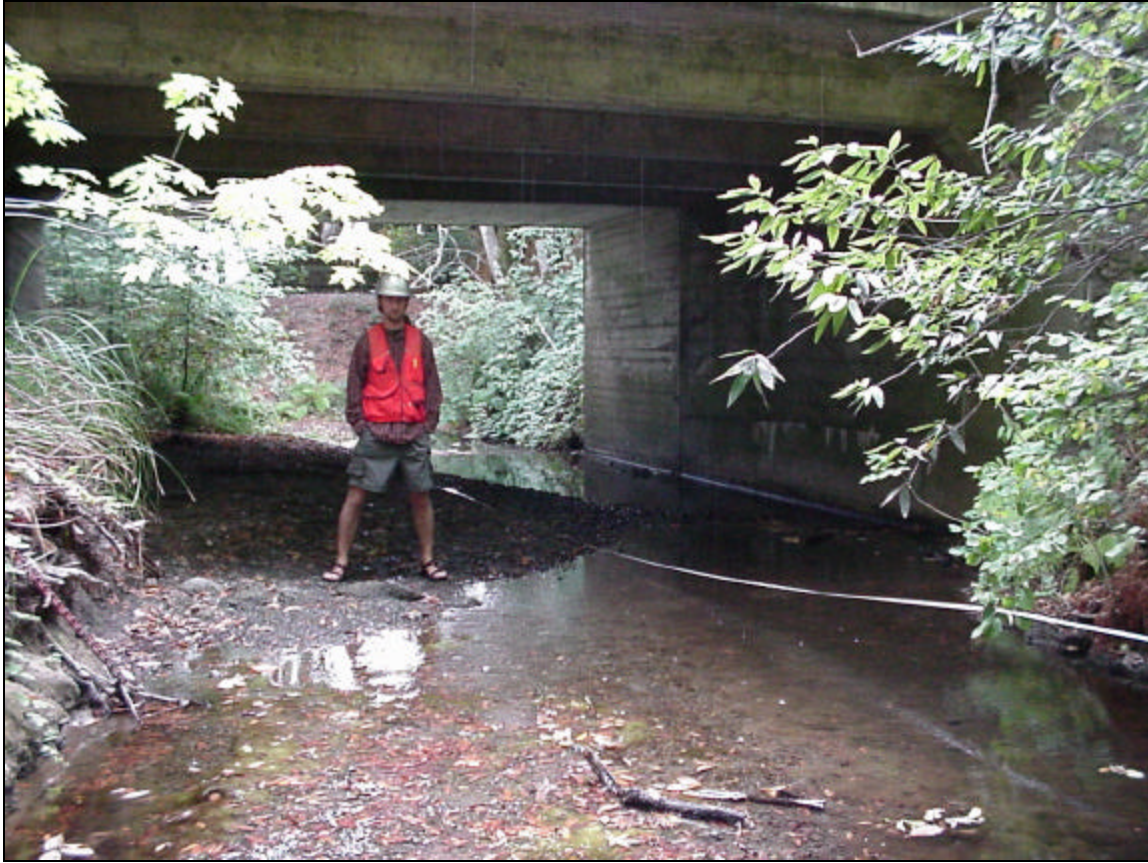
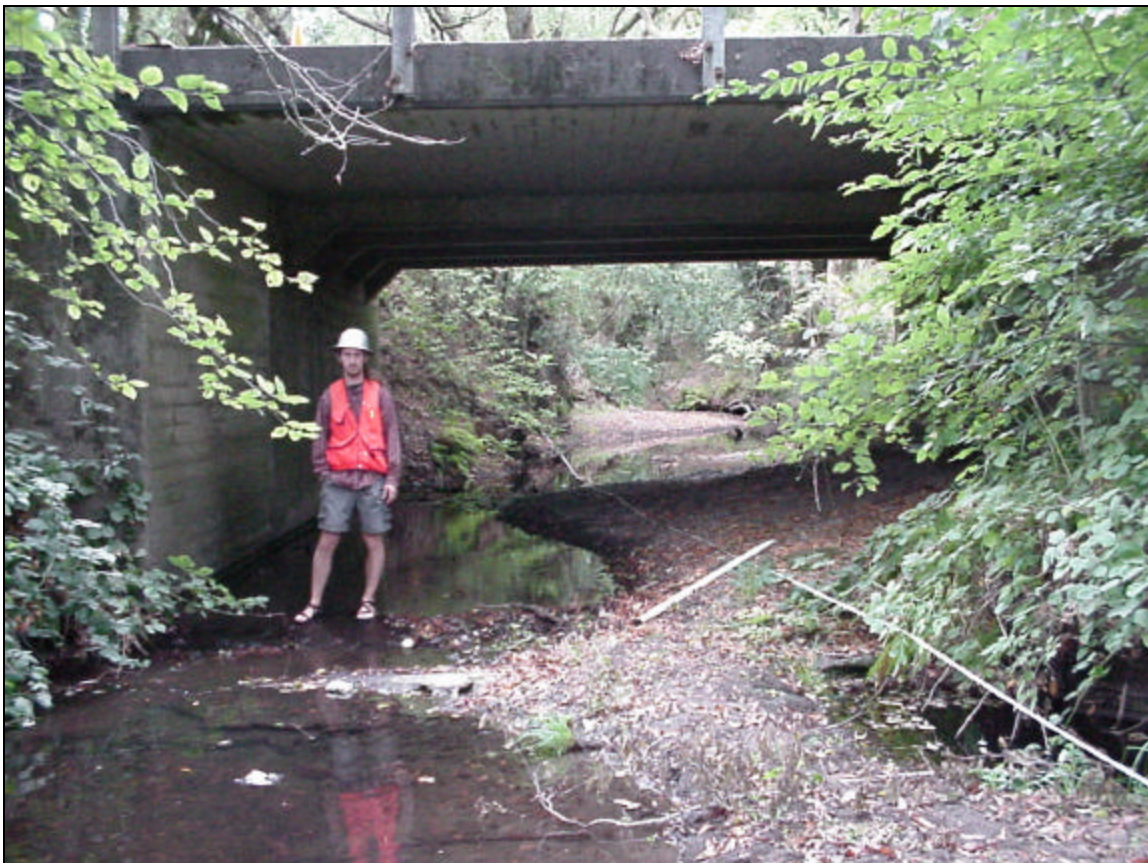
Site ID #S-021: Jonive Creek #3/Furlong Road; Atascadero Creek; Green Valley Creek; Russian River

Culvert Type: Box, Concrete. **Corrugations:** None. **Dimensions:** 9.2' height x 12.0' width **Length:** 27.8' **Slope:** 0.65% **Modifications:** None. **Rustline Height:** N/A **Average Active Channel Width:** 12.3' **Fill Estimate:** 167 cubic yards. **Overall Condition:** Good. **Sizing:** Properly sized; HW/D = 1 on a storm flow with more than a 250-year recurrence interval. Furlong Road is overtopped on more than a 250-year storm flow.

Barrier Status: **GRAY:** FishXing determined this crossing meets the 8-16-16 ft/sec passage criteria for adult steelhead on 74% of the range of estimated migration flows and fails to meet passage criteria all age classes of juvenile salmonids. Actual adult passage may be higher than the FishXing estimate because the only violation of the criteria is lack-of-depth. For all juveniles the primary violation of the criteria is the excessive drop at the outlet.

Habitat: Quantity = approximately 14,750' of potential fish-bearing habitat upstream of Site ID# S-021. Quality = rated as "fair" for the ranking matrix by CDFG's professional judgment (Coey, pers. comm.). The crossing was surveyed by Taylor and Assoc. on 8/15/01 and there was continuous flow in the channel. At 9:30AM the air temp = 13°C and the water temp = 12°C. The culvert survey crew described the habitat as "good" and noted several deep pools near the crossing and a moderately dense riparian canopy of mostly hardwoods and some conifers. Between 10 to 20 young-of-year and 1+ salmonids were observed both upstream and downstream of Site ID #S-021.

Preferred Treatment: None recommended because current box culvert provides adequate adult passage, is in good condition, and is properly sized. One or two downstream boulder weirs and corner baffles within the culvert would cost-effectively improve passage conditions for juveniles if CDFG deemed this a vital concern.

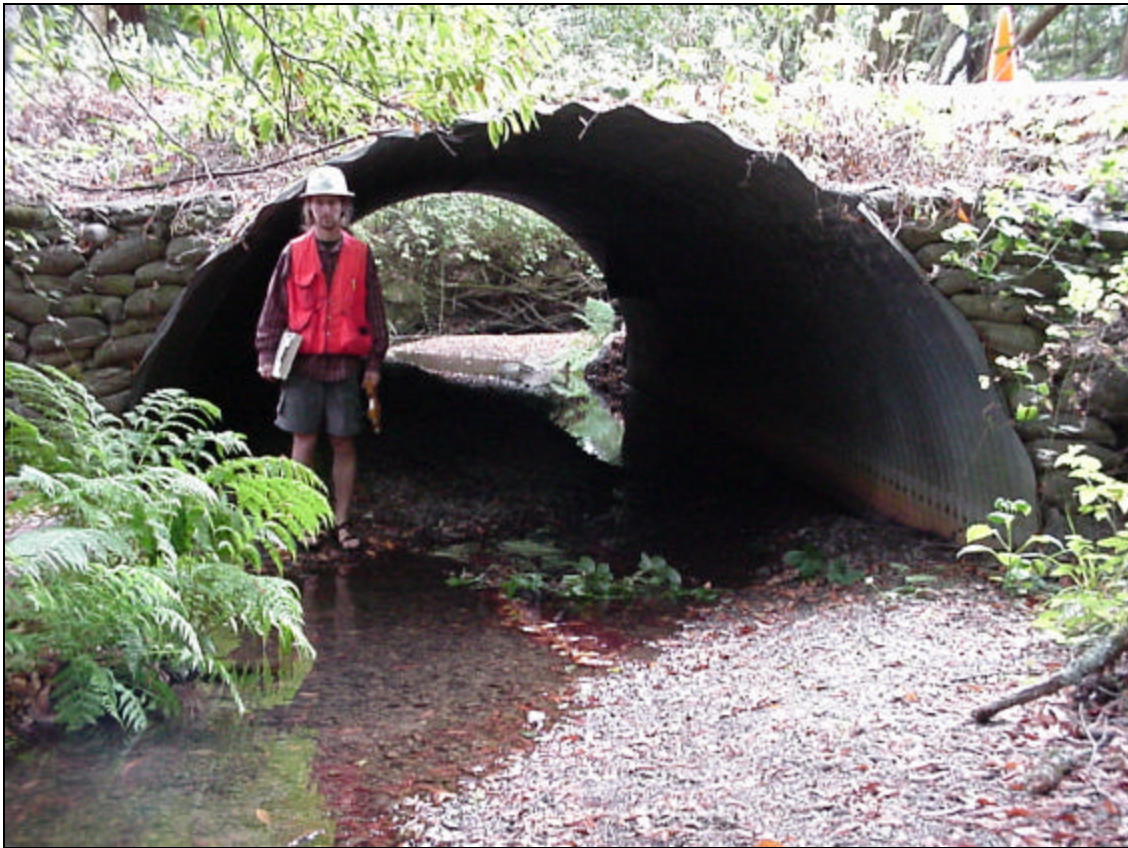
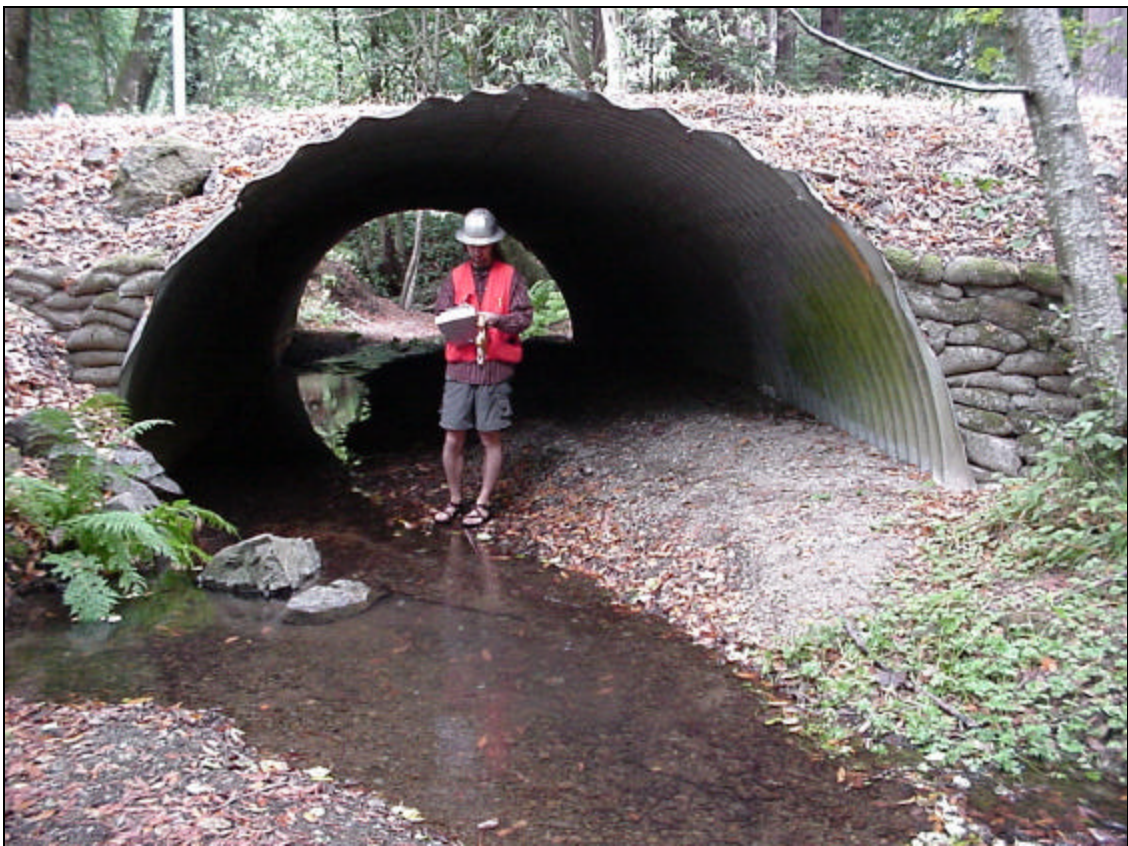
Site ID #S-022: Unnamed Tributary #1/Furlong Road; Jonive Creek; Atascadero Creek; Green Valley Creek; Russian River

Culvert Type: Pipe Arch, SSP. **Corrugations:** 6' x 2" **Dimensions:** 8.0' rise x 14.5' span **Length:** 43.0' **Slope:** 1.19% **Modifications:** None. **Rustline Height:** 2.0' **Average Active Channel Width:** 9.5' **Fill Estimate:** 210 cubic yards. **Overall Condition:** Good.

Habitat: Quantity = approximately 5,100' of potential fish-bearing habitat upstream of Site ID# S-022. Quality = rated as "fair" for the ranking matrix by CDFG's professional judgment (Coey, pers. comm.). The crossing was surveyed by Taylor and Assoc. on 9/24/01 and there was continuous flow in the channel. At 3:30PM the air temp = 15.5°C and the water temp = 12.5°C. The culvert survey crew described the habitat as "good" and noted several deep pools near the crossing and a moderately dense riparian canopy of mostly hardwoods and some conifers. The crew noted that there were good-quality spawning gravels in the pool tails. No fish were observed.

Preferred Treatment: None recommended because current crossing provides unimpeded passage, is in good condition, and is properly sized.

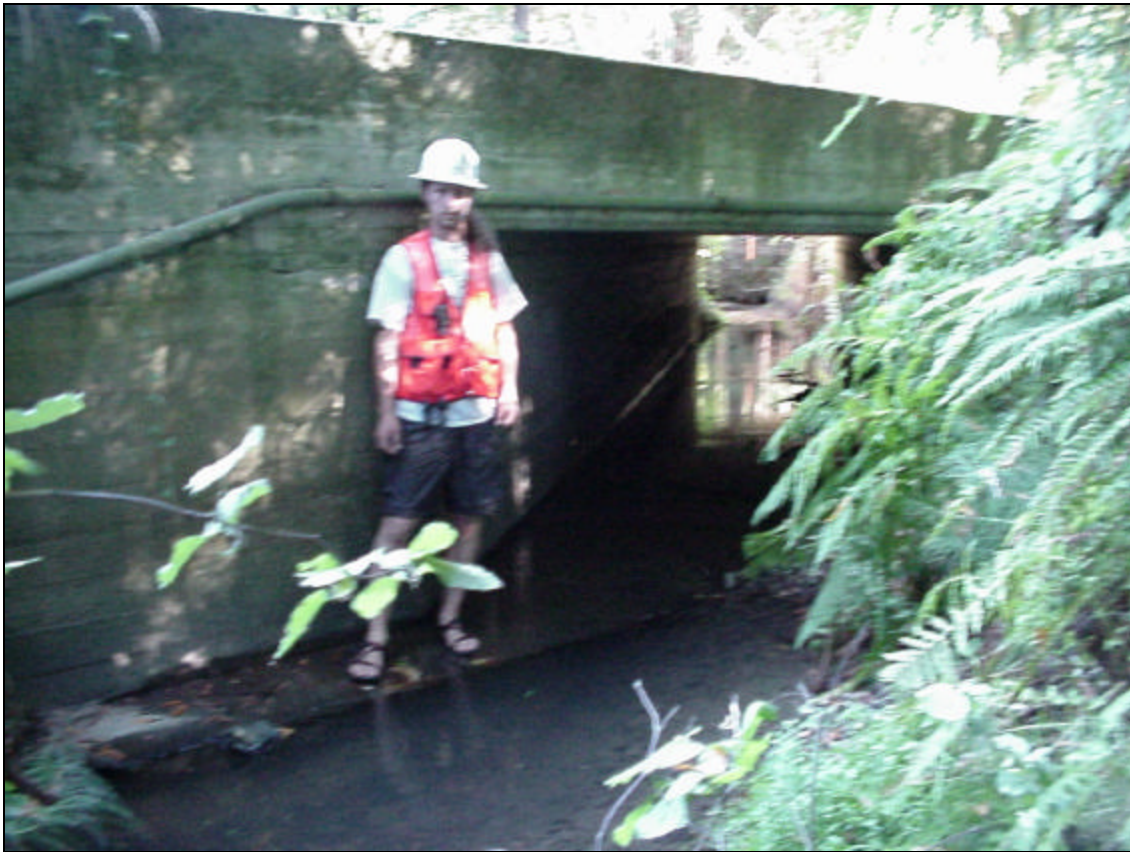
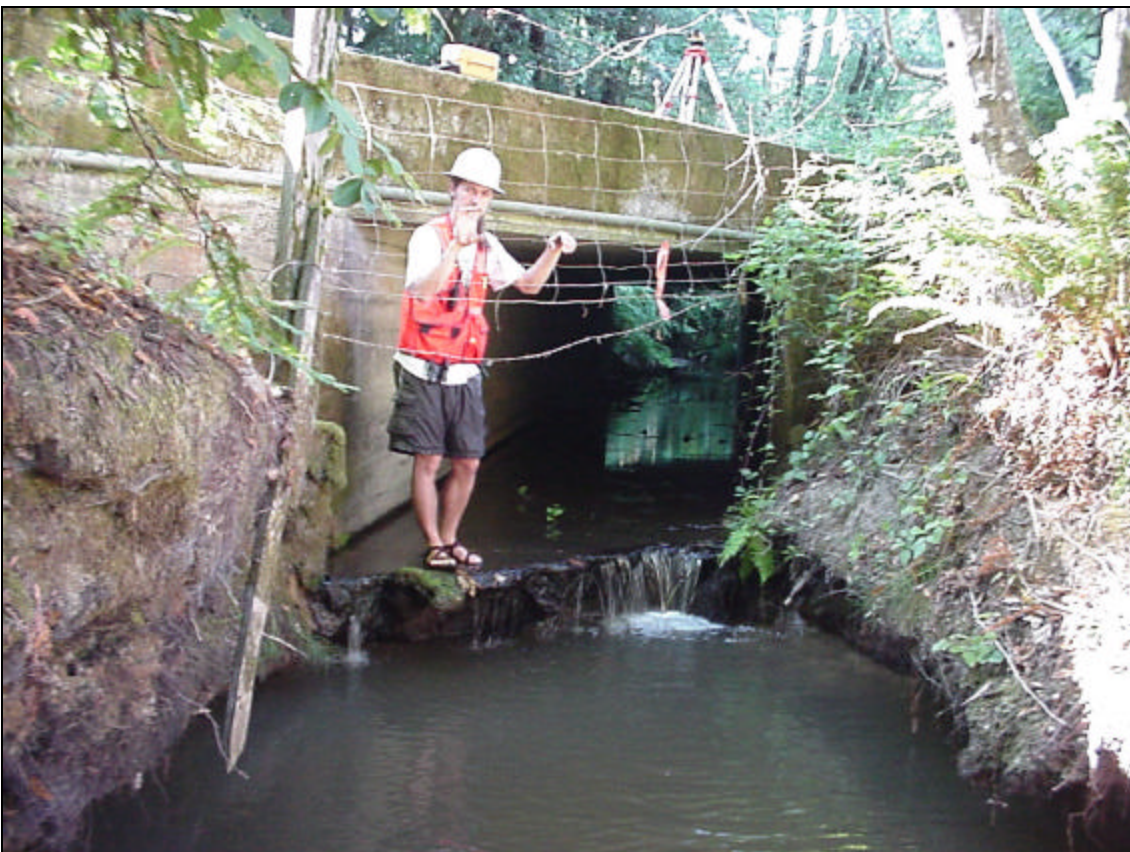
Site ID #S-023: Unnamed Tributary #2/Furlong Road; Jonive Creek; Atascadero Creek; Green Valley Creek; Russian River

Culvert Type: Box, Concrete. **Corrugations:** None. **Dimensions:** 5.0' height x 7.0' width **Length:** 61.2' **Slope:** 0.07 % **Modifications:** None. **Rustline Height:** N/A **Average Active Channel Width:** 7.7' **Fill Estimate:** 117 cubic yards. **Overall Condition:** Good. **Sizing:** Undersized; HW/D = 1 on a storm flow with approximately a 19-year recurrence interval. Furlong Road is overtopped on approximately a 193-year storm flow.

Barrier Status: GRAY: FishXing determined this crossing meets the 8-16-16 ft/sec passage criteria for adult steelhead on 70% of the range of estimated migration flows and fails to meet passage criteria all age classes of juvenile salmonids. Actual adult passage may be higher than the FishXing estimate because the only violation of the criteria is lack-of-depth. For all juveniles the primary violation of the criteria is the drop at the outlet.

Habitat: Quantity = approximately 2,050' of potential fish-bearing habitat upstream of Site ID# S-023. Quality = rated as “fair” for the ranking matrix by CDFG’s professional judgment (Coey, pers. comm.). The crossing was surveyed by Taylor and Assoc. on 8/14/01 and there was continuous flow in the channel. At 5:30PM the air temp = 24°C and the water temp = 15°C. The culvert survey crew described the habitat as “good” and noted several deep pools near the crossing and a moderately dense riparian canopy of mostly hardwoods and some conifers. Several young-of-year salmonids were observed upstream of Site ID #S-023..

Preferred Treatment: None recommended immediately because current box culvert provides adequate adult passage and in good condition. One or two downstream boulder weirs would cost-effectively improve passage conditions for juveniles if CDFG deemed this a vital concern. The feasibility of corner baffles in culvert should be cautiously considered due to effects of further reduction of the culvert’s limited storm flow capacity.

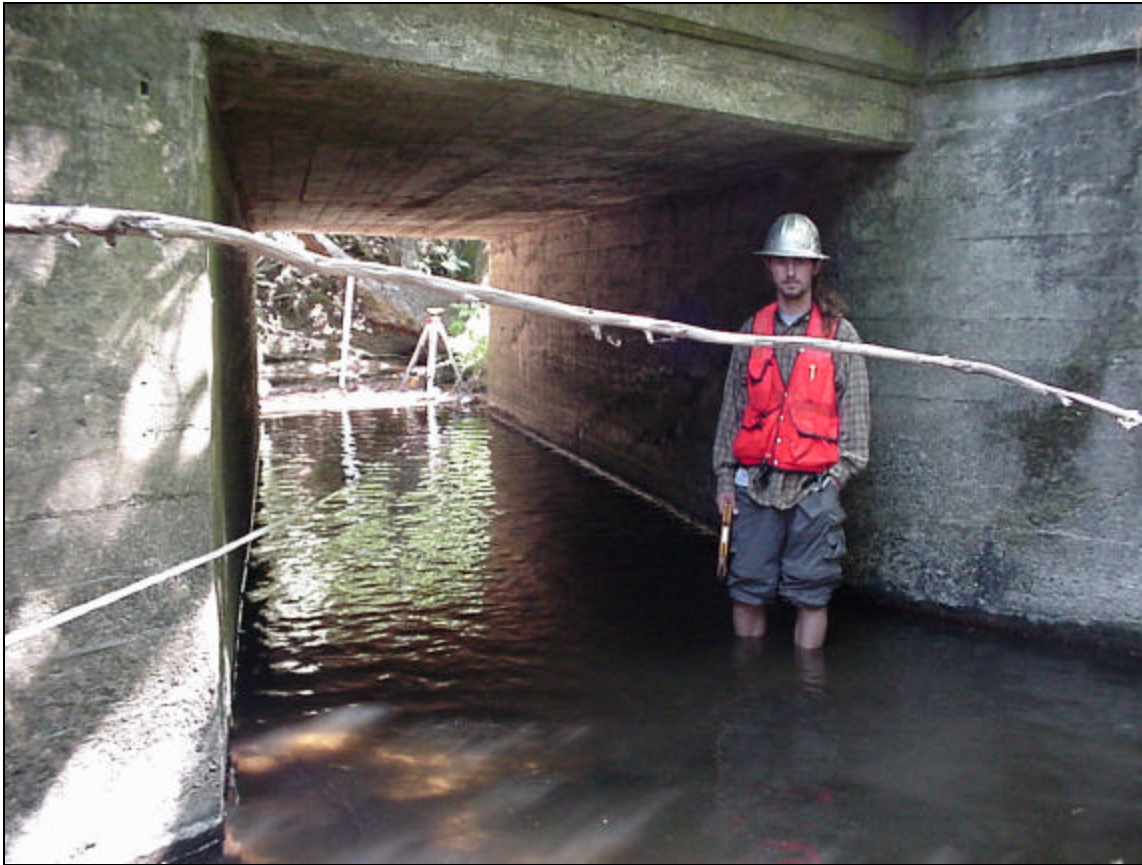
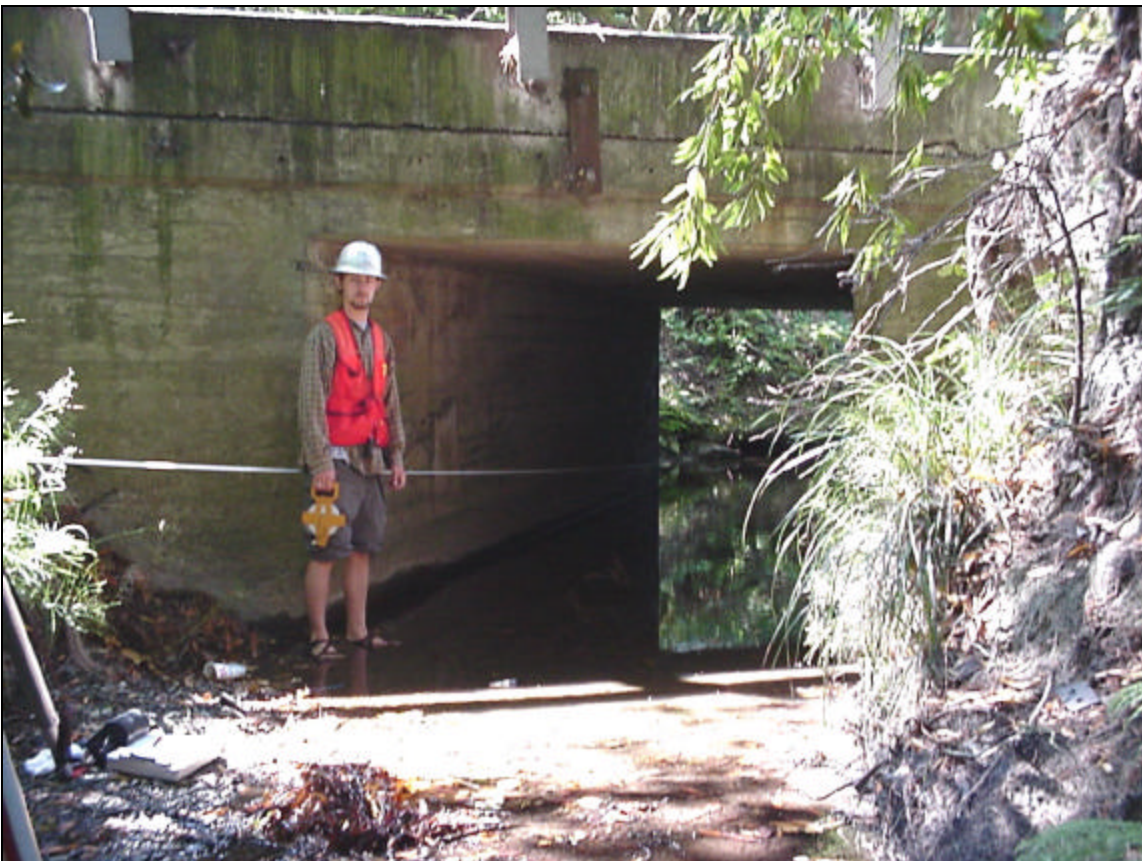
Site ID #S-024: Jonive Creek #4/Bodega Highway; Atascadero Creek; Green Valley Creek; Russian River

Culvert Type: Box, Concrete. **Corrugations:** None. **Dimensions:** 7.0' height x 8.0' width **Length:** 31.7'
Slope: -2.21 % **Modifications:** None. **Rustline Height:** N/A **Average Active Channel Width:** 9.2'
Fill Estimate: 245 cubic yards. **Overall Condition:** Good.

Habitat: Quantity = approximately 7,450' of potential fish-bearing habitat upstream of Site ID# S-024. Quality = rated as "fair" for the ranking matrix by CDFG's professional judgment (Coey, pers. comm.). The crossing was surveyed by Taylor and Assoc. on 8/15/01 and there was continuous flow in the channel. At 11:00AM the air temp = 14°C and the water temp = 12°C. The culvert survey crew described the habitat as "good" and noted several deep pools near the crossing and a moderately dense riparian canopy of mostly hardwoods and some conifers. However, the water was described as silty and the streambed was silty too. Between five and 10 young-of-year salmonids were observed upstream and downstream of Site ID #S-024.

Preferred Treatment: None recommended immediately because current box culvert provides unimpeded passage, is properly sized, and is in good condition.

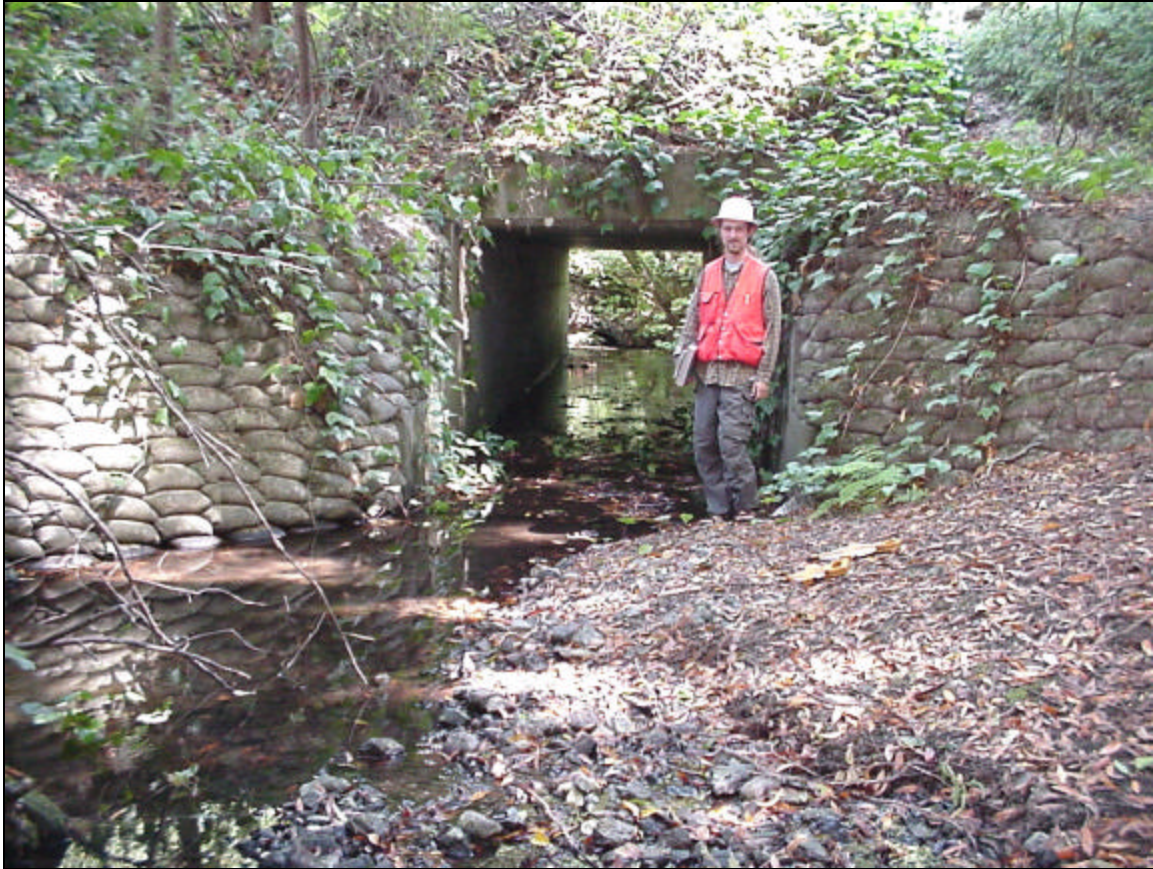
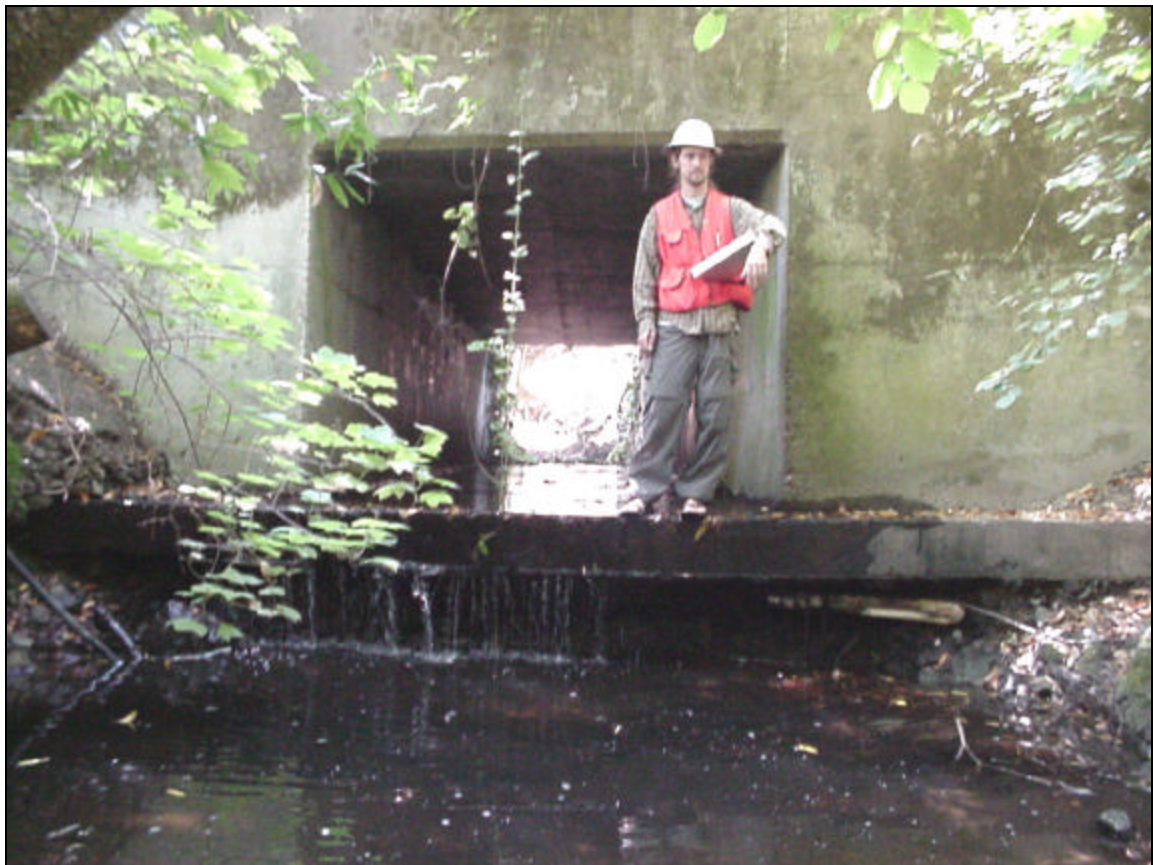
Site ID #S-025: Jonive Creek #5/Wagnon Road; Atascadero Creek; Green Valley Creek; Russian River

Culvert Type: Box, Concrete. **Corrugations:** None. **Dimensions:** 6.0' height x 8.0' width **Length:** 54.5'
Slope: 0.86 % **Modifications:** None. **Rustline Height:** N/A **Average Active Channel Width:** 7.9'
Fill Estimate: 305 cubic yards. **Overall Condition:** Good. **Sizing:** Properly sized; HW/D = 1 on a storm flow with approximately a 123-year recurrence interval. Wagnon Road is overtopped on more than a 250-year storm flow.

Barrier Status: GRAY: FishXing determined this crossing meets the 8-16-16 ft/sec passage criteria for adult steelhead on 42% of the range of estimated migration flows and fails to meet passage criteria all age classes of juvenile salmonids. Actual adult passage may be higher than the FishXing estimate because the only violation of the criteria is lack-of-depth. For all juveniles the primary violation of the criteria is the excessive (2.8') drop at the outlet.

Habitat: Quantity = approximately 5,750' of potential fish-bearing habitat upstream of Site ID# S-025. Quality = rated as "fair" for the ranking matrix by CDFG's professional judgment (Coey, pers. comm.). The crossing was surveyed by Taylor and Assoc. on 8/15/01 and there was continuous flow in the channel. At 12:00PM the air temp = 19°C and the water temp = 13°C. The culvert survey crew described the habitat as "good" and noted a moderately dense riparian canopy of mostly hardwoods and some conifers. The streambed was described as gravel and cobble – good spawning substrate. No fish were observed.

Preferred Treatment: None recommended immediately because current box culvert provides adequate adult passage, is in good condition, and is properly sized. Two or three downstream boulder weirs and corner baffles within the culvert would cost-effectively improve passage conditions for juveniles if CDFG deemed this a vital concern.

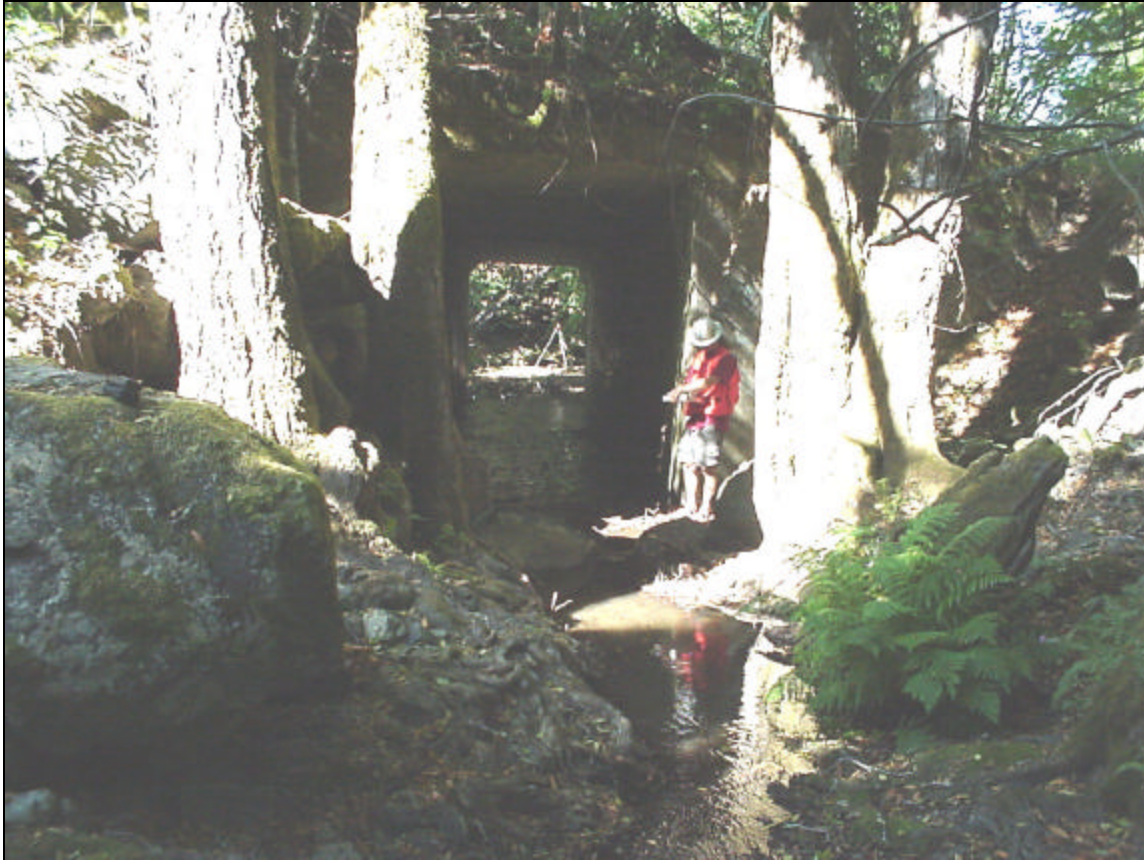
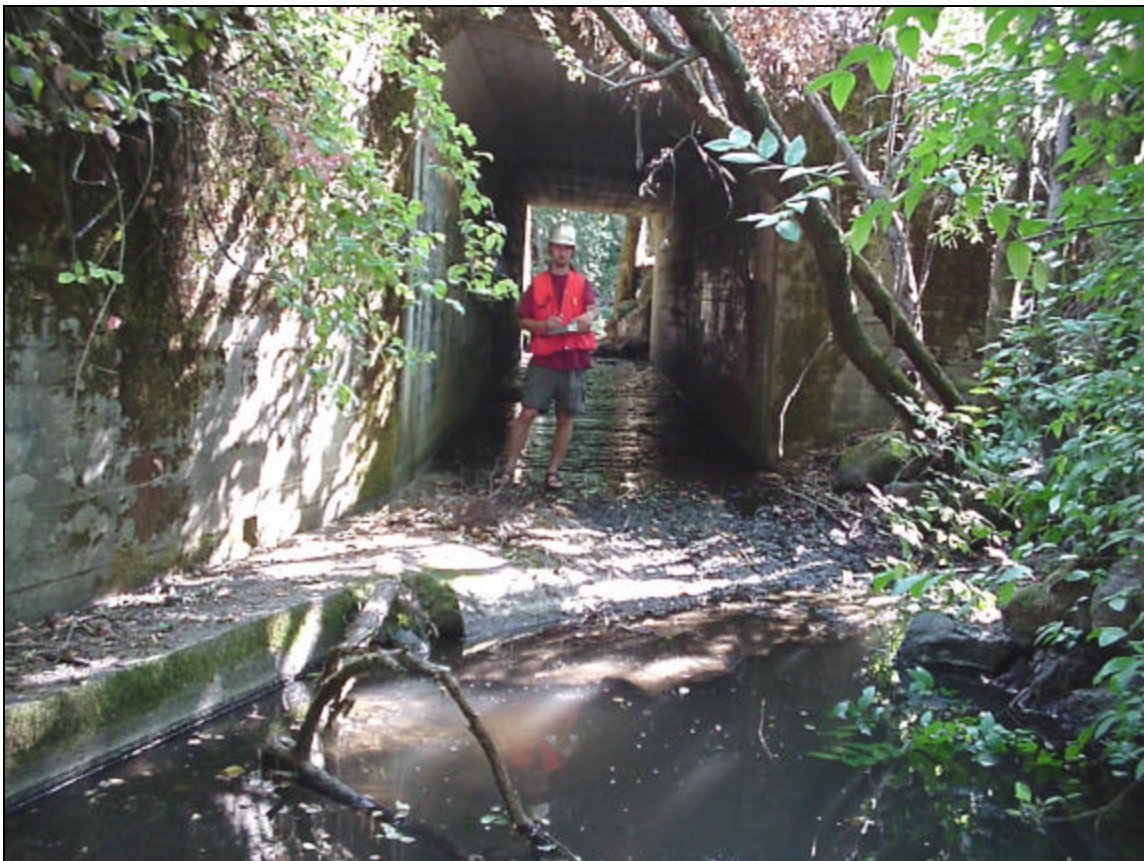
Site ID #S-026: Purrington Creek#1/Graton Road; Green Valley Creek; Russian River **Road Ownership:** County

Culvert Type: Box, Concrete. **Corrugations:** None. **Dimensions:** 9.9' height x 8.7' width **Length:** 59.2'
Slope: 3.23% **Modifications:** None. **Rustline Height:** N/A **Average Active Channel Width:** 8.4'
Fill Estimate: 643 cubic yards. **Overall Condition:** Abraded. **Sizing:** Properly sized; HW/D = 1 on a storm flow with more than a 250-year recurrence interval. Graton Road is overtopped on more than a 250-year storm flow.

Barrier Status: **RED:** the Green-Gray-Red filter determined this crossing fails to meet passage criteria for all species of adult salmonids and all age classes of juveniles. For adults, there is a lack-of-depths at lower flows and excessive velocities over the upper 50% range of migration flows. Excessive velocity is the primary impediment for juveniles.

Habitat: Quantity = approximately 4,700' of potential fish-bearing habitat upstream of Site ID# S-026. Quality = rated as "fair" for the ranking matrix (quality score = 0.55) by CDFG's 1994 habitat typing survey of 19,000' of channel. Juvenile coho salmon were sampled (in small numbers) as recently as 1994 and are considered to be sporadically present (Coey, pers. comm.). CDFG crew noted lots of garbage dumps, eroding banks, erosion at wet fords, and cutting of riparian vegetation. The crossing was surveyed by Taylor and Assoc. on 8/07/01 and there was continuous flow in the channel. At 12:00PM the air temp = 19°C and the water temp = 13°C. The culvert survey crew described the habitat as "good" and noted a moderately dense riparian canopy of hardwoods and conifers. The streambed was described as gravel and cobble – good spawning substrate. Approximately 30-50 young-of-year salmonids were observed both upstream and downstream of Site ID #S-026.

Preferred Treatment: Two or three downstream boulder weirs and corner baffles within the culvert would cost-effectively improve passage conditions for both adults and juveniles. Passage over the five dams on private property and the box culvert 100' upstream should be assessed by CDFG before committing funds to treat Site ID #S-026.

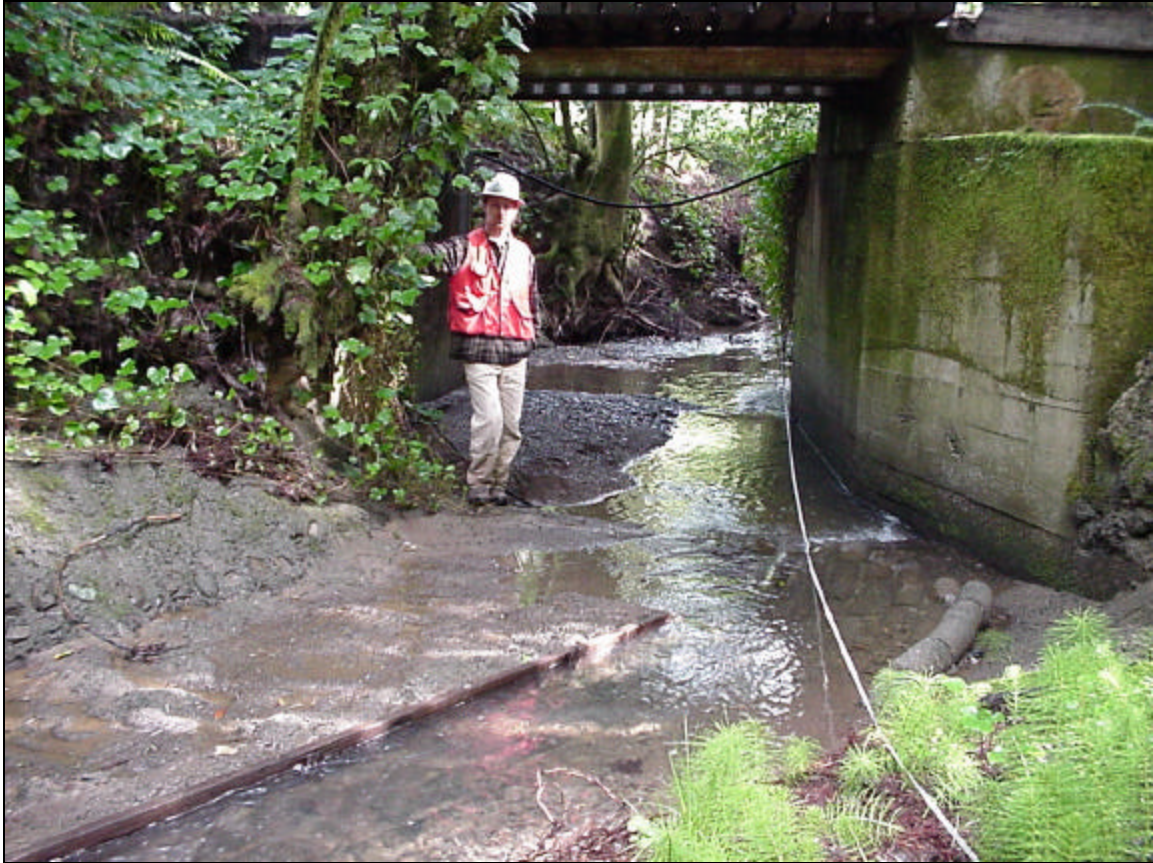
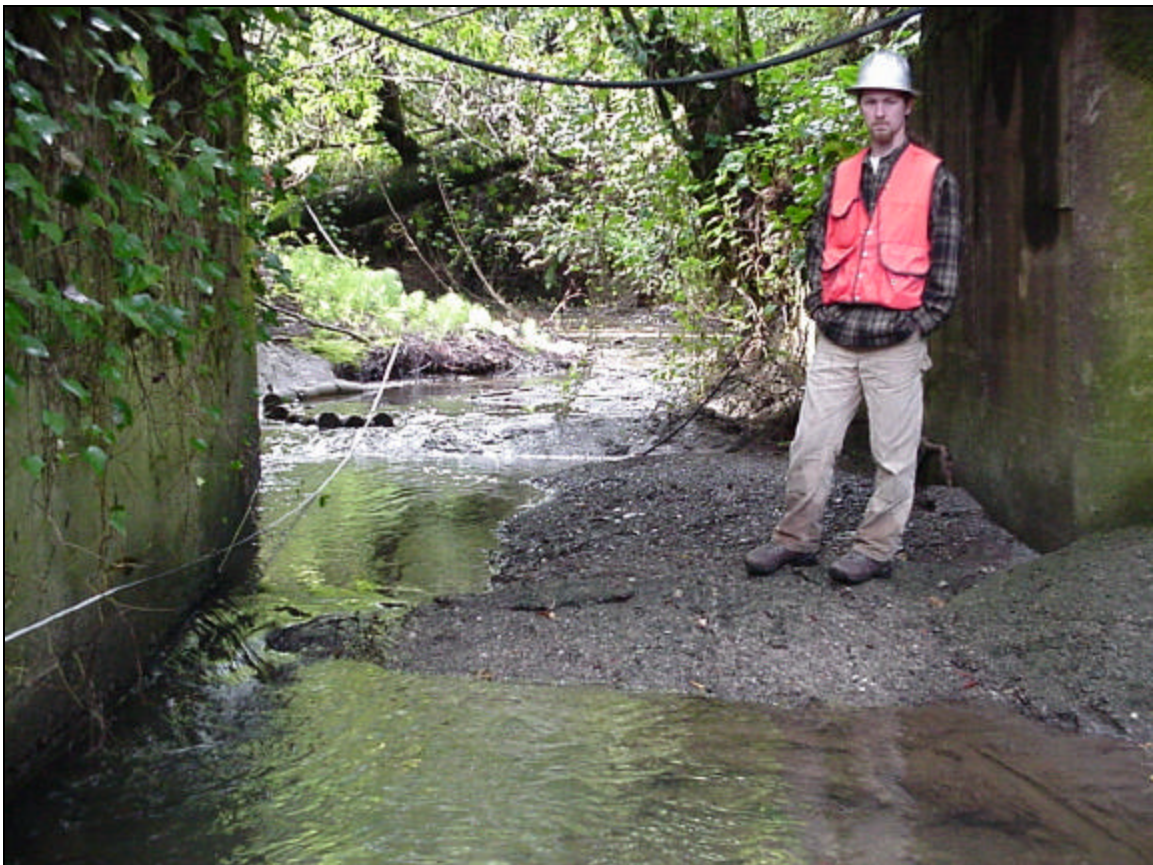
Site ID #S-027: Purrington Creek #2/Private Driveway; Green Valley Ck; Russian River **Road Ownership:** Private

Culvert Type: Box, Concrete. **Corrugations:** None. **Dimensions:** 10.6' height x 10.65' width **Length:** 12.0' **Slope:** -5.50% **Modifications:** None. **Rustline Height:** N/A **Average Active Channel Width:** 14.4' **Fill Estimate:** 122 cubic yards. **Overall Condition:** Fair. **Sizing:** Properly sized; HW/D = 1 on a storm flow with more than a 250-year recurrence interval. This private driveway is overtopped on more than a 250-year storm flow.

Barrier Status: **GRAY:** FishXing determined this crossing meets the 8-16-16 ft/sec passage criteria for all species of adult salmonids on 86% of the range of estimated migration flows, meets passage criteria for resident/2+ fish on 100% of estimated migratons and fails to meet passage criteria for 1+/young-of-year juvenile salmonids.

Habitat: Quantity = approximately 3,700' of potential fish-bearing habitat upstream of Site ID# S-027. Quality = rated as "fair" for the ranking matrix (quality score = 0.55) by CDFG's 1994 habitat typing survey of 19,000' of channel. Juvenile coho salmon were sampled (in small numbers) as recently as 1994 and are considered to be sporadically present (Coey, pers. comm.). CDFG crew noted lots of garbage dumps, eroding banks, erosion at wet fords, and cutting of riparian vegetation. The crossing was surveyed by Taylor and Assoc. on 4/10/02 and there was continuous flow in the channel. At 10:00AM the air temp = 14.5°C and the water temp = 10.5°C. The culvert survey crew described the habitat as "good" and noted a dense riparian canopy of hardwoods and conifers. The streambed was described as mostly gravel and cobble – good spawning substrate. No fish were observed.

Preferred Treatment: None recommended because the current crossing provides ample fish passage, is in fair condition, and is properly sized for storm flow conveyance.

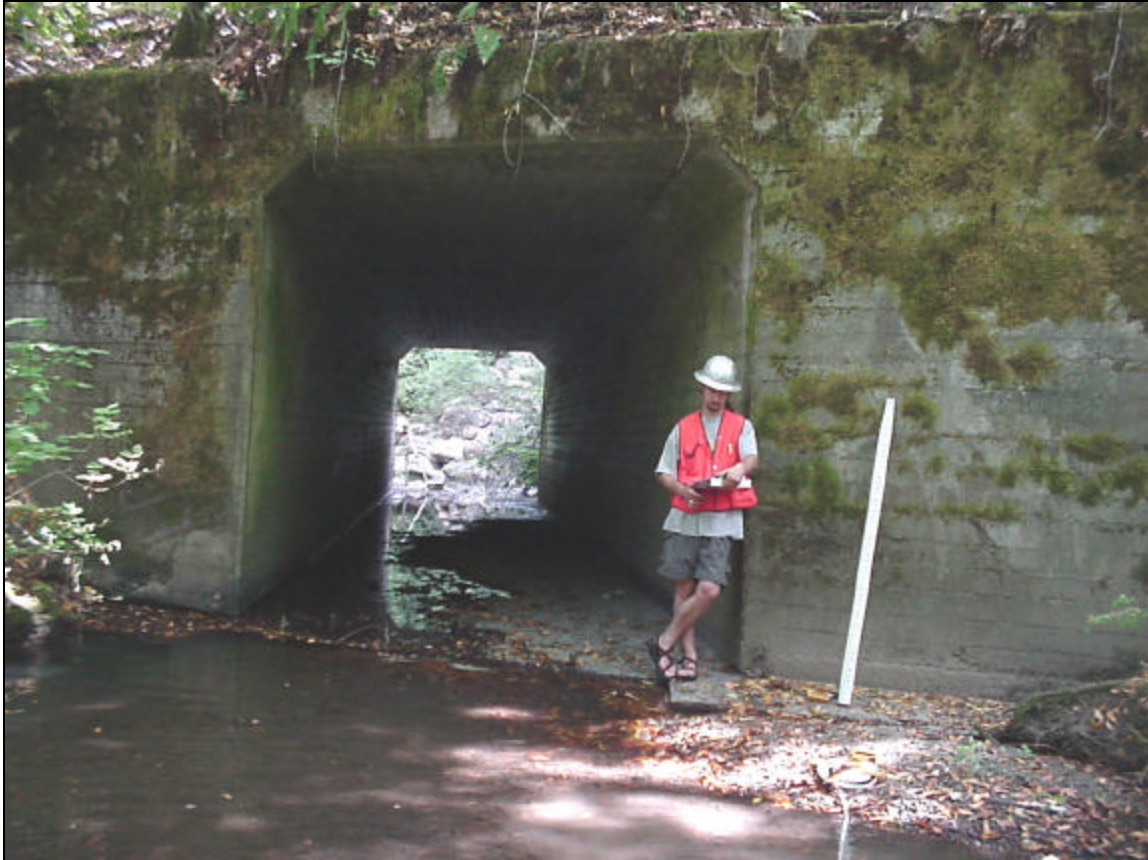
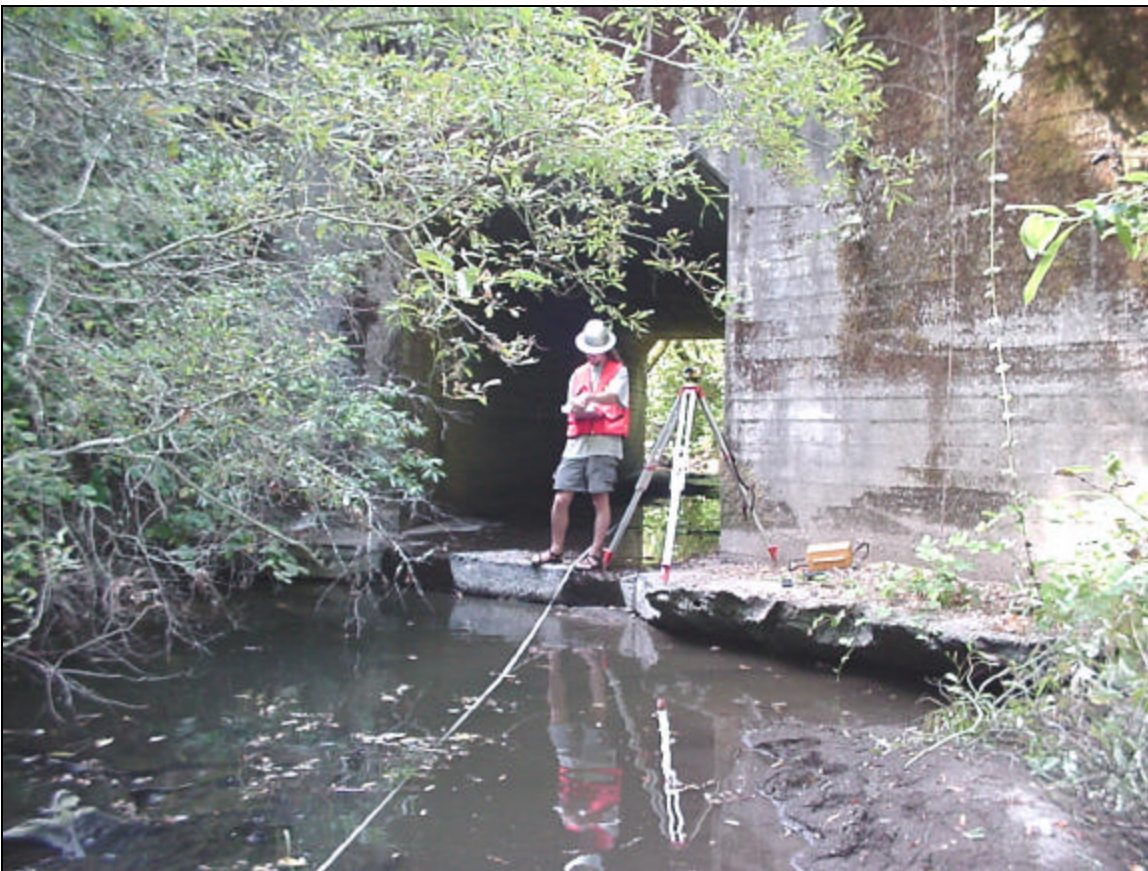
Site ID #S-028: Green Valley Creek/Green Valley Road; Russian River **Road Ownership** County

Culvert Type: Box, Concrete. **Corrugations:** None. **Dimensions:** 10.15' height x 10.00' width **Length:** 68.0'
Slope: 0.54% **Modifications:** None. **Rustline Height:** N/A **Average Active Channel Width:** 11.9'
Fill Estimate: 876 cubic yards. **Overall Condition:** Good. **Sizing:** Undersized; HW/D = 1 on a storm flow with approximately a 48-year recurrence interval. Green Valley Road is overtopped on more than a 250-year storm flow.
Barrier Status: FishXing determined this crossing meets the 8-16-16 ft/sec passage criteria for adult steelhead on 71% of the range of estimated migration flows and fails to meet passage criteria all age classes of juvenile salmonids. Actual adult passage may be higher than the FishXing estimate because the only violation of the criteria is lack-of-depth. For all juveniles the primary violation of the criteria is the excessive (2.7') drop at the outlet.

Habitat: Quantity = approximately 11,500' of potential fish-bearing habitat upstream of Site ID# S-028. Quality = rated as “fair” for the ranking matrix (quality score = 0.55) by CDFG’s 1994 habitat typing survey of 51,000' of channel. Juvenile coho salmon were sampled (in small numbers) as recently as 1995 and are considered to be sporadically present (Coey, pers. comm.). A 1966 fisheries survey by Water Resources “found steelhead and coho commonly throughout 16 miles of Green Valley Creek”. CDFG crew noted impacts of unfenced grazing, bank erosion, and garbage in the channel. The crossing was surveyed by Taylor and Assoc. on 8/08/01 and there was continuous flow in the channel. At 10:00AM the air temp = 14.5°C and the water temp = 10.5°C. The culvert survey crew described the habitat as “good” and noted a dense riparian canopy of hardwoods and conifers. The streambed was described as mostly gravel and cobble – good spawning substrate. Approximately 10 to 15 young-of-year salmonids were observed both upstream and downstream of Site ID #S-028.

Preferred Treatment: Two or three downstream boulder weirs and corner baffles within the culvert would cost-effectively improve passage conditions for both adults and juveniles. Other barriers should be addressed by CDFG.

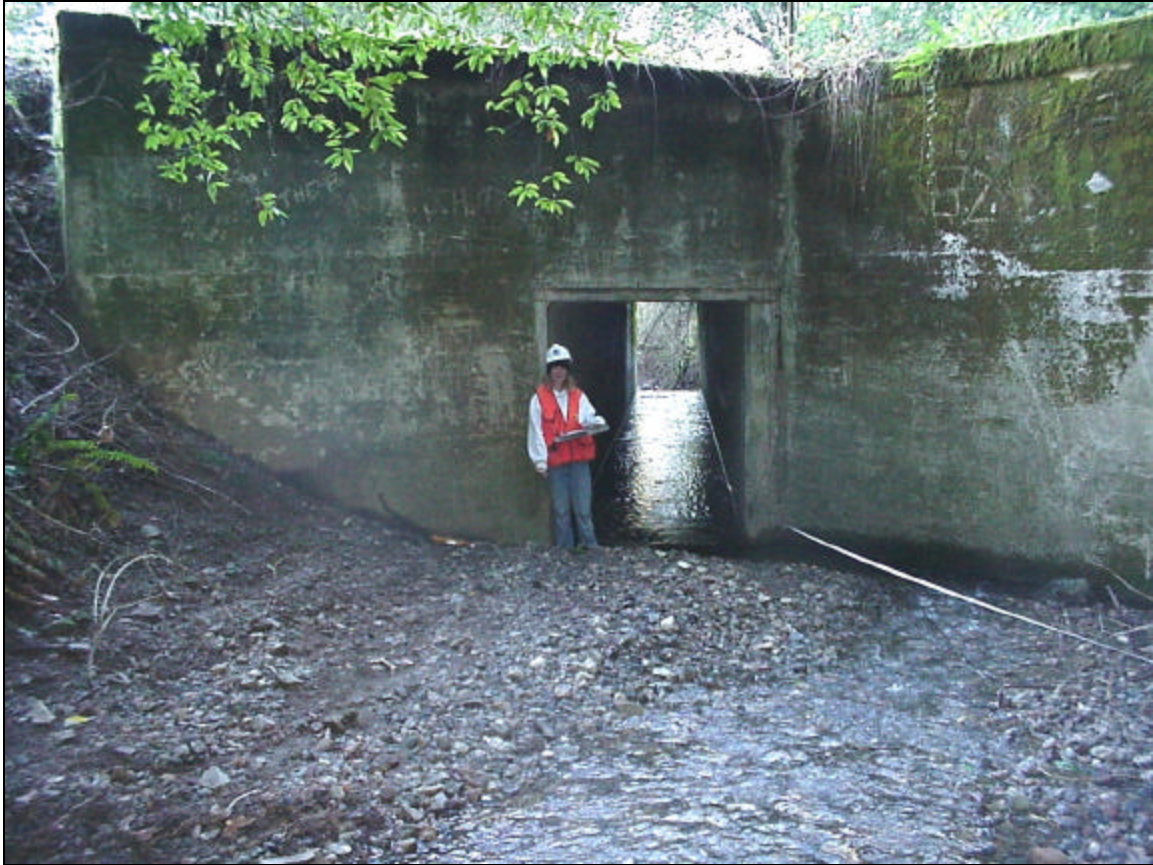
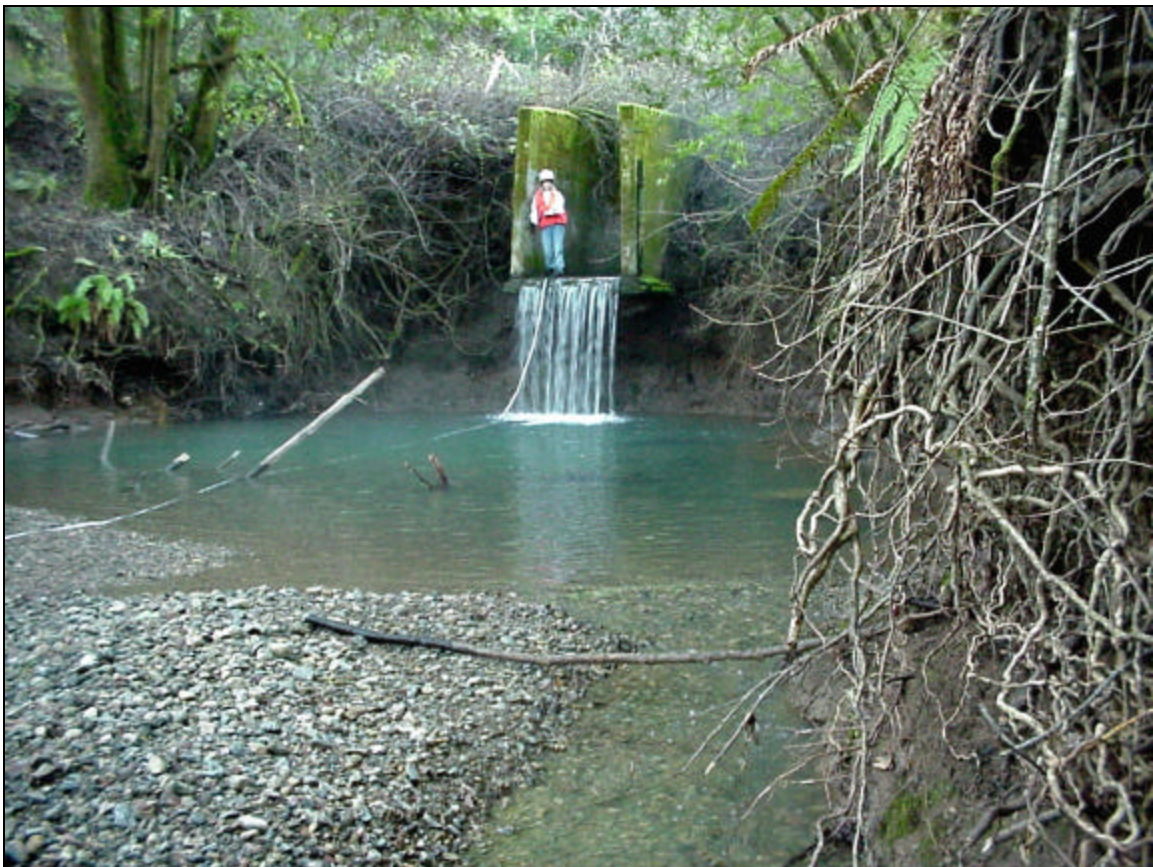
Culvert Type: Box, Concrete. **Corrugations:** None. **Dimensions:** 7.0' height x 5.0' width **Length:** 67.1'
Slope: 0.04% **Modifications:** None. **Rustline Height:** N/A **Average Active Channel Width:** 15.3'
Fill Estimate: 1,381 cubic yards. **Overall Condition:** Fair. **Sizing:** Slightly undersized; HW/D = 1 on a storm flow with approximately a 54-year recurrence interval. Green Valley Road is overtopped on a 250-year storm flow.

Barrier Status: **RED:** the Green-Gray-Red filter determined this crossing fails to meet passage criteria for all species of adult salmonids and all age classes of juveniles due to the extremely perched outlet (~ 7 feet).

Habitat: Quantity = approximately 5,300' of potential fish-bearing habitat upstream of Site ID# S-029. Quality = rated as "poor" for the ranking matrix as based on CDFG's professional judgment (Coe, pers. comm.). On 6/13/95, CDFG sampled the creek and only found salmonids downstream of Site ID #S-029 – including a single coho y-o-y. The crossing was surveyed by Taylor and Assoc. on 1/17/02 and there was continuous flow in the channel. At 9:30AM the air temp = 4°C and the water temp = 9°C. The culvert survey crew described the habitat as "good" and noted a dense riparian canopy of mostly hardwoods and a few conifers. The channel had "nice pools" and was low-gradient. The streambed was described as mostly gravel and cobble. No fish were observed. The culvert crew spoke with a local, Charlie Chenoweth (sp?), who has seen adult steelhead in the creek, but not many in recent years. Also said Harrison Grade Creek dries up every summer.

Preferred Treatment: A full replacement with a properly sized SSP circular culvert is the best long-term solution for this crossing. Because of the extremely perched nature of the current culvert, grade-control structures may be required to minimize headcutting. Consult with CDFG and NMFS hydraulic engineers for design assistance. Site may require a design similar to Morrison Gulch in Humboldt County that incorporated three boulder grade-control weirs upstream of the crossing and three boulder grade-control weirs downstream of the crossing.
