CATALOG OF SONOMA COUNTY STREAM CROSSINGS WITH CULVERTS LOCATED ON FISH-BEARING STREAM REACHES WITHIN THE RUSSIAN RIVER BASIN

By
Ross Taylor and Associates

Site ID# S-001: Unnamed Tributary/Willow Creek Road; Willow Creek; Russian River **Road Ownership** County

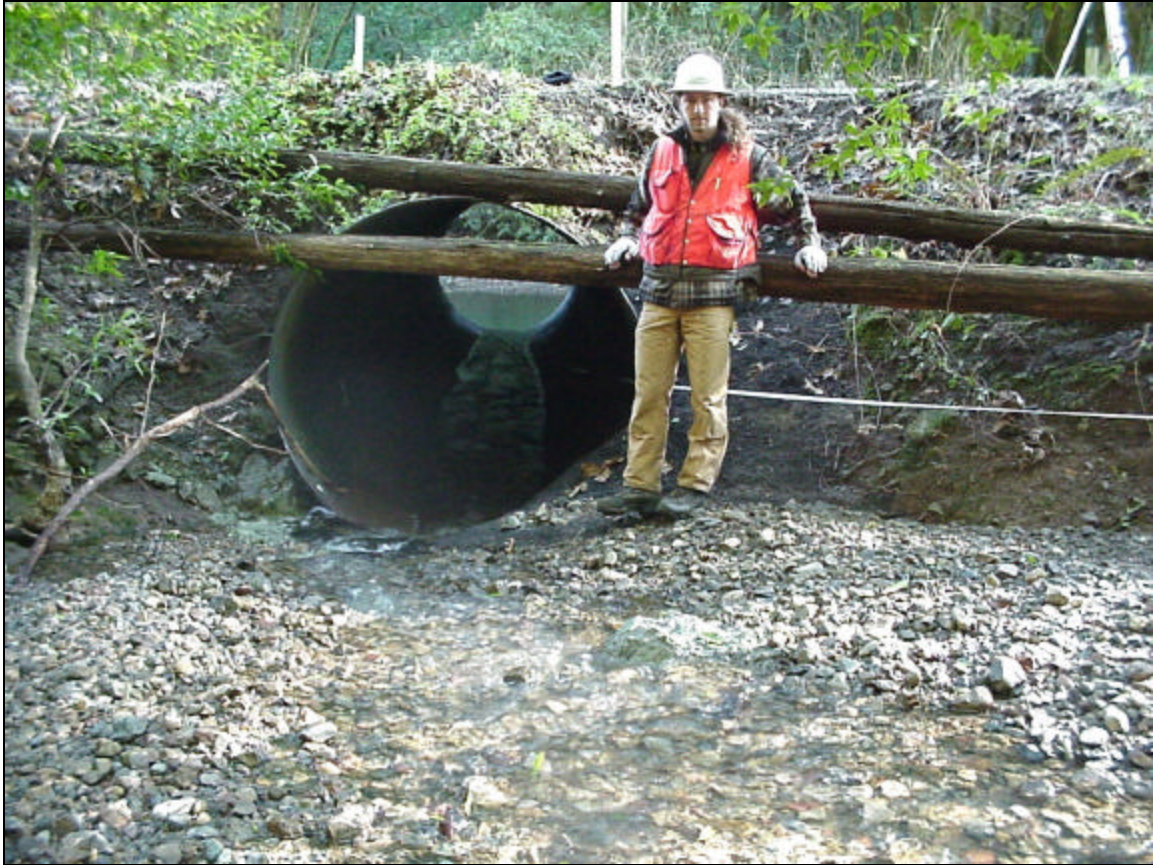
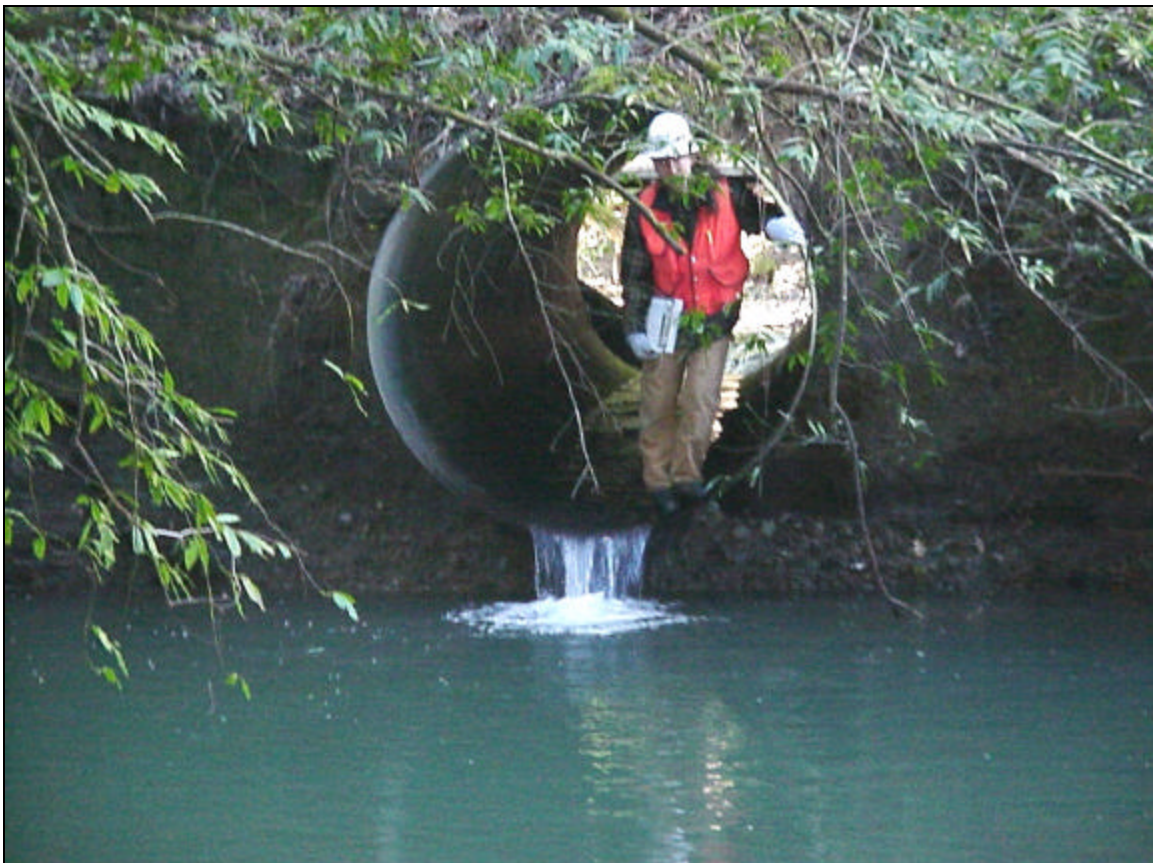
Site ID #S-030: Harrison Grade Creek #2/Harrison Grade Road; Green Valley Creek; Russian River

Culvert Type: Circular, SSP. **Corrugations:** 2-2/3" x 1/2" **Dimensions:** diameter= 6.0' **Length:** 40.8'
Slope: 1.72% **Modifications:** None. **Rustline Height:** 1.2' **Average Active Channel Width:** 18.8'
Fill Estimate: 472 cubic yards. **Overall Condition:** Fair. **Sizing:** Undersized; HW/D = 1 on a storm flow with approximately a 13-year recurrence interval. Harrison Grade Road is overtopped on approximately a 93-year storm flow.

Barrier Status: **GRAY:** FishXing determined this crossing meets the 8-16-16 ft/sec passage criteria for all species of adult salmonids on 94% of the range of estimated migration flows and fails to meet passage criteria for all age classes of juveniles because of the slightly perched outlet and also excessive velocities.

Habitat: Quantity = approximately 3,900' of potential fish-bearing habitat upstream of Site ID# S-030. Quality = rated as "poor" for the ranking matrix as based on CDFG's professional judgment (Coey, pers. comm.). On 6/13/95, CDFG sampled the creek and only found salmonids downstream of Site ID #S-029 – including a single coho y-o-y. The crossing was surveyed by Taylor and Assoc. on 1/17/02 and there was continuous flow in the channel. At 10:30AM the air temp = 5°C and the water temp = 9°C. The culvert survey crew described the habitat as "good" and noted a dense riparian canopy of mostly hardwoods and a few conifers. The channel had "nice pools" and was low-gradient. The streambed was described as mostly gravel and cobble. No fish were observed. The culvert crew spoke with a local, Charlie Chenoweth (sp?), who has seen adult steelhead in the creek, but not many in recent years. Also said Harrison Grade Creek dries up every summer.

Preferred Treatment: A full replacement with a properly sized open-bottom arch or a bridge is the best long-term solution for this crossing. A retrofit to backwater the culvert with weirs is not recommended because the current culvert is undersized and a further reduction in capacity may result in overtopping and/or failure of the road prism. In addition, the culvert invert is fairly rusted and worn – and may be due for replacement in the near future.

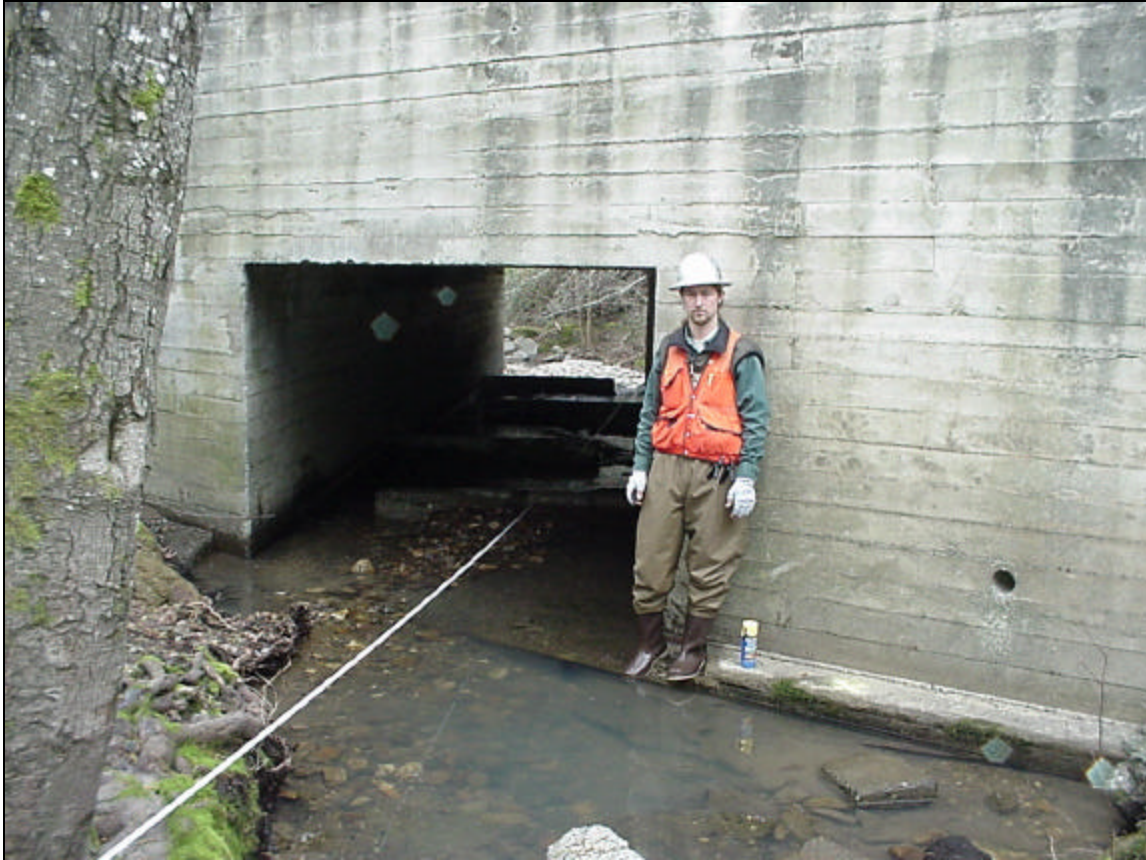
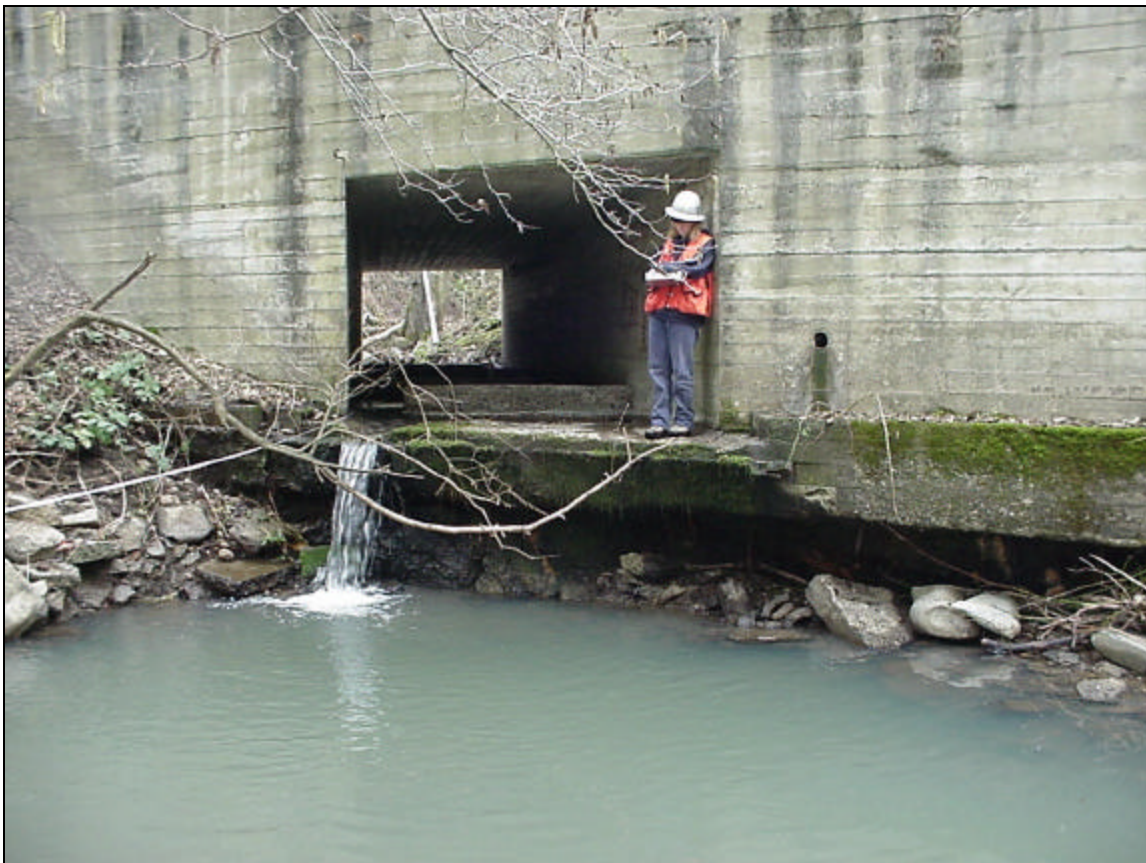
Site ID #S-031: Pool Creek; Chalk Hill Road; Windsor Ck; Mark West Ck; Russian River **Road Ownership:** County

Culvert Type: Box, Concrete. **Corrugations:** None. **Dimensions:** 6.2' height x 8.0' width **Length:** 46.0' **Slope:** 0.87% **Modifications:** Four offset concrete baffles. **Rustline Height:** N/A **Average Active Channel Width:** 7.9' **Fill Estimate:** 991 cubic yards. **Overall Condition:** Fair- exposed rebar on floor. **Sizing:** Undersized; HW/D = 1 on a storm flow with approximately a 17-year recurrence interval. Chalk Hill Road is overtopped on more than a 250-year storm flow.

Barrier Status: **RED:** the Green-Gray-Red filter determined this crossing fails to meet passage criteria for adult steelhead and all age classes of juveniles due to the extremely perched outlet (4.1 feet).

Habitat: Quantity = approximately 11,600' of potential fish-bearing habitat upstream of Site ID# S-031. Quality = rated as "poor" for the ranking matrix as based on CDFG's professional judgment (Coey, pers. comm.). The lower 11,000' of Pool Creek was habitat typed in 1997, but access was denied to the upper ½ of the watershed. The crossing was surveyed by Taylor and Assoc. on 2/06/02 and there was continuous flow in the channel. At 10:00AM the air temp = 8°C and the water temp = 6.5°C. The culvert survey crew described the habitat as "fair to good" and noted a dense hardwood riparian canopy. The flow in the channel was described as, "gray and murky". No fish were observed.

Preferred Treatment: A series of four to five boulder weirs downstream of the crossing will raise the tail-water elevation and cost-effectively improve fish passage. The offset baffles already within the culvert should increase depths and decrease velocities.

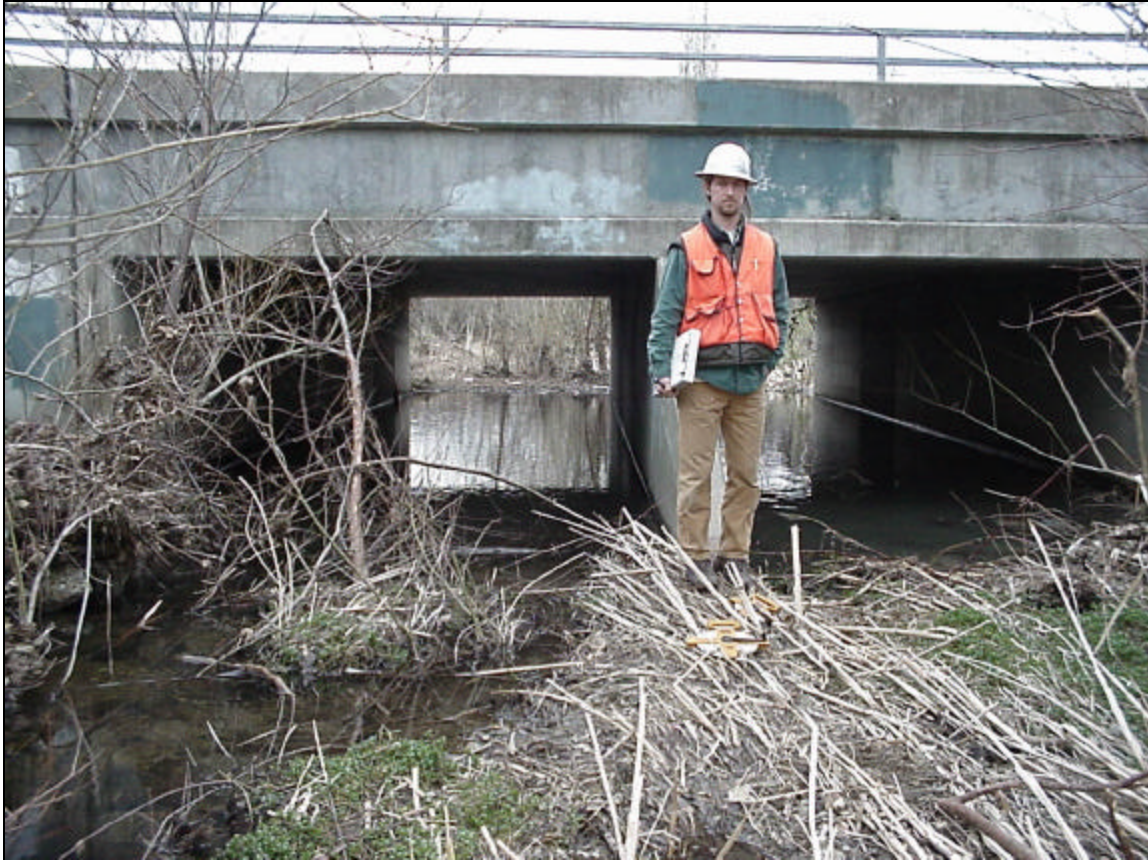
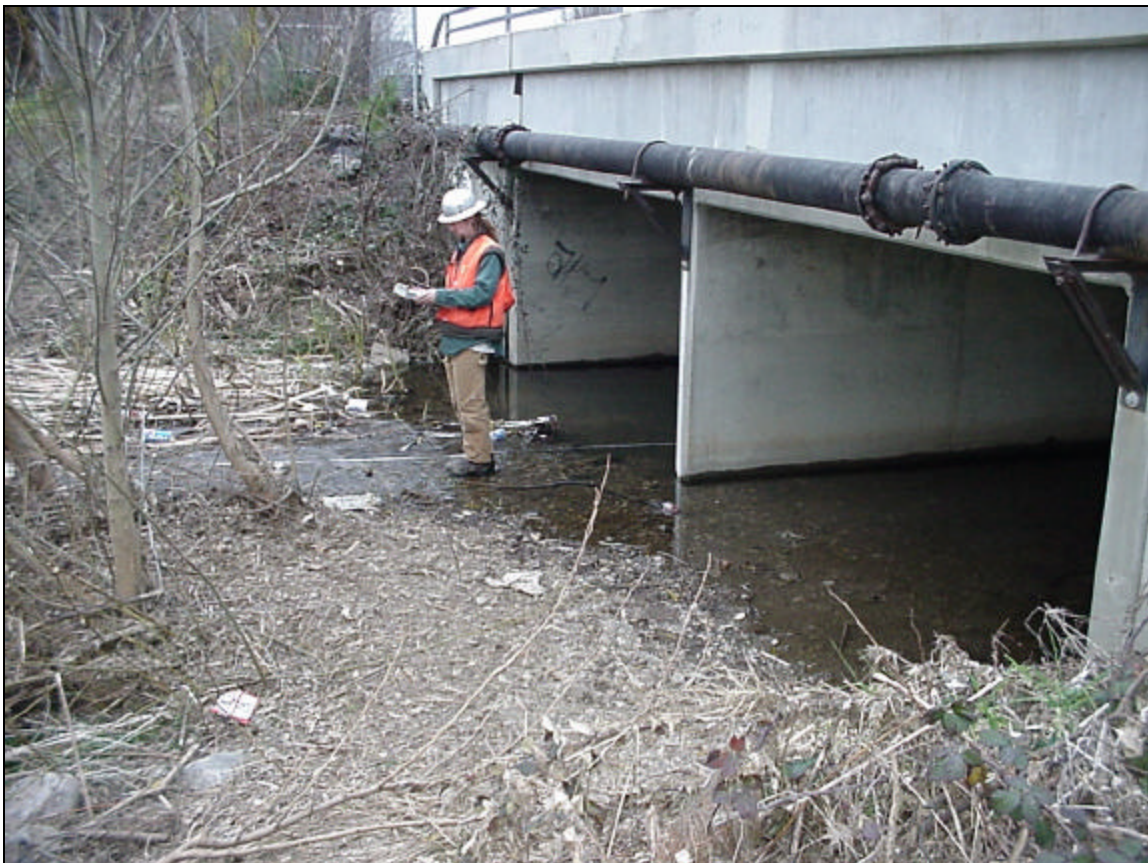
Site ID #S-032: Windsor Creek #1; Natalie Road; Mark West Creek; Russian River **Road Ownership:** County

Culvert Type: Two Bay Box, Concrete. **Corrugations:** None. **Dimensions:** 7.85' height x 12.0' width
Length: 53.2' **Slopes:** LB = -2.22%; RB = -0.39% **Modifications:** None. **Rustline Height:** N/A
Average Active Channel Width: 19.6' **Fill Estimate:** 400 cubic yards. **Overall Condition:** Good.

Habitat: Quantity = approximately 34,550' of potential fish-bearing habitat upstream of Site ID# S-032. Quality = rated as “poor” for the ranking matrix as based on CDFG’s professional judgment (Coe, pers. comm.). The crossing was surveyed by Taylor and Assoc. on 2/06/02 and there was continuous flow in the channel. At 5:00PM the air temp = 13°C and the water temp = 8°C. The culvert survey crew described the habitat as “poor” and noted a very sparse riparian canopy of brush. The channel was described as featureless and flowing through a residential area. Stream substrate was primarily silt and mud. No fish were observed.

Preferred Treatment: None recommended because the current crossing provides nearly unimpeded passage, is in good condition, and is properly sized.

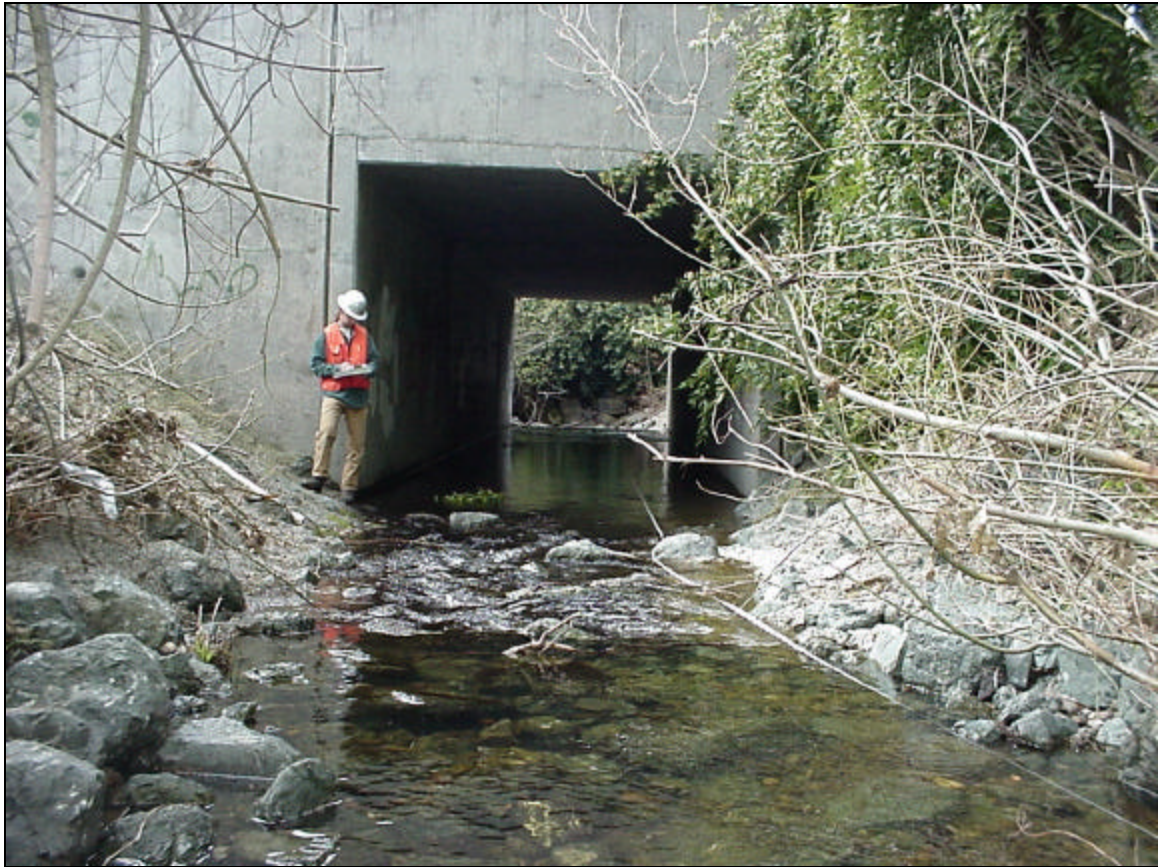
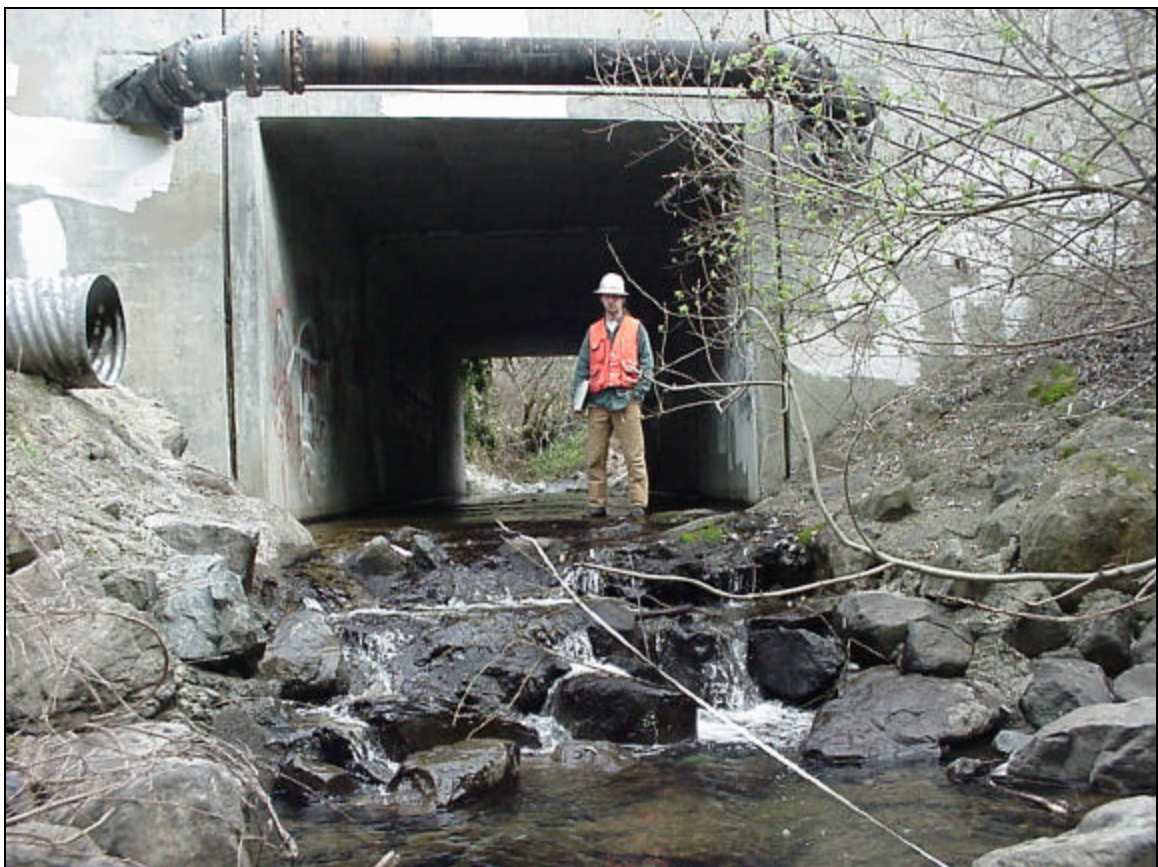
Site ID #S-033: Windsor Creek #2; Brooks Road; Mark West Creek; Russian River **Road Ownership:** County

Culvert Type: Box, Concrete. **Corrugations:** None. **Dimensions:** 10.0' height x 12.0' width **Length:** 61.9' **Slopes:** 0.10% **Modifications:** None. **Rustline Height:** N/A **Average Active Channel Width:** 19.7' **Fill Estimate:** 1,213 cubic yards. **Overall Condition:** Good. **Sizing:** Properly sized; HW/D = 1 on a storm flow with more than a 250-year recurrence interval. Brooks Road is overtopped on more than a 250-year storm flow.

Barrier Status: **GRAY:** FishXing determined this crossing meets the 8-16-16 ft/sec passage criteria for adult steelhead on 54% of the range of estimated migration flows and fails to meet passage criteria for all age classes of juvenile salmonids. The drop at the outlet, armoured with riprap, is the crossing's main feature that impedes fish passage. There are also lack-of-depth and excessive velocity concerns within the culvert too.

Habitat: Quantity = approximately 32,450' of potential fish-bearing habitat upstream of Site ID# S-033. Quality = rated as "poor" for the ranking matrix as based on CDFG's professional judgment (Coey, pers. comm.). The crossing was surveyed by Taylor and Assoc. on 2/06/02 and there was continuous flow in the channel. At 1:00PM the air temp = 12.5°C and the water temp = 8°C. The culvert survey crew described the habitat as "fair" and noted a sparse riparian canopy of hardwoods and brush. The channel was flowing through a residential area. Stream substrate was primarily gravel and cobble, but highly embedded with fines. No fish were observed. Culvert survey crew talked to locals who had never seen steelhead in the winter and said this section of creek is dry every summer.

Preferred Treatment: Because the current crossing is properly sized and in good condition, a retrofit is recommended. Construction of three to four boulder weirs downstream of the crossing to raise tail-water elevation and the installation of corner baffles within the culvert should cost-effectively improve fish passage.

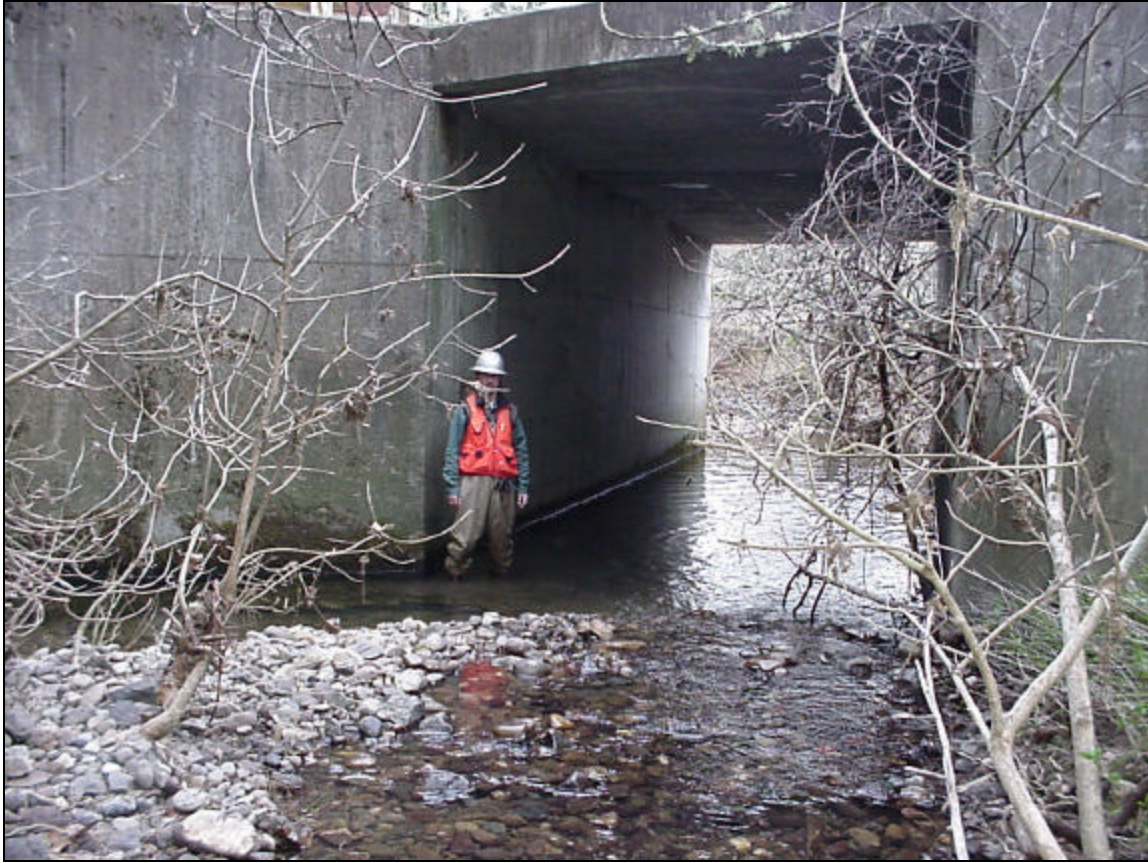
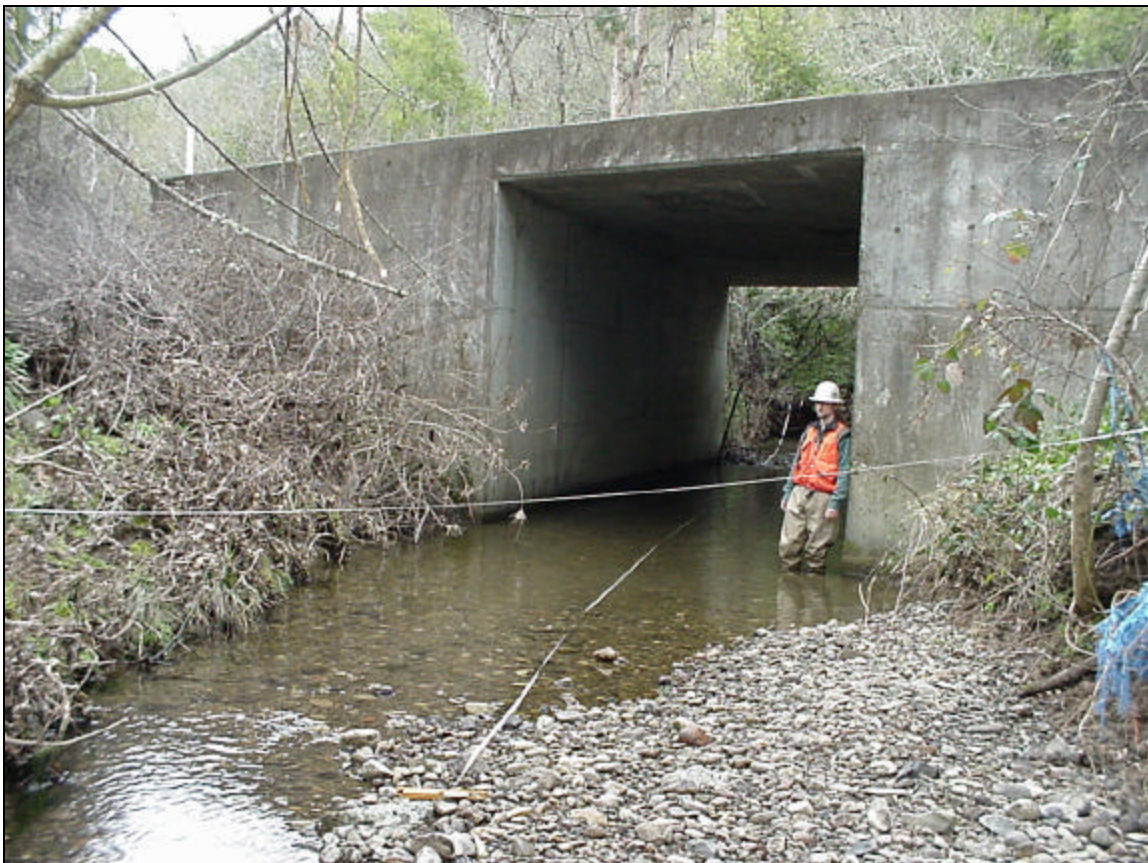
Site ID #S-034: Windsor Creek #3; Brooks Road; Mark West Creek; Russian River **Road Ownership:** County

Culvert Type: Box, Concrete. **Corrugations:** None. **Dimensions:** 12.0' height x 12.0' width **Length:** 42.0'
Slopes: 0.38% **Modifications:** None. **Rustline Height:** N/A **Average Active Channel Width:** 16.3'
Fill Estimate: 457 cubic yards. **Overall Condition:** Good.

Habitat: Quantity = approximately 26,350' of potential fish-bearing habitat upstream of Site ID# S-034. Quality = rated as “fair” for the ranking matrix as based on CDFG’s professional judgment (Coey, pers. comm.). The crossing was surveyed by Taylor and Assoc. on 2/06/02 and there was continuous flow in the channel. At 3:30PM the air temp = 10°C and the water temp = 6°C. The culvert survey crew described the habitat as “good” and noted a moderately dense riparian canopy of hardwoods. The crew noted several large/deep pools, located both upstream and downstream of the crossing. Stream substrate was primarily gravel and cobble and appeared to be good-quality for spawning. No fish were observed.

Preferred Treatment: No treatment required because the current crossing is properly sized, in good condition, and provides unimpeded passage of all steelhead lifestages.

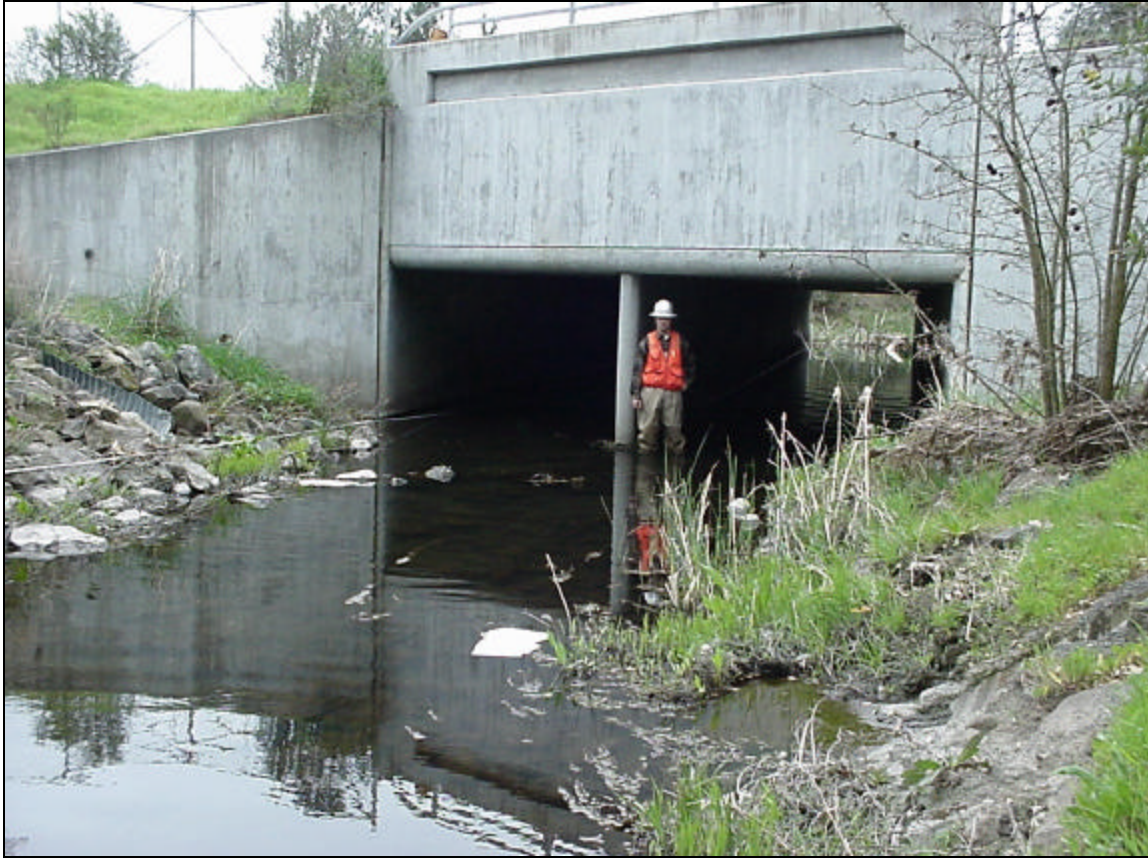
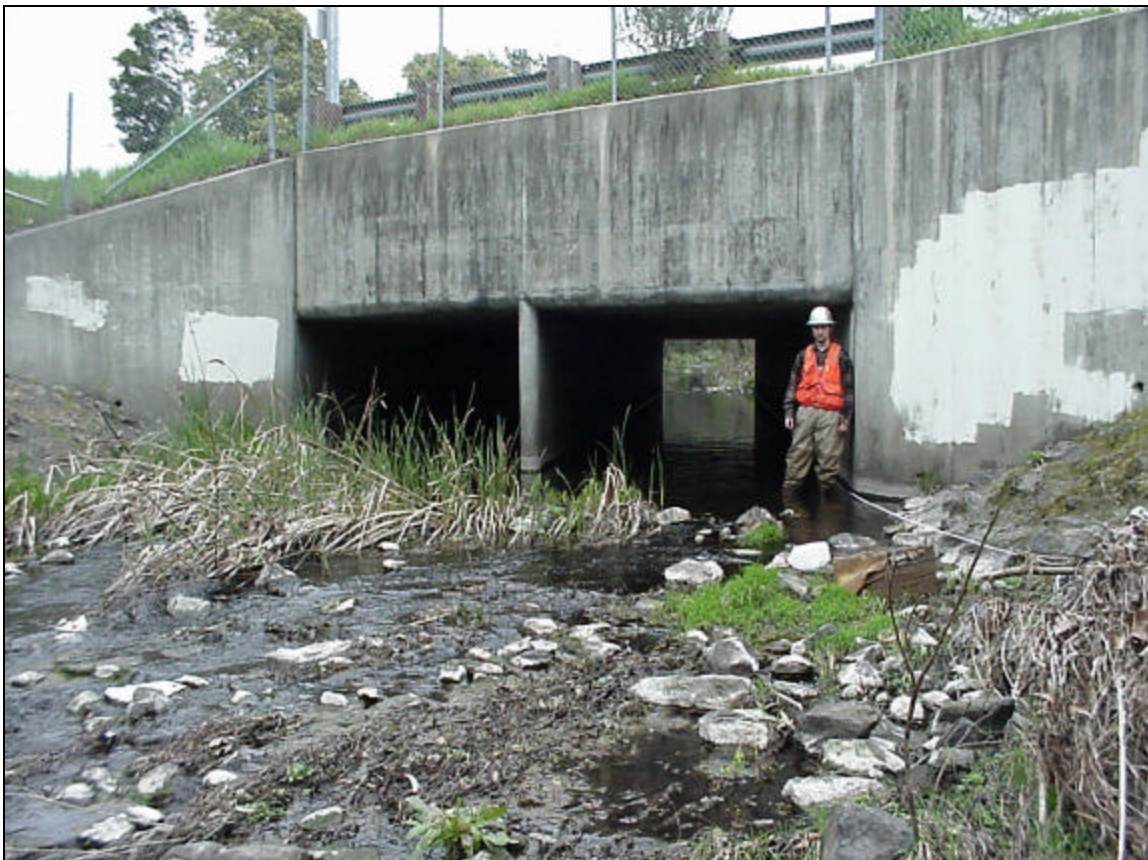
Site ID #S-035: Pauline Creek #1/Marlow Road; Piner Creek; Santa Rosa Creek; Mark West Creek; Russian River
Road Ownership: County

Culvert Type: Box, Concrete. **Corrugations:** None. **Dimensions:** 6.8' height x 10.0' width **Length:** 104.5'
Slope: 0.57% **Modifications:** None. **Rustline Height:** N/A **Average Active Channel Width:** 17.9'
Fill Estimate: 1,243 cubic yards. **Overall Condition:** Good. **Sizing:** Properly sized; HW/D = 1 on a storm flow with more than a 250-year recurrence interval. Marlow Road is overtopped on more than a 250-year storm flow.

Habitat: Quantity = approximately 21,050' of potential fish-bearing habitat upstream of Site ID# S-035. Quality = rated as “poor” for the ranking matrix as based on Taylor and Associates field notes. The crossing was surveyed by Taylor and Assoc. on 3/05/02 and there was continuous flow in the channel. At 3:30PM the air temp = 10°C and the water temp = 6°C. The culvert survey crew described the habitat as “poor” and noted a sparse riparian canopy of hardwoods. The crew noted a featureless channelized reach through residential/urban area. Stream substrate was primarily silt and mud. About 30 fish of unknown species (not salmonids) were observed upstream and downstream of Site ID #S-035.

Preferred Treatment: No treatment required because the current crossing is properly sized, in good condition, and provides unimpeded passage of all steelhead lifestages.

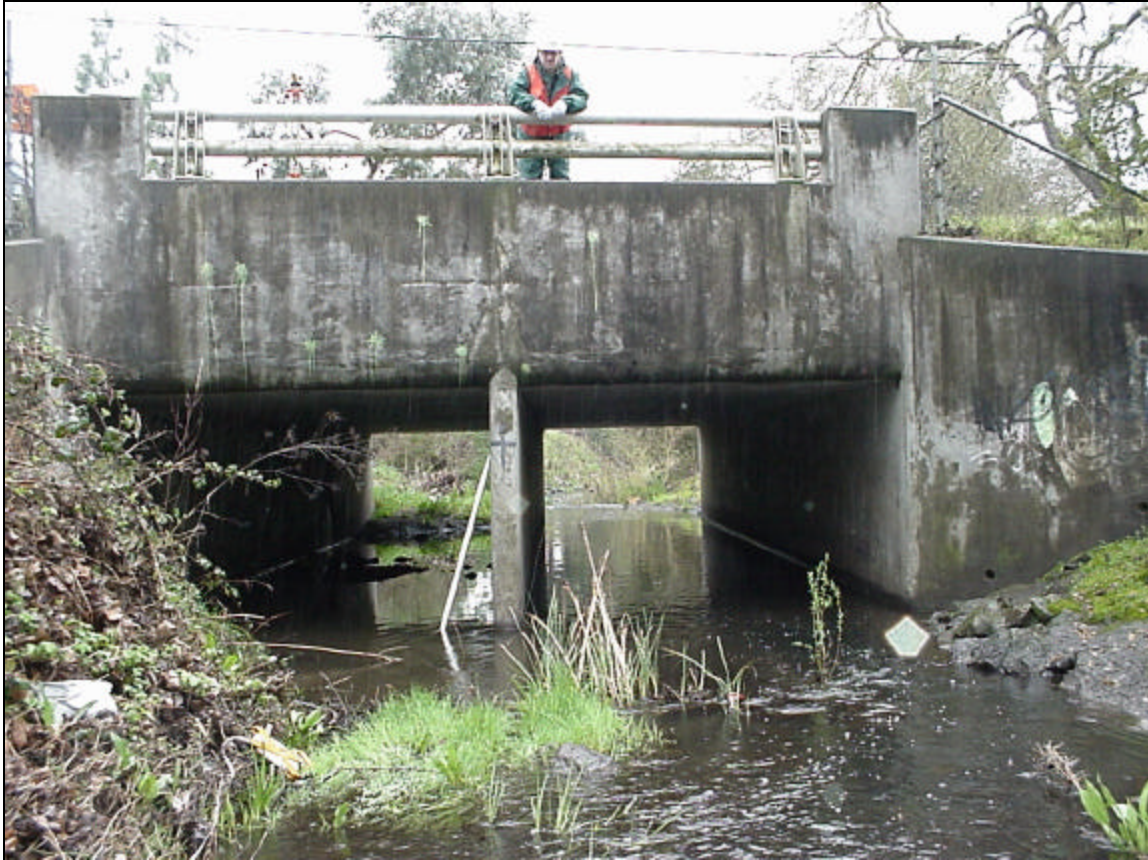
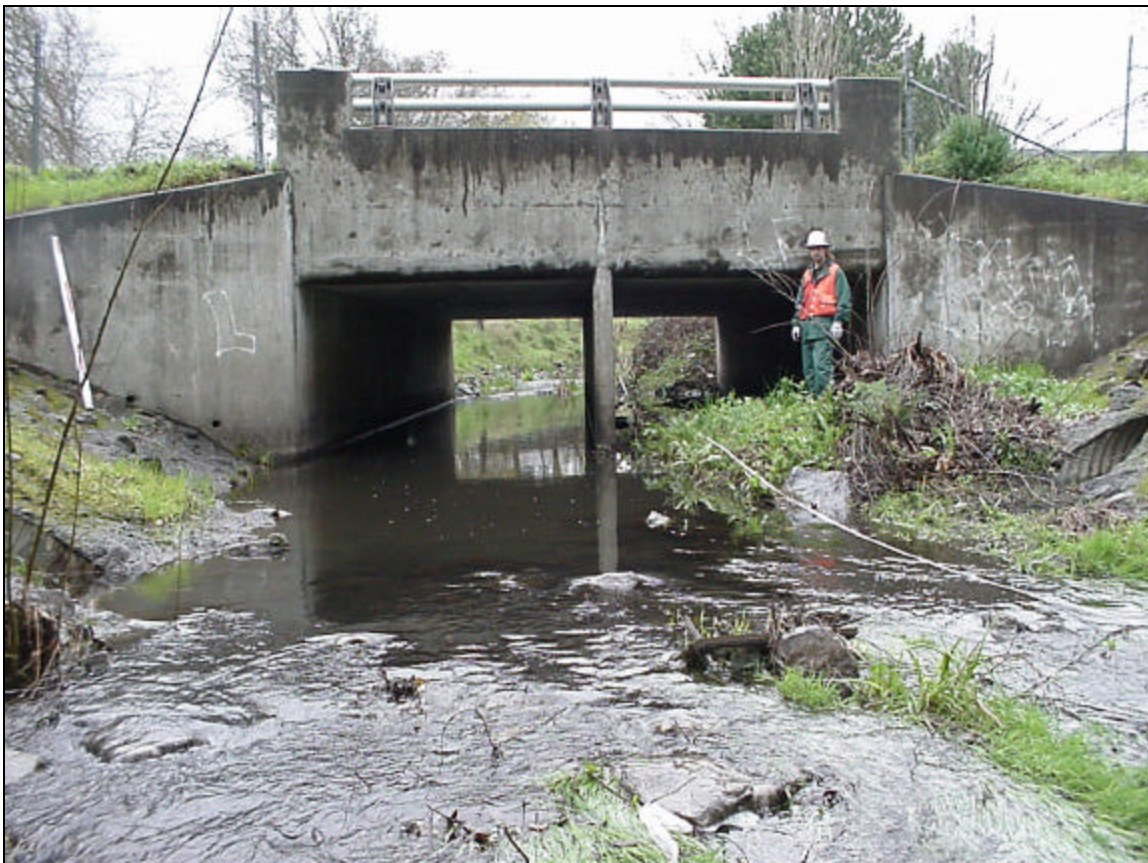
Site ID #S-036: Pauline Creek #2/Steele Lane; Piner Creek; Santa Rosa Creek; Mark West Creek; Russian River
Road Ownership: County

Culvert Type: Two Bay Box, Concrete. **Corrugations:** None. **Dimensions:** Each Bay = 6.9' height x 10.0' width
Length: 56.3' **Slopes:** LB = -1.49%; RB = 0.18% **Modifications:** None. **Rustline Height:** N/A
Average Active Channel Width: 17.1' **Fill Estimate:** 539 cubic yards. **Overall Condition:** Good. **Sizing:**
Properly sized; HW/D = 1 on a storm flow with more than a 250-year recurrence interval. Steele Lane is overtopped on more than a 250-year storm flow.

Habitat: Quantity = approximately 19,350' of potential fish-bearing habitat upstream of Site ID# S-036. Quality = rated as "fair" for the ranking matrix as based on Taylor and Associates field notes. The crossing was surveyed by Taylor and Assoc. on 3/06/02 and there was continuous flow in the channel. At 11:00AM the air temp = 15°C and the water temp = 15.5°C. The culvert survey crew described the habitat as "poor" and noted a sparse riparian canopy of hardwoods. The crew noted a featureless channelized reach both upstream and downstream of the crossing. Stream substrate was primarily mud and silt. No fish were observed.

Preferred Treatment: No treatment required because the current crossing is properly sized, in good condition, and provides nearly unimpeded passage of all steelhead lifestages.

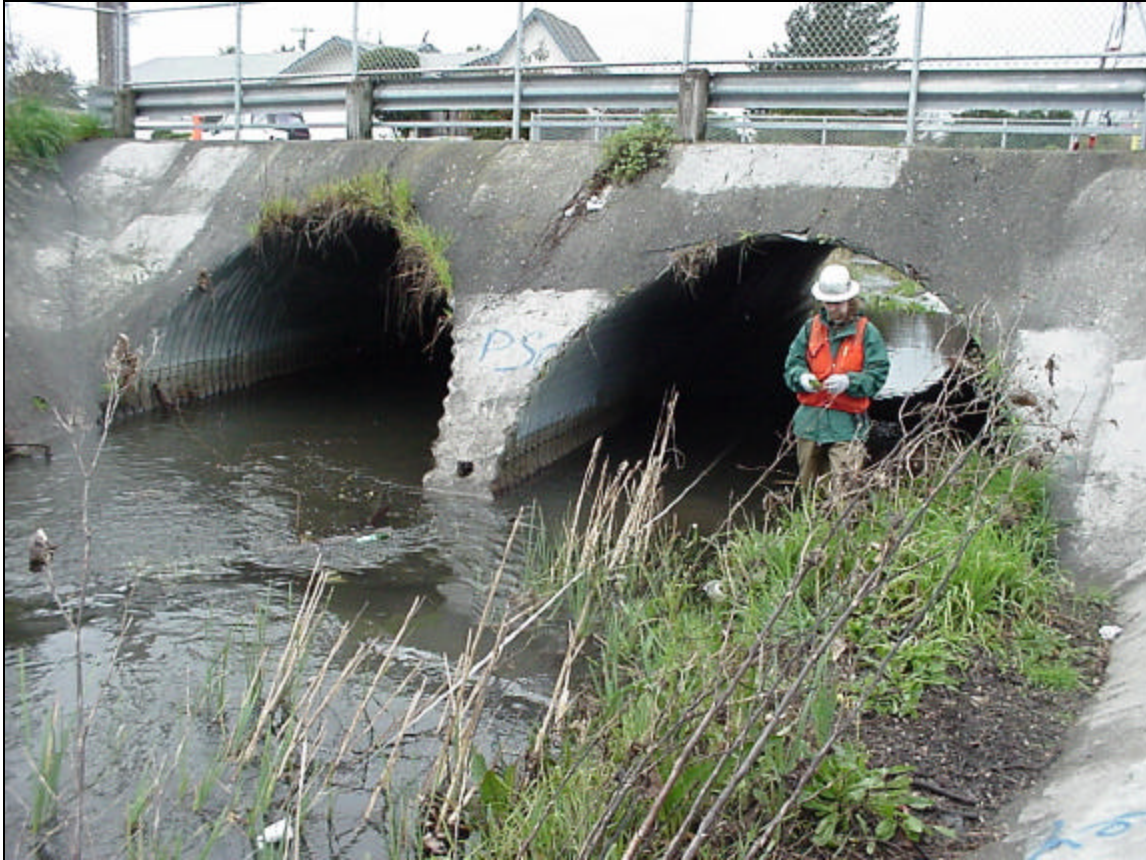
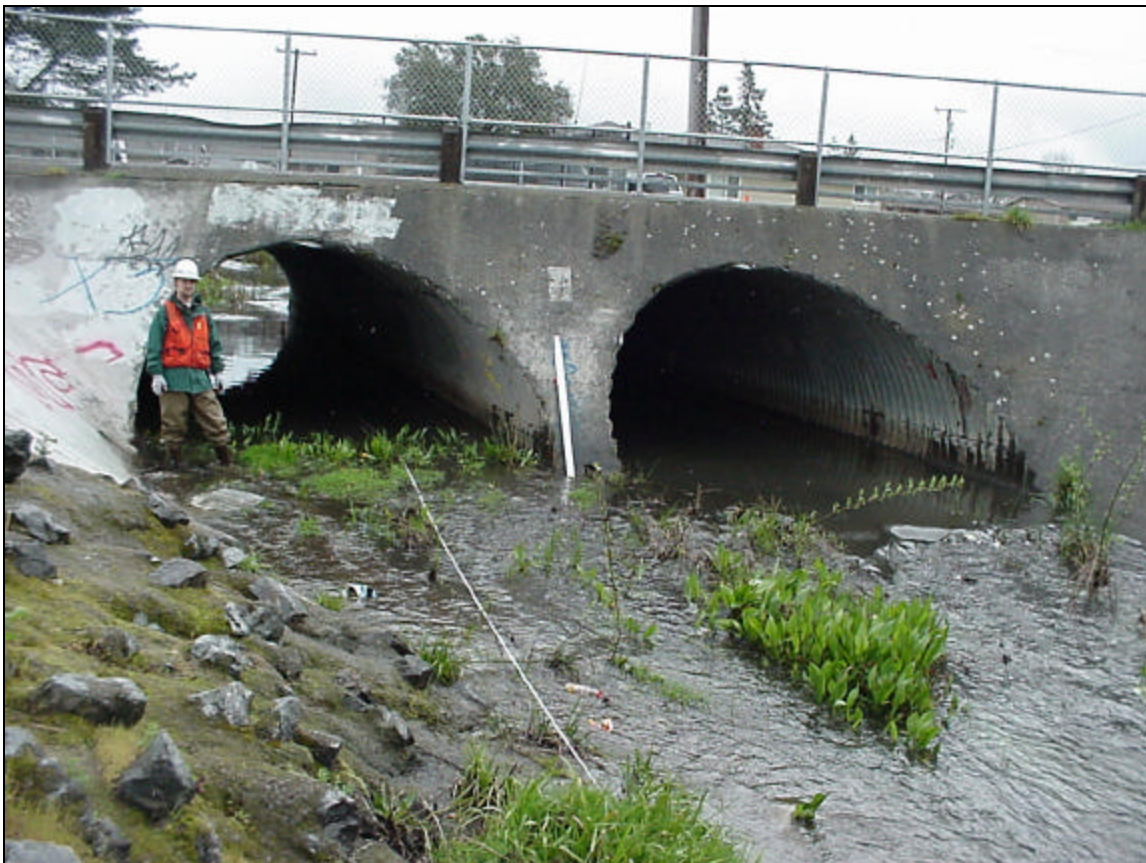
Site ID #S-037: Pauline Creek #3/Apache Way; Piner Creek; Santa Rosa Creek; Mark West Creek; Russian River
Road Ownership: City of Santa Rosa

Culvert Type: Two Pipe Arches, SSP. **Corrugations:** 6"x 2" **Dimensions:** Each Bay = 7.5' rise x 11.7' span
Lengths: LB = 74.8'; RB = 68.8' **Slopes:** LB = -0.21%; RB = -0.36% **Modifications:** None. **Rustline Height:** 1.4'
Average Active Channel Width: 19.4' **Fill Estimate:** 556 cubic yards. **Overall Condition:** Good.
Sizing: Properly sized; HW/D = 1 on a storm flow with more than a 250-year recurrence interval. Apache Way is overtopped on more than a 250-year storm flow.

Habitat: Quantity = approximately 18,150' of potential fish-bearing habitat upstream of Site ID# S-037. Quality = rated as "poor" for the ranking matrix as based on Taylor and Associates field notes. The crossing was surveyed by Taylor and Assoc. on 3/06/02 and there was continuous flow in the channel. At 12:15PM the air temp = 18°C and the water temp = 16°C. The culvert survey crew described the habitat as "poor" and noted a sparse riparian canopy of hardwoods. The crew noted a featureless channelized reach through a residential area within Santa Rosa's city limits. Stream substrate was primarily mud and silt. No fish were observed.

Preferred Treatment: No treatment required because the current crossing is properly sized, in good condition, and provides unimpeded passage of all steelhead lifestages.

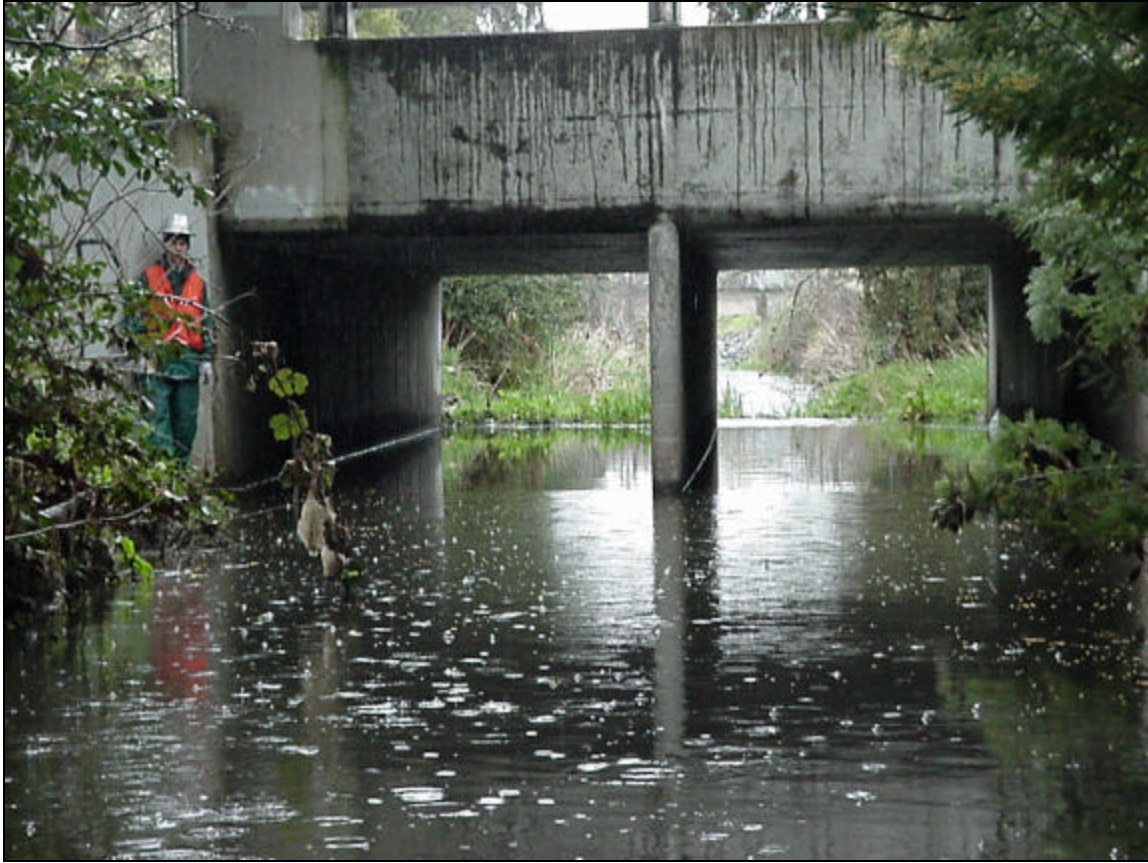
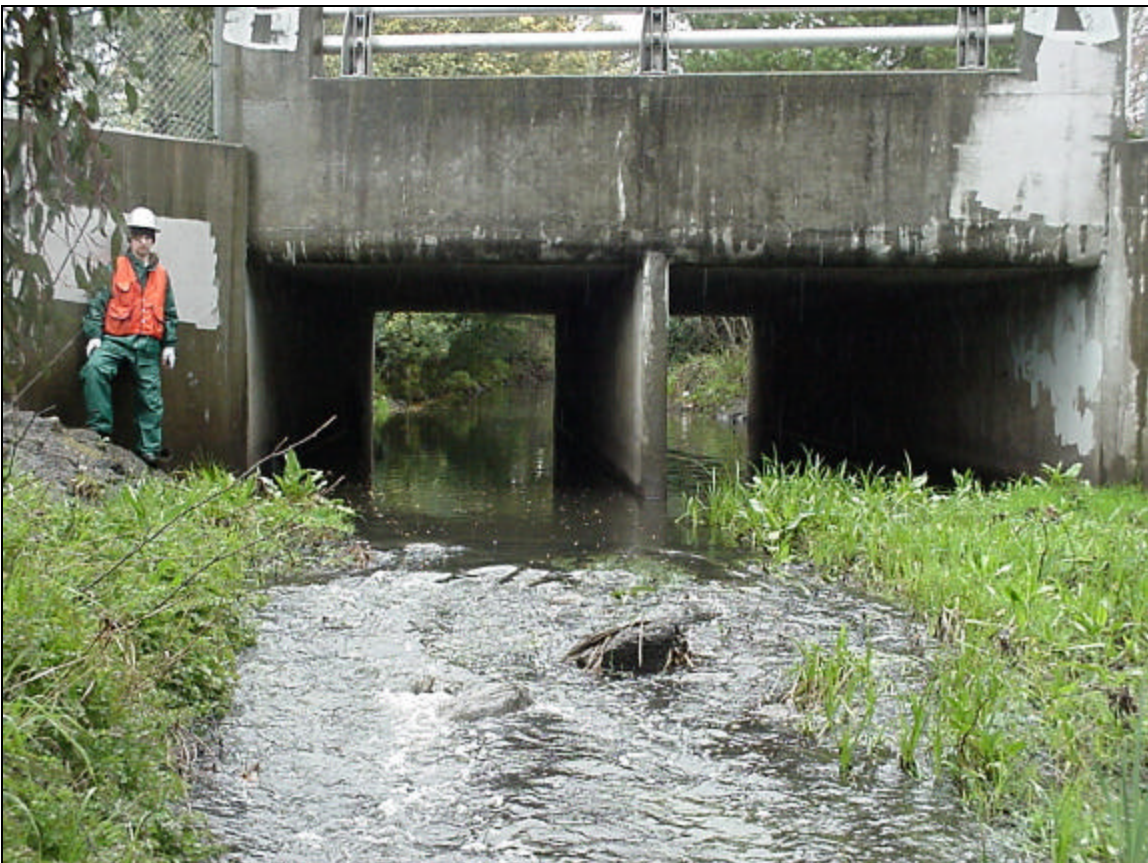
Site ID #S-038: Pauline Creek #4/Coffey Lane; Piner Creek; Santa Rosa Creek; Mark West Creek; Russian River
Road Ownership: County

Culvert Type: Two Bay Box, Concrete. **Corrugations:** None. **Dimensions:** 6.9' height x 20.0' width
Length: 61.0' **Slope:** 0.08% **Modifications:** None. **Rustline Height:** N/A **Average Active Channel Width:** 17.9'
Fill Estimate: 537 cubic yards. **Overall Condition:** Good. **Sizing:** Properly sized; HW/D = 1 on a storm flow with more than a 250-year recurrence interval. Coffey Lane is overtopped on more than a 250-year storm flow.

Habitat: Quantity = approximately 17,100' of potential fish-bearing habitat upstream of Site ID# S-038. Quality = rated as “poor” for the ranking matrix as based on Taylor and Associates field notes. The crossing was surveyed by Taylor and Assoc. on 3/06/02 and there was continuous flow in the channel. At 12:15PM the air temp = 18°C and the water temp = 16°C. The culvert survey crew described the habitat as “poor” and noted a sparse riparian canopy of hardwoods. The crew noted a featureless channelized reach through a residential area within Santa Rosa’s city limits. Stream substrate was primarily mud and silt. No fish were observed.

Preferred Treatment: No treatment required because the current crossing is properly sized, in good condition, and provides nearly unimpeded passage of all steelhead lifestages.
