CATALOG OF SONOMA COUNTY STREAM CROSSINGS WITH CULVERTS LOCATED ON FISH-BEARING STREAM REACHES WITHIN THE RUSSIAN RIVER BASIN

By
Ross Taylor and Associates

Site ID# S-001: Unnamed Tributary/Willow Creek Road; Willow Creek; Russian River **Road Ownership** County

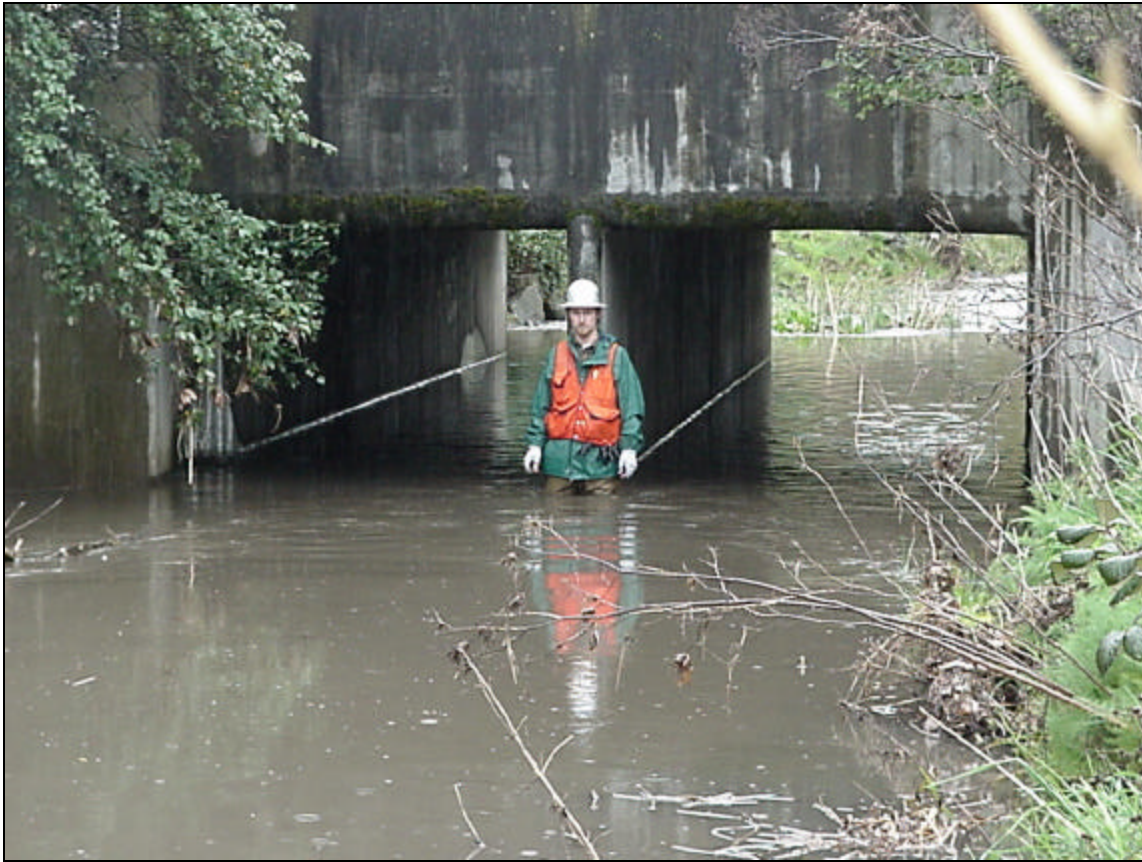
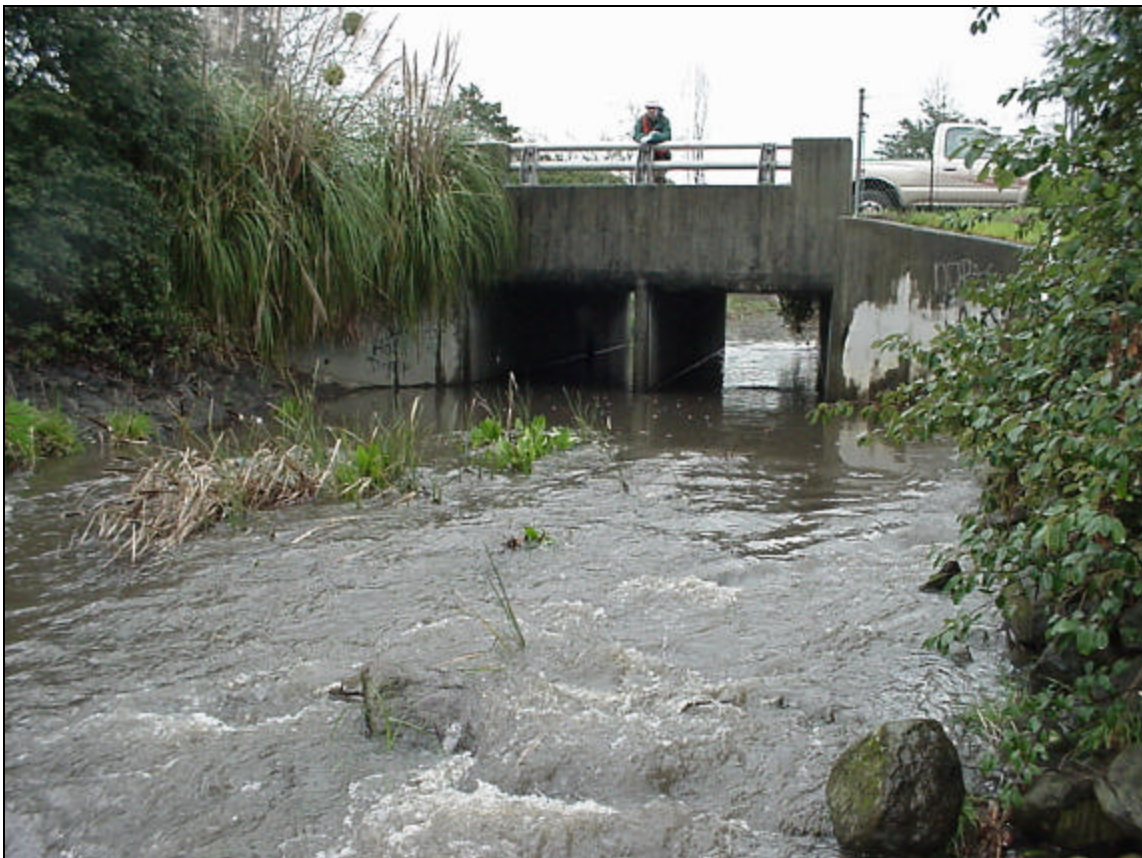
Site ID #S-039: Pauline Creek #5/Mardie's Lane; Piner Creek; Santa Rosa Creek; Mark West Creek; Russian River
Road Ownership: City of Santa Rosa

Culvert Type: Two Bay Box, Concrete. **Corrugations:** None. **Dimensions:** 7.0' height x 16.0' width
Length: 56.8' **Slope:** 0.00% **Modifications:** None. **Rustline Height:** N/A **Average Active Channel Width:** 22.4'
Fill Estimate: 566 cubic yards. **Overall Condition:** Good. **Sizing:** Properly sized; HW/D = 1 on a storm flow with approximately a 210-year recurrence interval. Mardie's Lane is overtopped on more than a 250-year storm flow.

Habitat: Quantity = approximately 15,200' of potential fish-bearing habitat upstream of Site ID# S-039. Quality = rated as "poor" for the ranking matrix as based on Taylor and Associates field notes. The crossing was surveyed by Taylor and Assoc. on 3/06/02 and there was continuous flow in the channel. At 3:15PM the air temp = 16°C and the water temp = 17°C. The culvert survey crew described the habitat as "poor" and noted a sparse riparian canopy of hardwoods. The crew noted a featureless channelized reach through a residential area within Santa Rosa's city limits. Stream substrate was primarily mud and silt. No fish were observed.

Preferred Treatment: No treatment required because the current crossing is properly sized, in good condition, and provides unimpeded passage of all steelhead lifestages.

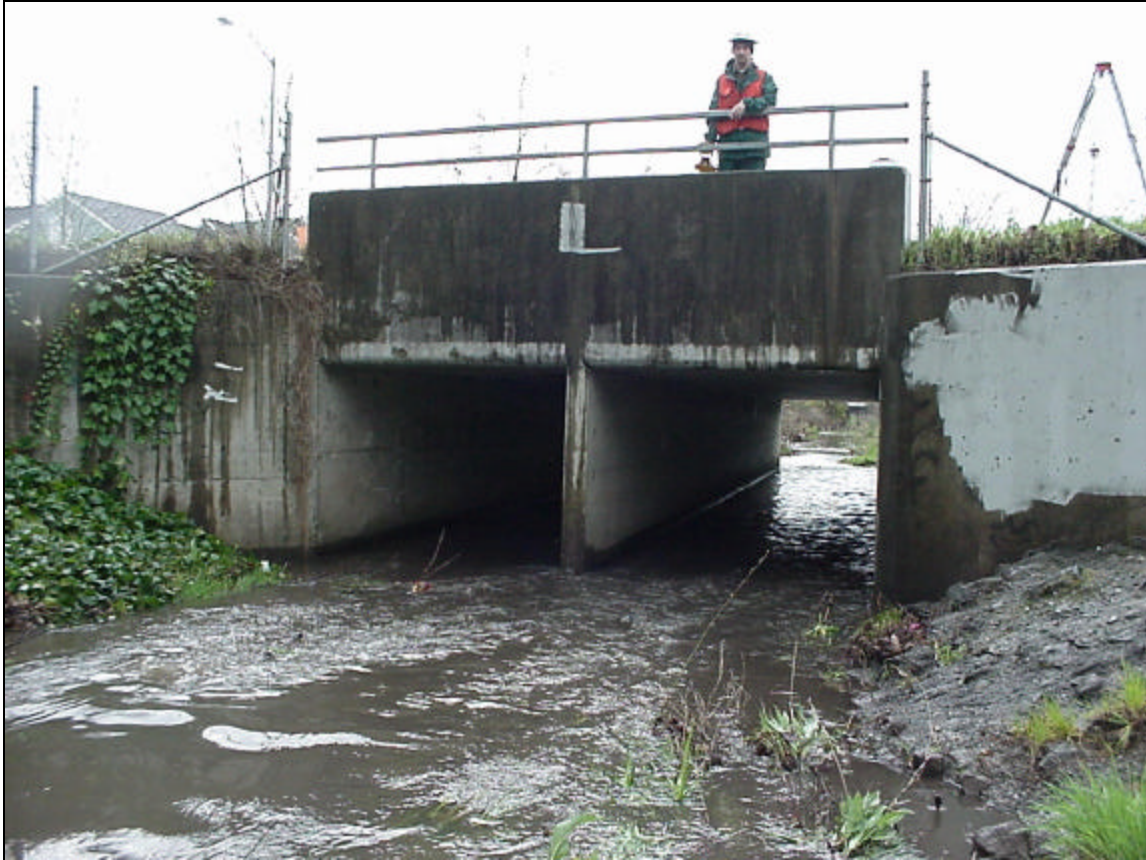
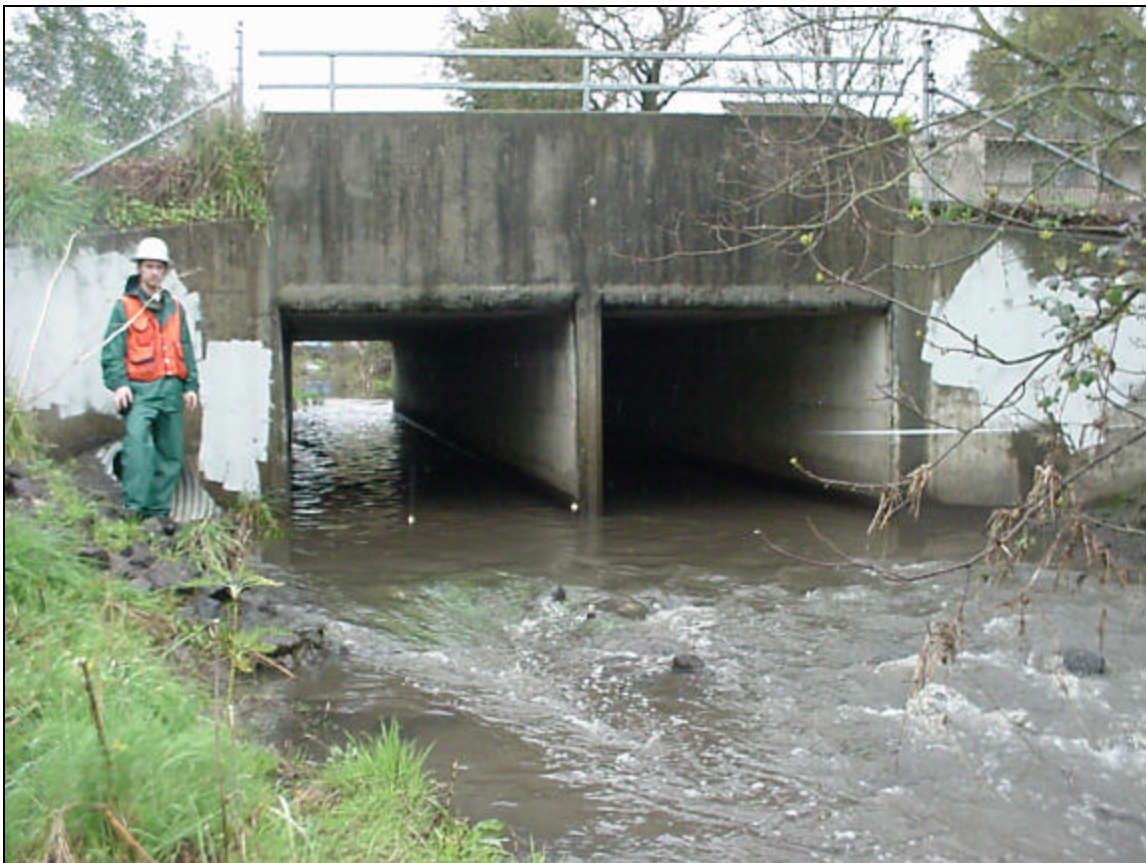
Site ID #S-040: Pauline Creek #6/Range Avenue; Piner Creek; Santa Rosa Creek; Mark West Creek; Russian River
Road Ownership: County

Culvert Type: Two Bay Box, Concrete. **Corrugations:** None. **Dimensions:** 6.9' height x 16.0' width
Length: 71.0' **Slope:** 0.41% **Modifications:** None. **Rustline Height:** N/A **Average Active Channel Width:** 20.7'
Fill Estimate: 779 cubic yards. **Overall Condition:** Good. **Sizing:** Properly sized; HW/D = 1 on a storm flow with approximately a 199-year recurrence interval. Range Avenue is overtopped on more than a 250-year storm flow.

Habitat: Quantity = approximately 14,550' of potential fish-bearing habitat upstream of Site ID# S-040. Quality = rated as “poor” for the ranking matrix as based on Taylor and Associates field notes. The crossing was surveyed by Taylor and Assoc. on 3/06/02 and there was continuous flow in the channel. At 4:00PM the air temp = 15°C and the water temp = 15.5°C. The culvert survey crew described the habitat as “poor” and noted a sparse riparian canopy of hardwoods. The crew noted a featureless channelized reach through a residential area within Santa Rosa’s city limits. Stream substrate was primarily mud and silt. No fish were observed.

Preferred Treatment: No treatment required because the current crossing is properly sized, in good condition, and provides unimpeded passage of all steelhead lifestages.

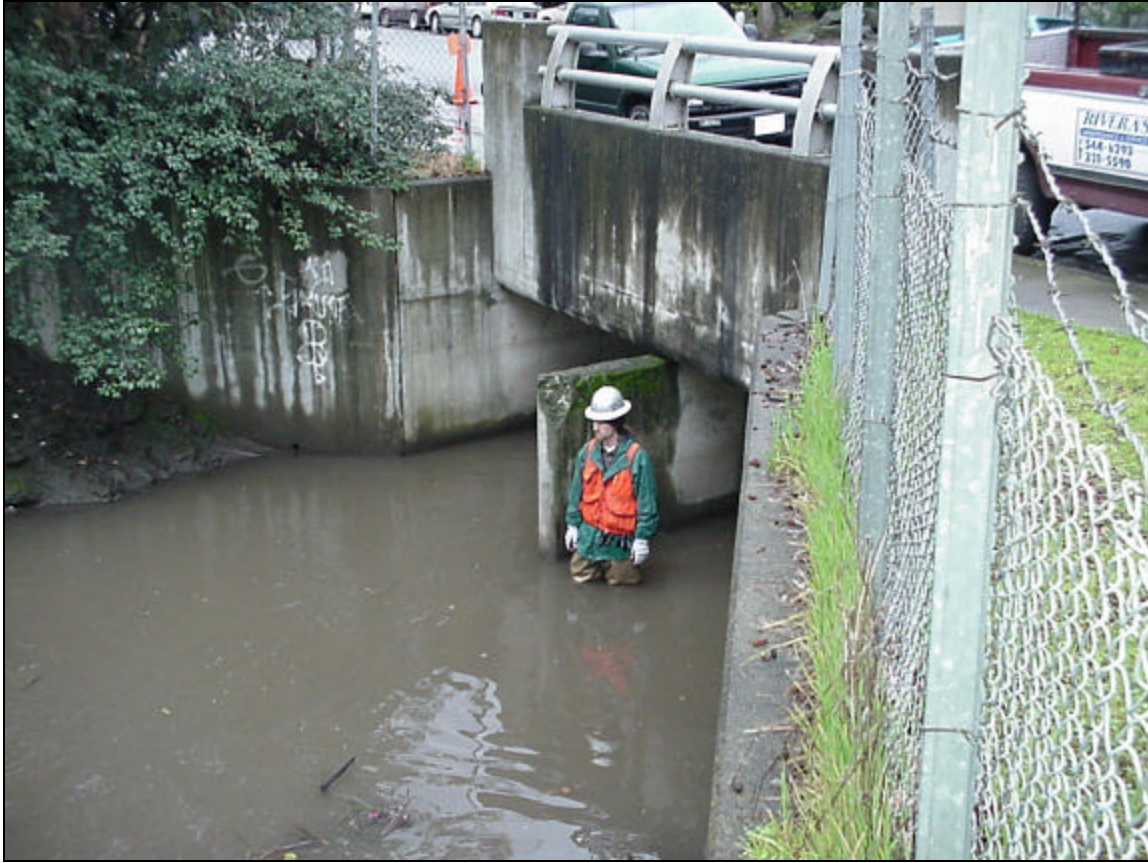
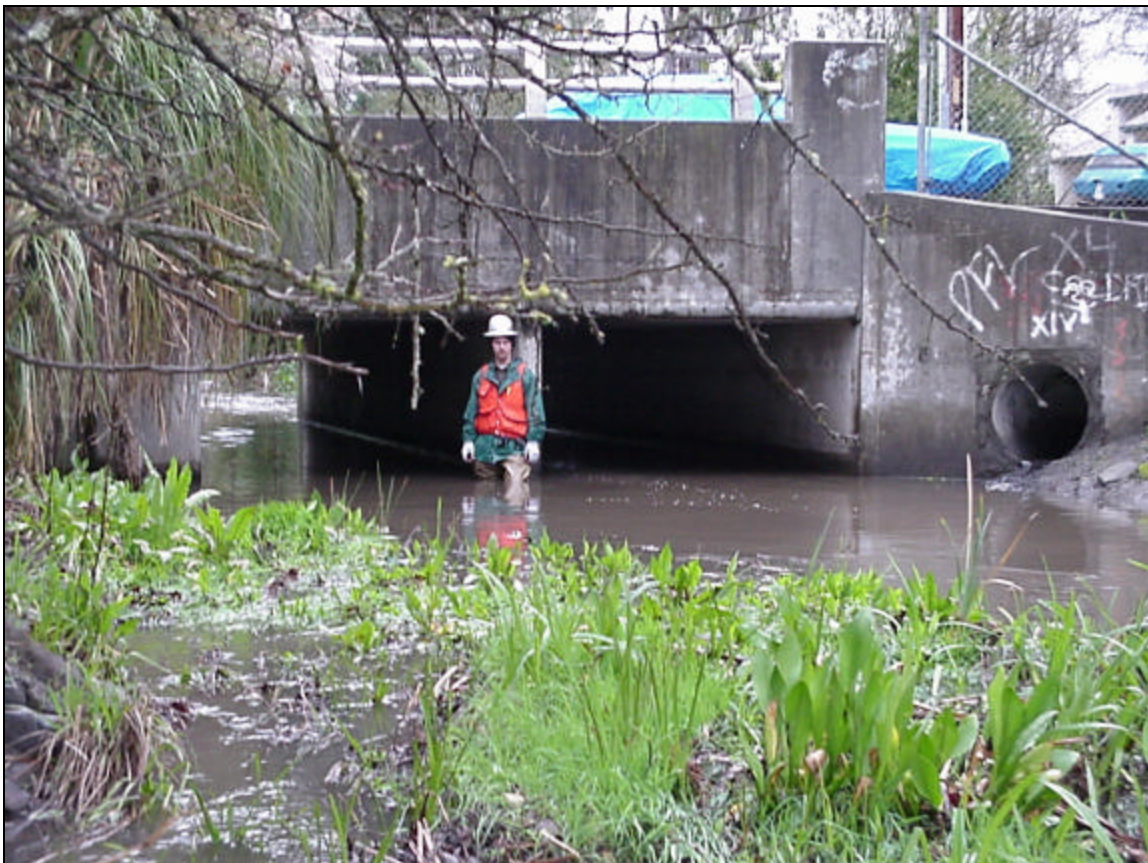
Site ID #S-041: Pauline Creek #7/McBride Lane; Piner Creek; Santa Rosa Creek; Mark West Creek; Russian River
Road Ownership: City of Santa Rosa

Culvert Type: Two Bay Box, Concrete. **Corrugations:** None. **Dimensions:** 5.9' height x 16.0' width
Length: 54.3' **Slope:** 0.41% **Modifications:** None. **Rustline Height:** N/A **Average Active Channel Width:** 21.2'
Fill Estimate: 553 cubic yards. **Overall Condition:** Good. **Sizing:** Undersized; HW/D = 1 on a storm flow with approximately a 61-year recurrence interval. McBride Lane is overtopped on more than a 250-year storm flow.

Barrier Status: **GREEN:** the Green-Gray-Red filter determined this crossing fails to meet passage criteria for adult steelhead and all age classes of juveniles.

Habitat: Quantity = approximately 13,800' of potential fish-bearing habitat upstream of Site ID# S-041. Quality = rated as "poor" for the ranking matrix as based on Taylor and Associates field notes. The crossing was surveyed by Taylor and Assoc. on 3/06/02 and there was continuous flow in the channel. At 5:00PM the air temp = 16°C and the water temp = 17°C. The culvert survey crew described the habitat as "poor" and noted a sparse riparian canopy of hardwoods. The crew noted a featureless channelized reach through a residential area within Santa Rosa's city limits. Stream substrate was primarily mud and silt. No fish were observed.

Preferred Treatment: No treatment required because the current crossing is properly sized, in good condition, and provides unimpeded passage of all steelhead lifestages.

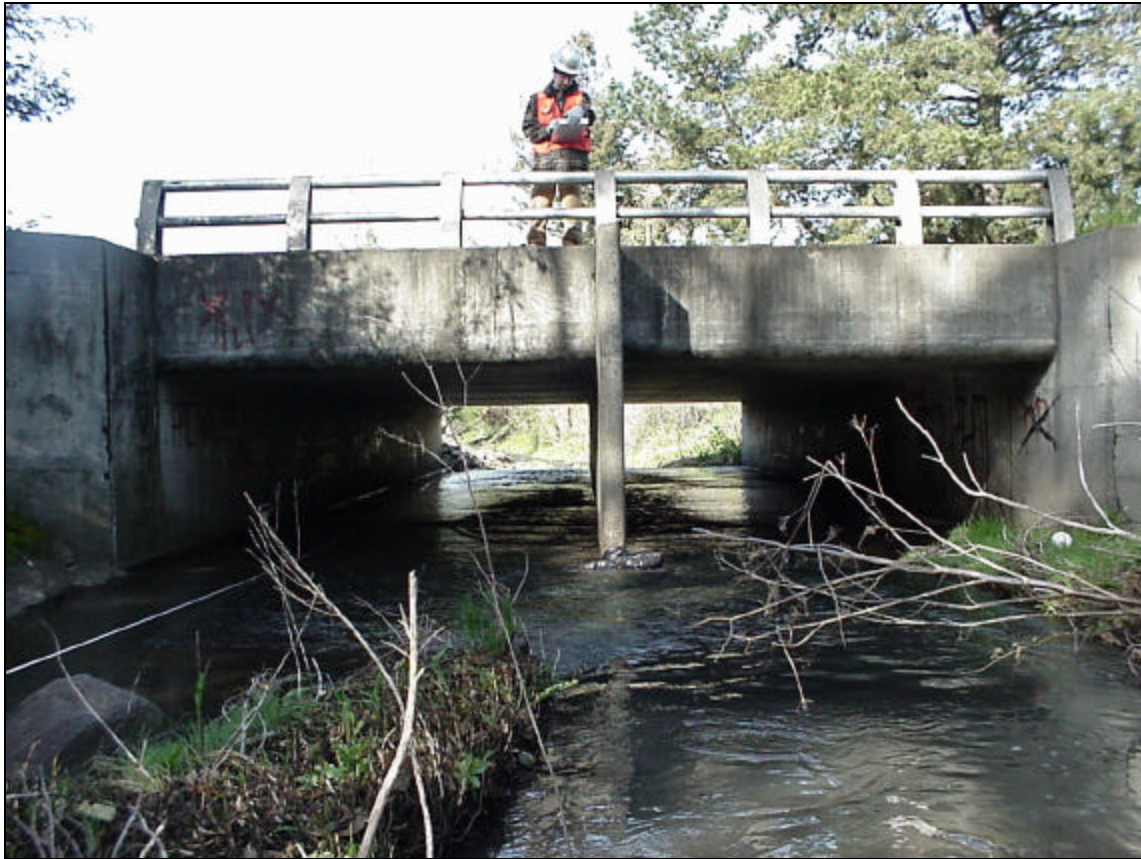
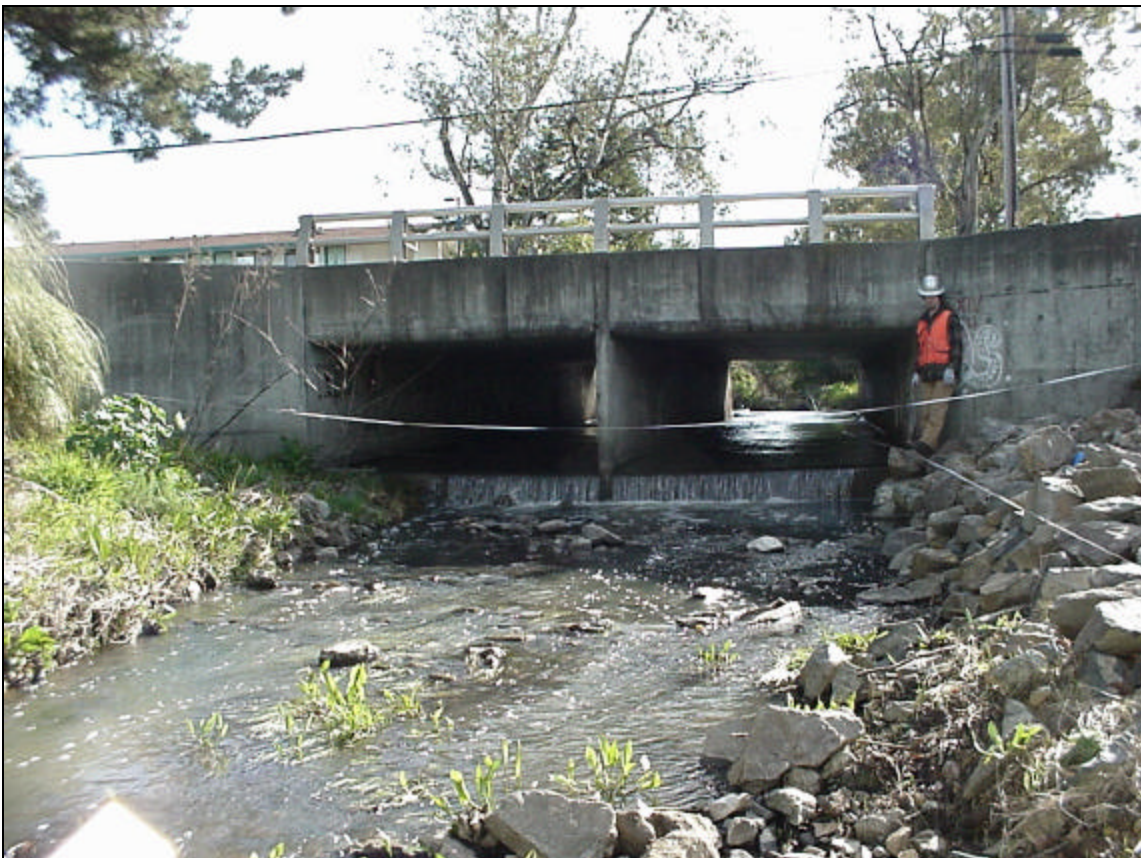
Barrier Status: **GRAY:** FishXing determined this crossing meets the 8-16-16 ft/sec passage criteria for adult steelhead on 47% of the range of expected migration flows and all fails to meet passage criteria for all age classes of juvenile salmonids. For all juveniles, the perched outlet (1.8') is the crossing's primary feature that impedes passage.

Habitat: Quantity = approximately 13,250' of potential fish-bearing habitat upstream of Site ID# S-042. Quality = rated as "poor" for the ranking matrix as based on Taylor and Associates field notes. The crossing was surveyed on 3/08/02 and there was continuous flow in the channel. At 8:30AM the air temp = 8°C and the water temp = 12°C. The culvert survey crew described the habitat as "poor" and noted a sparse riparian canopy of hardwoods. The crew noted a featureless channelized reach through a residential area within Santa Rosa's city limits. Stream substrate was primarily mud and silt. No fish were observed. Homeless encampment upstream by Highway 101 crossing.

Preferred Treatment: Because the current crossing is properly sized and in good condition, a retrofit is recommended. Construction of three to four boulder weirs downstream of the crossing to raise tail-water elevation and the installation of corner baffles within the culvert should cost-effectively improve fish passage.

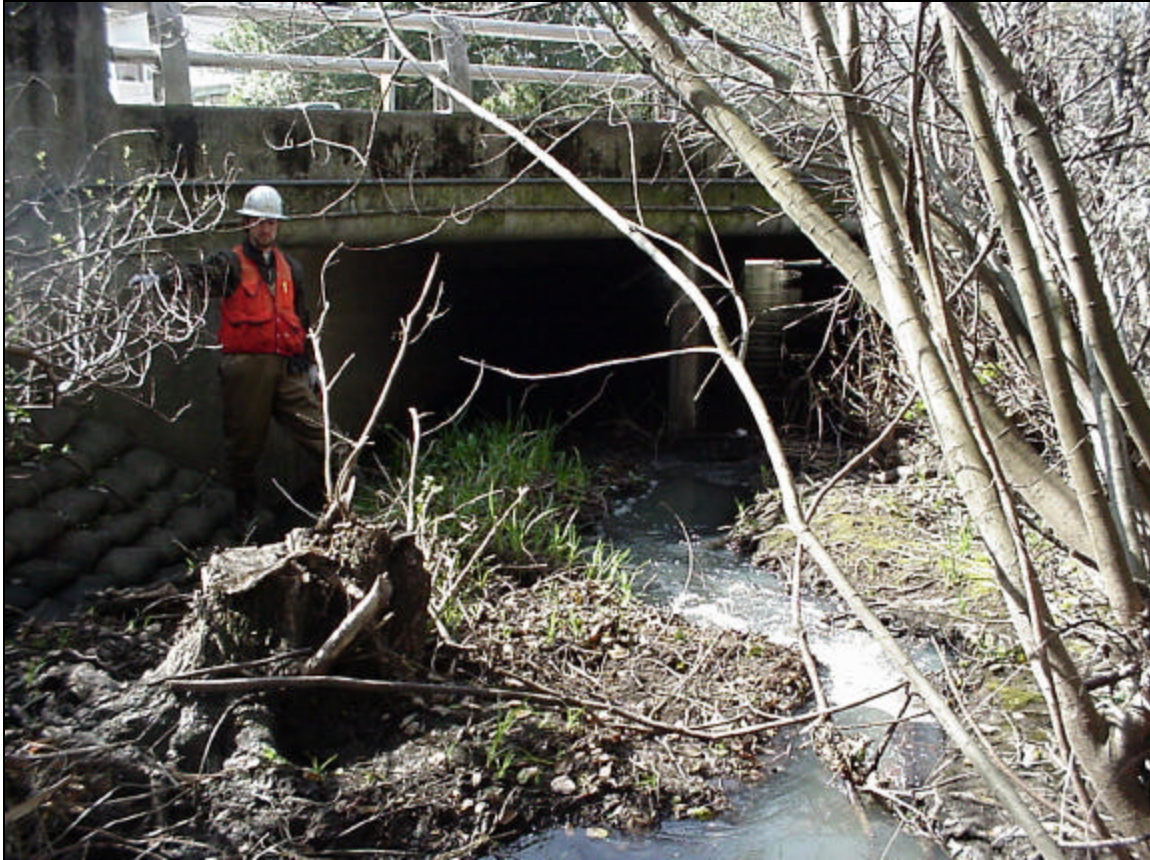
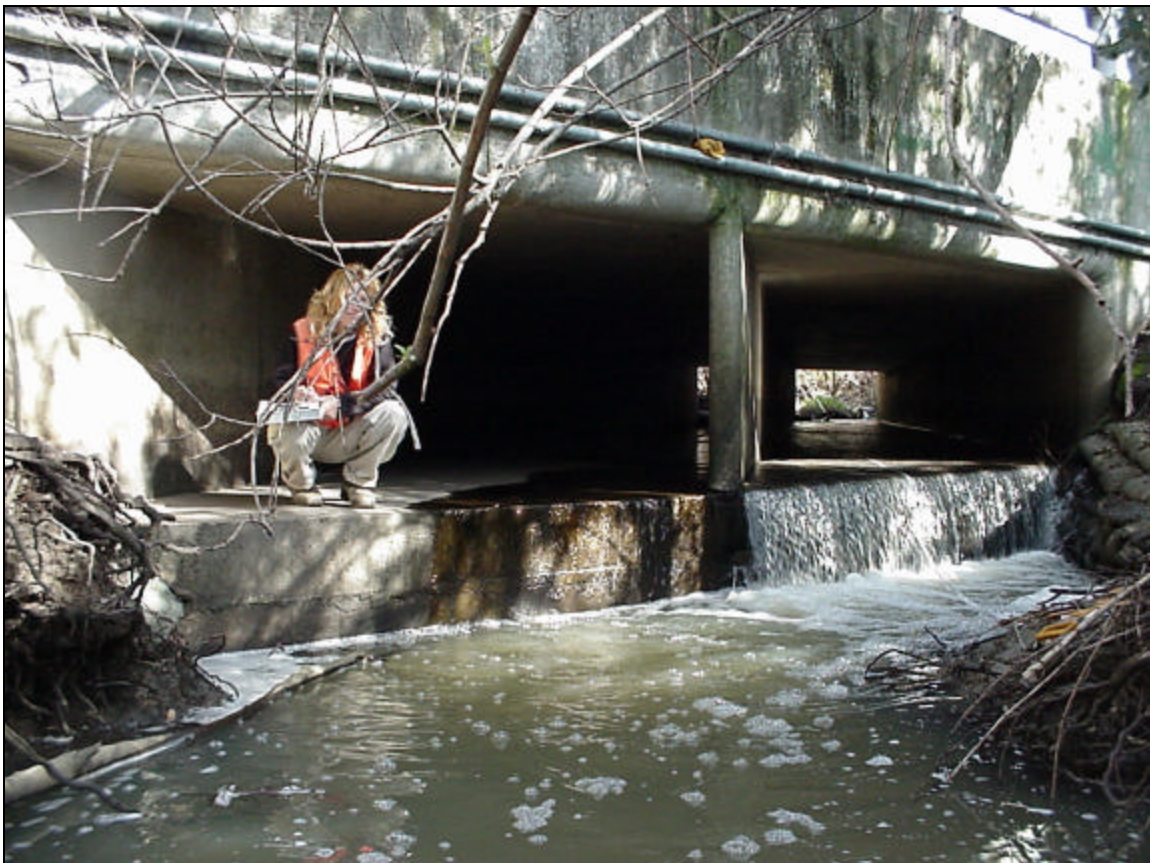
Site ID #S-043: Pauline Creek #9/Chanate Road; Piner Creek; Santa Rosa Creek; Mark West Creek; Russian River
Road Ownership: County
County Ranking: Tied for #21 = Moderate-Priority **Basin-wide Ranking:** Tied for #28 = Moderate-Priority

Culvert Type: Two Bay Box, Concrete. **Corrugations:** None. **Dimensions:** 4.0' height x 14.0' width
Length: 89.0' **Slope:** 1.06% **Modifications:** None. **Rustline Height:** N/A **Average Active Channel Width:** 14.0' **Fill Estimate:** 474 cubic yards. **Overall Condition:** Good. **Sizing:** Extremely undersized; HW/D = 1 on a storm flow with approximately a three-year recurrence interval. Chanate Road is overtopped on approximately a 66-year storm flow.

Barrier Status: **GRAY:** FishXing determined this crossing meets the 8-16-16 ft/sec passage criteria for adult steelhead on 37% of the range of expected migration flows and all fails to meet passage criteria for all age classes of juvenile salmonids. For all juveniles, the perched outlet (1.8') is the crossing's primary feature that impedes passage.

Habitat: Quantity = approximately 10,300' of potential fish-bearing habitat upstream of Site ID# S-043. Quality = rated as "poor" for the ranking matrix as based on Taylor and Associates field notes. The crossing was surveyed on 3/08/02 and there was continuous flow in the channel. At 10:15AM the air temp = 13°C and the water temp = 12°C. The culvert survey crew described the habitat as "poor" and noted a dense riparian canopy of hardwoods, but still a featureless channelized reach through a residential area within Santa Rosa's city limits. Upstream of the crossing the in-stream habitat appeared to start to improve. No fish were observed.

Preferred Treatment: Because the current box culvert is extremely undersized, a retrofit may not be feasible. Three to four downstream boulder weirs would raise tail-water elevation and possibly back-water the culvert. The installation of corner baffles within the culvert is not recommended due to the already low storm-flow capacity. A full replacement is the best long-term solution for improving fish passage and storm flow conveyance, but this is probably cost-prohibitive due to the poor quality of the habitat in Pauline Creek.

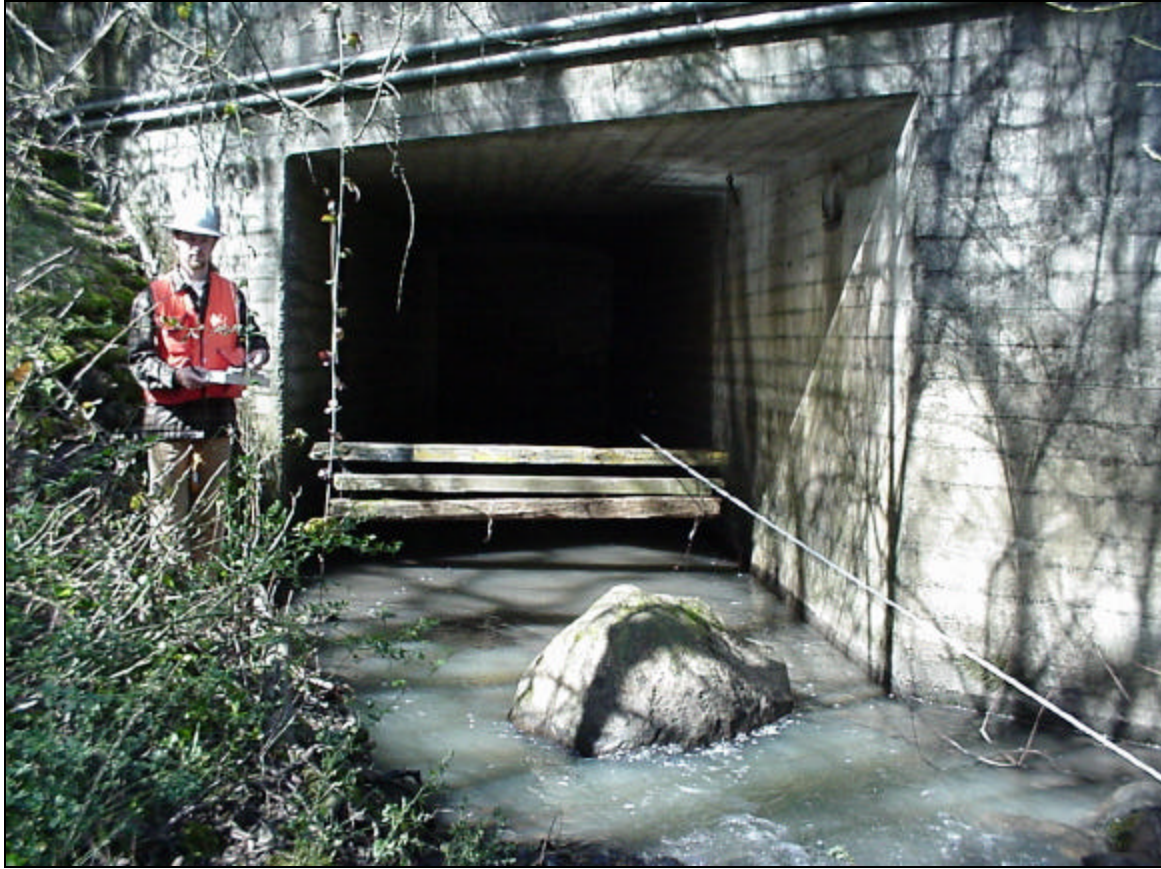
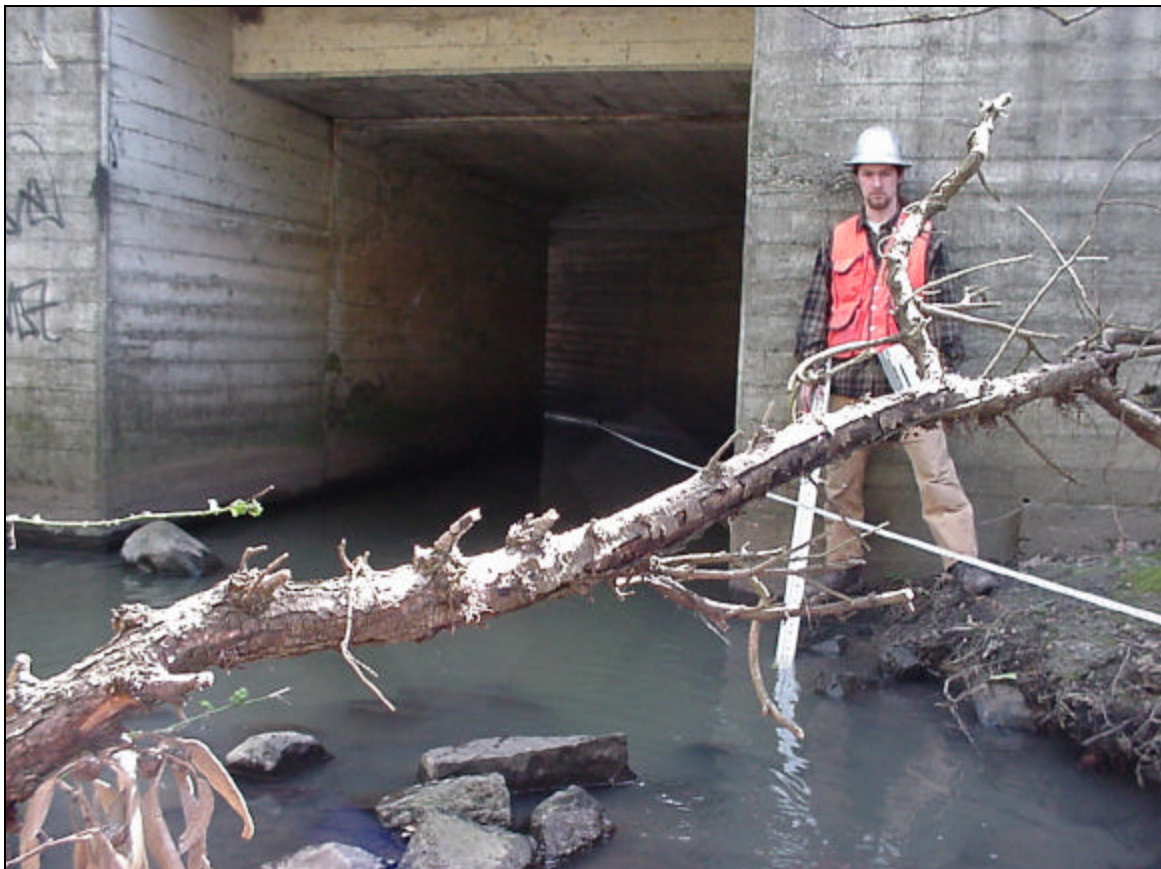
Site ID #S-044: Pauline Creek #10/Chanate Road; Piner Creek; Santa Rosa Creek; Mark West Creek; Russian River
Road Ownership: County
County Ranking: Tied for #53 = Low-Priority **Basin-wide Ranking:** less than 20.0 points – not ranked

Culvert Type: Box, Concrete. **Corrugations:** None. **Dimensions:** 8.6' height x 8.9' width **Length:** 62.0'
Slope: 0.97% **Modifications:** None. **Rustline Height:** N/A **Average Active Channel Width:** 13.0'
Fill Estimate: 1,186 cubic yards. **Overall Condition:** Good. **Sizing:** Undersized; HW/D = 1 on a storm flow with approximately a 44-year recurrence interval. Chanate Road is overtopped on more than a 250-year storm flow.

Barrier Status: **GRAY:** FishXing determined this crossing meets the 8-16-16 ft/sec passage criteria for adult steelhead on 54% of the range of expected migration flows and all fails to meet passage criteria for all age classes of juvenile salmonids. For adults, lack-of-depth is the only passage criteria violation – actual passage may be higher than predicted by FishXing. For older juveniles, there is only a lack-of-depth violation up to 8 c.f.s. - then excessive velocities occur. For 1+/young-of-year juveniles excessive velocities is the primary factor that impedes passage.

Habitat: Quantity = approximately 8,100' of potential fish-bearing habitat upstream of Site ID# S-044. Quality = rated as “fair” for the ranking matrix as based on Taylor and Associates field notes. The crossing was surveyed on 3/08/02 and there was continuous flow in the channel. At 11:30AM the air temp = 16°C and the water temp = 13°C. The culvert survey crew described the habitat as “fair to good” and noted a moderately dense riparian canopy of hardwoods, and finally a more natural channel upstream of Santa Rosa’s city limits. No fish were observed.

Preferred Treatment: None recommended because crossing provides adequate adult passage and probably some juvenile passage. Also, downstream crossing is a more serious impediment to migration.

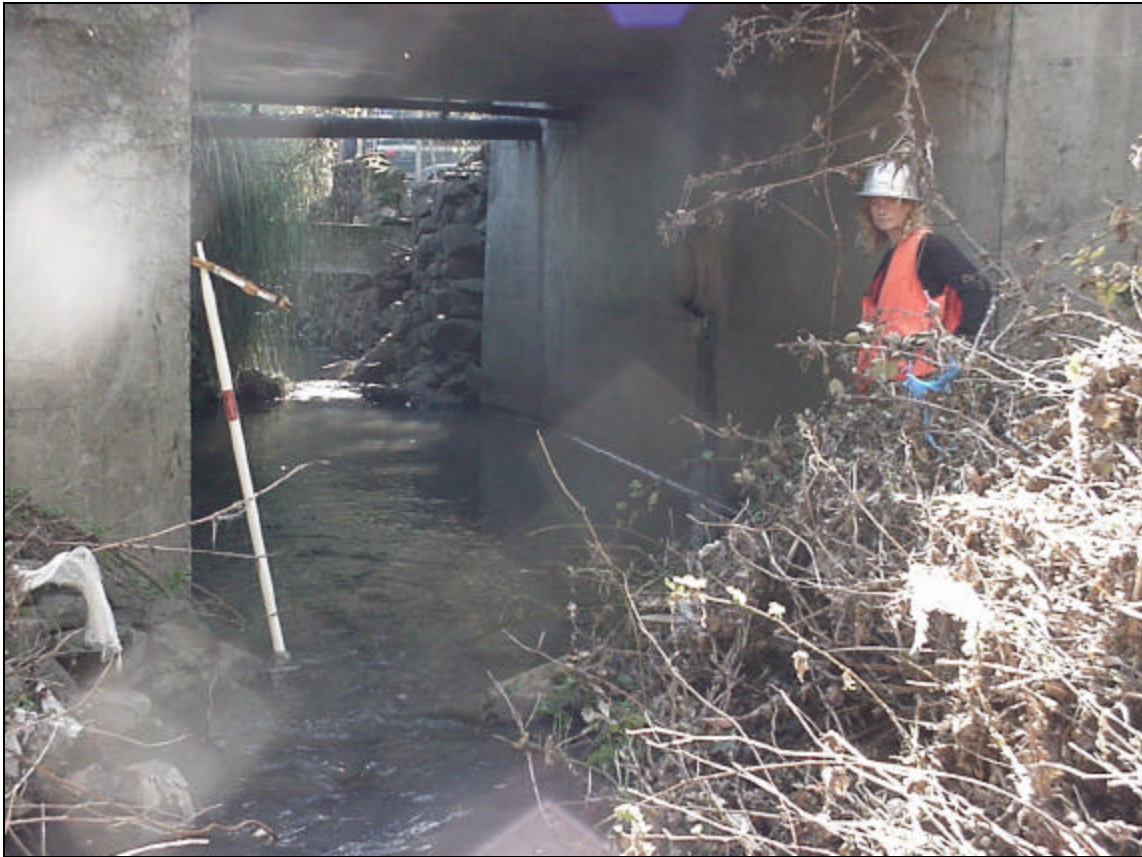
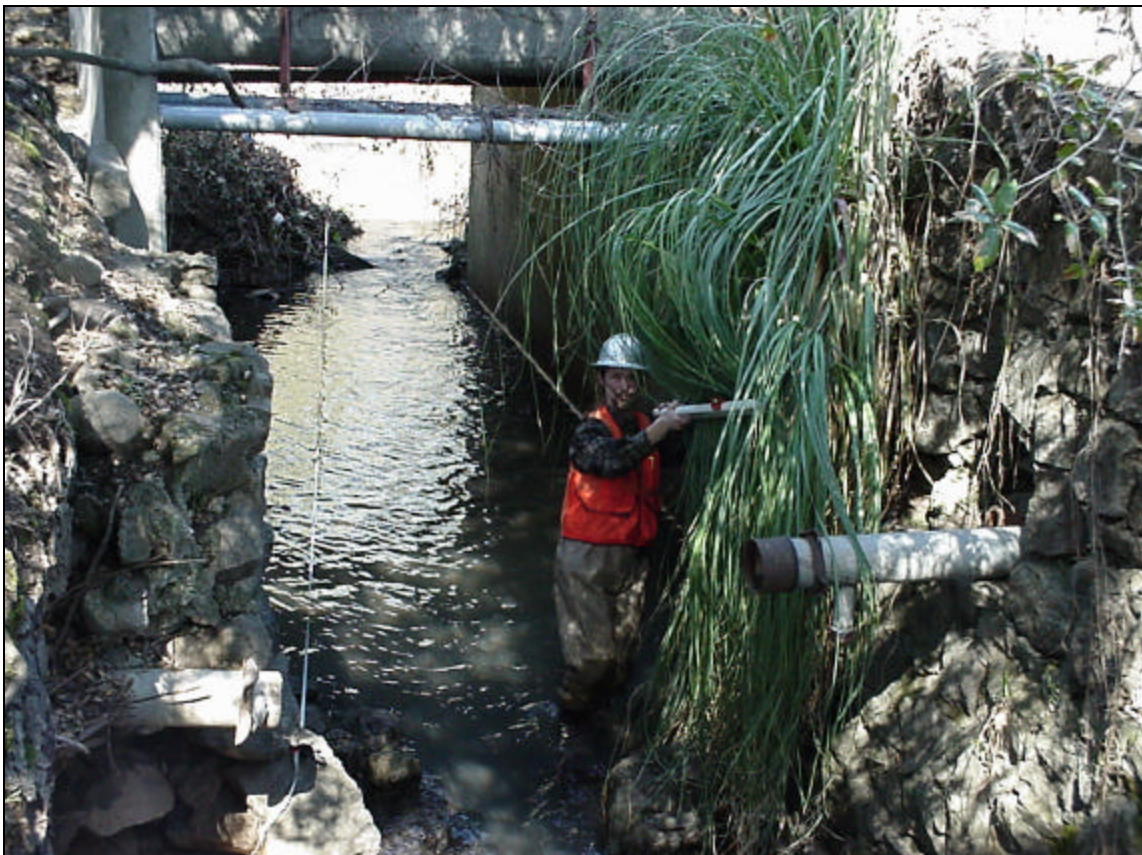
Site ID #S-045: Pauline Creek #11/County Farm Road; Piner Creek; Santa Rosa Ck; Mark West Ck; Russian River

Culvert Type: Box, Concrete. **Corrugations:** None. **Dimensions:** 10.0' height x 9.0' width **Length:** 29.8'
Slope: 0.64% **Modifications:** None. **Rustline Height:** N/A **Average Active Channel Width:** 8.4'
Fill Estimate: 151 cubic yards. **Overall Condition:** Good. **Sizing:** Properly sized; HW/D = 1 on a storm flow with more than a 250-year recurrence interval. County Farm Road is overtopped on more than a 250-year storm flow.

Habitat: Quantity = approximately 4,450' of potential fish-bearing habitat upstream of Site ID# S-045. Quality = rated as “fair” for the ranking matrix as based on Taylor and Associates field notes. The crossing was surveyed on 3/08/02 and there was continuous flow in the channel. At 1:40PM the air temp = 14°C and the water temp = 15°C. The survey crew described the habitat as “fair” and noted a moderately dense riparian canopy of hardwoods and brush. Overall there was a more natural channel than the reach through Santa Rosa city limit. No fish were observed.

Preferred Treatment: None recommended because crossing provides unimpeded passage, is properly sized, and is in good condition.

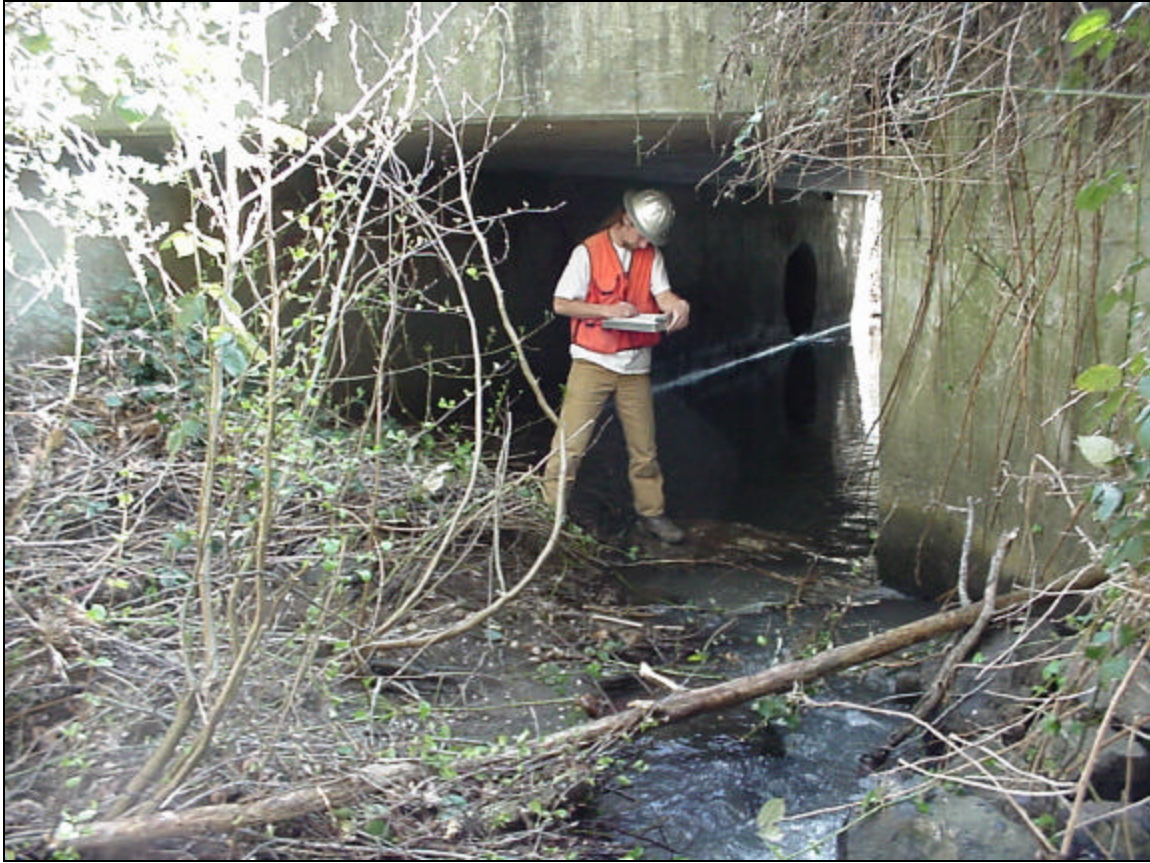
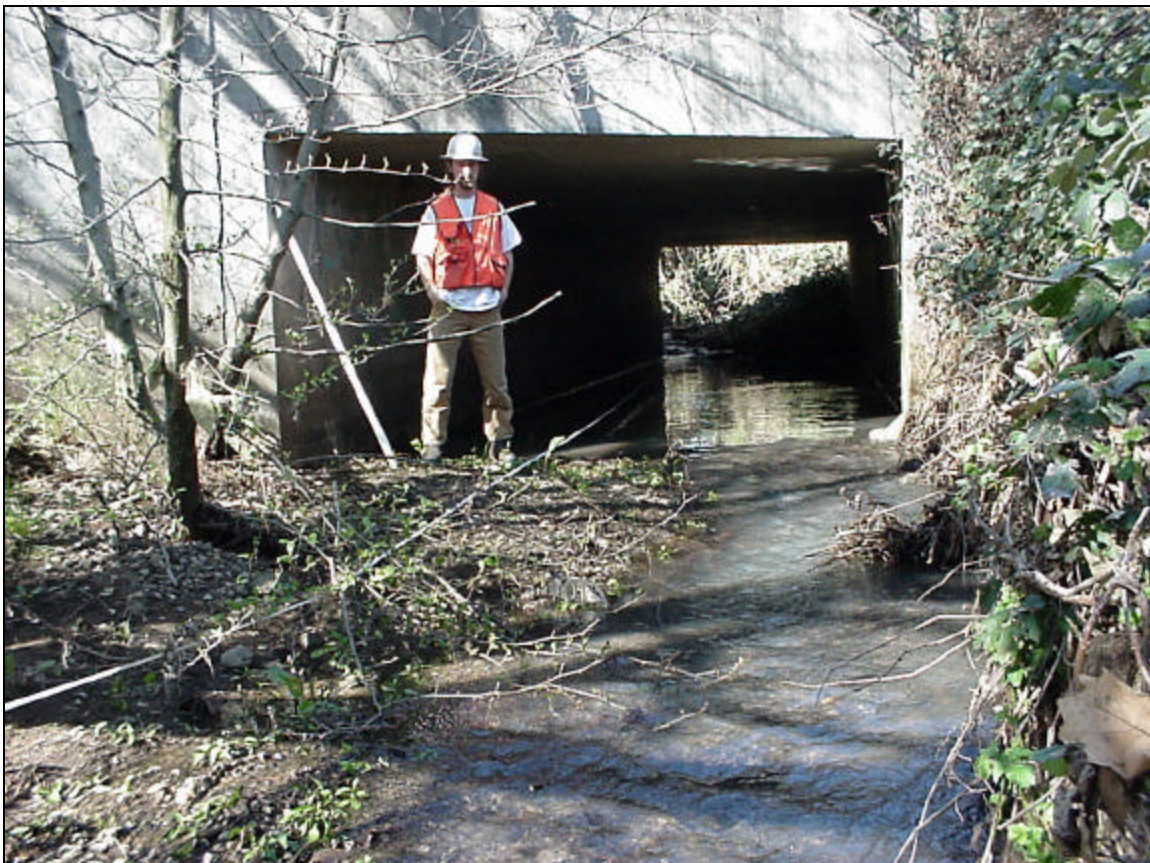
Site ID #S-046: Pauline Creek #12/Chanate Road; Piner Creek; Santa Rosa Creek; Mark West Creek; Russian River
Road Ownership: County

Culvert Type: Box, Concrete. **Corrugations:** None. **Dimensions:** 8.0' height x 11.9' width **Length:** 54.8'
Slope: -0.80% **Modifications:** None. **Rustline Height:** N/A **Average Active Channel Width:** 10.6'
Fill Estimate: 331 cubic yards. **Overall Condition:** Good. **Sizing:** Properly sized; HW/D = 1 on a storm flow with more than a 250-year recurrence interval. Chanate Road is overtopped on more than a 250-year storm flow.

Barrier Status: **GRAY:** FishXing determined this crossing meets the 8-16-16 ft/sec passage criteria for adult steelhead on 82% of the range of estimated migration flows, meets passage criteria for resident/2+ fish on 60% of the range of estimated migration flows, and 22% of the migration flows for 1+/young-of-year juvenile salmonids. Actual passage of juveniles may be higher than predicted by FishXing because lack-of-depth is the primary violation.

Habitat: Quantity = approximately 3,550' of potential fish-bearing habitat upstream of Site ID# S-046. Quality = rated as "fair" for the ranking matrix as based on Taylor and Associates field notes. The crossing was surveyed on 3/08/02 and there was continuous flow in the channel. At 2:30PM the air temp = 19°C and the water temp = 15°C. The survey crew described the habitat as "fair" and noted a moderately dense riparian canopy of hardwoods and brush. Overall there was a more natural channel than the reach through Santa Rosa city limit. No fish were observed.

Preferred Treatment: None recommended because crossing provides adequate passage, is properly sized, and is in good condition.

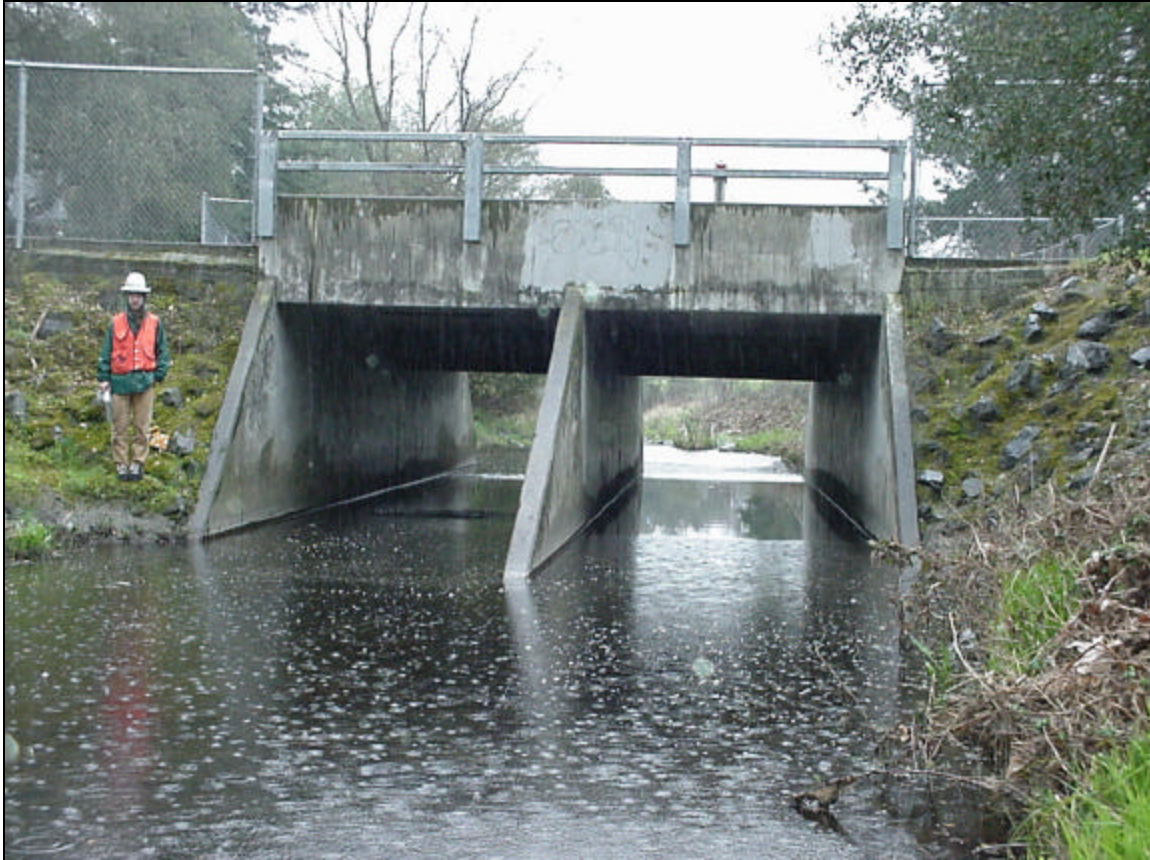
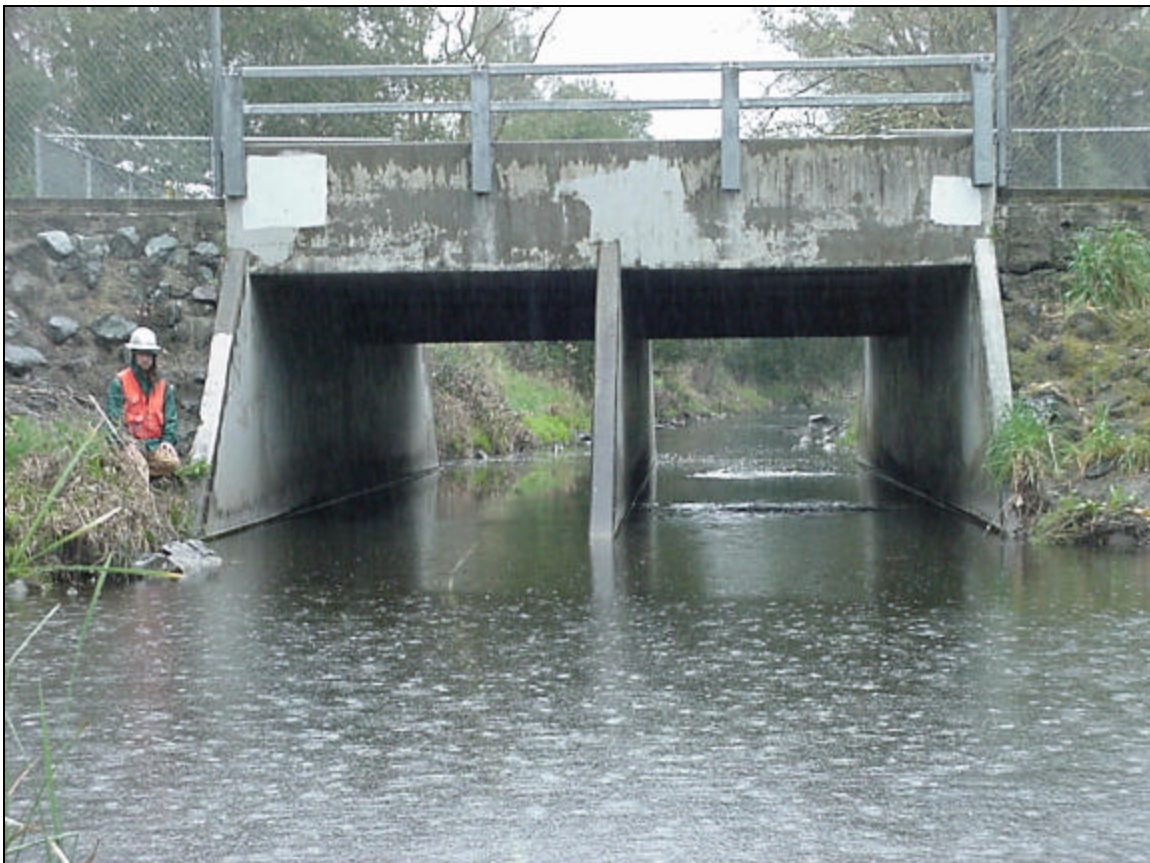
Site ID #S-047: Piner Creek #1/Valdez Drive; Santa Rosa Creek; Mark West Ck; Russian River
Road Ownership: City of Santa Rosa

Culvert Type: Two Bay Box, Concrete. **Corrugations:** None. **Dimensions:** 9.05' height x 20.0' width
Length: 45.0' **Slope:** 0.80% **Modifications:** None. **Rustline Height:** N/A
Average Active Channel Width: 23.5' **Fill Estimate:** 614 cubic yards. **Overall Condition:** Good.

Barrier Status: **GREEN:** the Green-Gray-Red filter determined this crossing fails to meet passage criteria for all species of adult salmonids and all age classes of juveniles.

Habitat: Quantity = approximately 28,100' of potential fish-bearing habitat upstream of Site ID# S-047. Length estimate includes several tributaries of questionable fish-bearing habitat. The main channel is 13,400' in length up to a dam/reservoir. Quality = rated as “poor” for the ranking matrix as based on Taylor and Associates field notes. The crossing was surveyed on 3/05/02 and there was continuous flow in the channel. At 4:00PM the air temp = 16°C and the water temp = 15°C. The survey crew described the habitat as “poor” and noted a lack of a riparian zone and a channelized reach through a residential area of Santa Rosa. No fish were observed.

Preferred Treatment: None recommended because crossing provides unimpeded passage, is properly sized, and is in good condition.
