CATALOG OF SONOMA COUNTY STREAM CROSSINGS WITH CULVERTS LOCATED ON FISH-BEARING STREAM REACHES WITHIN THE RUSSIAN RIVER BASIN

By
Ross Taylor and Associates

Site ID# S-001: Unnamed Tributary/Willow Creek Road; Willow Creek; Russian River **Road Ownership** County

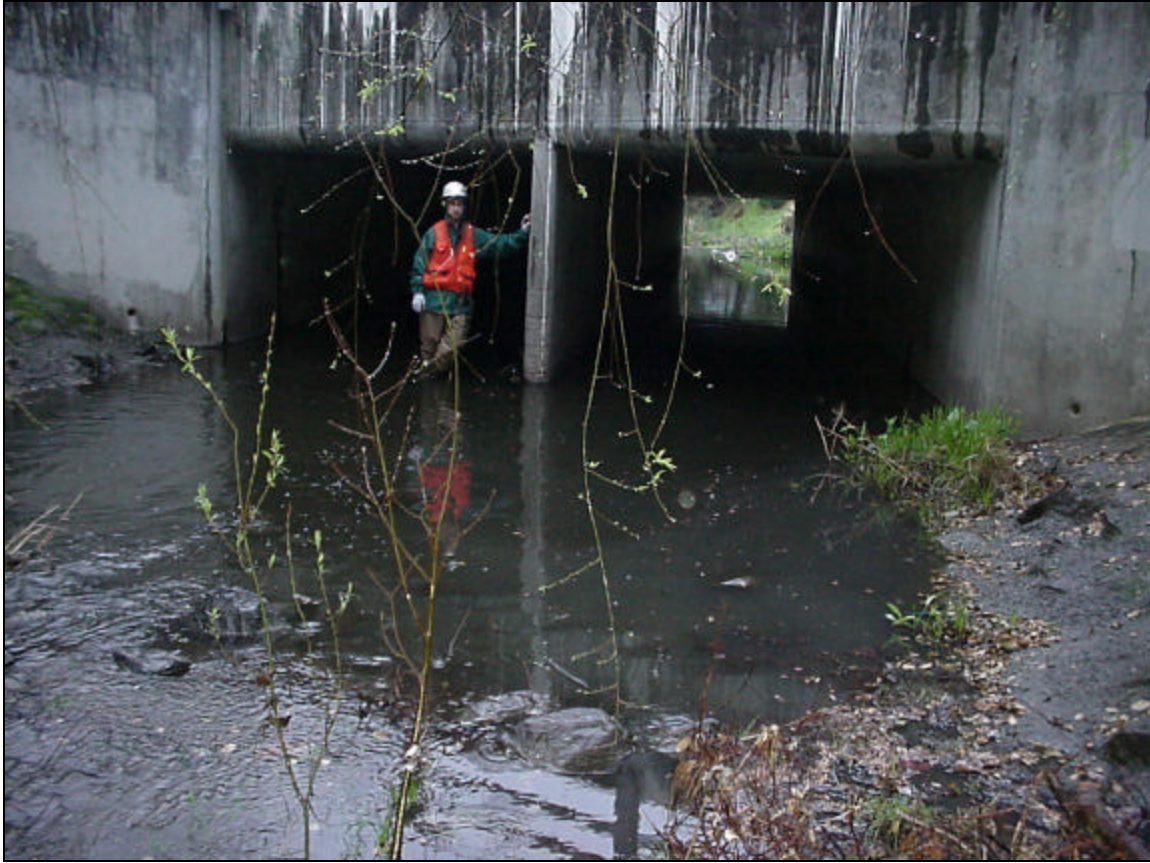
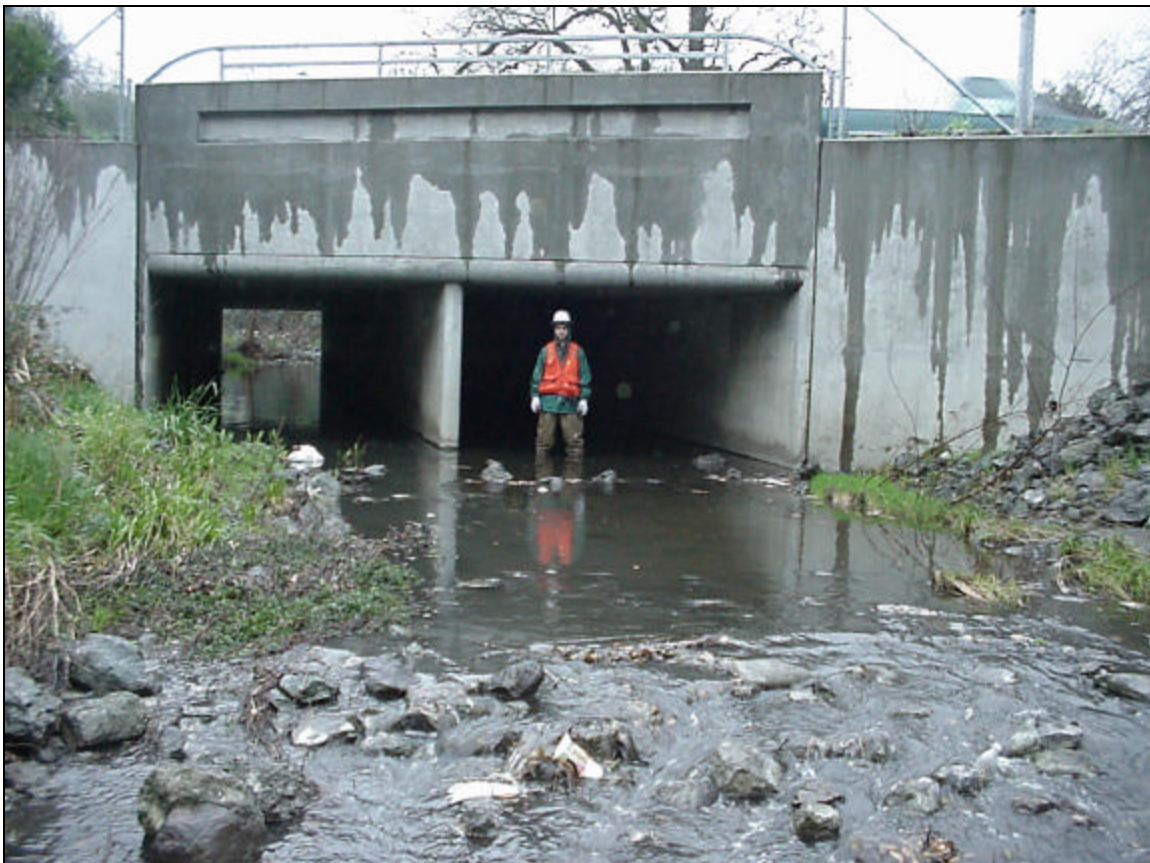
Site ID #S-048: Piner Creek #2/Marlow Road; Santa Rosa Creek; Mark West Creek; Russian River

Culvert Type: Two Bay Box, Concrete. **Corrugations:** None. **Dimensions:** 6.9' height x 21.0' width
Length: 97.0' **Slope:** 0.36% **Modifications:** None. **Rustline Height:** N/A **Average Active Channel Width:** 21.3'
Fill Estimate: 1,305 cubic yards. **Overall Condition:** Good. **Sizing:** Properly sized; HW/D = 1 on a storm flow with more than a 250-year recurrence interval. Marlow Road is overtopped on more than a 250-year storm flow.

Barrier Status: **GRAY:** FishXing determined this crossing meets the 8-16-16 ft/sec passage criteria for adult steelhead on 71% of the range of estimated migration flows, meets passage criteria for resident/2+ fish on 35% of the range of estimated migration flows, and 41% of the migration flows for 1+/young-of-year juvenile salmonids. Actual passage of juveniles may be higher than predicted by FishXing because lack-of-depth is the primary violation.

Habitat: Quantity = approximately 26,950' of potential fish-bearing habitat upstream of Site ID# S-048. Length estimate includes several tributaries of questionable fish-bearing habitat. The main channel is 12,250' in length up to a dam/reservoir. Quality = rated as "poor" for the ranking matrix as based on Taylor and Associates field notes. The crossing was surveyed on 3/05/02 and there was continuous flow in the channel. At 5:30PM the air temp = 15°C and the water temp = 15°C. The survey crew described the habitat as "poor" and noted a lack of a riparian zone and a channelized reach through a residential area of Santa Rosa. No fish were observed.

Preferred Treatment: None recommended because crossing provides adequate passage, is properly sized, and is in good condition.

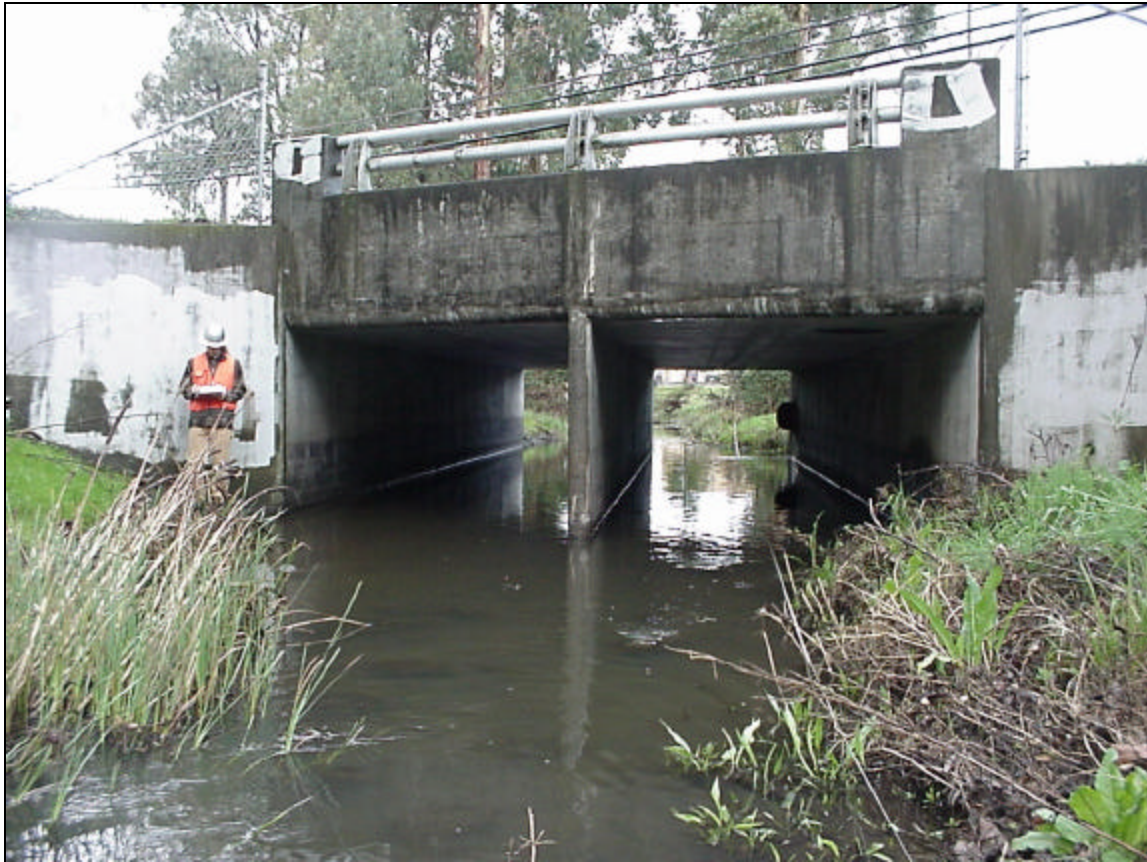
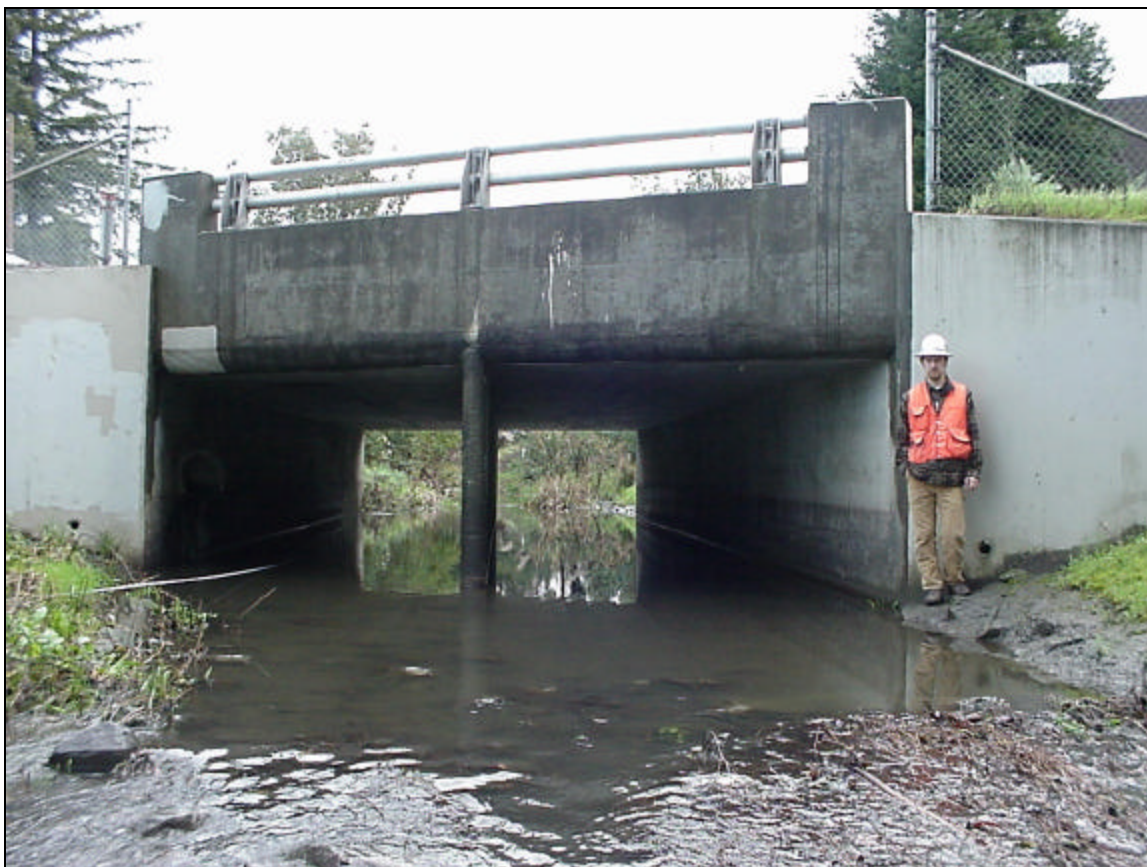
Site ID #S-049: Piner Creek #3/Coffey Lane; Santa Rosa Creek; Mark West Creek; Russian River

Culvert Type: Two Bay Box, Concrete. **Corrugations:** None. **Dimensions:** 6.9' height x 20.0' width
Length: 61.0' **Slope:** 0.08% **Modifications:** None. **Rustline Height:** N/A **Average Active Channel Width:** 17.5'
Fill Estimate: 478 cubic yards. **Overall Condition:** Good. **Sizing:** Properly sized; HW/D = 1 on a storm flow with more than a 250-year recurrence interval. Coffey Lane is overtopped on more than a 250-year storm flow.

Barrier Status: **GRAY:** FishXing determined this crossing meets the 8-16-16 ft/sec passage criteria for adult steelhead on 55% of the range of estimated migration flows and fails to meet passage criteria for all age classes of juvenile salmonids. Actual passage of all lifestages is probably much greater than predicted by FishXing because lack-of-depth is the only violation of criteria – even for 1+/young-of-year juvenile salmonids

Habitat: Quantity = approximately 8,600' of potential fish-bearing habitat upstream of Site ID# S-049. Quality = rated as “poor” for the ranking matrix as based on Taylor and Associates field notes. The crossing was surveyed on 3/06/02 and there was continuous flow in the channel. At 8:30AM the air temp = 16.5°C and the water temp = 15.5°C. The survey crew described the habitat as “poor” and noted a very sparse riparian zone and a channelized, featureless reach through a residential area of Santa Rosa. No fish were observed.

Preferred Treatment: None recommended because crossing provides adequate passage (regardless of FishXing output), is properly sized, and is in good condition.

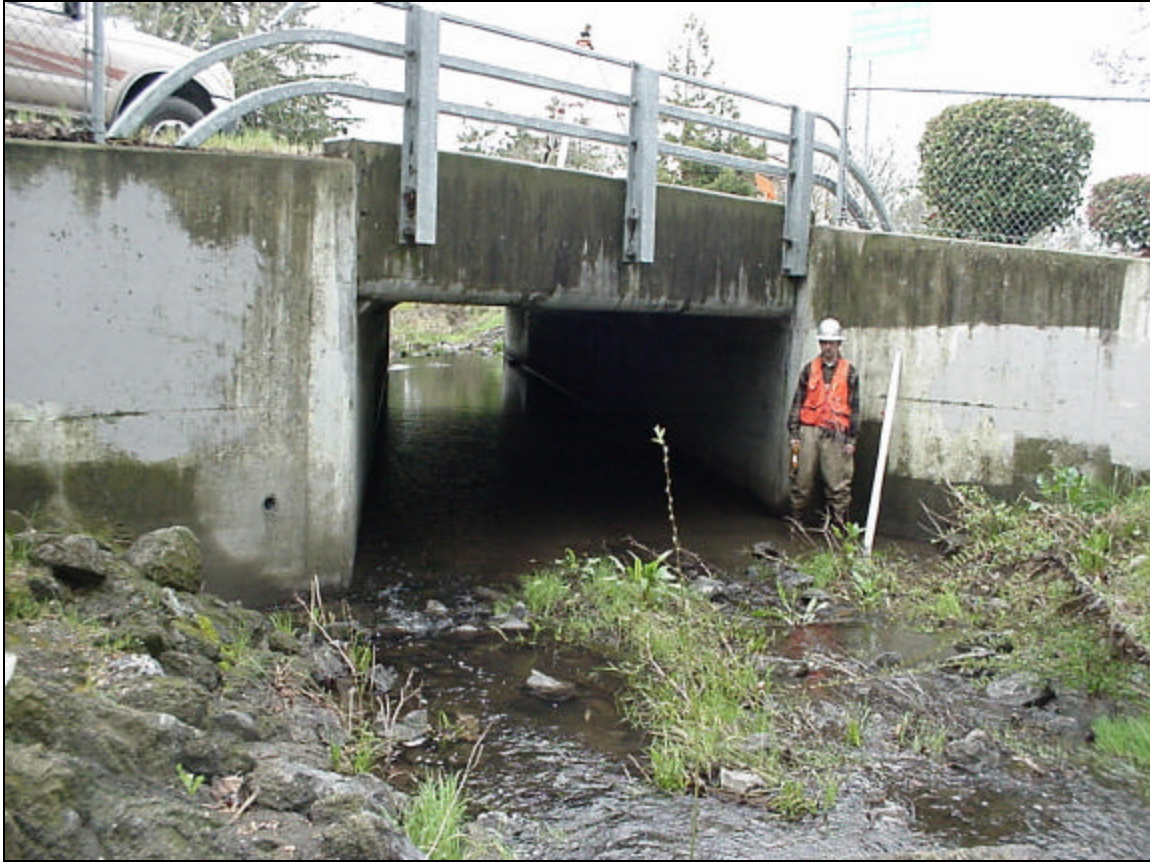
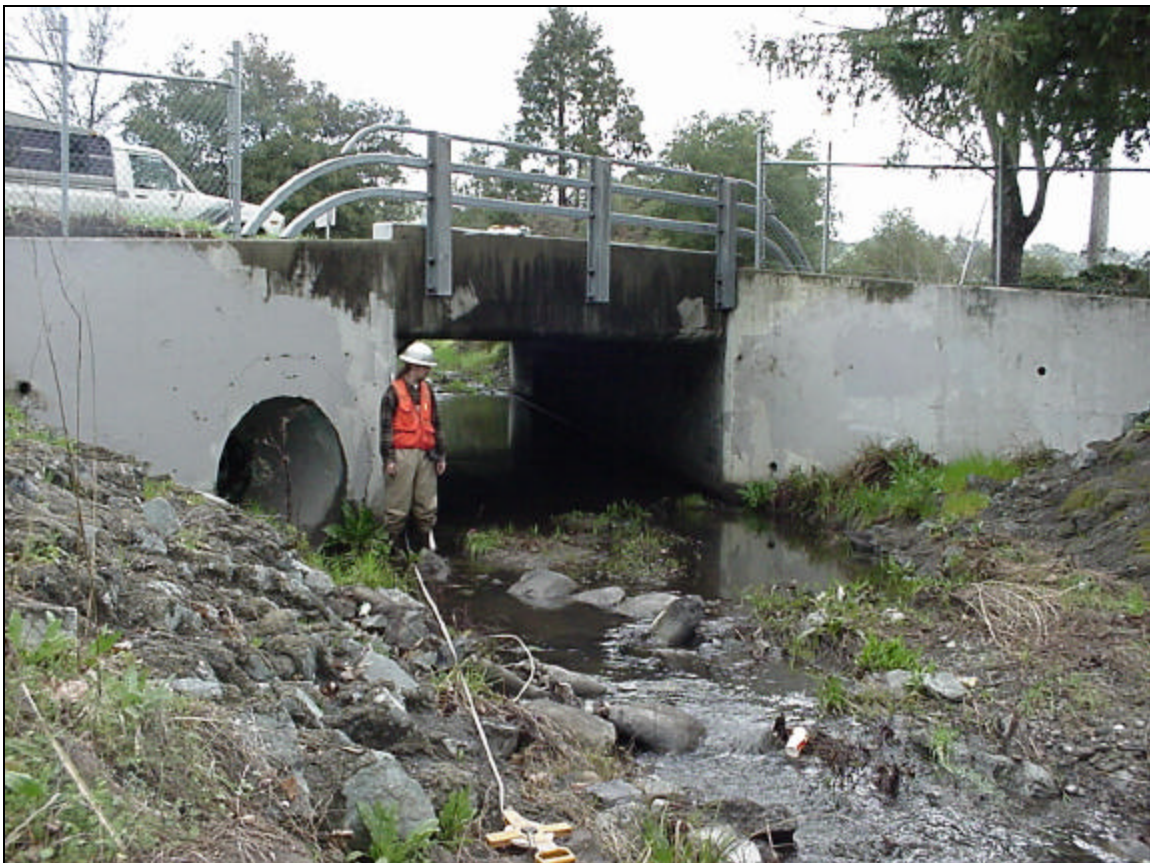
Site ID #S-050: Piner Creek #4/Hopper Avenue; Santa Rosa Creek; Mark West Creek; Russian River **Road**
Ownership: County

Culvert Type: Box, Concrete. **Corrugations:** None. **Dimensions:** 6.1' height x 12.0' width **Length:** 101.5'
Slope: 0.10% **Modifications:** None. **Rustline Height:** N/A **Average Active Channel Width:** 15.9'

Fill Estimate: 751 cubic yards. **Overall Condition:** Good. **Sizing:** Properly sized; HW/D = 1 on a storm flow with more than a 250-year recurrence interval. Hopper Avenue is overtopped on more than a 250-year storm flow.

Barrier Status: **GRAY:** FishXing determined this crossing meets the 8-16-16 ft/sec passage criteria for adult steelhead on 64% of the range of estimated migration flows and fails to meet passage criteria for all age classes of juvenile salmonids. Actual passage of all lifestages is probably much greater than predicted by FishXing because lack-of-depth is the only violation of criteria – even for 1+/young-of-year juvenile salmonids

Habitat: Quantity = approximately 3,600' of potential fish-bearing habitat upstream of Site ID# S-050. Quality = rated as “poor” for the ranking matrix as based on Taylor and Associates field notes. The crossing was surveyed on 3/06/02 and there was continuous flow in the channel. At 10:00AM the air temp = 16.5°C and the water temp = 15.5°C. The survey crew described the habitat as “poor” and noted a very sparse riparian zone and a channelized, featureless reach through a residential area of Santa Rosa. No fish were observed.

Preferred Treatment: None recommended because crossing provides adequate passage (regardless of FishXing output), is properly sized, and is in good condition.

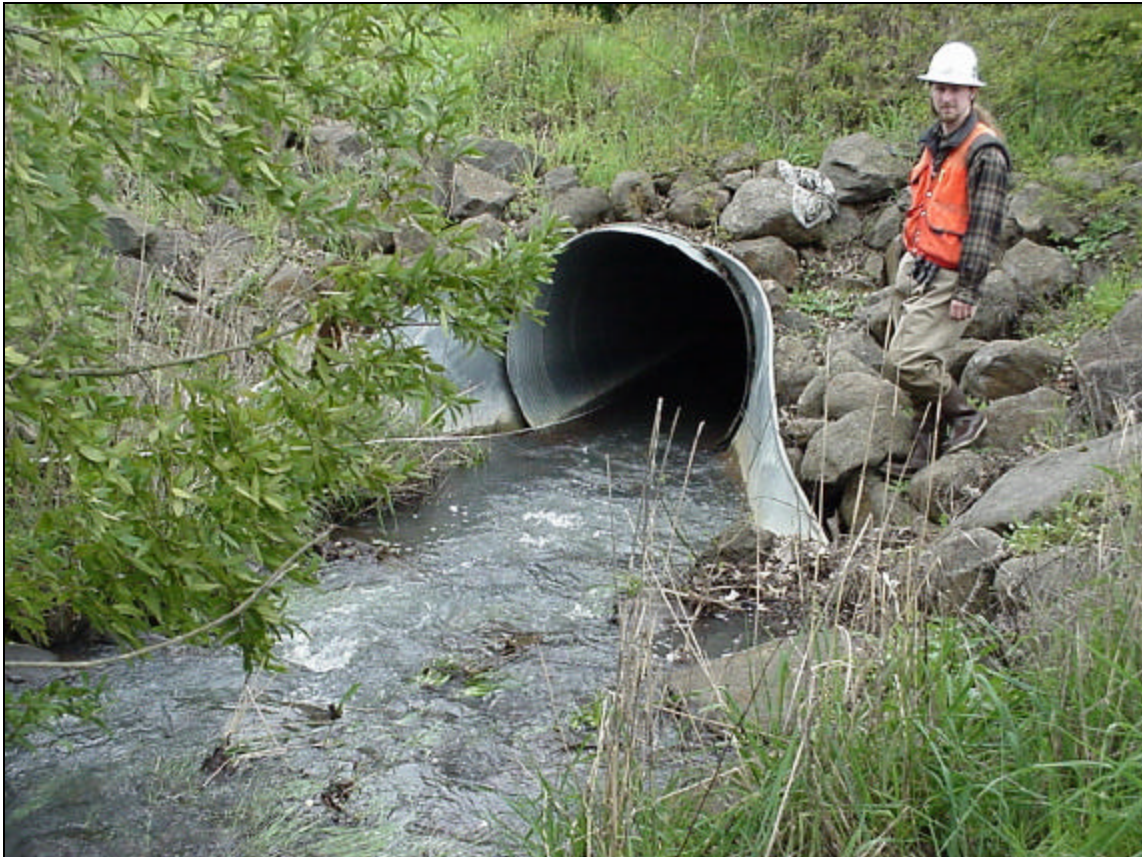
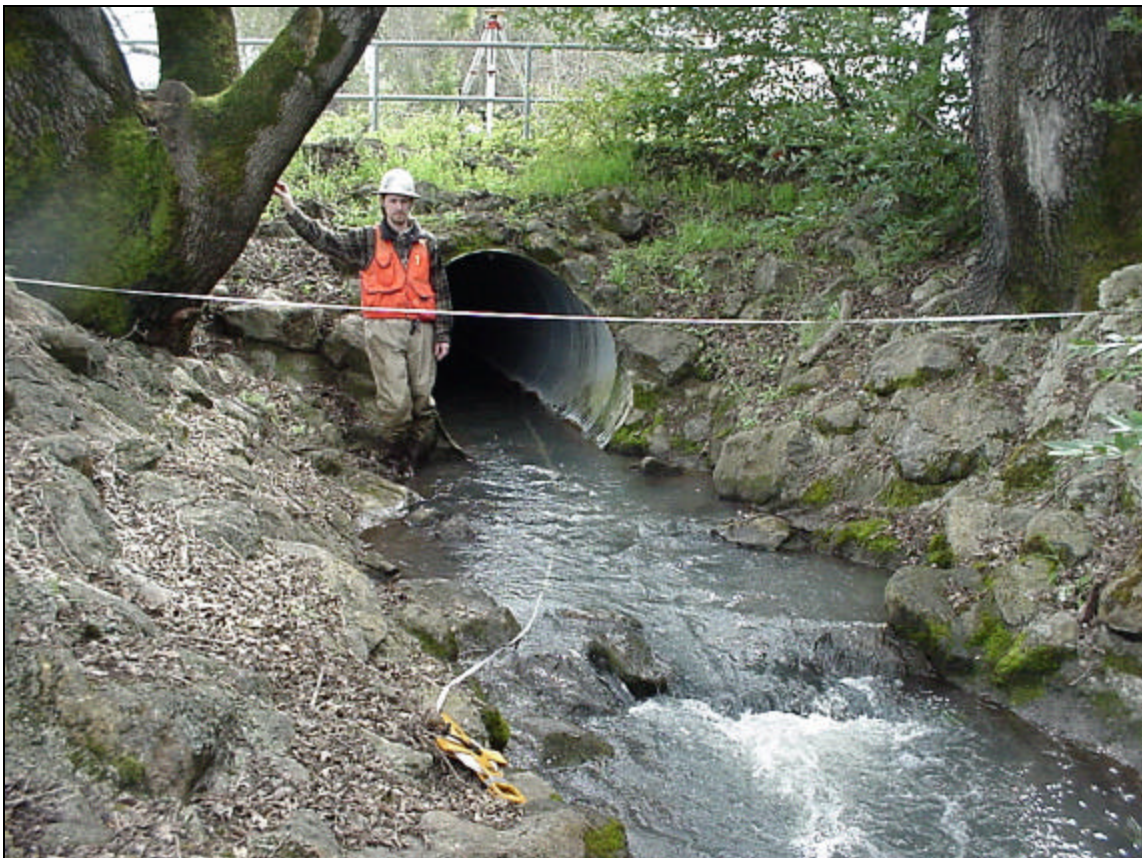
Site ID #S-051: Spring Creek #1/Summerfield Road; Matanzas Creek; Santa Rosa Ck; Mark West Ck; Russian River

Culvert Type: Circular, CSP. **Corrugations:** 2-2/3" x 1/2" **Dimensions:** diameter= 4.5' **Length:** 98.9'
Slope: 0.52% **Modifications:** None. **Rustline Height:** 0.7' **Average Active Channel Width:** 12.2'
Fill Estimate: 626 cubic yards. **Overall Condition:** Fair.

Barrier Status: **GRAY:** FishXing determined this crossing meets the 8-16-16 ft/sec passage criteria for adult steelhead on 100% of the range of estimated migration flows, meets passage criteria for resident/2+ salmonids on 15% of the range of estimated migration flows, and fails to meet passage criteria for 1+/young-of-year juveniles.

Habitat: Quantity = approximately 8,200' of potential fish-bearing habitat upstream of Site ID# S-051. Quality = rated as "poor" for the ranking matrix as based on Taylor and Associates field notes and assessment channel at lower crossings. The crossing was surveyed on 3/09/02 and there was continuous flow in the channel. At 11:45AM the air temp = 15°C and the water temp = 13°C. The survey crew described the habitat at this site as "fair" and noted moderately dense riparian zone along a channelized reach through a residential area east of downtown Santa Rosa. No fish were observed.

Preferred Treatment: None recommended because crossing provides adequate adult passage. The culvert is extremely undersized and should be replaced if there are known flooding problems at this location. A lack of quality habitat makes a replacement of this crossing a poor candidate for treatment with fisheries restoration funding.

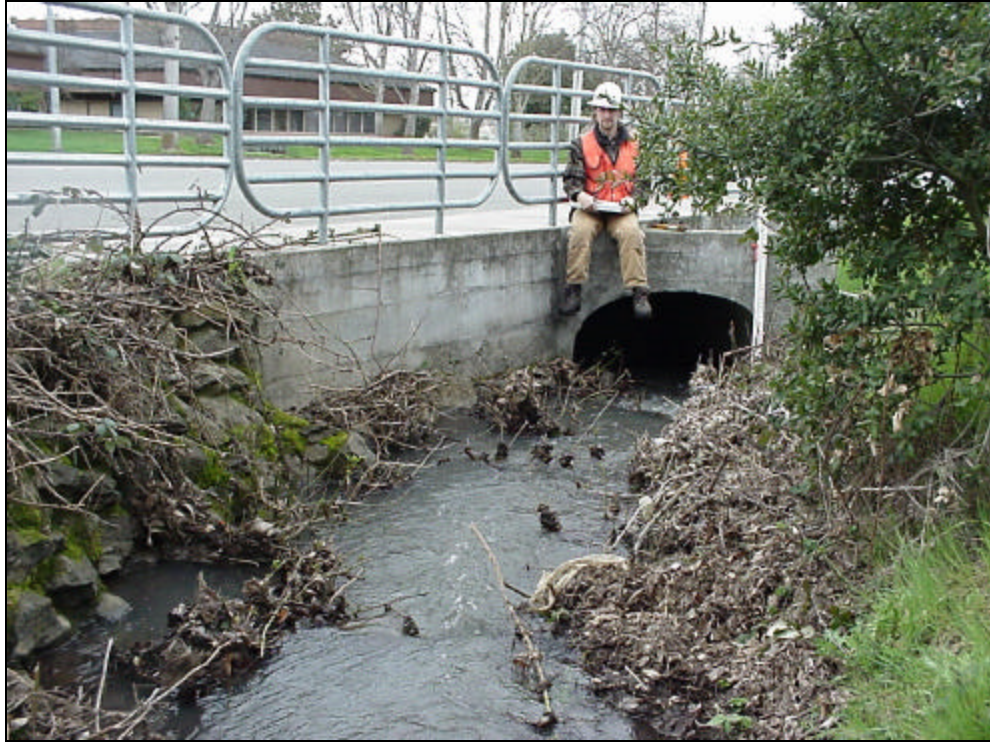
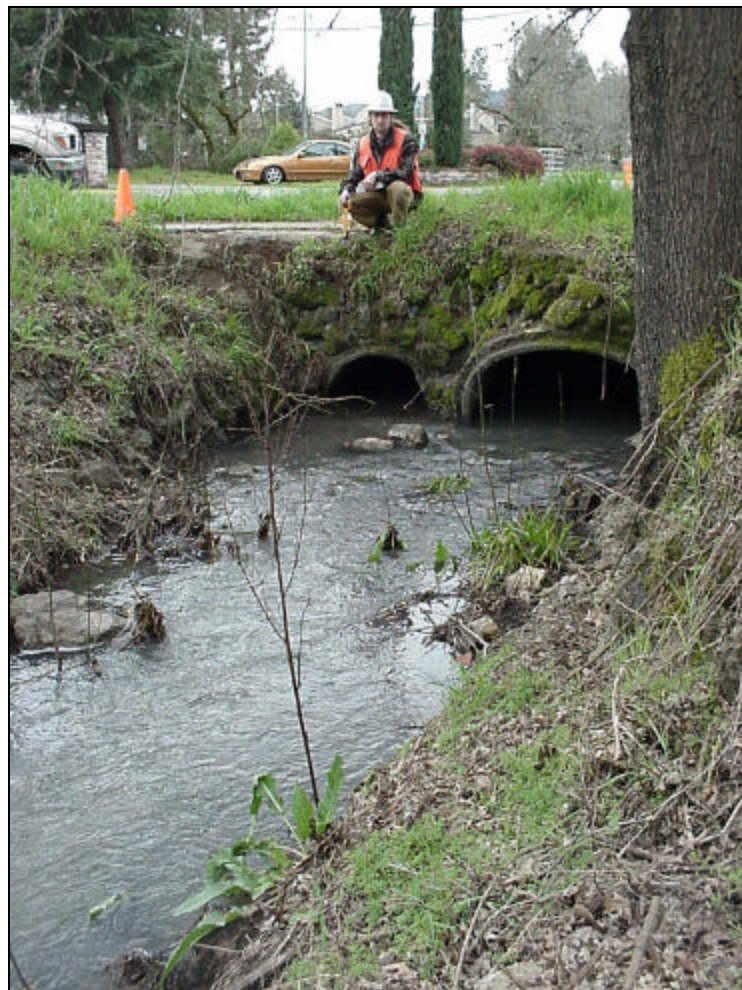
Site ID #S-052: Spring Creek #2/Stone Hedge Drive; Matanzas Creek; Santa Rosa Ck; Mark West Ck; Russian River

Culvert Type: Oval, Concrete. **Corrugations:** None. **Dimensions:** 2.8' rise x 4.4' span **Length:** 113.4' **Slope:** 0.72% **Modifications:** None. **Rustline Height:** N/A **Average Active Channel Width:** 8.3' **Fill Estimate:** 268 cubic yards. **Overall Condition:** Fair. **Sizing:** Extremely undersized; HW/D = 1 on a storm flow with approximately a one-year recurrence interval. Stone Hedge Drive is overtopped on approximately a one-year storm flow.

Barrier Status: **GRAY:** FishXing determined this crossing meets the 8-16-16 ft/sec passage criteria for adult steelhead on 99% of the range of estimated migration flows, meets passage criteria for resident/2+ salmonids on 16% of the range of estimated migration flows, and fails to meet passage criteria for 1+/young-of-year juveniles.

Habitat: Quantity = approximately 7,050' of potential fish-bearing habitat upstream of Site ID# S-052. Quality = rated as "poor" for the ranking matrix as based on Taylor and Associates field notes and assessment channel at lower crossings. The crossing was surveyed on 3/09/02 and there was continuous flow in the channel. At 11:00AM the air temp = 18°C and the water temp = 16°C. The survey crew described the habitat at this site as "poor to fair" and noted moderately dense riparian zone along a relatively featureless channelized reach through a residential area east of downtown Santa Rosa. No fish were observed.

Preferred Treatment: None recommended because crossing provides adequate adult passage. The culvert is extremely undersized and should be replaced if there are known flooding problems at this location. A lack of quality habitat makes a replacement of this crossing a poor candidate for treatment with fisheries restoration funding.

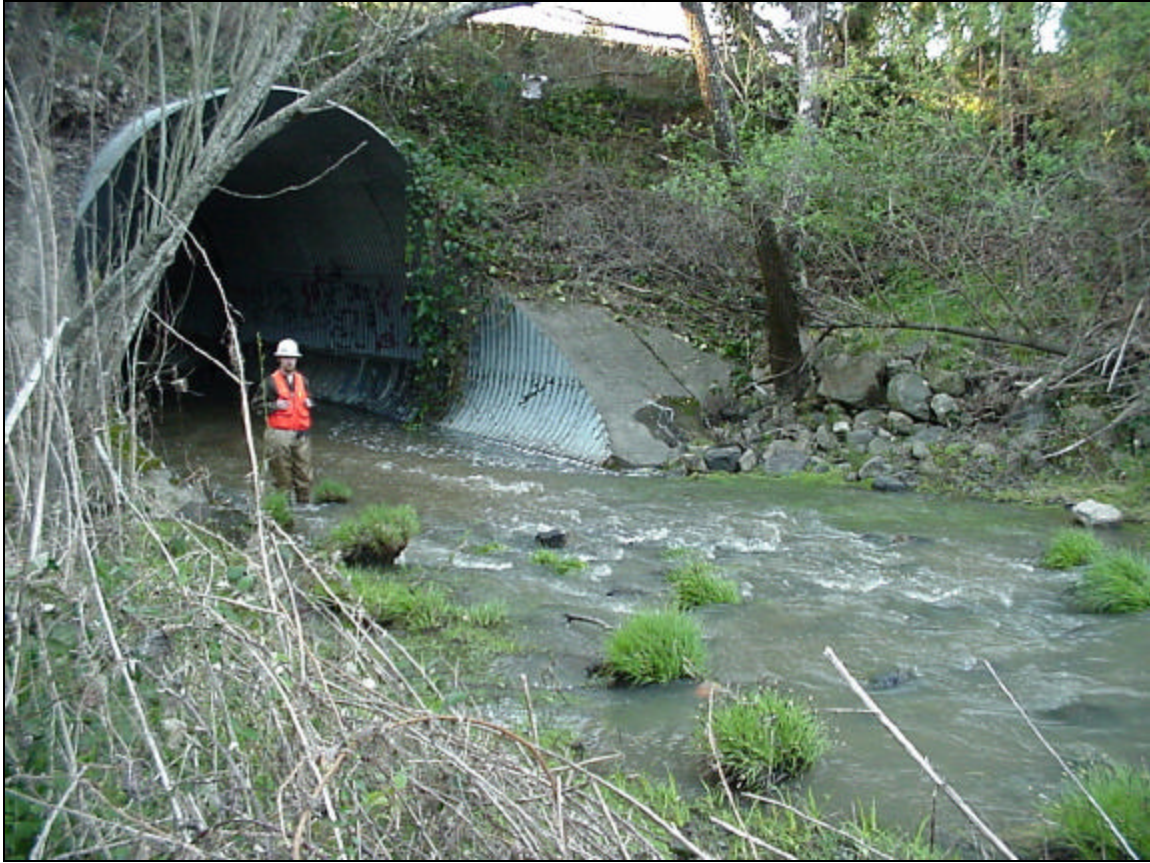
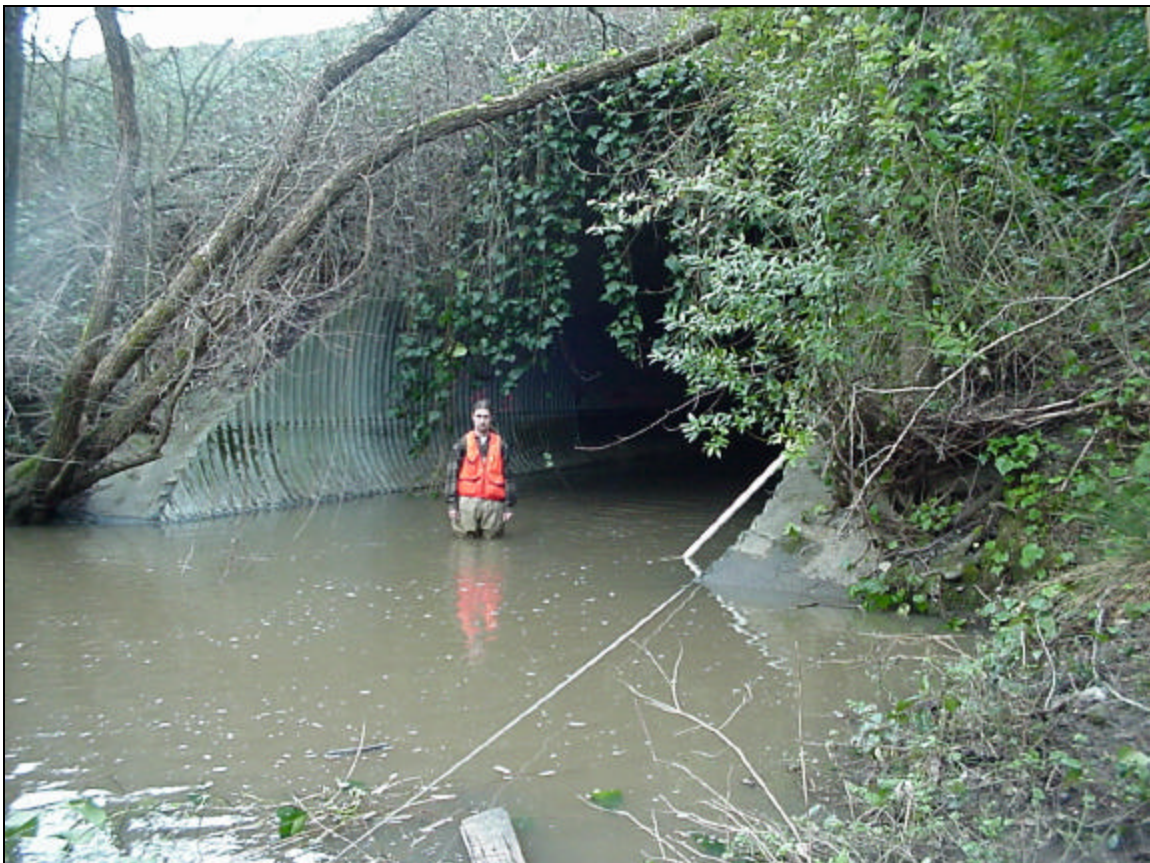
Site ID #S-053: Matanzas Creek/Bethards Drive; Santa Rosa Creek; Mark West Creek; Russian River
Road Ownership: County

Culvert Type: Pipe Arch, SSP. **Corrugations:** 6" x 2" **Dimensions:** 16.8' rise x 19.1' span **Length:** 150.0'
Slope: 0.53% **Modifications:** None. **Rustline Height:** N/A **Average Active Channel Width:** 27.2'
Fill Estimate: 4,605 cubic yards. **Overall Condition:** Good. **Sizing:** Undersized; HW/D = 1 on a storm flow with approximately a 51-year recurrence interval. Bethards Drive is overtopped on approximately a 174-year storm flow.

Habitat: Quantity = approximately 14,700' of potential fish-bearing habitat upstream of Site ID# S-053. Quality = rated as "poor" for the ranking matrix (quality score = 0.37) as based on CDFG's 1997 habitat typing survey of 22,600' of channel. Spawning habitat is limited, and what exists is highly embedded. Much of the creek has been channelized and levied and lacks riparian vegetation. Most of the fish observed by CDFG's crew were exotic, warm-water species, such as green sunfish and bluegills. The crossing was surveyed by Taylor and Assoc. on 3/08/02 and there was continuous flow in the channel. At 5:00PM the air temp = 14°C and the water temp = 14.5°C. The survey crew described the habitat at this site as "poor to fair" and noted moderately dense riparian zone along a relatively featureless channelized reach through a residential area east of downtown Santa Rosa. No fish were observed.

Preferred Treatment: None recommended because crossing provides adequate adult passage and some juvenile passage. The crossing can convey approximately the 50-year storm-flow and is in good condition.

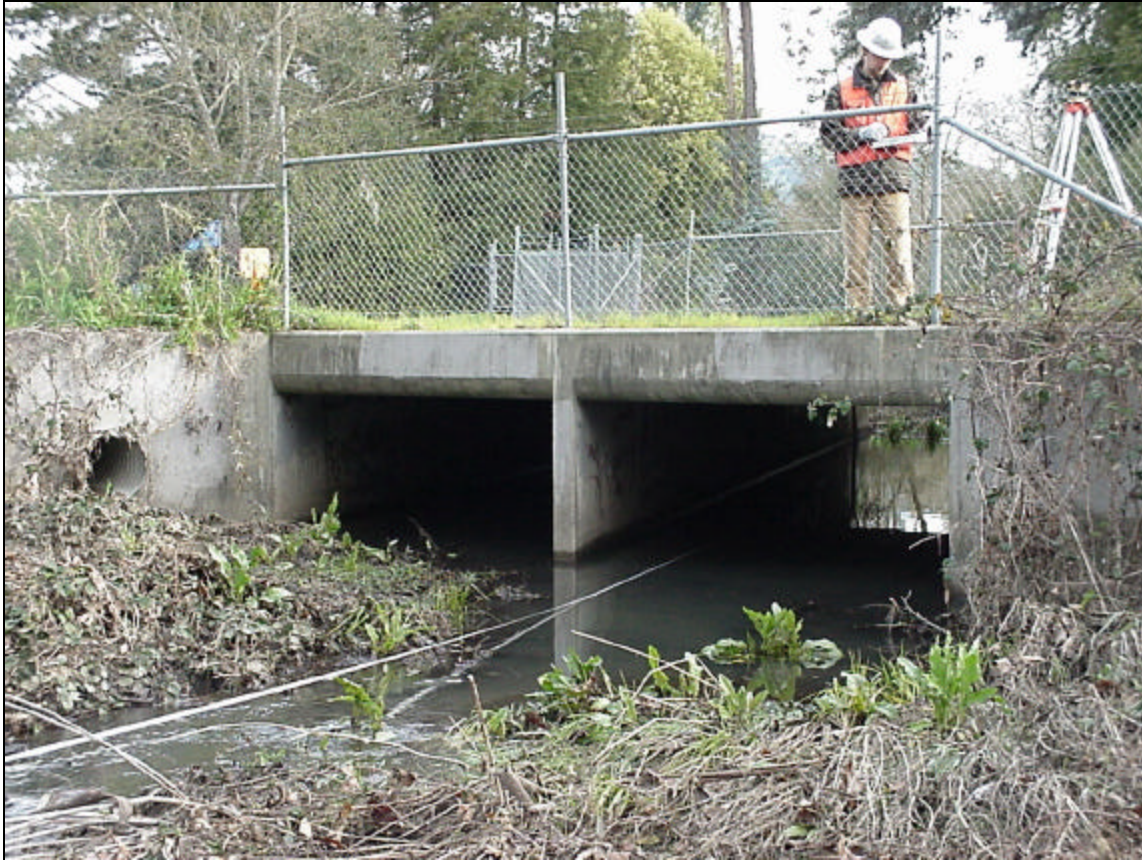
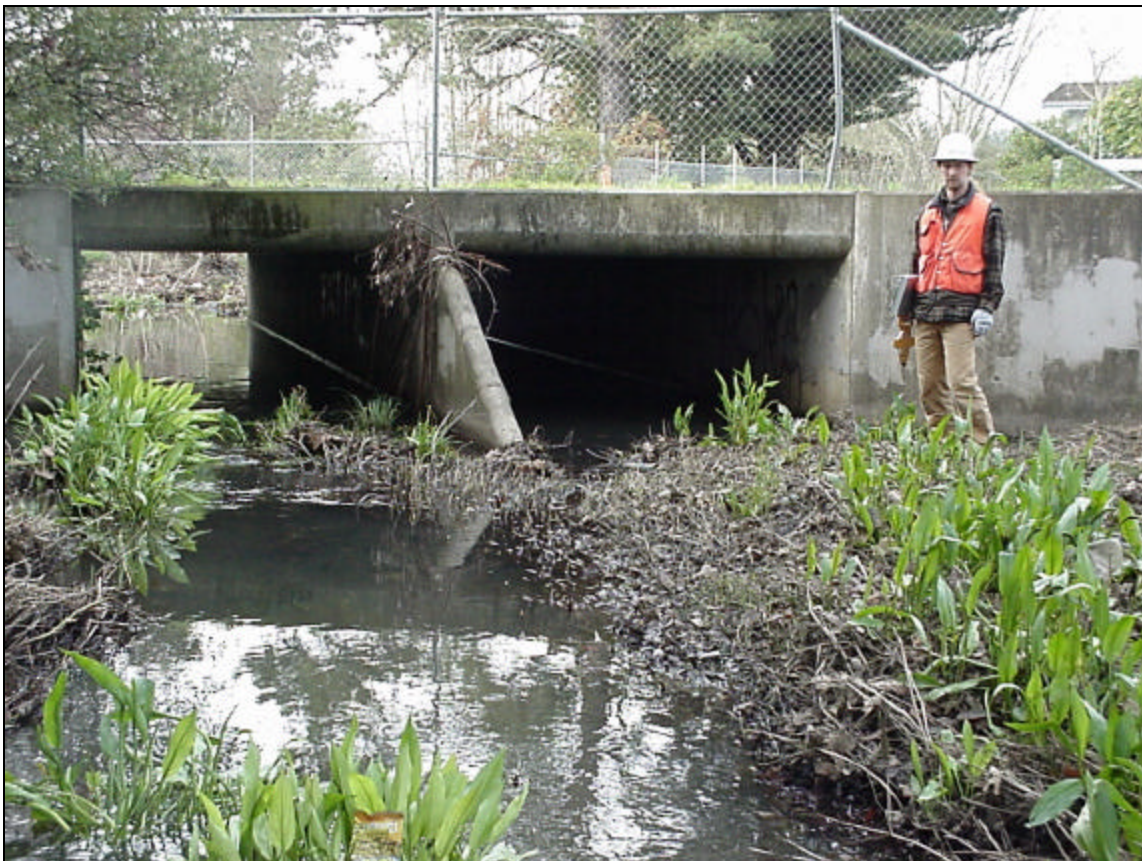
Site ID #S-054: Ducker Creek #1/Benicia Drive; Rincon Creek; Santa Rosa Creek; Mark West Creek; Russian River
Road Ownership: City of Santa Rosa

Culvert Type: Two Bay Box, Concrete. **Corrugations:** None. **Dimensions:** Each Bay = 6.0' height x 8.0' width. **Length:** 52.3' **Slopes:** LB = -1.91%; RB = -2.87 **Modifications:** None. **Rustline Height:** N/A
Average Active Channel Width: 14.4' **Fill Estimate:** 197 cubic yards. **Overall Condition:** Good.

Habitat: Quantity = approximately 7,600' of potential fish-bearing habitat upstream of Site ID# S-054. Quality = rated as “poor” for the ranking matrix as based on Taylor and Associates’ field notes. The crossing was surveyed by Taylor and Assoc. on 3/09/02 and there was continuous flow in the channel. At 8:00AM the air temp = 9.5°C and the water temp = 14.5°C. The survey crew described the habitat at this site as “poor” and noted a sparse riparian zone along a relatively featureless channelized reach through a residential area of Santa Rosa. No fish were observed.

Preferred Treatment: None recommended because crossing provides unimpeded passage for all life-stages of steelhead. The crossing can convey more than a 250-year storm-flow and is in good condition.

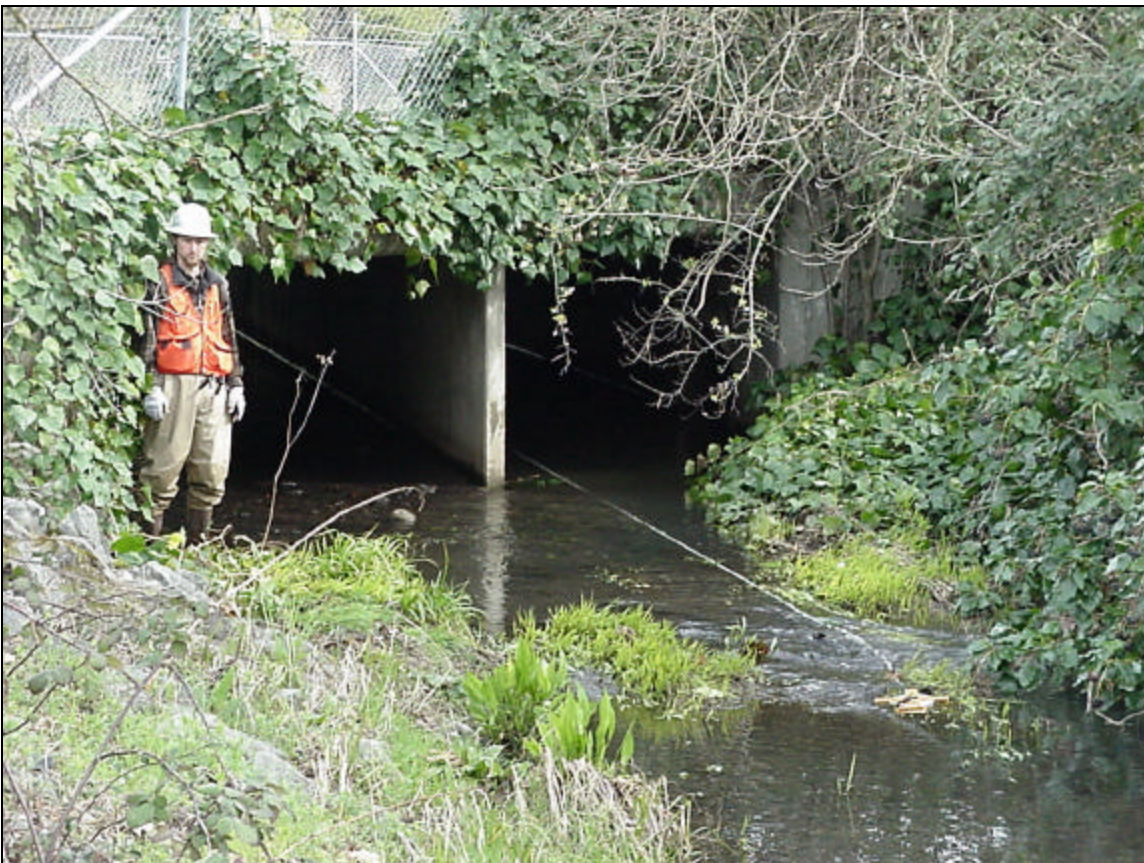
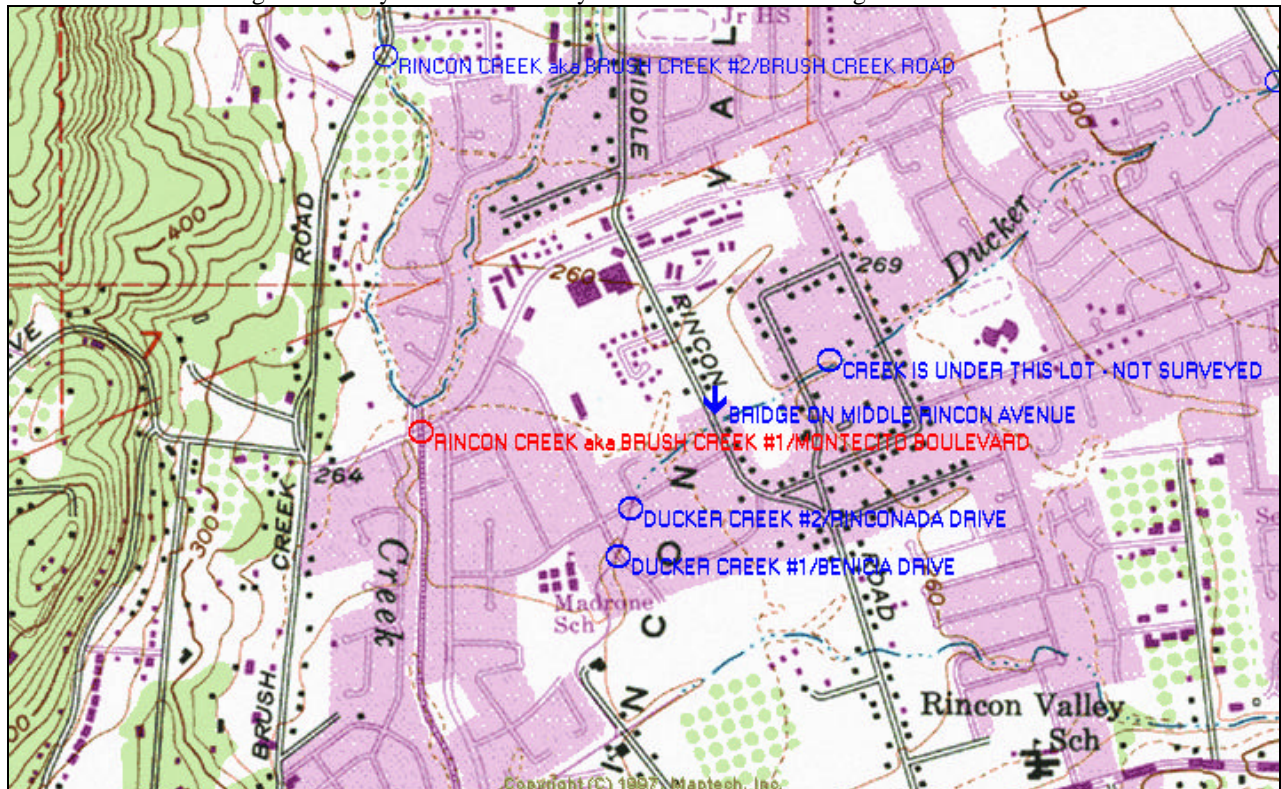
Site ID #S-056: Rincon Creek aka Brush Creek #1/Montecito Boulevard; Santa Rosa Creek; Mark West Creek; Russian River

Culvert Type: Two Bay Bridge with concrete floor. **Corrugations:** None. **Dimensions:** LB= 9.1' height x 9.9' width; RB = 9.3' height x 9.9' width **Lengths:** 78.2' **Slopes:** LB = 0.28%; RB = 1.05% **Modifications:** None. **Rustline Height:** N/A **Average Active Channel Width:** 25.3' **Fill Estimate:** 1,569 cubic yards.

Overall Condition: Good. **Sizing:** Properly sized; HW/D = 1 on a storm flow with more than a 250-year recurrence interval. Montecito Boulevard is overtopped on more than a 250-year storm flow.

Barrier Status: **GRAY:** FishXing determined this crossing meets the 8-16-16 ft/sec passage criteria for adult steelhead on (LB = 86% and RB = 81%) of the range of estimated migration flows, meets passage criteria for resident/2+ salmonids on (LB = 60% and RB = 11%) of the range of estimated migration flows, and both bays fail to criteria on of the migration flows for 1+/young-of-year juveniles.

Preferred Treatment: None recommended because crossing provides adequate passage for most life-stages of steelhead. The crossing can convey more than a 250-year storm-flow and is in good condition.

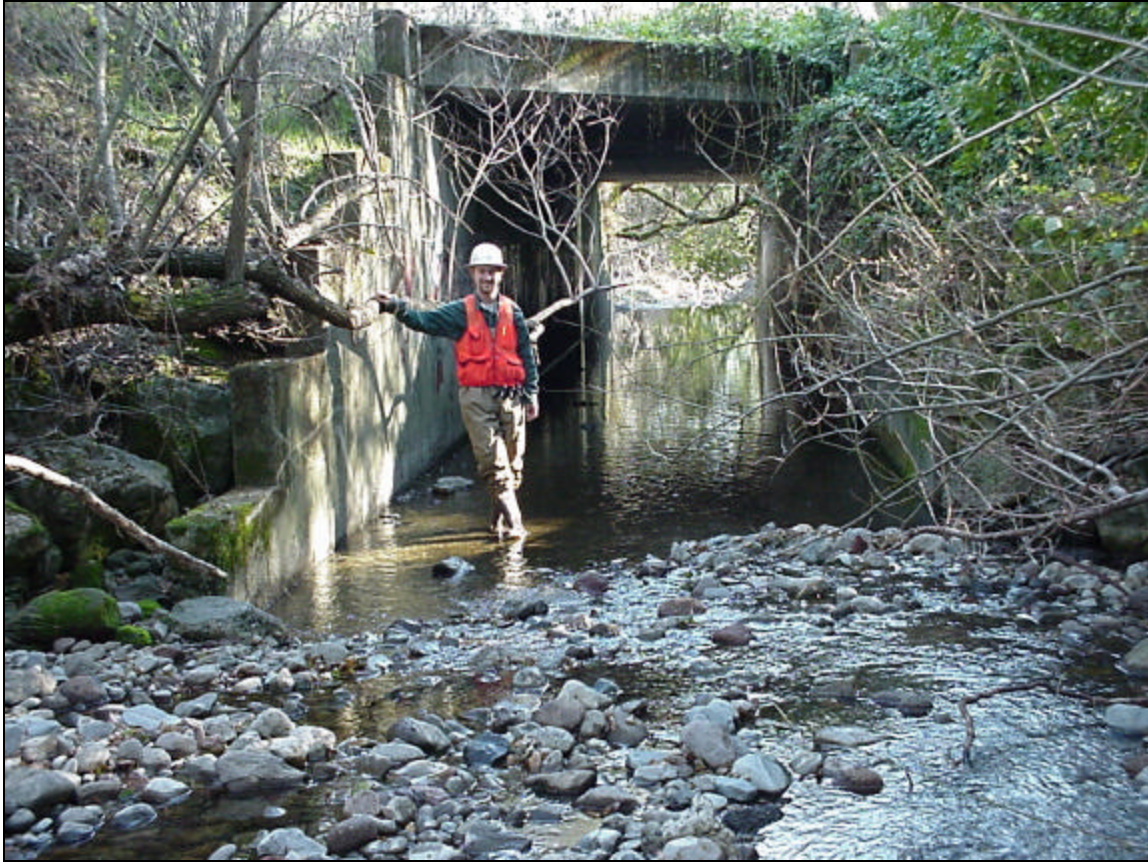
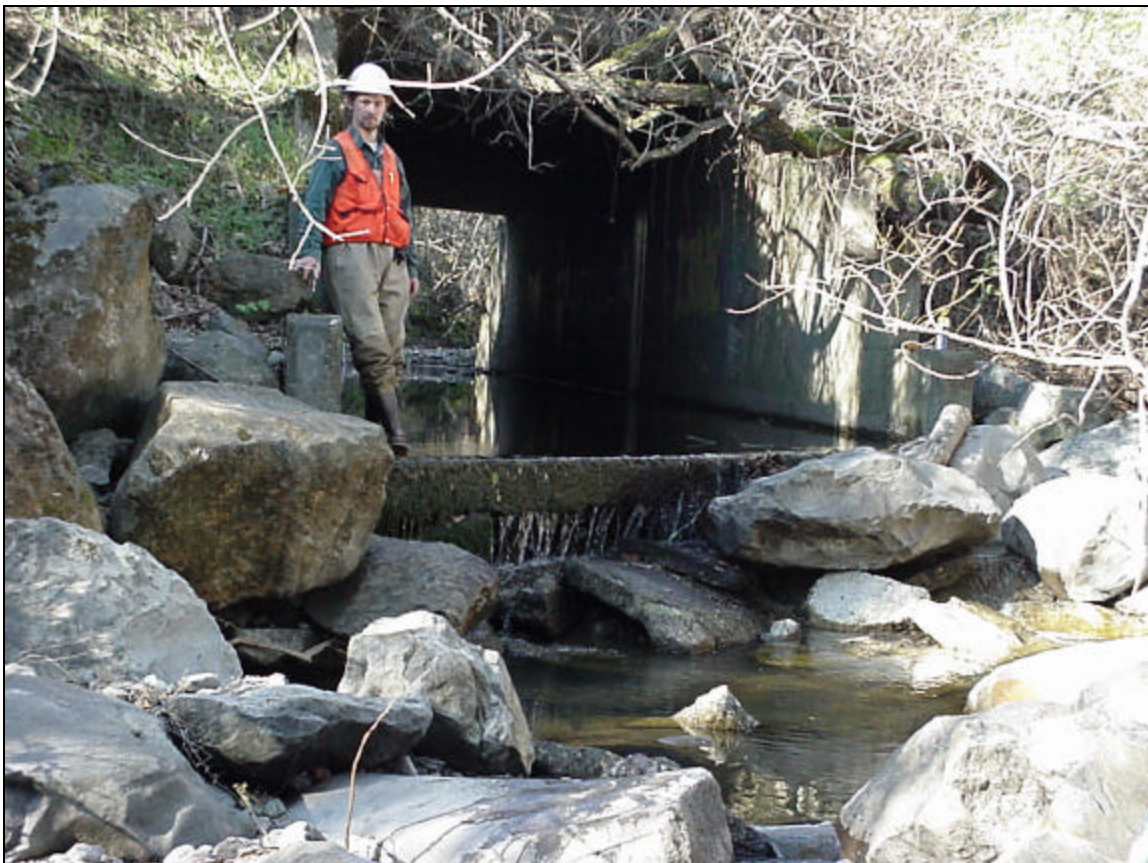
Culvert Type: Box, Concrete. **Corrugations:** None. **Dimensions:** 10.0' height x 12.0' width **Length:** 75.0' **Slope:** -0.04% **Modifications:** None. **Rustline Height:** N/A **Average Active Channel Width:** 21.5' **Fill Estimate:** 710 cubic yards. **Overall Condition:** Good. **Sizing:** Properly sized; HW/D = 1 on a storm flow with more than a 250-year recurrence interval. Brush Creek Road is overtopped on more than a 250-year storm flow.

Barrier Status: **GRAY:** FishXing determined this crossing meets the 8-16-16 ft/sec passage criteria for adult steelhead on 86% of the range of estimated migration flows and fails to meet passage criteria for all age classes of juvenile salmonids. The perched outlet (2.7') is the crossing's main feature that impedes juvenile passage. Riprap placed at base of outlet may create a confusing attractant flow for adults too.

Preferred Treatment: Because the culvert is properly sized and in good condition, a retrofit is recommended to cost-effectively improve passage. Three to four downstream boulder weirs will raise tail-water elevation and corner baffles within the culvert will increase depths and decrease velocities.
