CATALOG OF SONOMA COUNTY STREAM CROSSINGS WITH CULVERTS LOCATED ON FISH-BEARING STREAM REACHES WITHIN THE RUSSIAN RIVER BASIN

By
Ross Taylor and Associates

Site ID# S-001: Unnamed Tributary/Willow Creek Road; Willow Creek; Russian River **Road Ownership** County

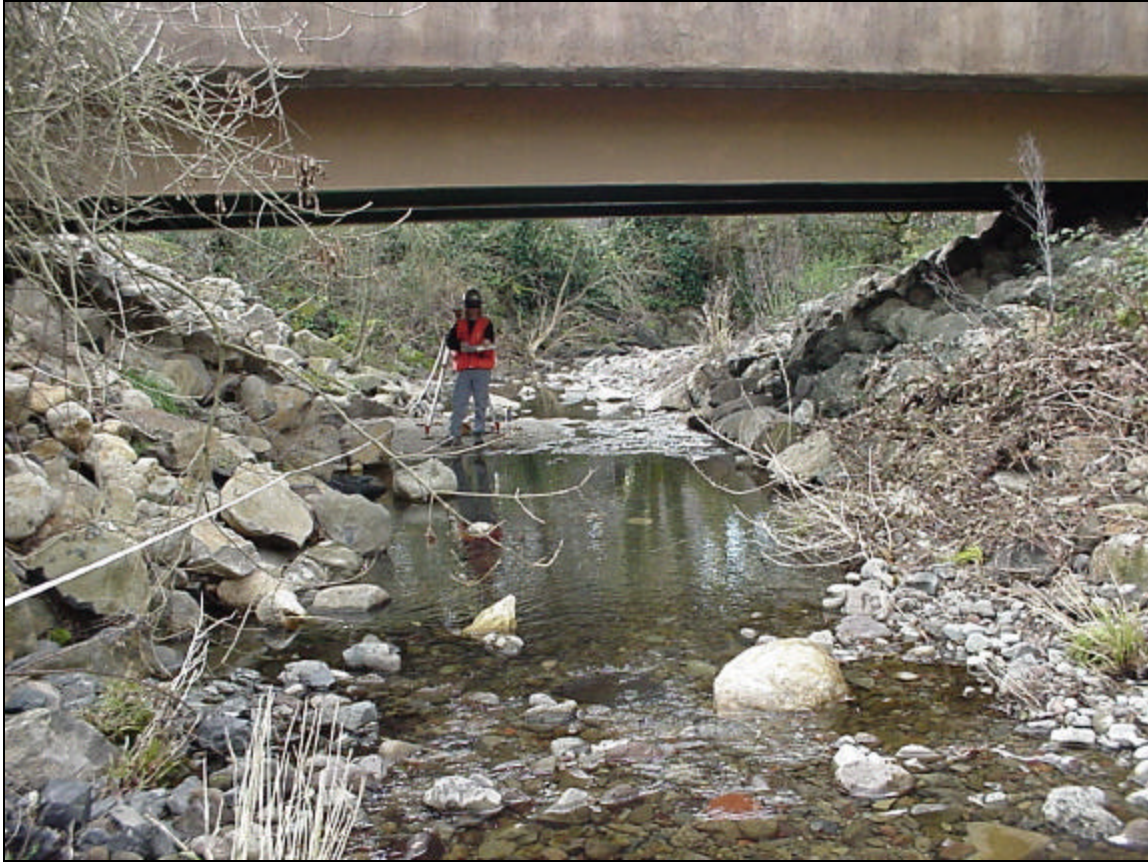
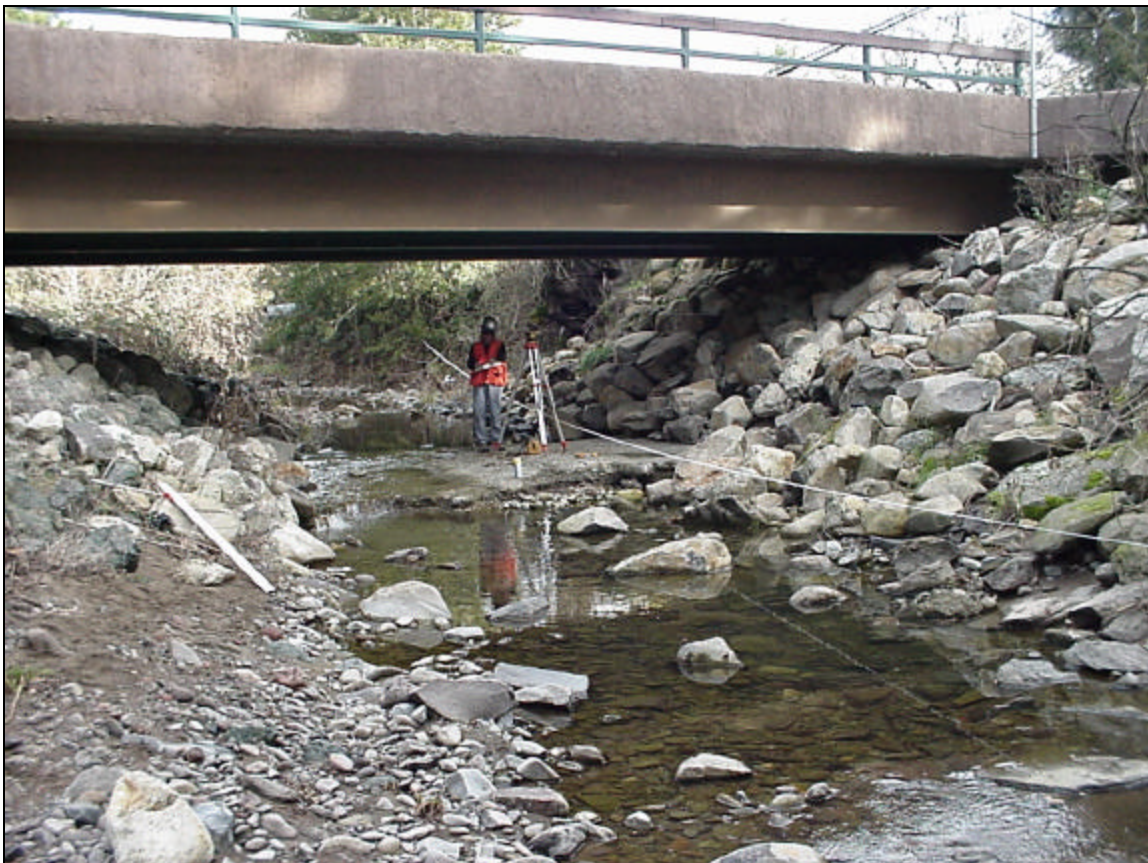
Culvert Type: Bridge with concrete floor – is the concrete slab remains of the previous crossing? **Corrugations:** None. **Dimensions:** 8.3' height x 15.9' width **Length:** 20.3' **Slope:** -3.10% **Modifications:** None. **Rustline Height:** N/A **Average Active Channel Width:** 16.6' **Fill Estimate:** 569 cubic yards. **Overall Condition:** Fair. **Sizing:** Properly sized; HW/D = 1 on a storm flow with more than a 250-year recurrence interval. Deer Trail Road is overtopped on more than a 250-year storm flow.

Barrier Status: **GRAY:** FishXing determined this crossing meets the 8-16-16 ft/sec passage criteria for adult steelhead on 75% of the range of estimated migration flows and fails to meet passage criteria for all age classes of juvenile salmonids. For juveniles there is both a lack-of-depth and excessive velocities over the concrete slab that is in the channel – it appears this might be the remains of an old box culvert.

Preferred Treatment: Remove the concrete slab in the channel – if this does not affect the structural integrity of the crossing. At least partially remove so there is a section of natural streambed underneath the bridge-like structure.

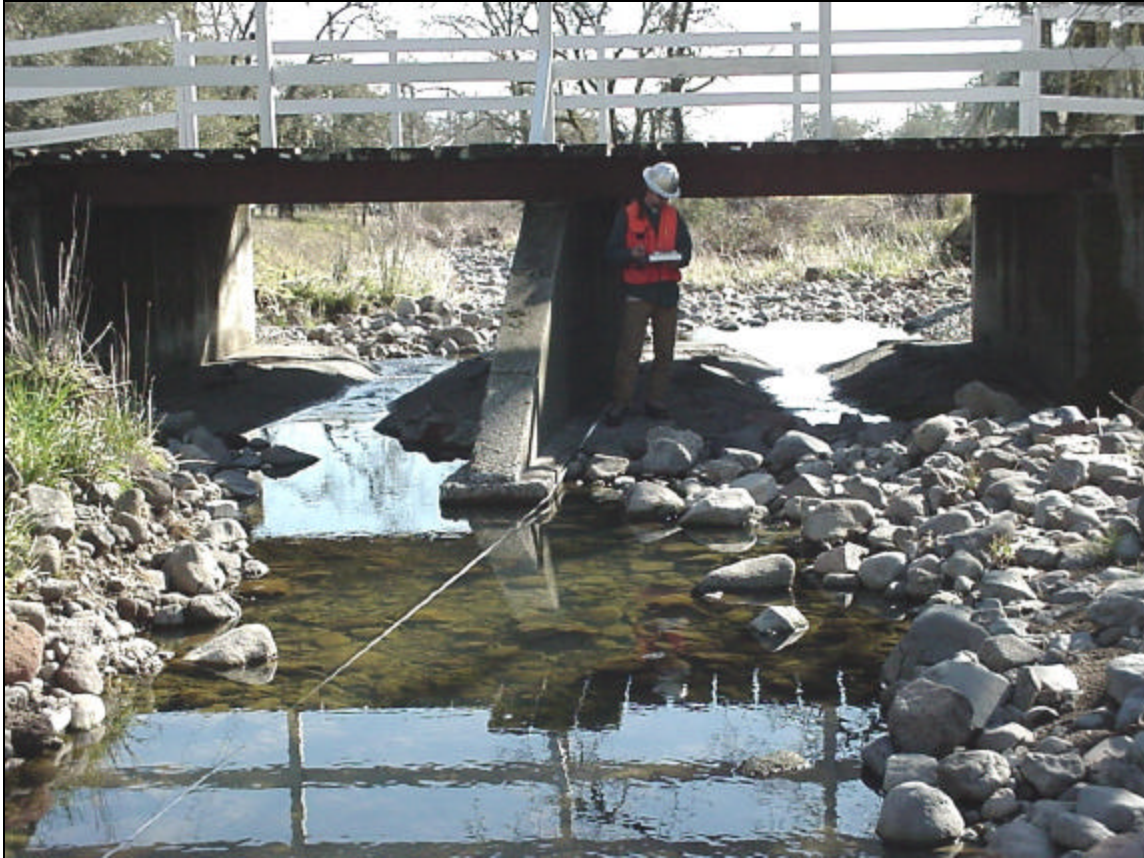
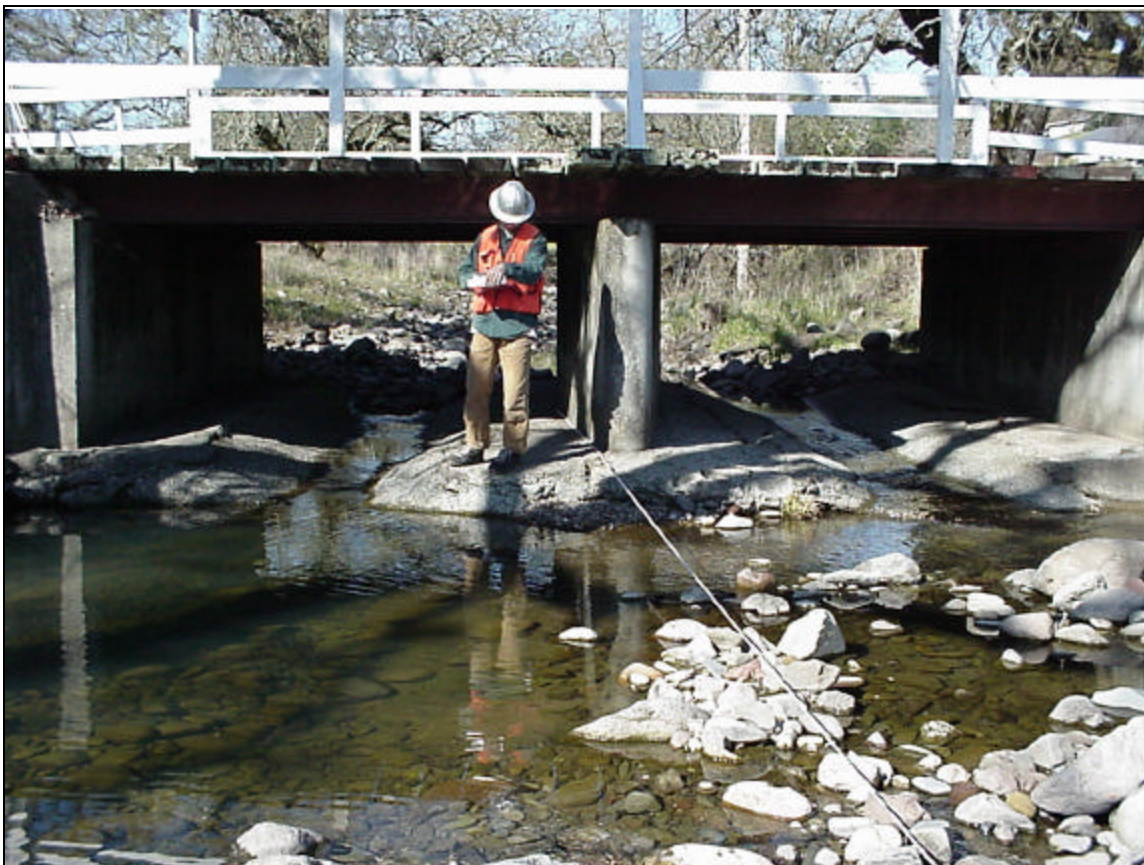
Culvert Type: Two Bay Box, Concrete. **Corrugations:** None. **Dimensions:** 6.8' height x 10.8' width
Length: 20.5' **Slopes:** LB = 0.54%, RB = 1.80% **Modifications:** None. **Rustline Height:** N/A
Average Active Channel Width: 18.0' **Fill Estimate:** 232 cubic yards. **Overall Condition:** Fair.
Sizing: Properly sized; HW/D = 1 on a storm flow with more than a 250-year recurrence interval. Amber Lane is overtopped on more than a 250-year storm flow.

Barrier Status: **GRAY:** FishXing determined this crossing meets the 8-16-16 ft/sec passage criteria for adult steelhead on 22% of the range of estimated migration flows and fails to meet passage criteria for all age classes of juvenile salmonids. For adults and older juveniles actual passage is probably higher than predicted by FishXing because the primary violation of the passage criteria is lack-of-depth.

Preferred Treatment: Partially remove the concrete floor in the channel – if this does not affect the structural integrity of the crossing. Treat downstream partial/temporal barriers before addressing this crossing.

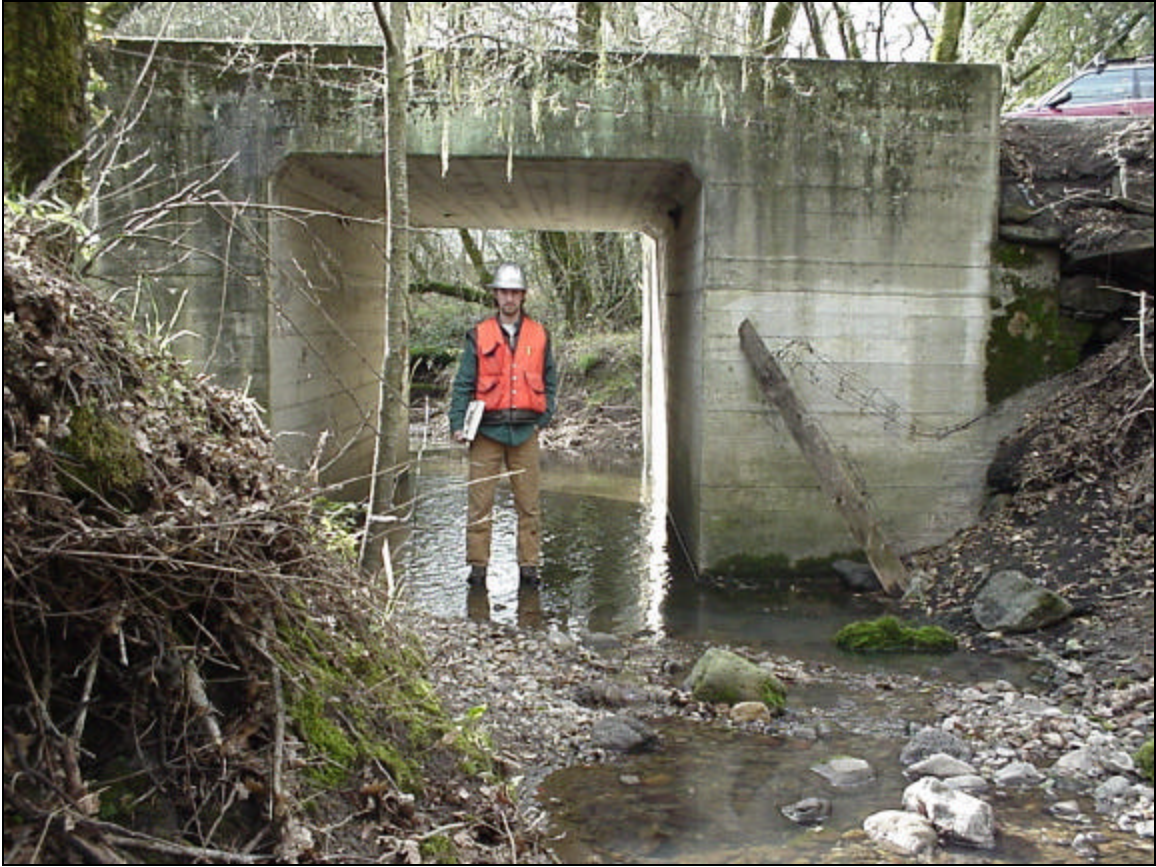
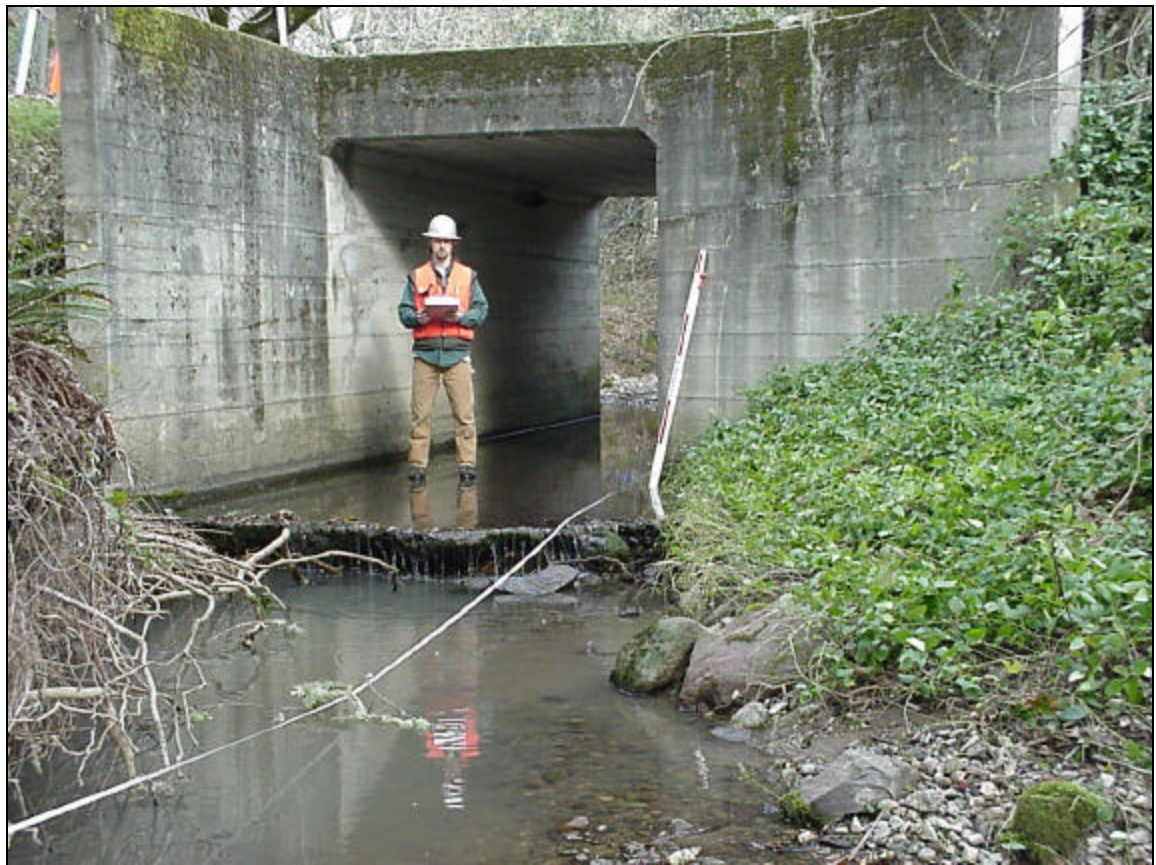
Culvert Type: Box, Concrete. **Corrugations:** None. **Dimensions:** 8.0' height x 8.0' width **Length:** 21.3'
Slope: 0.05% **Modifications:** None. **Rustline Height:** N/A **Average Active Channel Width:** 11.1'
Fill Estimate: 191 cubic yards. **Overall Condition:** Good. **Sizing:** Properly sized; HW/D = 1 on a storm flow with more than a 250-year recurrence interval. Riebli Road is overtopped on more than a 250-year storm flow.

Barrier Status: **GRAY:** FishXing determined this crossing meets the 8-16-16 ft/sec passage criteria for adult steelhead on 32% of the range of estimated migration flows and fails to meet passage criteria for all age classes of juvenile salmonids. For juveniles, there are numerous factors impeding migration – perched outlet, lack-of-depth, and excessive velocities.

Preferred Treatment: Because the crossing is properly sized, a retrofit is recommended. One to two boulder weirs downstream of the culvert will raise tail-water elevation and corner baffles will increase depths and decrease velocities. However, the County will need permission of downstream property owners for placement of weirs. Treat the partial/temporal barriers at downstream crossings on Rincon Creek before addressing this site.

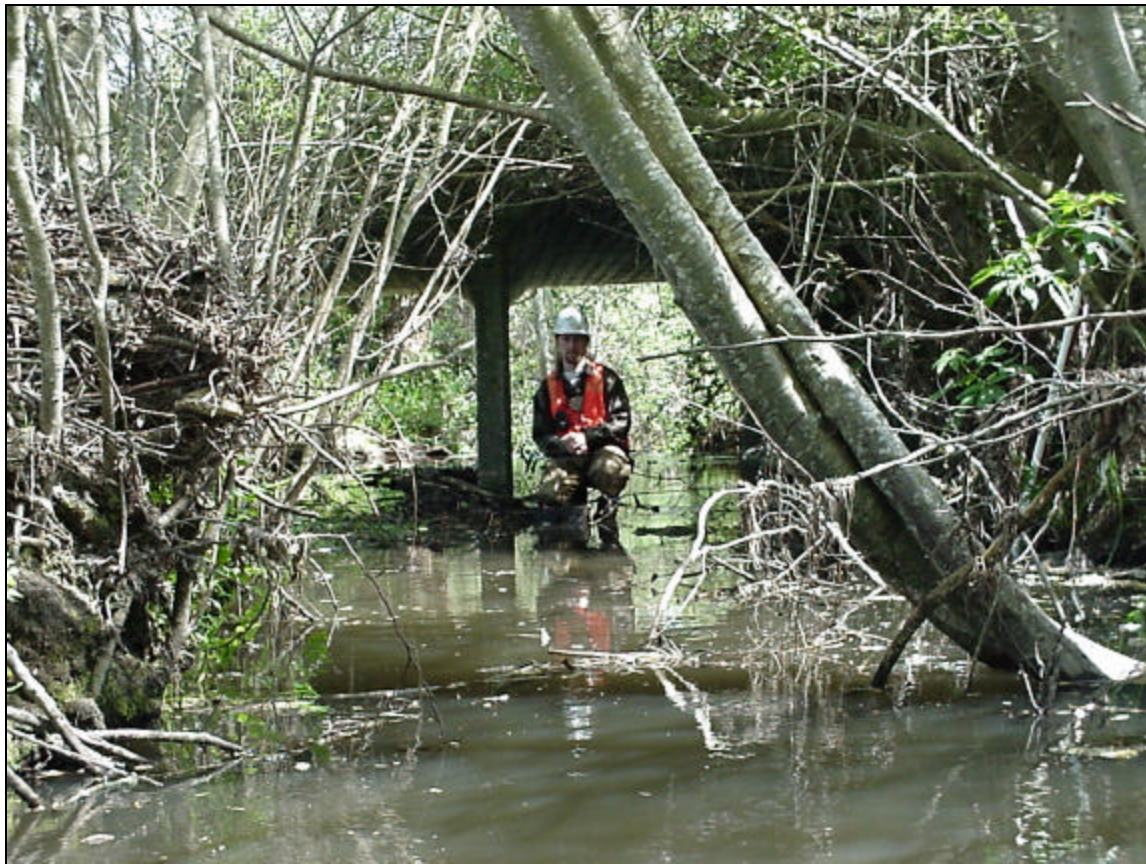
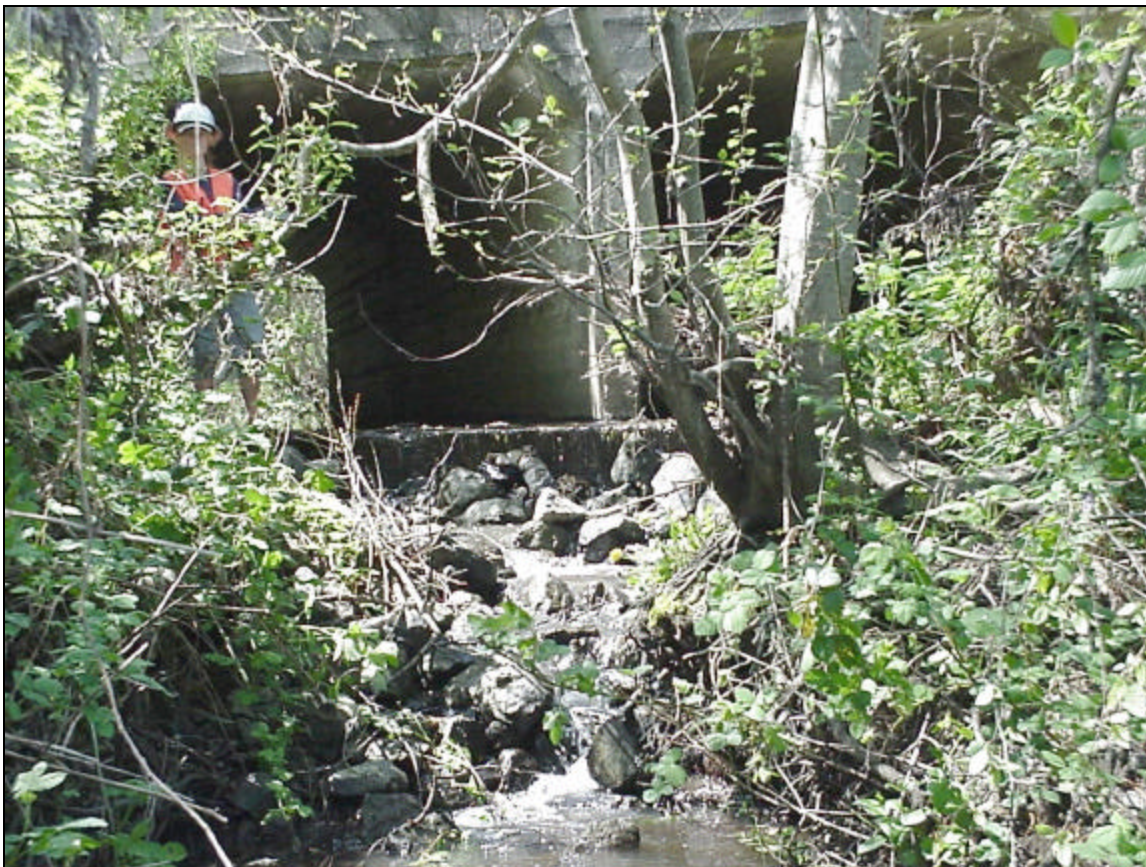
Culvert Type: Two Bay Box, Concrete. **Corrugations:** None. **Dimensions:** 6.1' height x 16.0' width
Length: 42.0' **Slope:** 0.19% **Modifications:** None. **Rustline Height:** N/A **Average Active Channel Width:** 13.9'
Fill Estimate: 232 cubic yards. **Overall Condition:** Good. **Sizing:** Properly sized; HW/D = 1 on a storm flow with more than a 250-year recurrence interval. Bloomfield Road is overtopped on more than a 250-year storm flow.

Barrier Status: **RED:** the Green-Gray-Red filter determined this crossing fails to meet passage criteria for adult steelhead and all age classes of juvenile salmonids due primarily to the drop at the outlet that spills over a 14-foot length of riprap (at about a 20% slope). Within the two-bay box culvert, passage is impeded by lack-of-depth and possibly excessive velocity at higher migration flows.

Preferred Treatment: Because the crossing is properly sized, a retrofit is recommended. Three to four boulder weirs downstream of the culvert will raise tail-water elevation and corner baffles will increase depths and decrease velocities. Recommend an evaluation of fish passage at the Railroad crossing prior to treating Site ID #S-062.

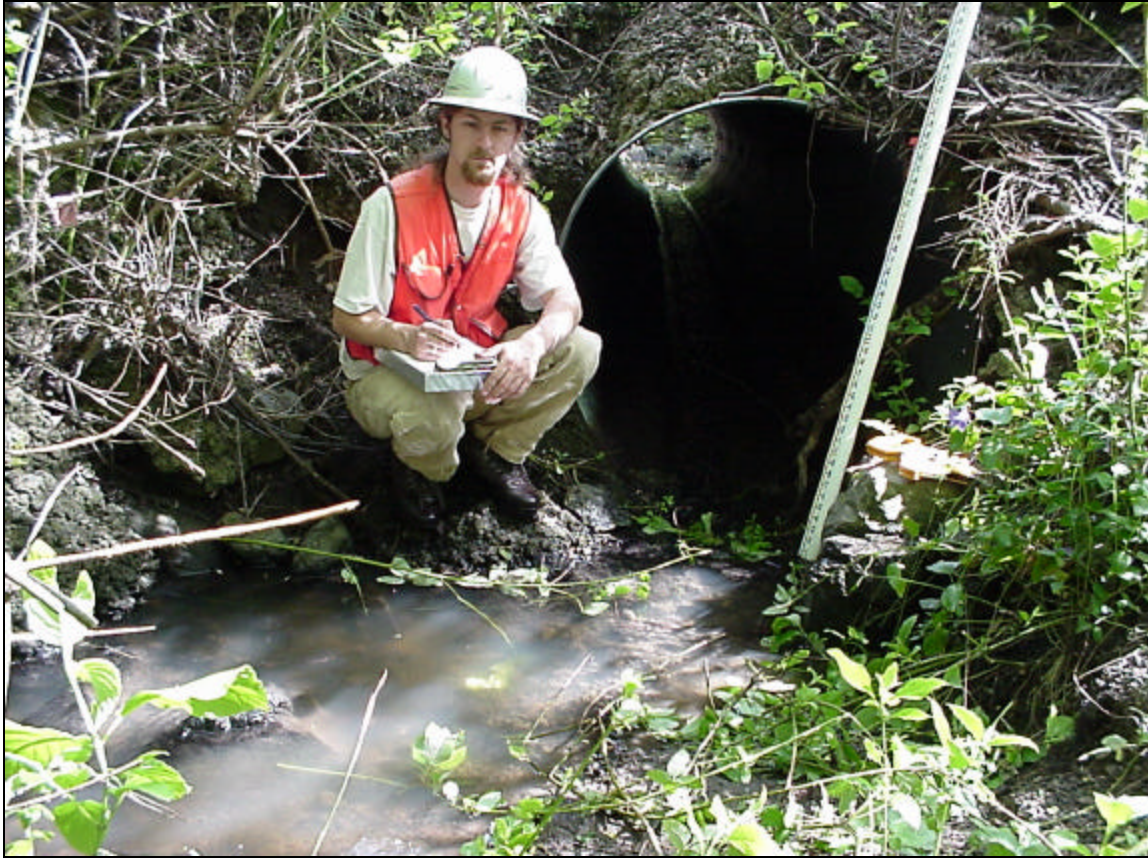
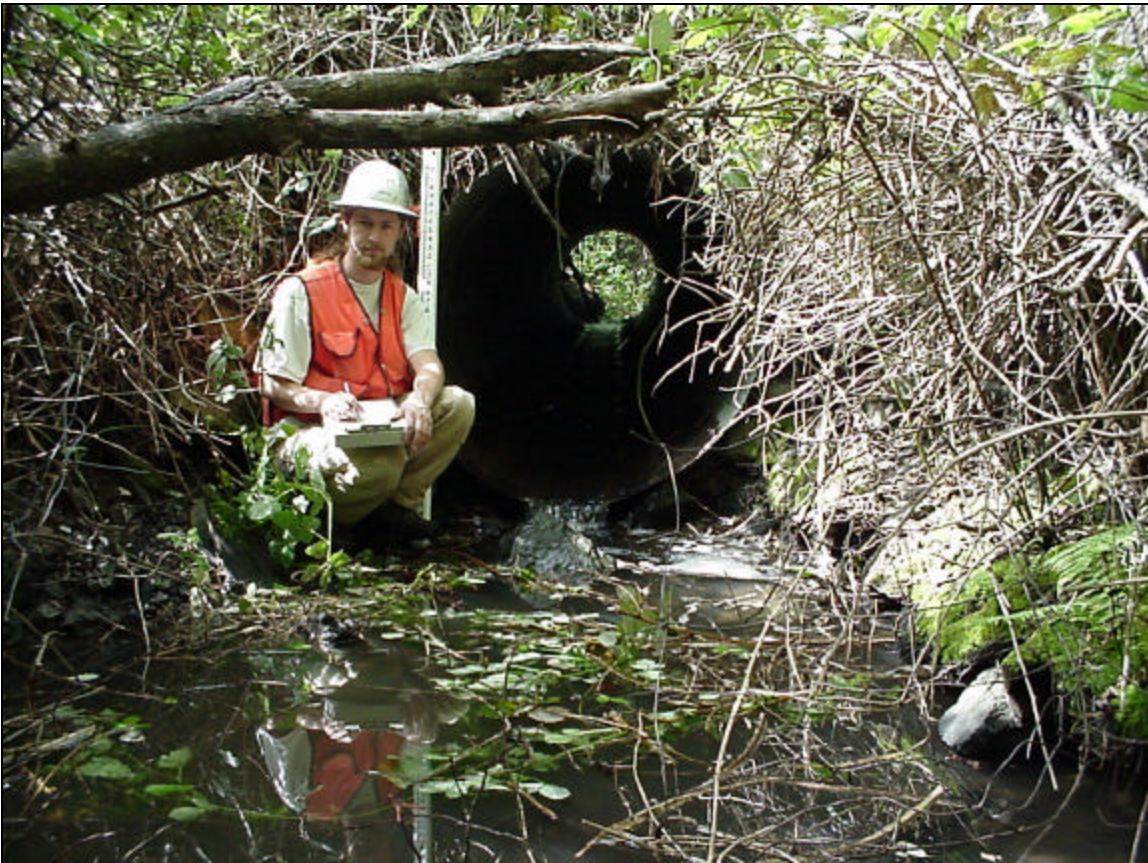
Culvert Type: Circular, SSP. **Corrugations:** 2-2/3" x 1/2" **Dimensions:** diameter = 4.0' **Length:** 40.5' **Slope:** 4.84% **Modifications:** None. **Rustline Height:** 1.0' **Average Active Channel Width:** 6.7' **Fill Estimate:** 205 cubic yards. **Overall Condition:** Poor- invert is rusted through. **Sizing:** Extremely undersized; HW/D = 1 on a storm flow with approximately a two-year recurrence interval. Blucher Valley Road is overtopped on approximately a 23-year storm flow.

Barrier Status: **GRAY:** FishXing determined this crossing meets the 8-16-16 ft/sec passage criteria for all adult steelhead on 86% of the range of estimated migration flows and fails to meet passage criteria for all age classes of juvenile salmonids. The nearly 5% slope creates excessive velocities for all age classes of juveniles.

Preferred Treatment: Although the current crossing allows adequate passage of adult steelhead, the culvert is extremely undersized, is in poor condition, and due for replacement. A properly sized embedded circular SSP culvert is recommended at this crossing. The limited upstream habitat gain makes this project a poor candidate for treating with fisheries restoration funding sources.

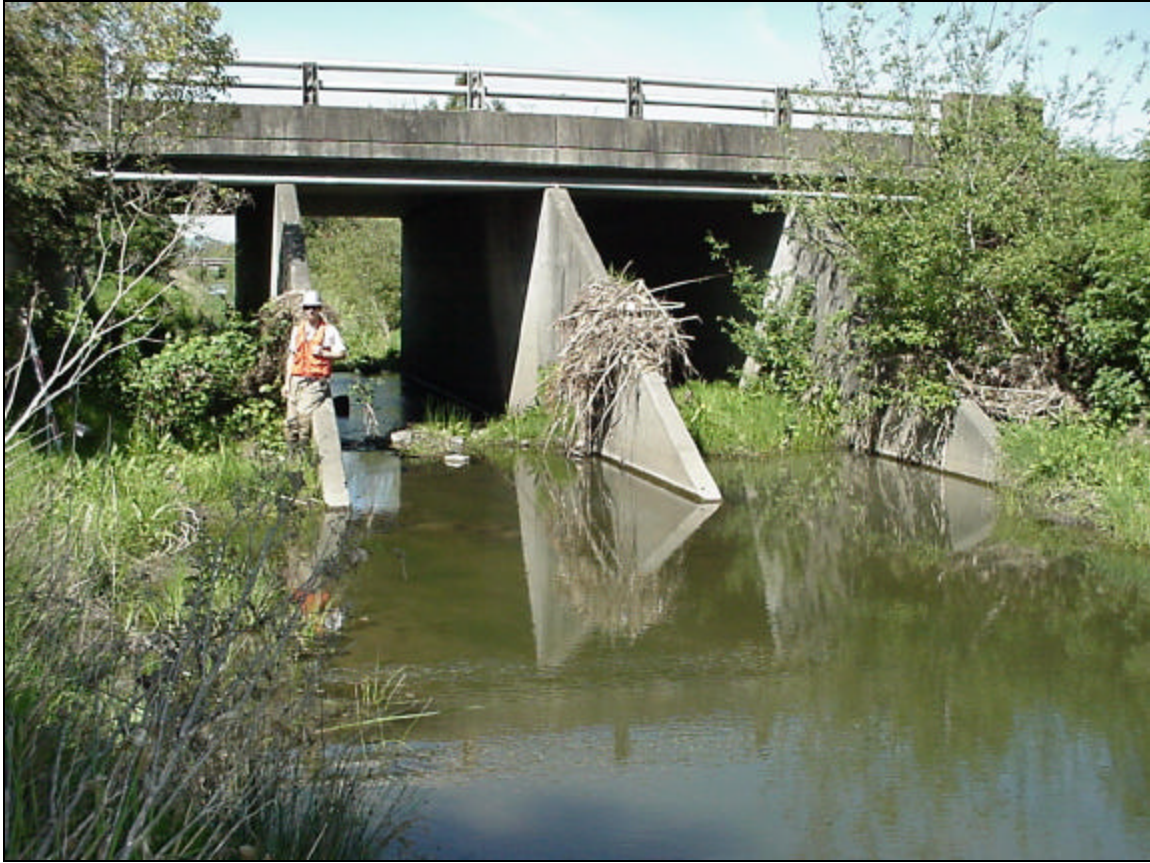
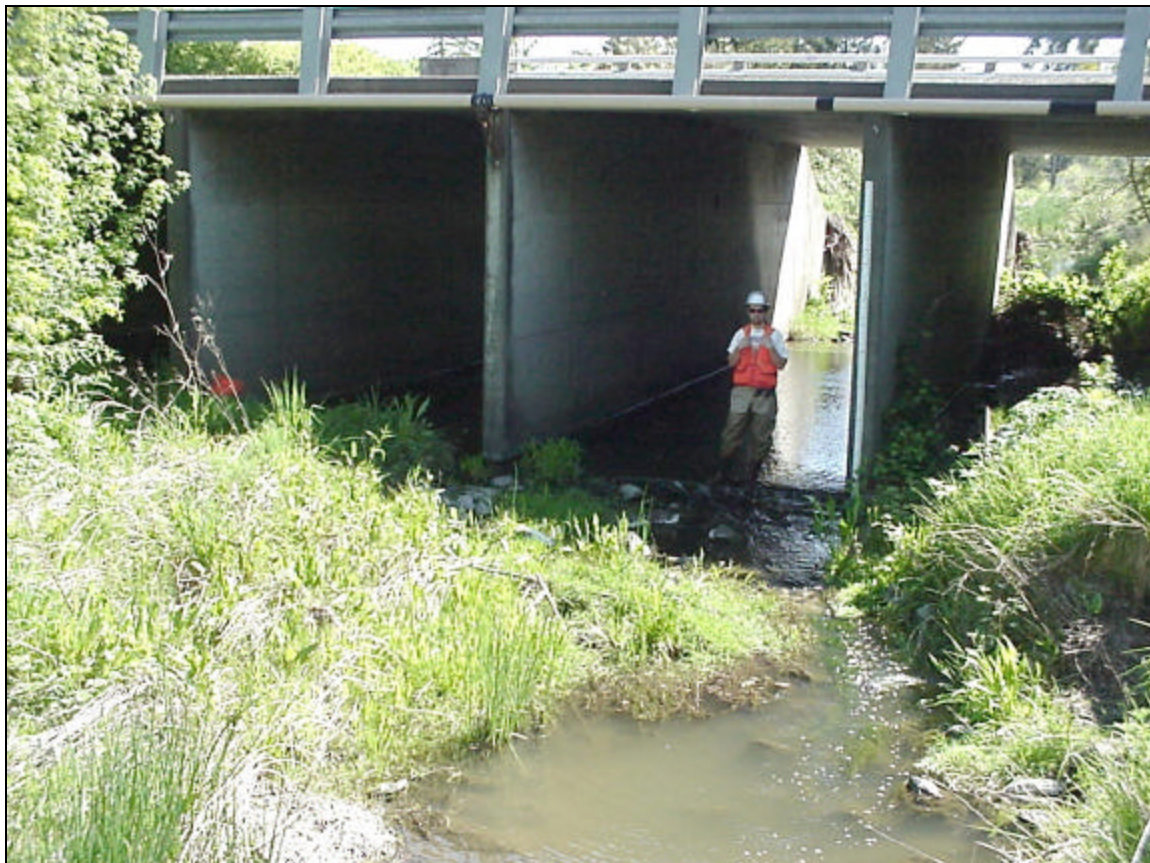
Culvert Type: Four Bay Box, Concrete. **Corrugations:** None. **Dimensions:** LB=11.8' height x 11.0' width; MLB=11.4' height x 11.0' width; MRB and RB =11.2' height x 11.0' width. **Lengths:** 44.9' **Slopes:** LB=-0.85%; MLB=-0.07%; MRB=-0.36%; RB=-2.52%. **Modifications:** None. **Rustline Height:** N/A **Average Active Channel Width:** 29.4' **Fill Estimate:** 759 cubic yards. **Overall Condition:** Good. **Sizing:** Properly sized; HW/D = 1 on a storm flow with more than a 250-year recurrence interval. Commerce Boulevard is overtopped on more than a 250-year storm flow.

Barrier Status: **GRAY:** FishXing determined three of the bays meet the 8-16-16 ft/sec passage criteria for adult steelhead (LB = 89%, MLB = 74% , MRB = 74%) of the range of estimated migration flows and fails to meet passage criteria for all age classes of juveniles. The RB=**RED:** FishXing determined this bay fails to meet passage criteria for adult steelhead and all age classes of juveniles. Actual juvenile passage is probably higher than predicted by FishXing because the primary violation of the passage criteria is lack-of-depth. At lower discharges, all the water flows through the middle two bays.

Preferred Treatment: None recommended because crossing provides adequate adult passage, is properly sized, and is in good condition. The poor quality habitat also makes this a low-priority site for fisheries habitat restoration.

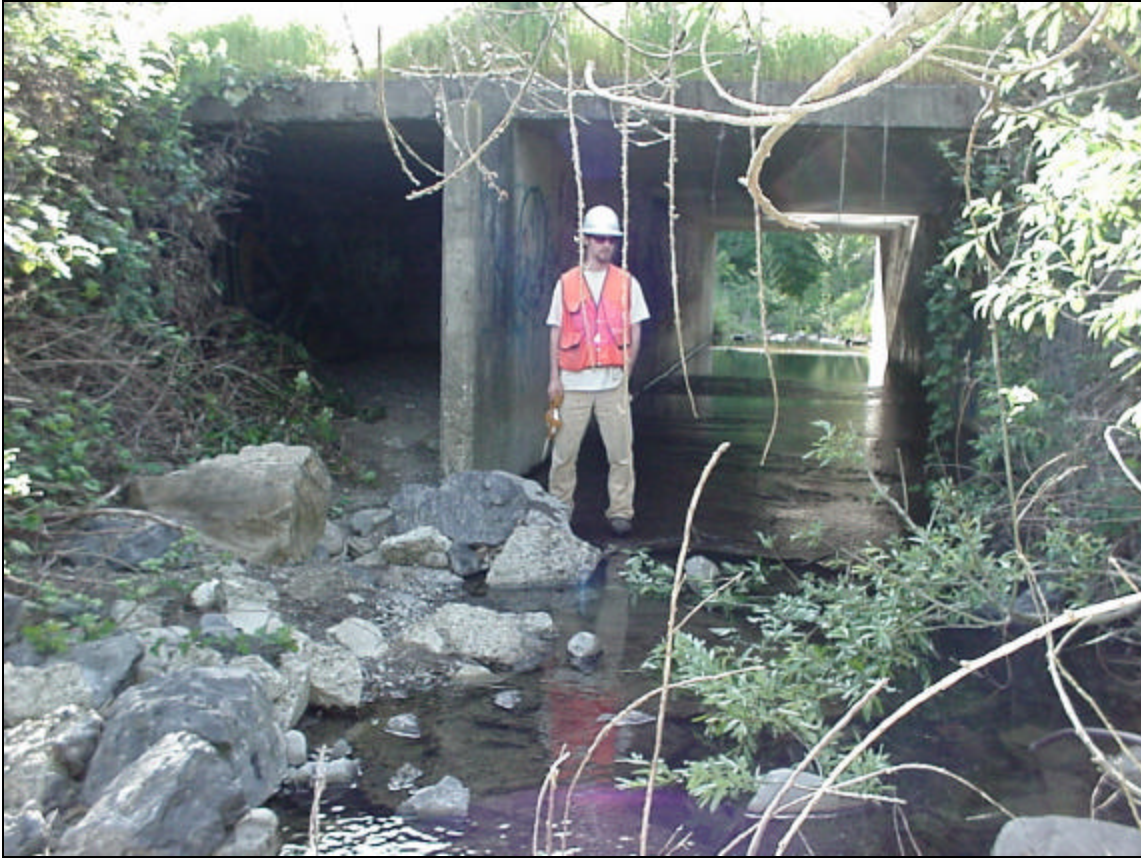
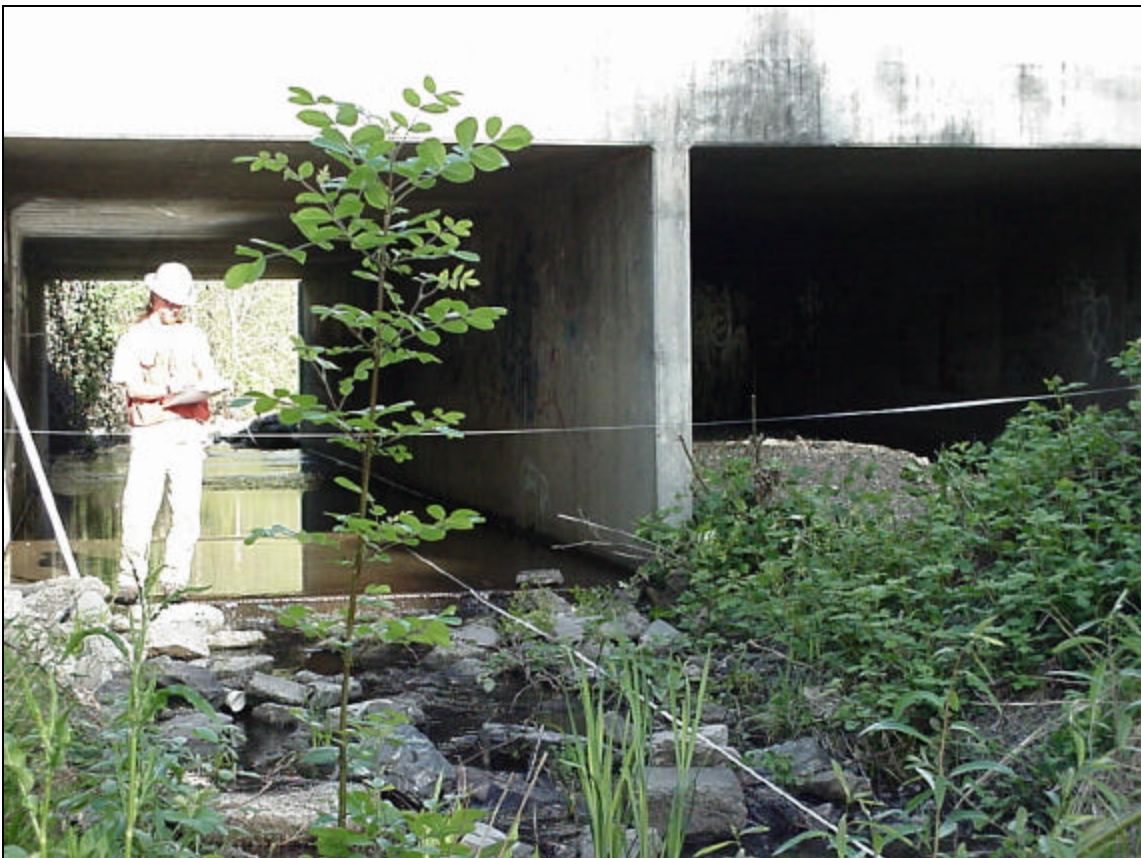
Culvert Type: Two Bay Box, Concrete. **Corrugations:** None. **Dimensions:** Each Bay = 8.05' height x 12.0' width
Length: 71.2' **Slopes:** LB = 0.15%; RB = 0.42% **Modifications:** None. **Rustline Height:** N/A
Average Active Channel Width: 12.3' **Fill Estimate:** 554 cubic yards. **Overall Condition:** Good.
Sizing: Properly sized; HW/D = 1 on a storm flow with more than a 250-year recurrence interval. Snyder Lane is overtopped on more than a 250-year storm flow.

Barrier Status: **GRAY:** FishXing determined the RB bay of this crossing meets the 8-16-16 ft/sec passage criteria for adult steelhead 72% of the range of estimated migration flows and fails to meet passage criteria for all age classes of juveniles. The LB bay is embedded several feet deep with cobble, gravel, and fines; and only receives flow on elevated discharges. Riprap at inlet assist in directing lower flows into the RB bay.

Preferred Treatment: None recommended because crossing provides adequate adult passage, is properly sized, and is in good condition. The poor quality habitat also makes this a low-priority site for fisheries habitat restoration.

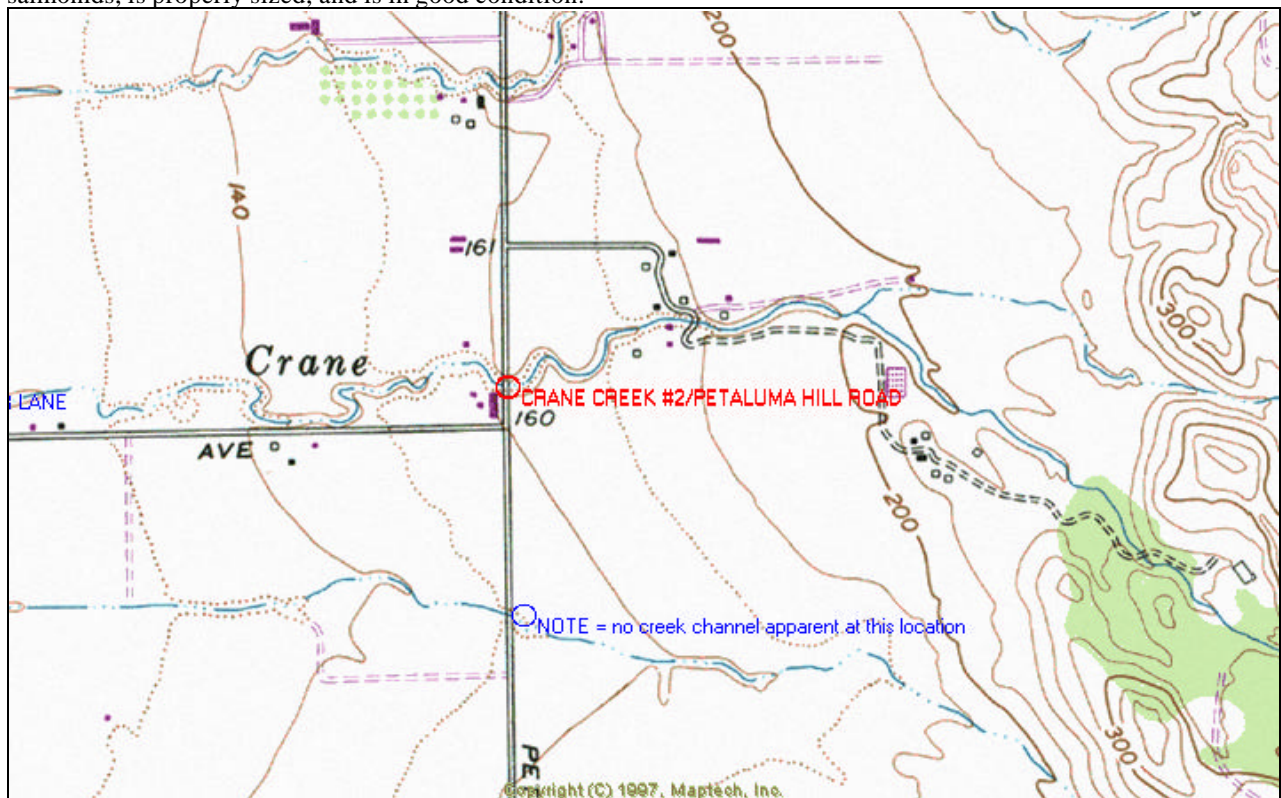
Site ID #S-066: Crane Creek #2/Petaluma Hill Road; Hinebaugh Creek; Laguna De Santa Rosa; Mark West Creek;
Russian River

Culvert Type: Box, Concrete. **Corrugations:** None. **Dimensions:** 11.0' height x 16.0' width **Length:** 70.3'
Slope: -1.29% **Modifications:** None. **Rustline Height:** N/A **Average Active Channel Width:** 17.3'
Fill Estimate: 667 cubic yards. **Overall Condition:** Good.

Preferred Treatment: None recommended because crossing provides unimpeded passage for all life stages of salmonids, is properly sized, and is in good condition.

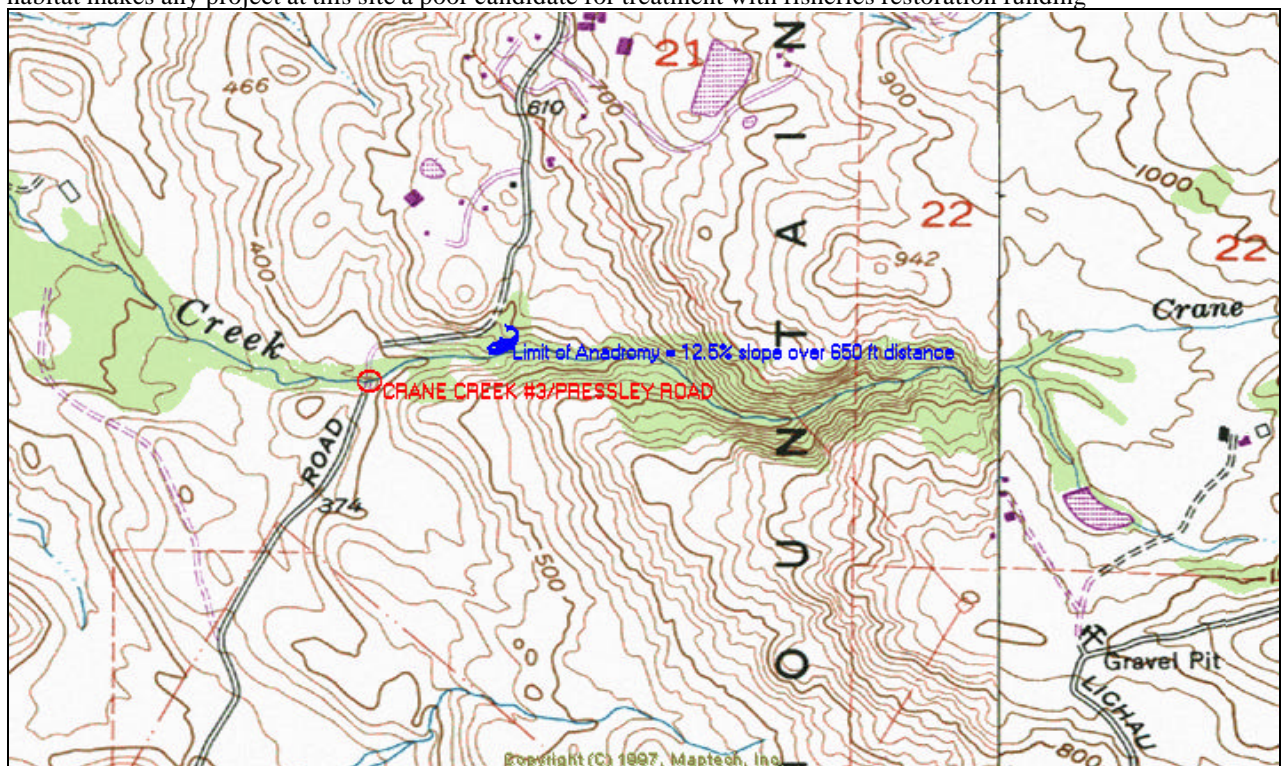
Site ID #S-067: Crane Creek #3/Pressley Road; Hinebaugh Creek; Laguna De Santa Rosa; Mark West Creek; Russian River

Culvert Type: Two Bay Box, Concrete. **Corrugations:** None. **Dimensions:** 11.0' height x 16.0' width
Length: 70.3' **Slope:** -1.29% **Modifications:** None. **Rustline Height:** N/A
Average Active Channel Width: 14.7' **Fill Estimate:** 180 cubic yards. **Overall Condition:** Fair.
Sizing: Extremely undersized; HW/D = 1 on a storm flow with approximately an eight-year recurrence interval.
Pressley Road is overtopped on approximately a 60-year storm flow.

Barrier Status: **RED:** the Green-Gray-Red filter determined this crossing fails to meet passage criteria for adult steelhead and all age classes of juvenile salmonids due to the extremely perched outlet (~ 5 ft).

Preferred Treatment: Because the current crossing is undersized (<10-year flow) and is extremely perched, a full replacement is the best long-term solution to restore fish passage. However, the limited reach of available upstream habitat makes any project at this site a poor candidate for treatment with fisheries restoration funding

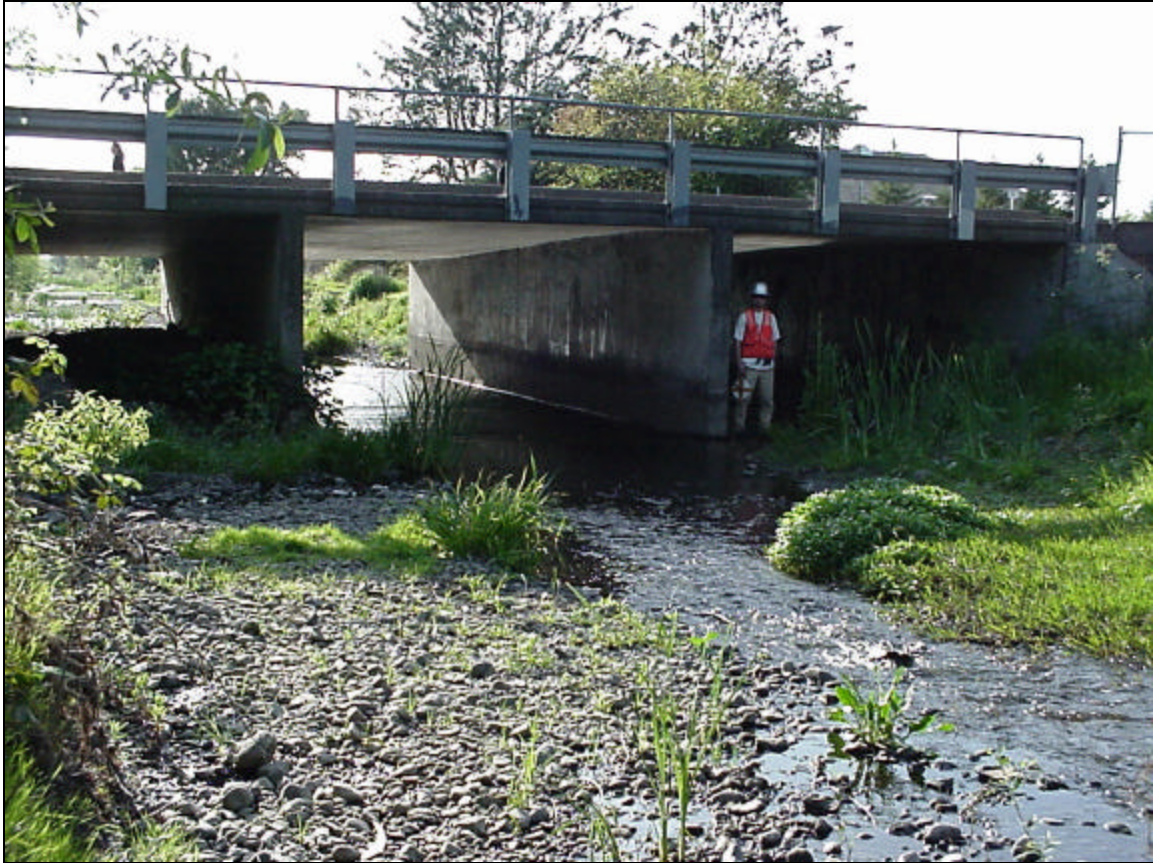
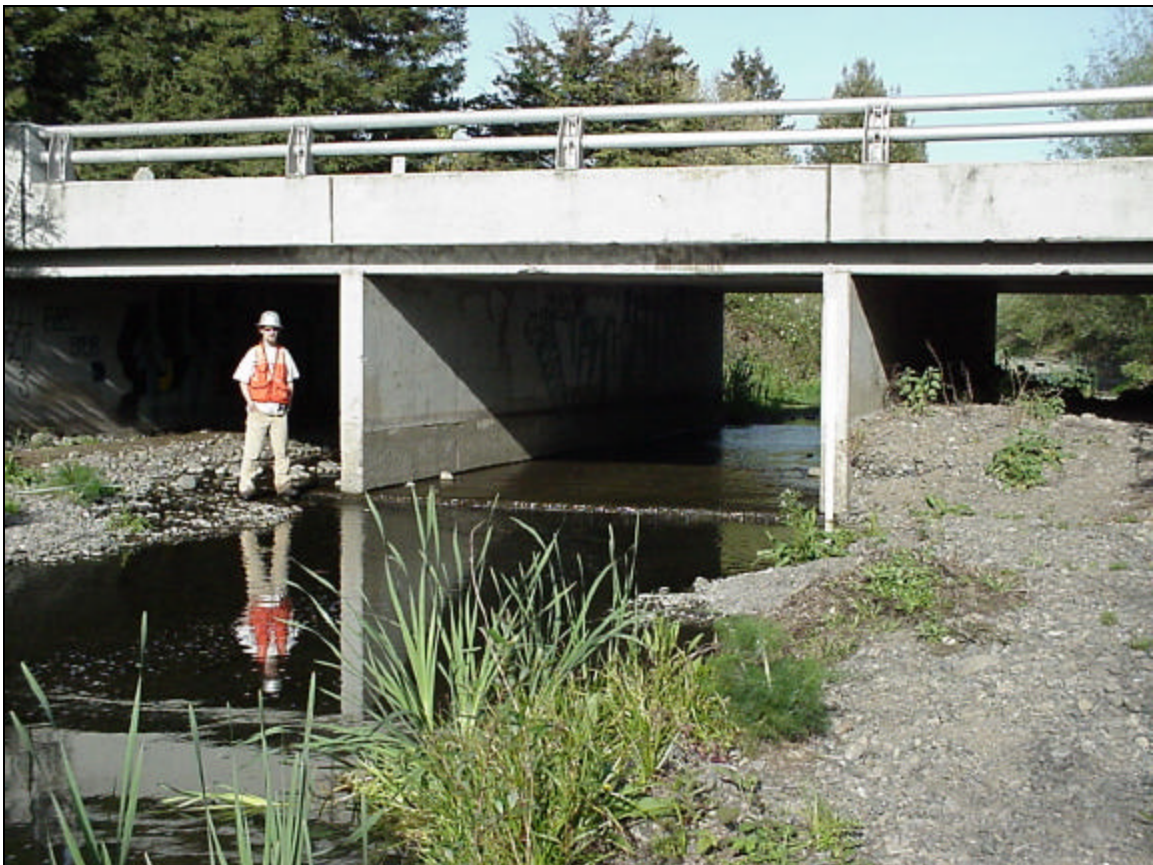
Site ID #S-069: Linda Creek #1/Mark West Springs Road; Mark West Ck; Russian River **Road Ownership:** County

Barrier Status: RED: the Green-Gray-Red filter determined this crossing fails to meet passage criteria for adult steelhead and all age classes of juveniles due to the extremely perched outlet.

Preferred Treatment: Because the crossing is properly sized, a retrofit is recommended. Four to five boulder weirs downstream of the culvert will raise tail-water elevation and corner baffles will increase depths and decrease velocities. Recommend fish passage evaluations at the eight private crossings prior to treating Site ID #S-069.
