CATALOG OF SONOMA COUNTY STREAM CROSSINGS WITH CULVERTS LOCATED ON FISH-BEARING STREAM REACHES WITHIN THE RUSSIAN RIVER BASIN

By
Ross Taylor and Associates

Site ID# S-001: Unnamed Tributary/Willow Creek Road; Willow Creek; Russian River **Road Ownership** County

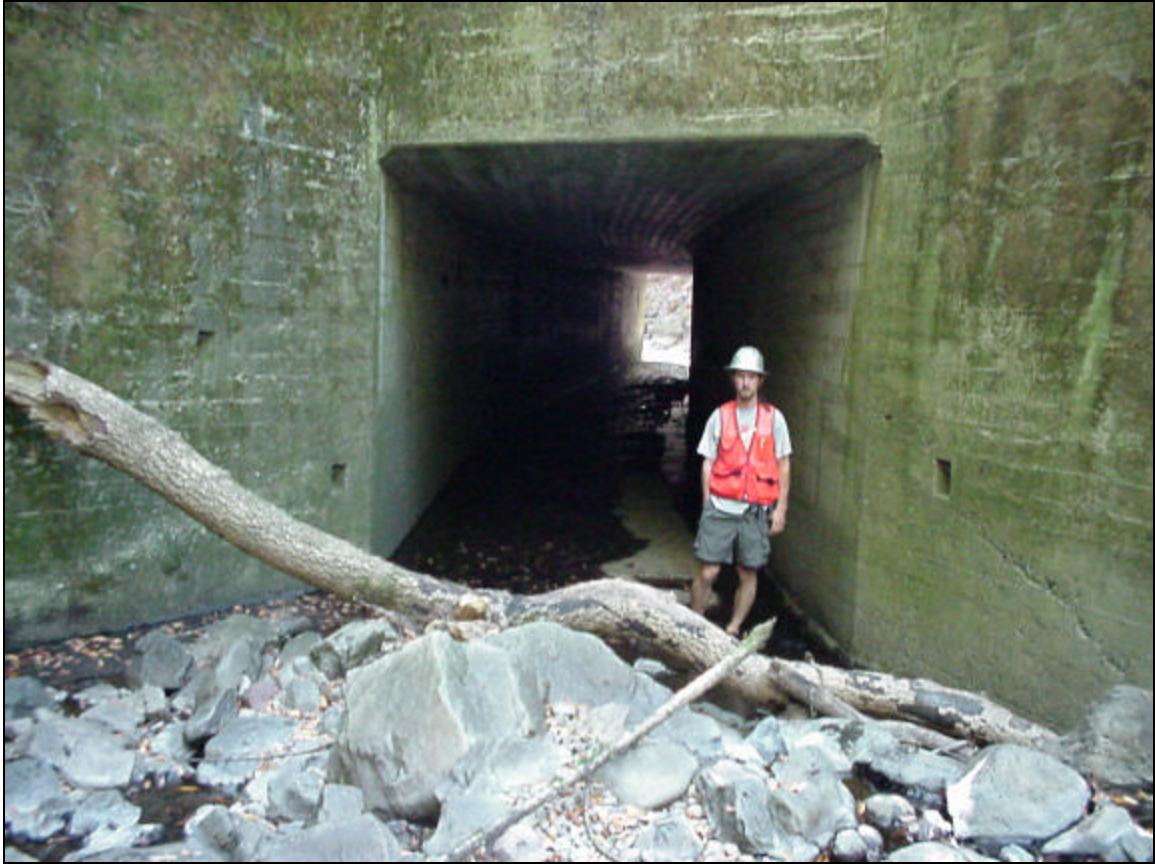
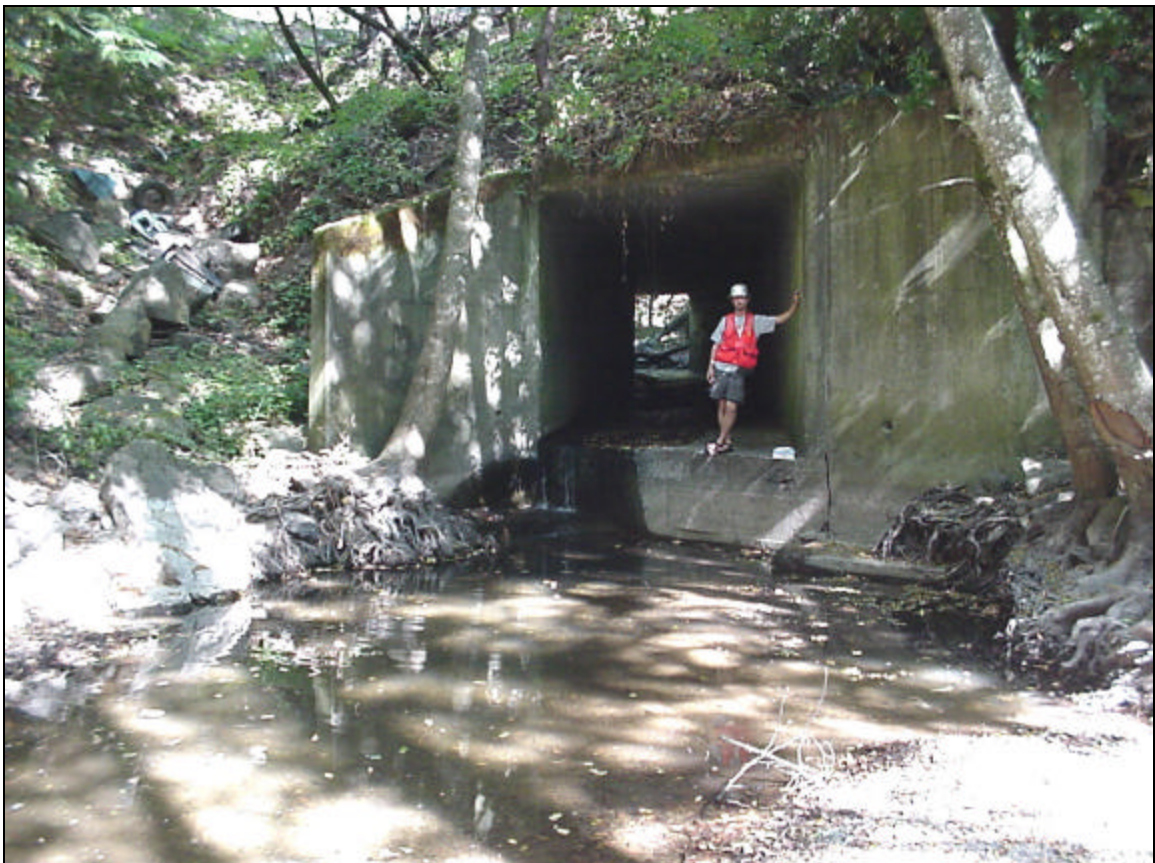
Site ID #S-070: Linda Creek #2/Riebli Road; Mark West Creek; Russian River **Road Ownership:** County

Culvert Type: Box, Concrete. **Corrugations:** None. **Dimensions:** 5.9' height x 12.0' width **Length:** 62.5' **Slope:** 1.07% **Modifications:** None. **Rustline Height:** N/A **Average Active Channel Width:** 21.3' **Fill Estimate:** 775 cubic yards. **Overall Condition:** Abraded.

Barrier Status: **RED:** FishXing determined this crossing fails to meet passage criteria for adult steelhead and all age classes of juvenile salmonids. For adults, the only violation of the passage criteria is lack-of-depth – so some passage of adults probably occurs. The slightly perched outlet impedes most juvenile passage, along with excessive velocities.

Preferred Treatment: Because the crossing is properly sized, a retrofit is recommended. Three to four boulder weirs downstream of the culvert will raise tail-water elevation and corner baffles will increase depths and decrease velocities. Recommend fish passage evaluations at the four private crossings prior to treating Site ID #S-070.

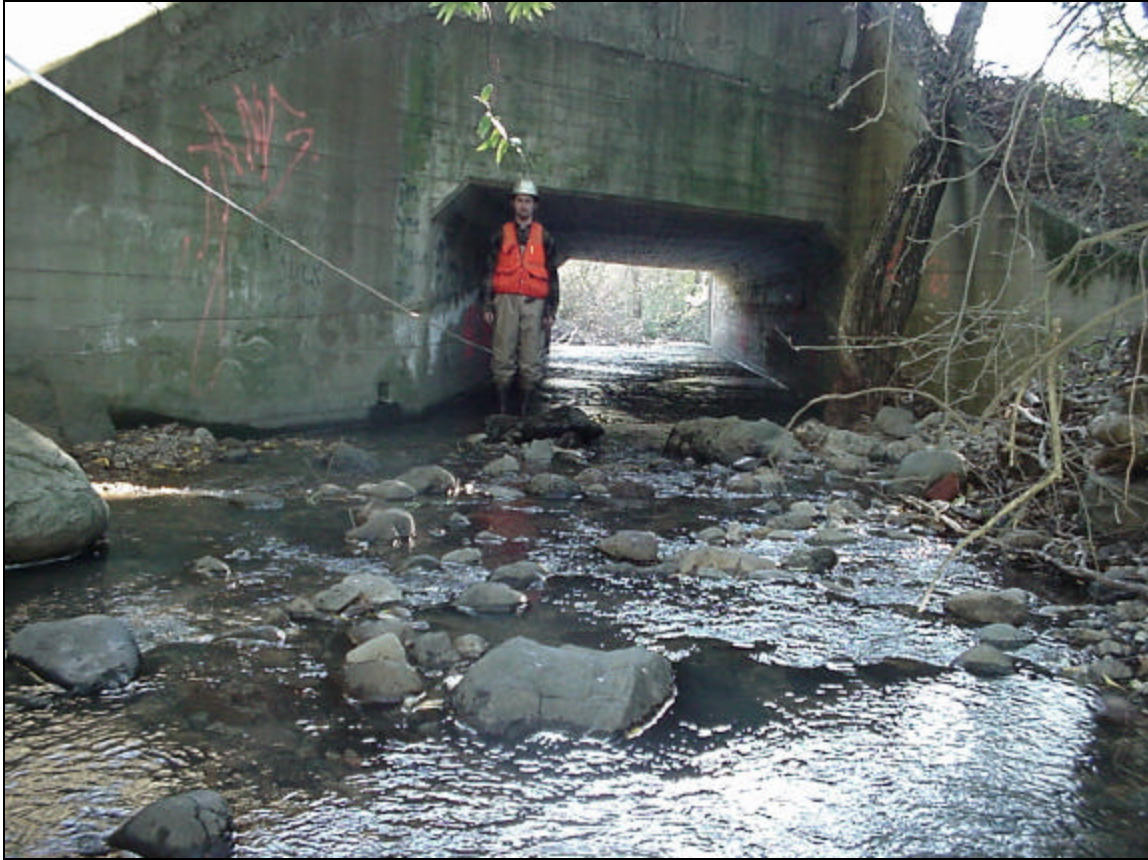
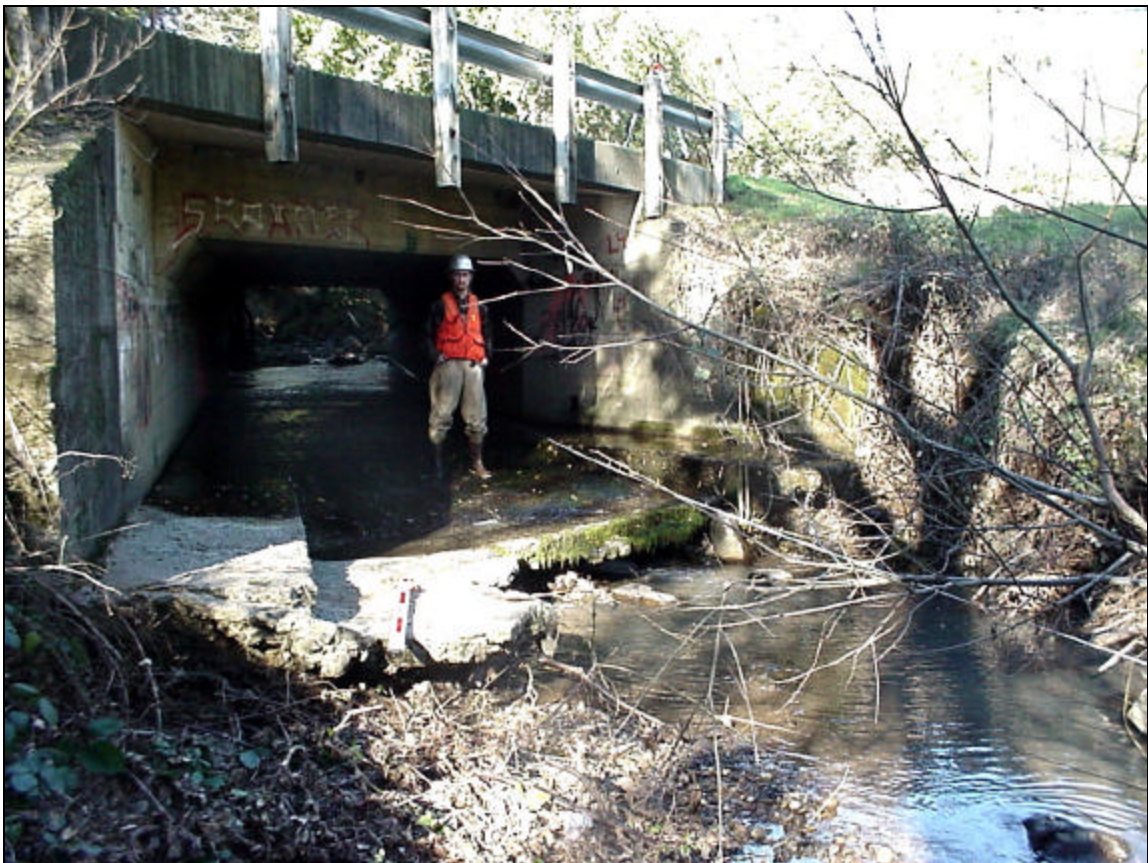
Site ID #S-071: Porter Creek #1 (tributary to Mark West Creek)/Porter Creek Road; Mark West Ck; Russian River
Road Ownership: County

Barrier Status: **GRAY:** FishXing determined this crossing meets the 8-16-16 ft/sec passage criteria for adult steelhead on 75% of the range of estimated migration flows and fails to meet passage criteria for all age classes of juvenile salmonids.

Preferred Treatment: Because the crossing is properly sized, a retrofit is recommended. Three to four boulder weirs downstream of the culvert will raise tail-water elevation and corner baffles will increase depths and decrease velocities. Consider placing a beam across one bay’s inlet to concentrate lower migration flows into a single bay.

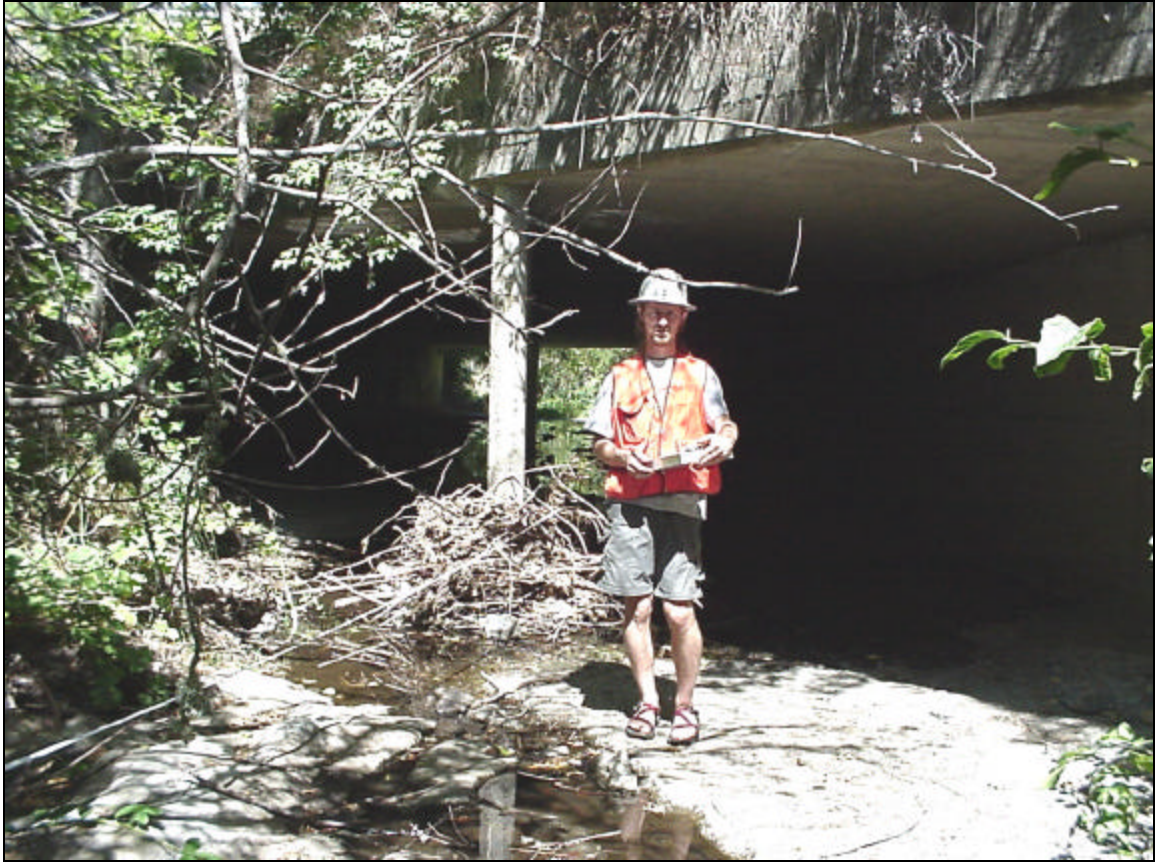
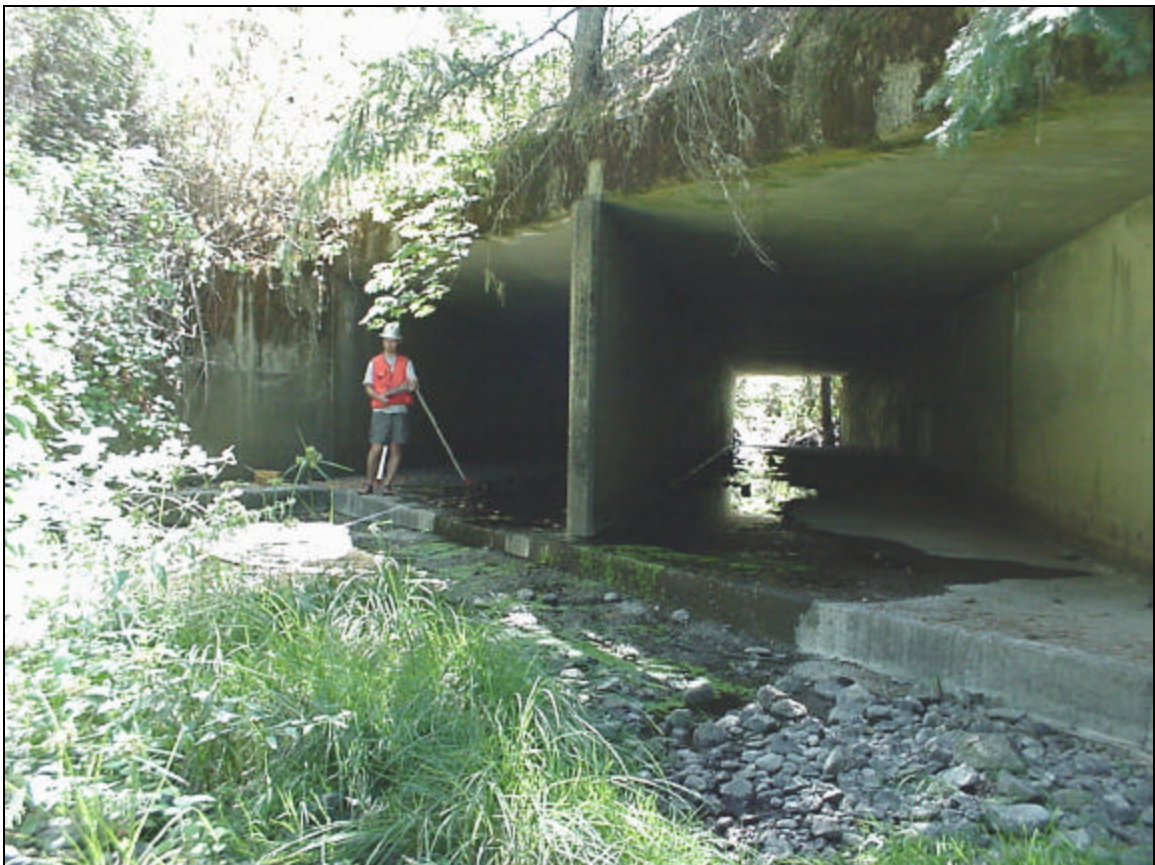
Site ID #S-072: Porter Creek #2 (tributary to Mark West Creek) /Calistoga Road; Mark West Creek; Russian River
Road Ownership: County

Culvert Type: Two Bay Box, Concrete. **Corrugations:** None. **Dimensions:** Each Bay= 10.8' height x 12.0' width
Lengths: LB= 120.0'; RB= 116.6' **Slopes:** LB=0.29%; RB= 0.42% **Modifications:** A fish Ladder in the left bay, alongside the left bank. **Rustline Height:** N/A **Average Active Channel Width:** 13.8' **Fill Estimate:** 2,689 cubic yards. **Overall Condition:** Good. **Sizing:** Properly sized; HW/D = 1 on a storm flow with more than a 250-year recurrence interval. Calistoga Road is overtopped on more than a 250-year storm flow.

Preferred Treatment: Possibly conduct a retrofit of the LB bay so that fish ladder is the entire width of the bay and also install sloped, v-notched concrete weirs within culvert. Recommend inspection of the crossing during migration-level storm flows to better assess effectiveness of the current fish ladder.

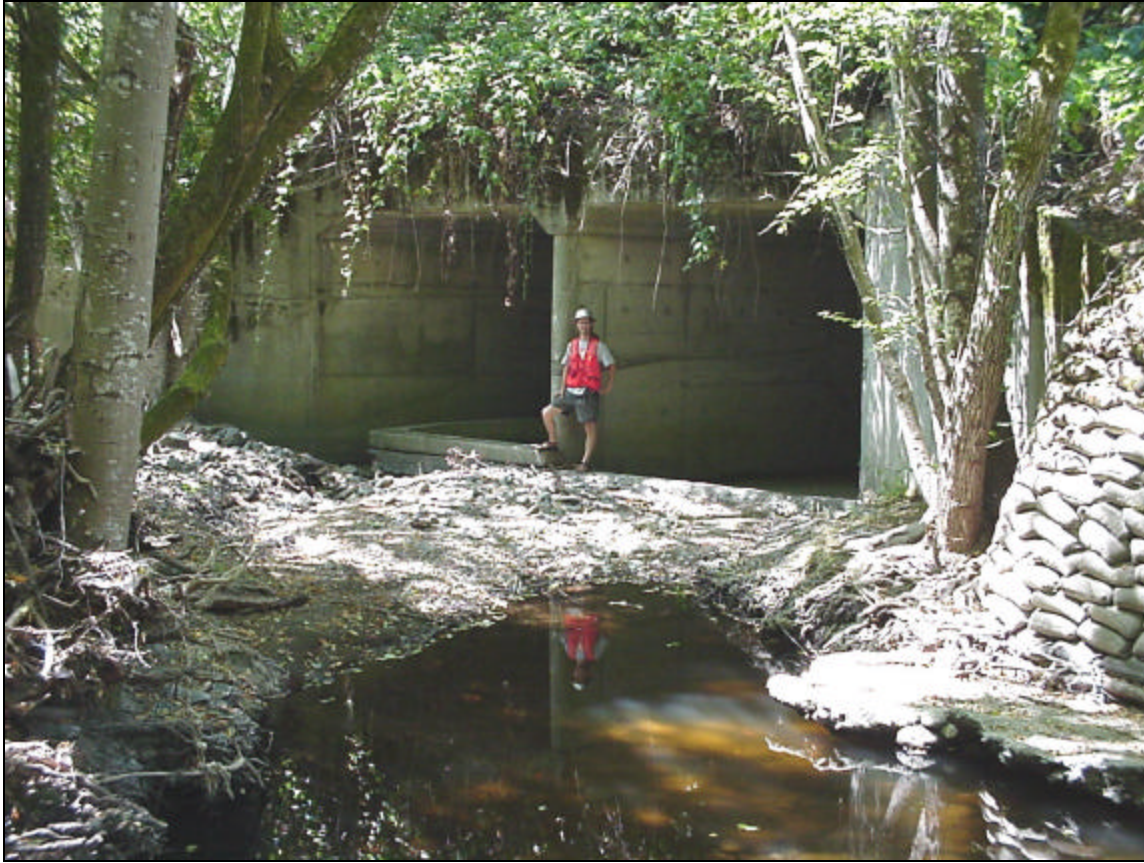
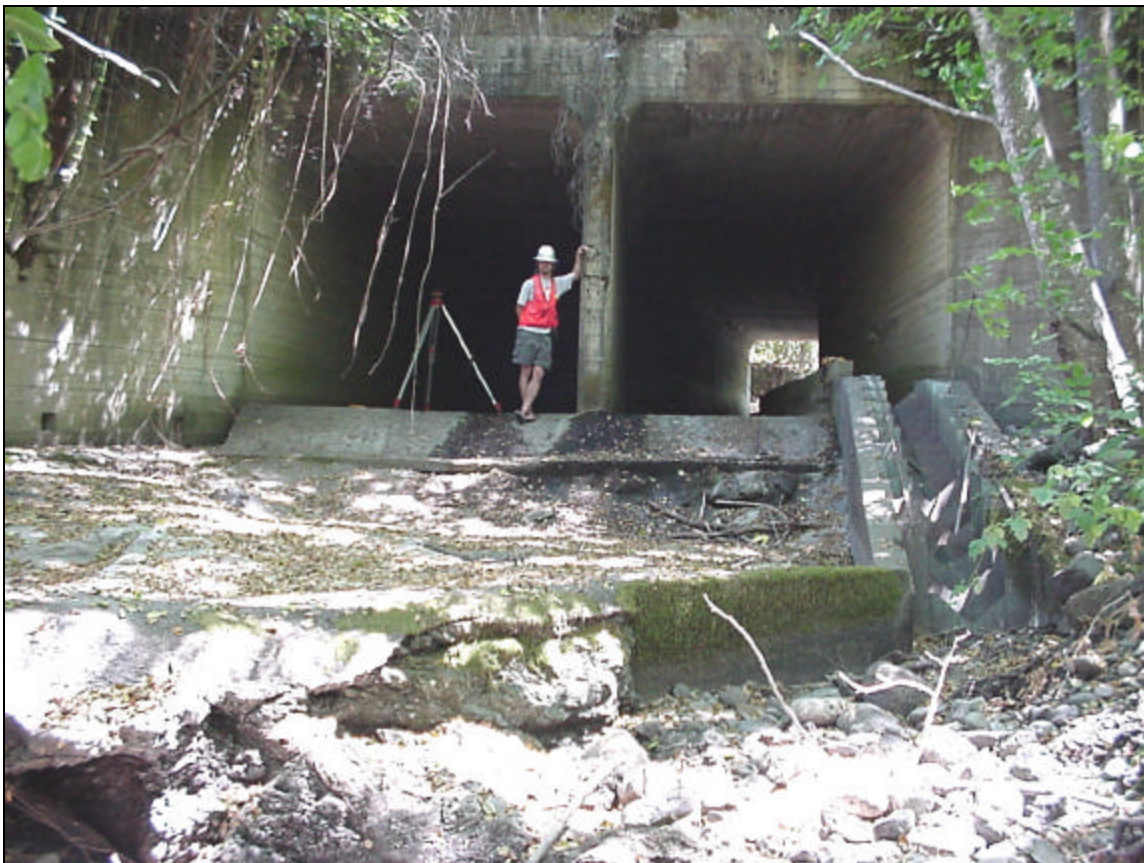
Site ID #S-073: Mark West Creek/Roehmer Road; Russian River

Barrier Status: LB=**GRAY**: FishXing determined this bay of the crossing meets the 8-16-16 ft/sec passage criteria for adult steelhead on 89% of the range of estimated migration flows, meets passage criteria for resident/2+ fish on 15% of the range of estimated migration flows, and fails to meet passage criteria for 1+/young-of-year juveniles. RB= **GRAY**: FishXing determined this bay of the crossing meets the 8-16-16 ft/sec passage criteria for adult steelhead on 94% of the range of estimated migration flows and fails to meet passage criteria for all age classes of juveniles. Juvenile passage may be higher than predicted by FishXing because the primary criteria violation over lower migration flows was a lack-of-depth.

Preferred Treatment: None recommended because the crossing provides adequate adult passage and probably allows some juvenile passage too.

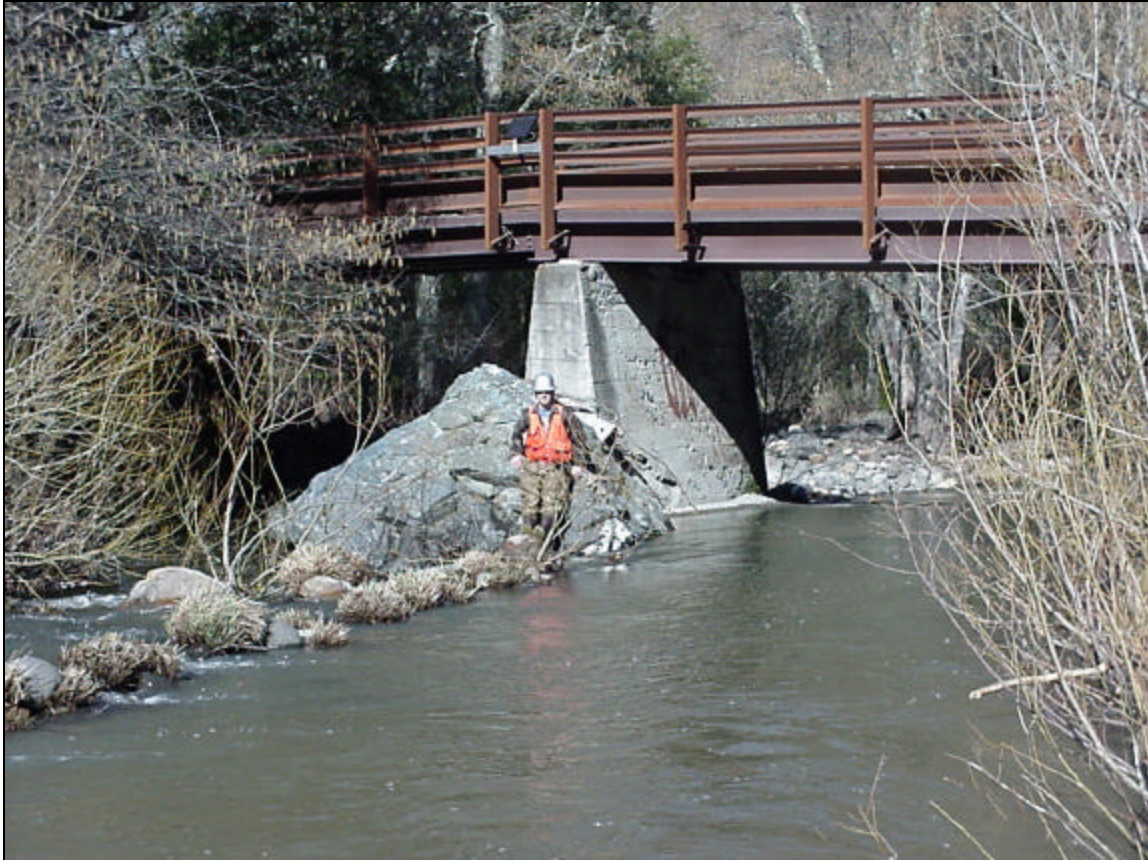
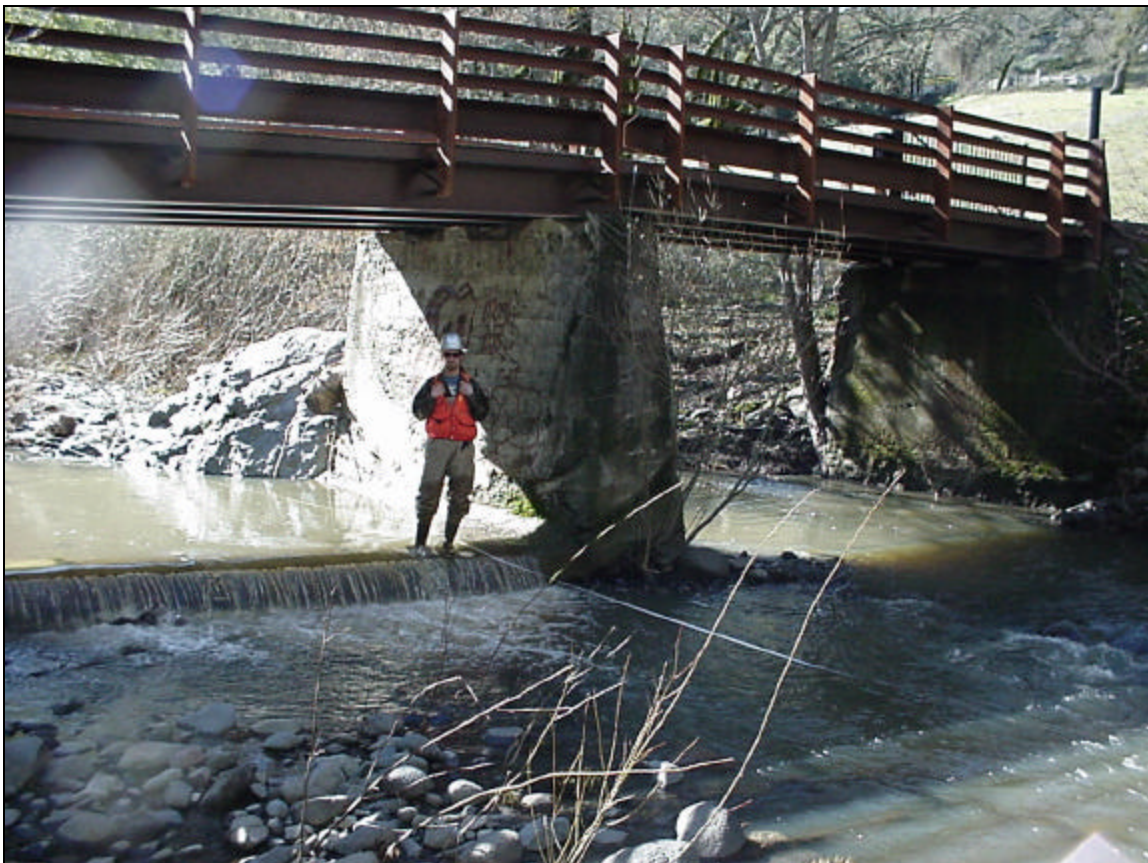
Site ID #S-074: Weeks Creek/Calistoga Road; Mark West Creek; Russian River **Road Ownership:** County

Barrier Status: LB=**GRAY**: FishXing determined this bay of the crossing meets the 8-16-16 ft/sec passage criteria for adult steelhead on 95% of the range of estimated migration flows, meets passage criteria for resident/2+ fish on 84% of the range of estimated migration flows, and fails to meet passage criteria for 1+/young-of-year juveniles.
RB=**RED**: because of the highly aggraded condition of this bay, it was assumed there is no flow through this bay at migration-level flows.

Preferred Treatment: The County should remove the hardware cloth placed across the inlet of the culvert – this fencing would impede fish passage and also cause plugging of debris during winter storms.

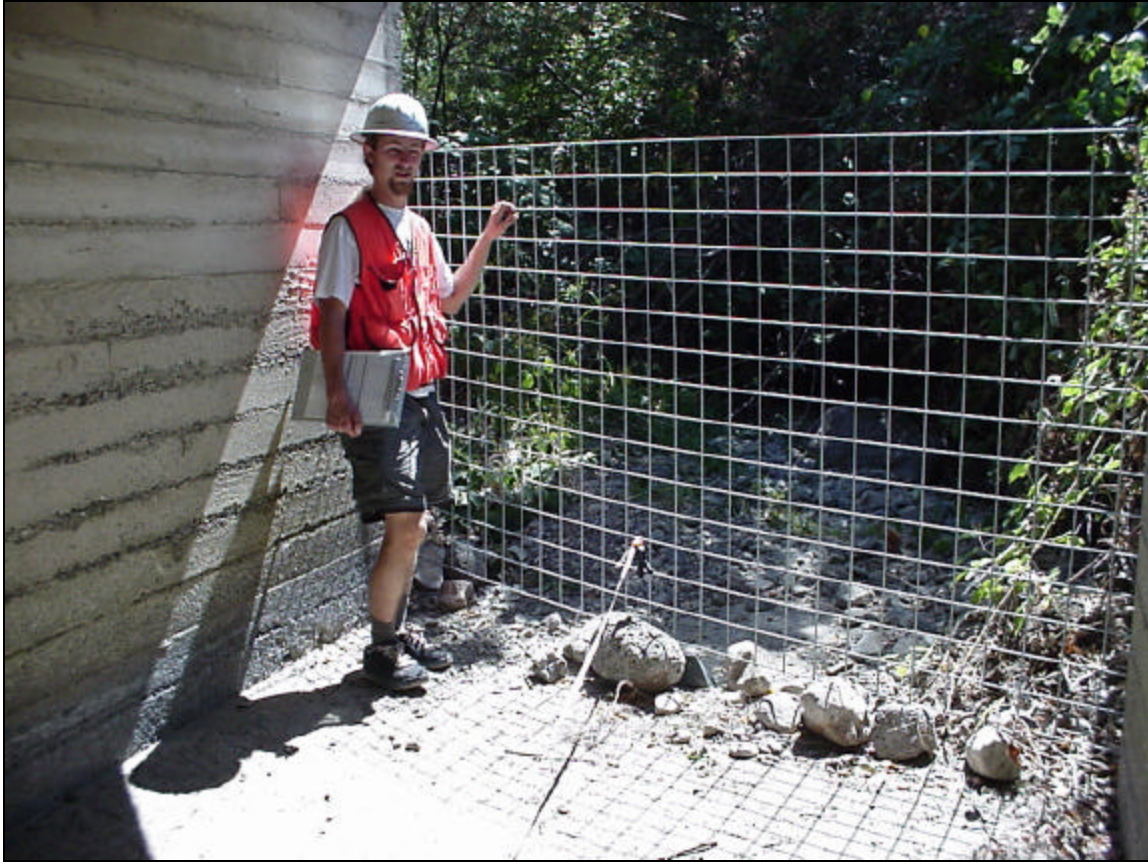
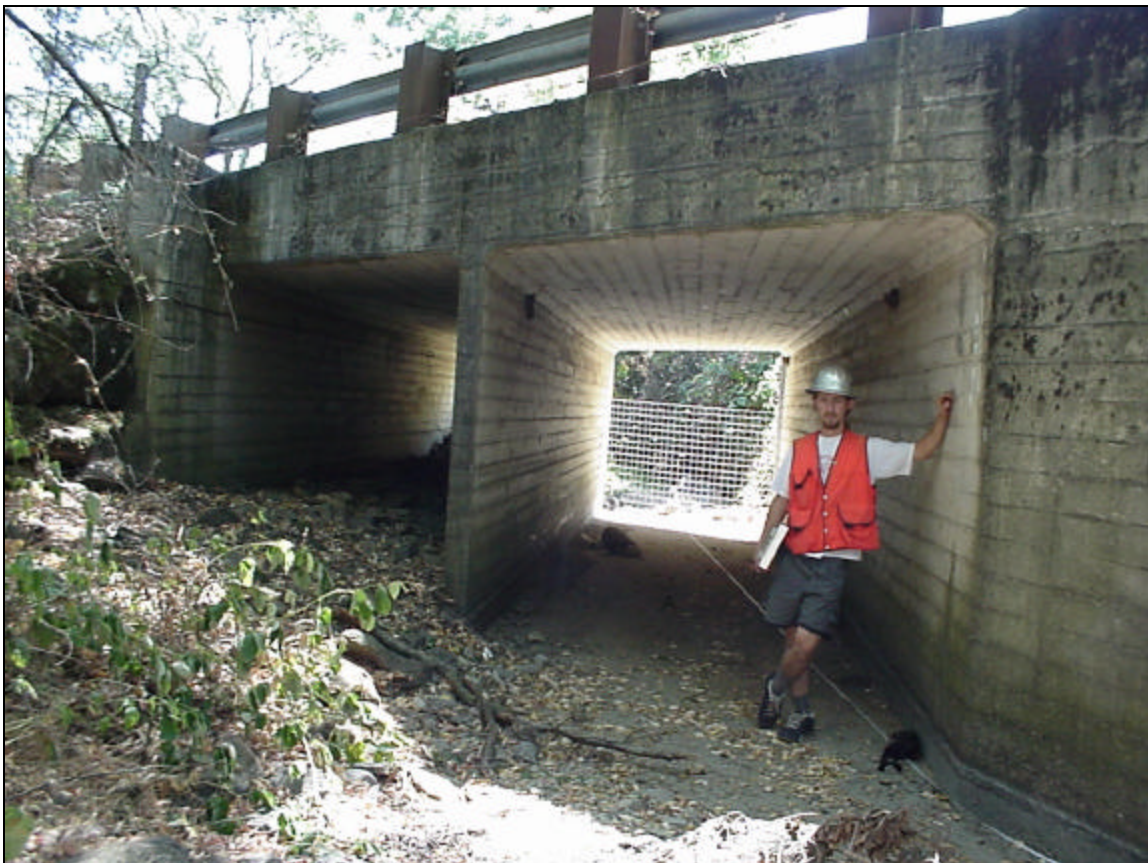
Site ID #S-075: Alpine Creek/St. Helena Road; Mark West Creek; Russian River **Road Ownership:** County

Barrier Status: **GRAY:** FishXing determined this bay of the crossing meets the 8-16-16 ft/sec passage criteria for adult steelhead on 54% of the range of estimated migration flows and fails to meet passage criteria for all age classes of juvenile salmonids. The perched outlet (1.8') is the main impediment to all age classes of juveniles.

Preferred Treatment: Due to the poor sizing of the current box culvert, a retrofit may not be a feasible option because of the increased risk of flooding if storm flow capacity is further reduced by downstream boulder weirs and/or baffles within the culvert. A full replacement is the best long-term solution to provide unimpeded passage and improve flow conveyance; however the limited upstream habitat makes this site a poor candidate for treatment with fisheries restoration funding.

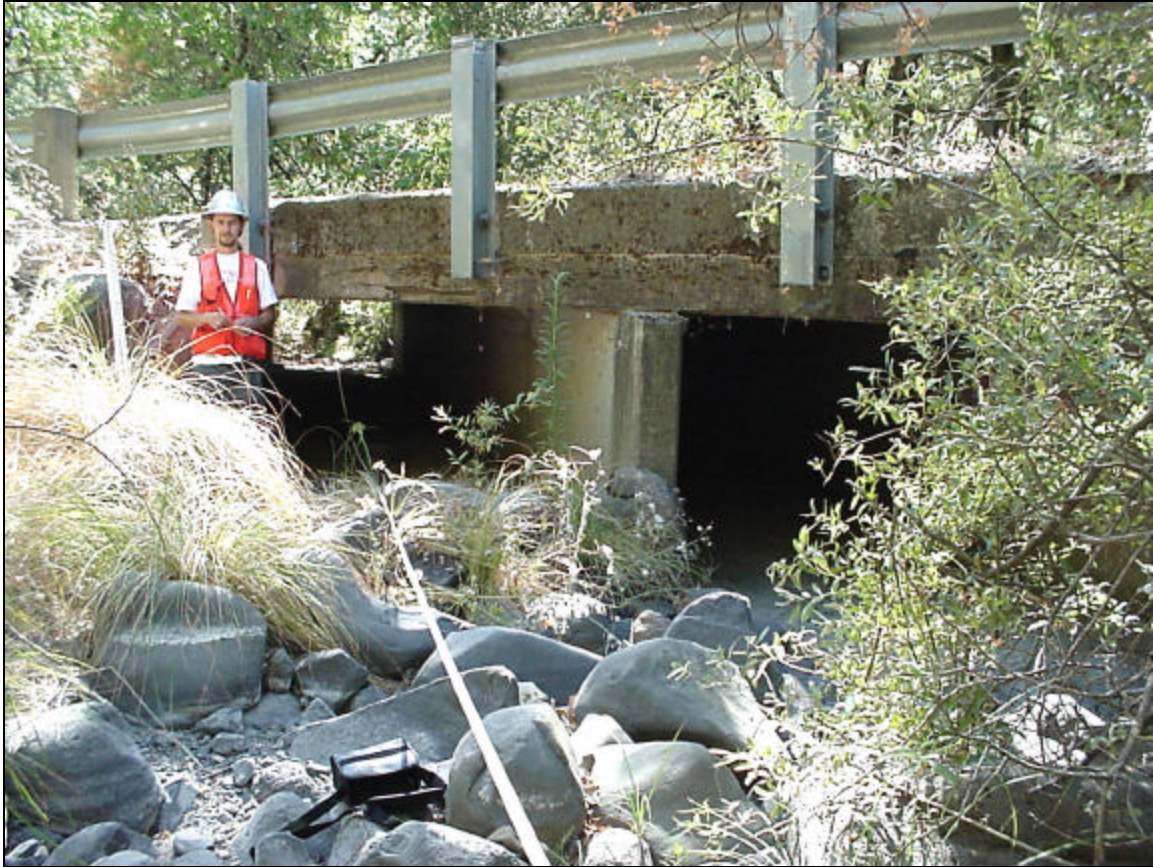
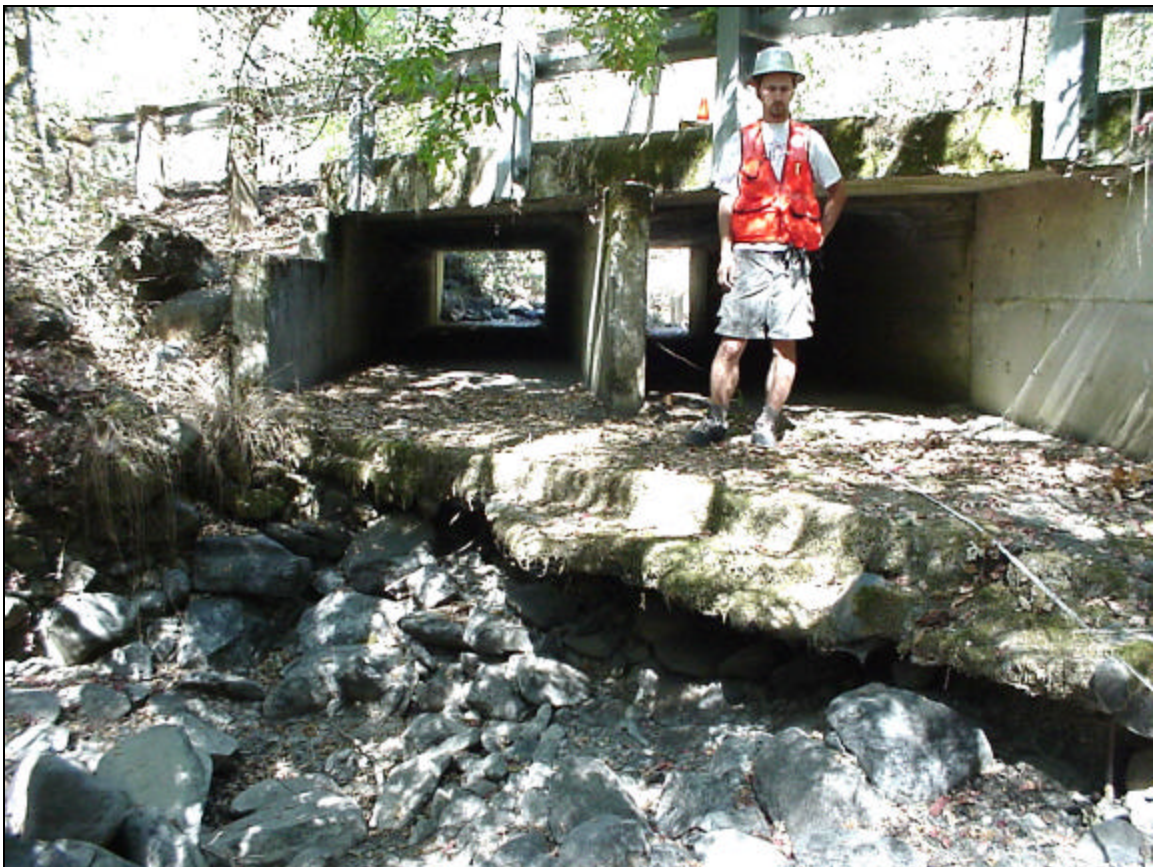
Site ID #S-077: Unnamed Tributary #1 to Mark West Creek/St. Helena Road; Mark West Creek; Russian River

Barrier Status: **RED:** the Green-Gray-Red filter determined this crossing fails to meet passage criteria for adult steelhead and all age classes of juvenile salmonids due to the >4 foot perched outlet and steeply-slope concrete apron.

Preferred Treatment: Although this crossing is located upstream of Mark West Creek's anadromous reach and the unnamd tributary has a very limited fish-bearing reach – the crossing is in poor condition and may require some maintenance or repair work.

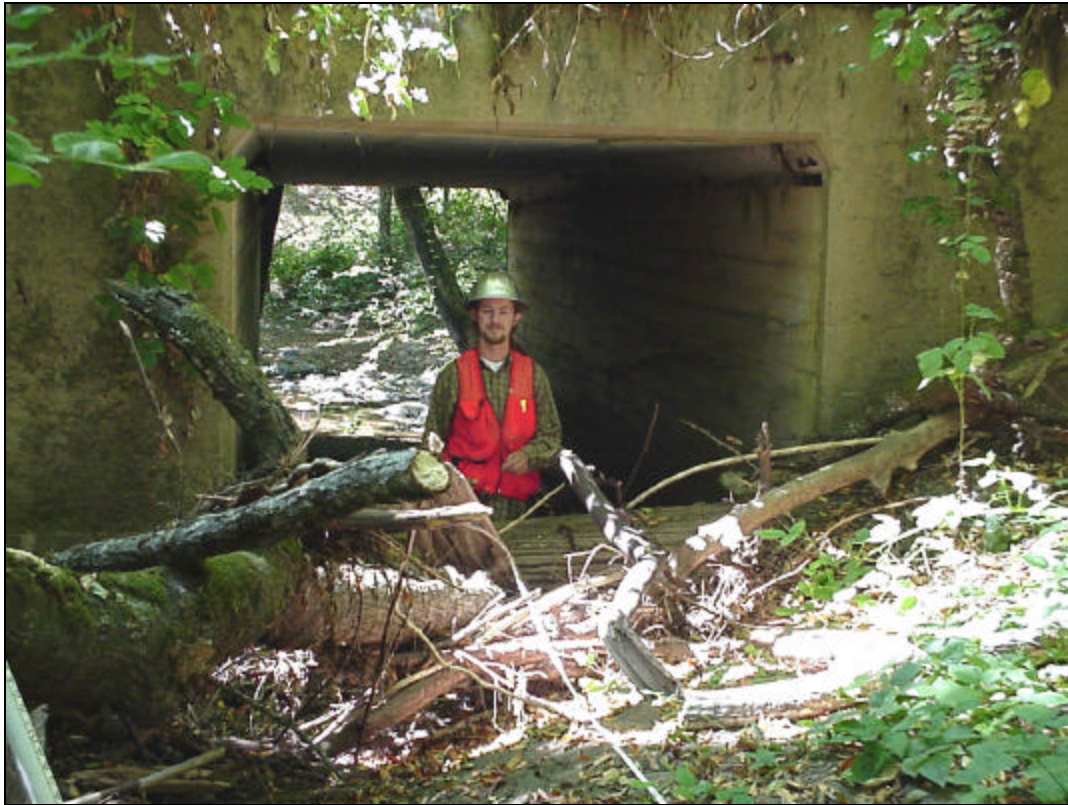
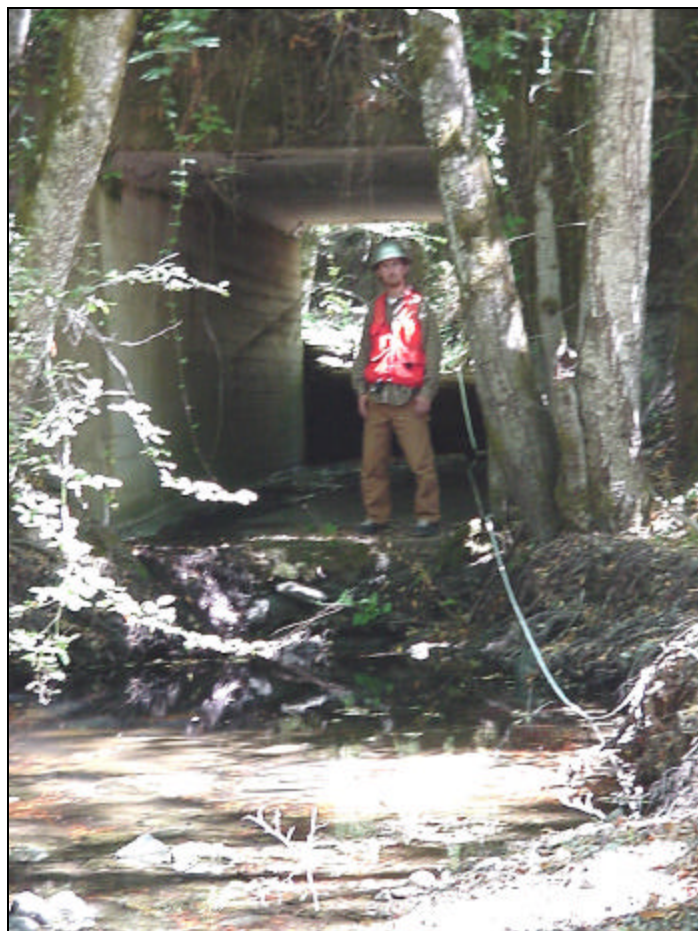
Site ID #S-080: Porter Creek #1/Sweetwater Springs Road; Russian River **Road Ownership:** County
County Ranking: #1 = High-Priority **Basin-wide Ranking: #1 = High-Priority**

Barrier Status: LB pipe=**RED**: the Green-Gray-Red filter determined this crossing fails to meet passage criteria for adult steelhead and all age classes of juveniles due to the culvert's nearly 8% slope. RB pipe = **GRAY**: FishXing determined this pipe meets the 8-16-16 ft/sec passage criteria for adult steelhead on 33% of the range of estimated migration flows and fails to meet passage criteria for all age classes of juvenile salmonids. This culvert's slightly perched outlet and nearly 3.5% slope are the features that impede juvenile migration.

Preferred Treatment: Due to the current crossing's poor condition, a replacement with a properly sized open-bottom arch set on concrete footings or a bridge is recommended. CDFG should assess and, if needed, treat any downstream migration impediments prior to treating Site ID #S-080.

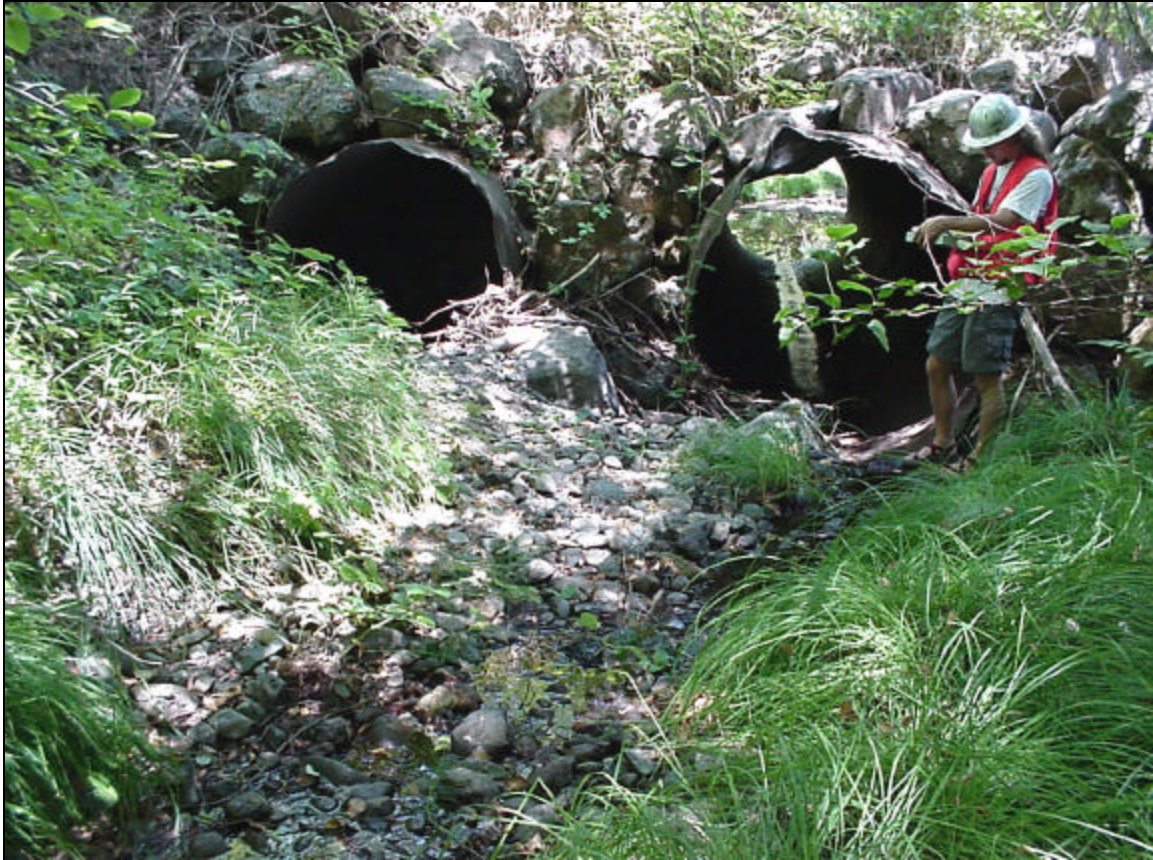
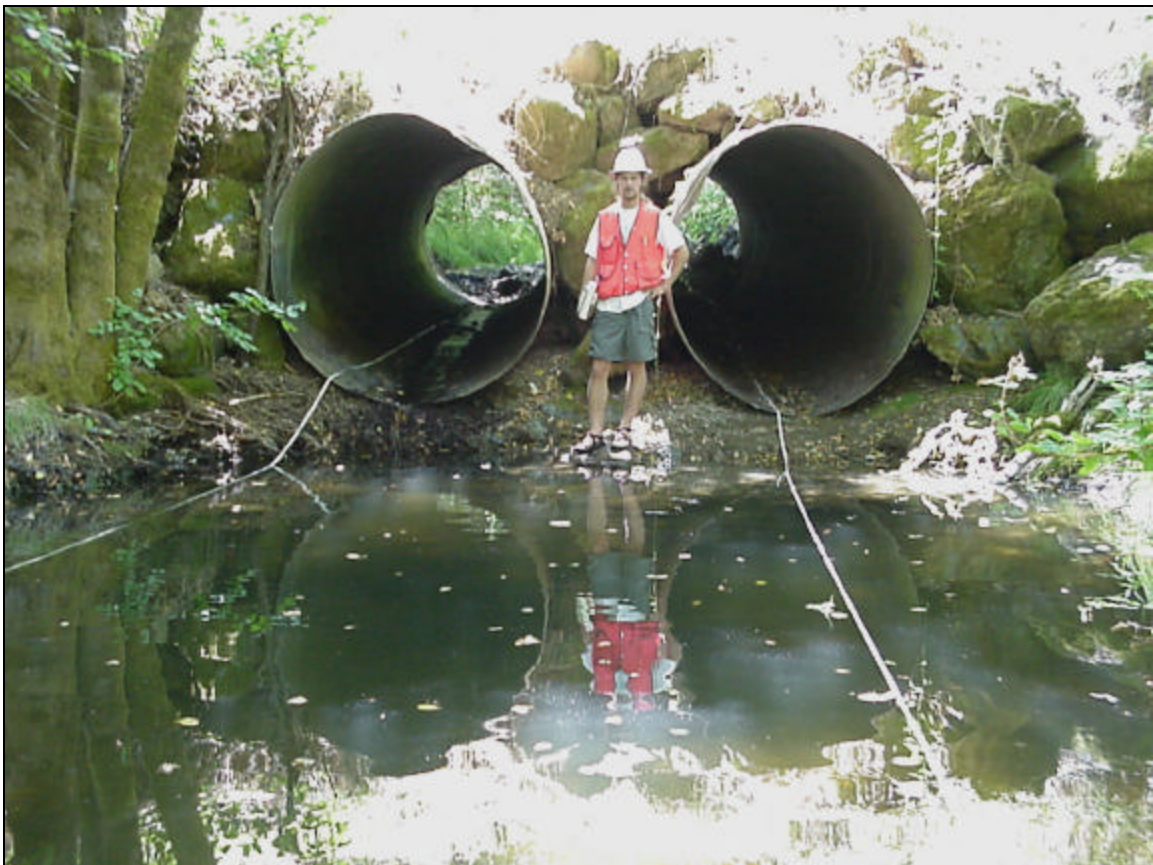
Site ID #S-081: Porter Creek #2/Hendren Driveway; Russian River **Road Ownership** Private
County Ranking: #37 = Low-Priority **Basin-wide Ranking:** less than 20.0 points – not ranked

Location: County Map Sheet #4J31. USGS Quad: Guerneville. T8N, R10W, Section 10. Lat/Long: 38° 32' 57.97" 122° 57' 9.89" Milepost = 0.1 miles to Sweetwater Springs Road. **Culvert Type:** Two Oval Pipes, Concrete. **Corrugations:** None. **Dimensions:** Each Bay = 2.9' height x 4.4' rise **Lengths:** LB = 16.6; RB = 16.4' **Slopes:** LB = 8.13%; RB = 5.91% **Modifications:** None. **Rustline Height:** N/A **Average Active Channel Width:** 10.8' **Fill Estimate:** 63 cubic yards. **Overall Condition:** Poor- break/separation in middle of each pipe. **Sizing:** Extremely undersized; HW/D = 1 on a storm flow with approximately a one-year recurrence interval. Sweetwater Springs Road is overtopped on approximately a three-year storm flow. **Barrier Status:** GRAY: FishXing determined that both pipes meet the 8-16-16 ft/sec passage criteria for adult steelhead on LB=17% and RB=74%) of the range of estimated migration flows and fail to meet passage criteria for all age classes of juvenile salmonids. Both culverts' slightly perched outlets and steep slopes are the features that impede juvenile migration.

Preferred Treatment: Due to the current crossing's poor condition, a replacement with a properly sized flat-car bridge is recommended. Although there is limited habitat upstream, the poor sizing and condition make a failure of this crossing highly likely – release of sediment would impact downstream spawning gravels. CDFG should assess and, if needed, treat any downstream migration impediments prior to treating Site ID #S-081.

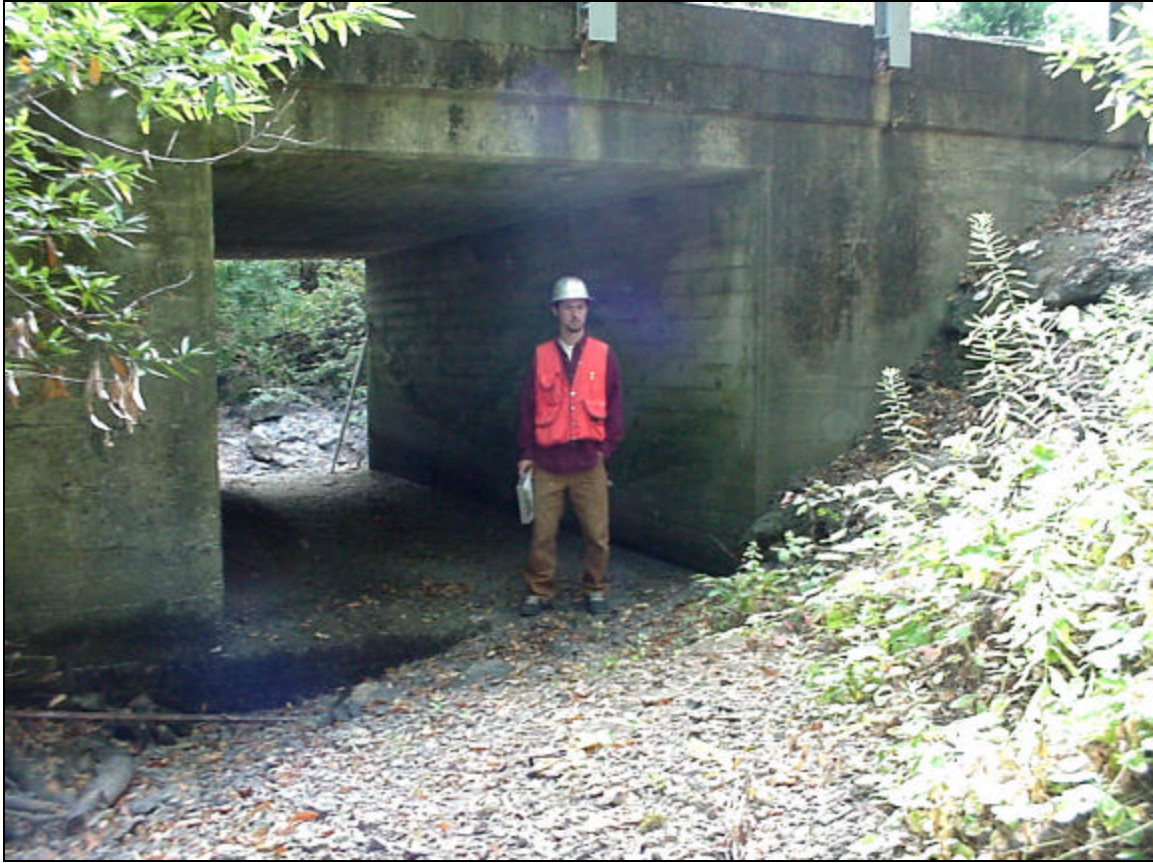
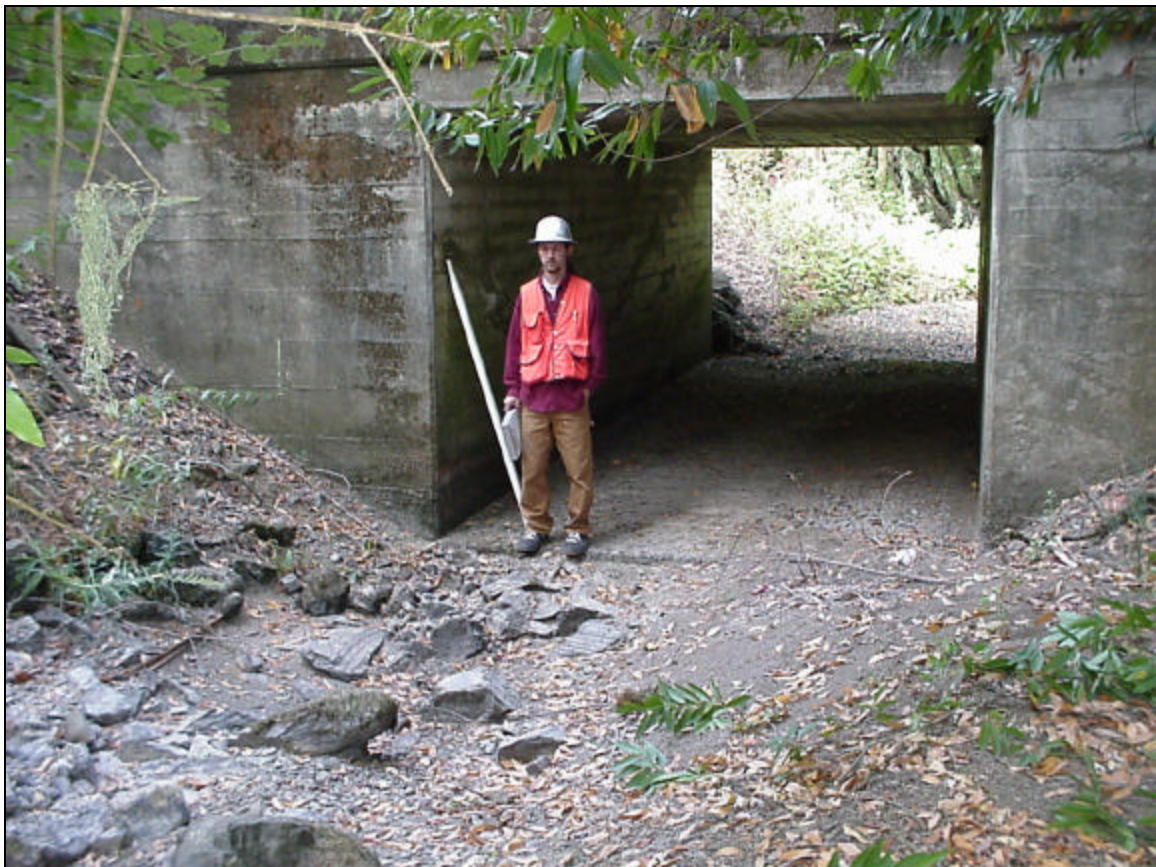
Site ID #S-082: Turtle Creek/West Side Road: Russian River

Barrier Status: **GRAY:** FishXing determined this crossing meets the 8-16-16 ft/sec passage criteria for adult steelhead on 31% of the range of estimated migration flows and fail to meet passage criteria for all age classes of juvenile salmonids. Actual adult passage may be higher than predicted by FishXing because the only passage criteria violation is lack-of-depth. The moderately-steep slope over a smooth concrete invert creates a velocity barrier to juvenile salmonids.

Preferred Treatment: Because the current crossing is properly sized and in good condition, a retrofit is recommended. Two downstream boulder weirs will raise tailwater elevation (possibly back-water the culvert) and corner baffles within the box culvert will increase depths and decrease velocities. An assessment of the eight-foot diameter private culvert is recommended prior to treating Site ID #S-082.
