CATALOG OF SONOMA COUNTY STREAM CROSSINGS WITH CULVERTS LOCATED ON FISH-BEARING STREAM REACHES WITHIN THE RUSSIAN RIVER BASIN

By
Ross Taylor and Associates

Site ID# S-001: Unnamed Tributary/Willow Creek Road; Willow Creek; Russian River **Road Ownership** County

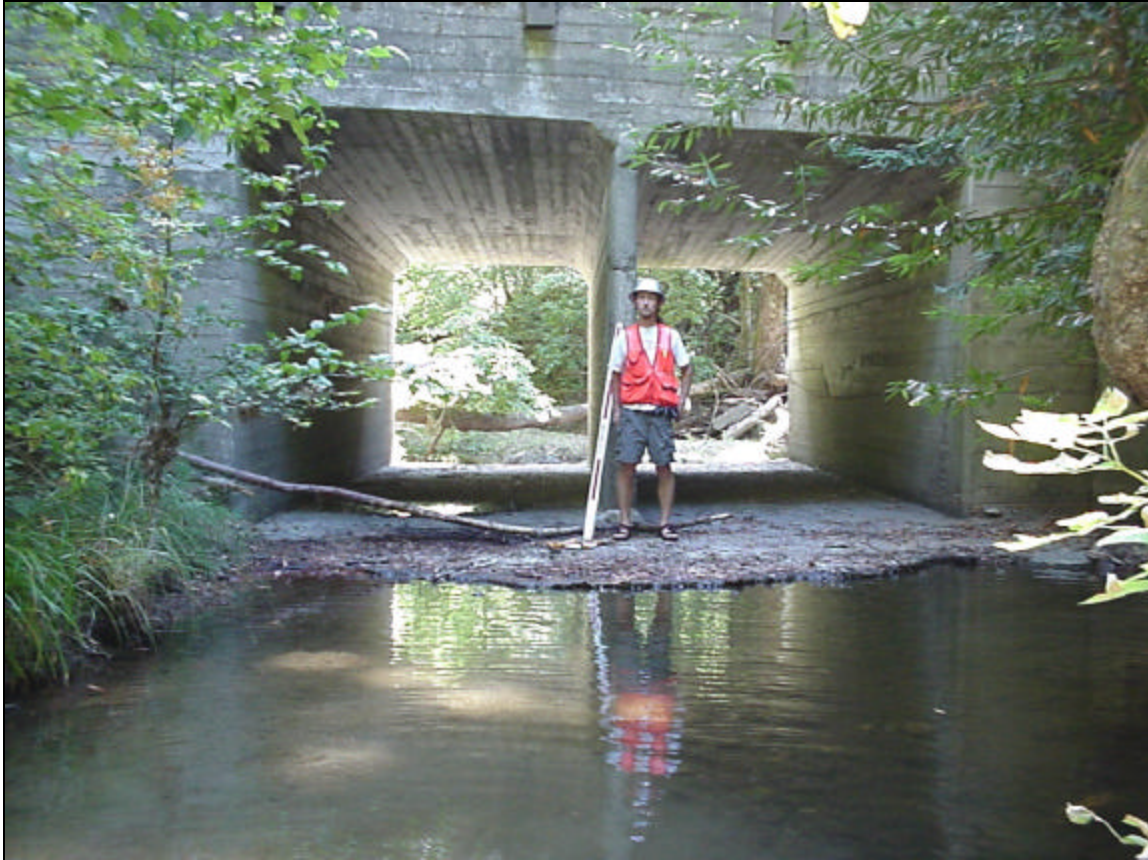
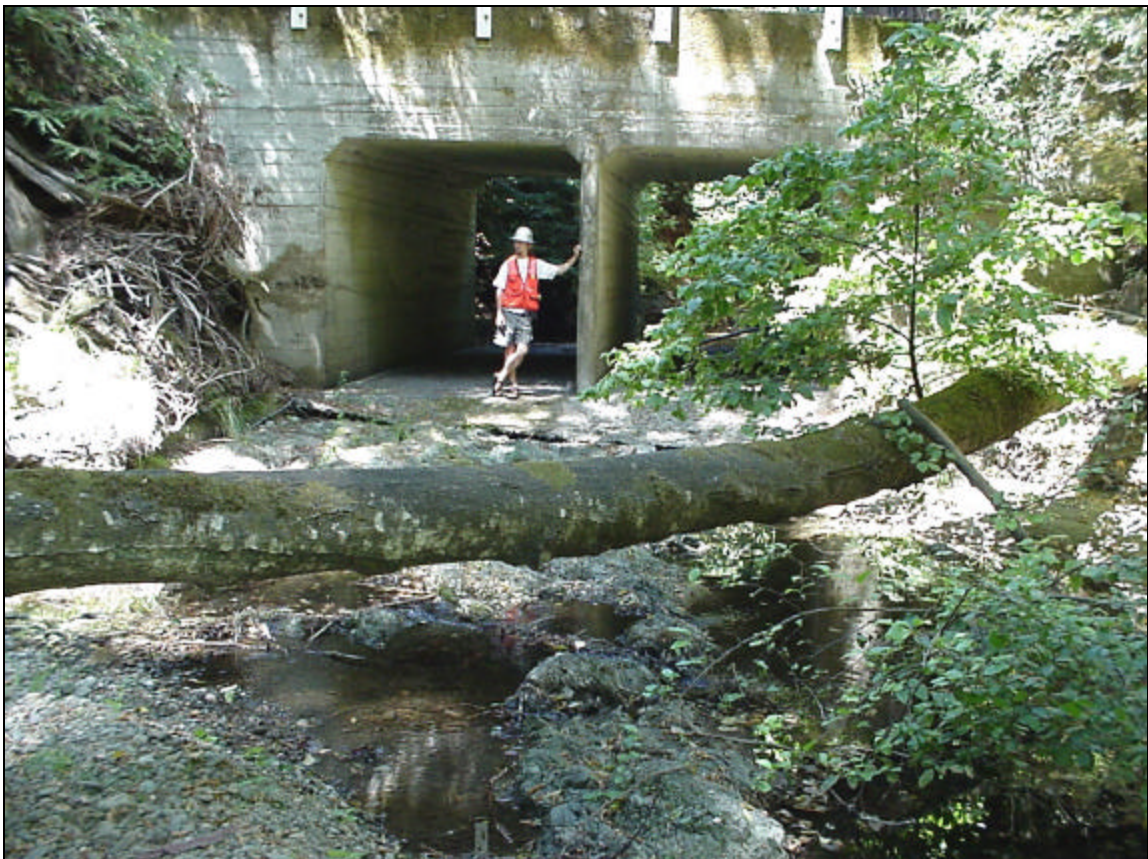
Culvert Type: Two Bay Box, Concrete. **Corrugations:** None. **Dimensions:** 9.9' height x 18.10' width
Length: 32.6' **Slope:** 0.64% **Modifications:** None. **Rustline Height:** N/A **Average Active Channel Width:** 11.4'
Fill Estimate: 376 cubic yards. **Overall Condition:** Good. **Sizing:** Undersized; HW/D = 1 on a storm flow with approximately a 61-year recurrence interval. Mill Creek Road is overtopped on more than a 250-year storm flow.

Barrier Status: GRAY: FishXing determined this crossing meets the 8-16-16 ft/sec passage criteria for adult steelhead on 22% of the range of estimated migration flows and fail to meet passage criteria for all age classes of juvenile salmonids. Actual adult passage may be higher than predicted by FishXing because the only passage criteria violation is lack-of-depth. The moderately-steep slope over a concrete invert creates a velocity barrier to juveniles.

Preferred Treatment: Because the current crossing is properly sized and in good condition, a retrofit is recommended. Two downstream boulder weirs will raise tailwater elevation (possibly back-water the culvert) and corner baffles within the box culvert will increase depths and decrease velocities. Consider a beam at the inlet to concentrate lower migration flows into a single bay of the crossing. Fish passage at diversion dams should be thoroughly assessed by CDFG before the County treats their stream crossings.

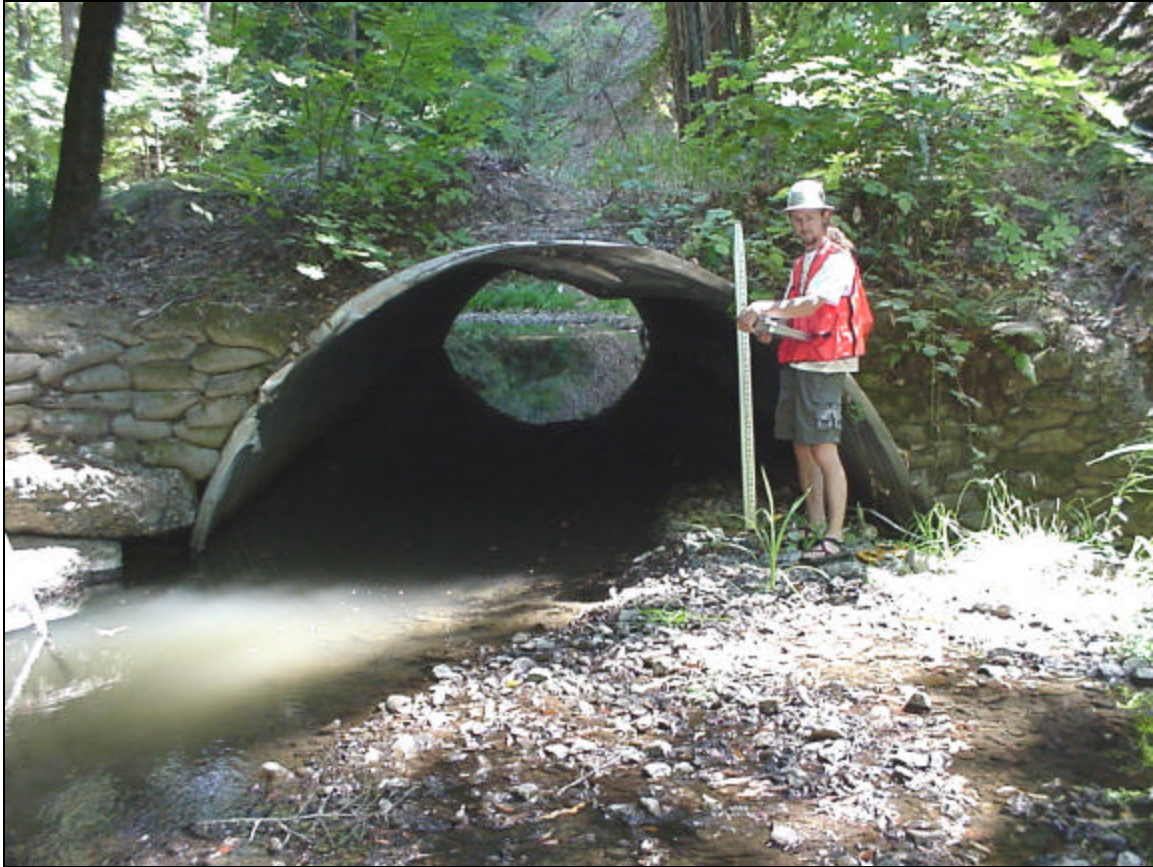
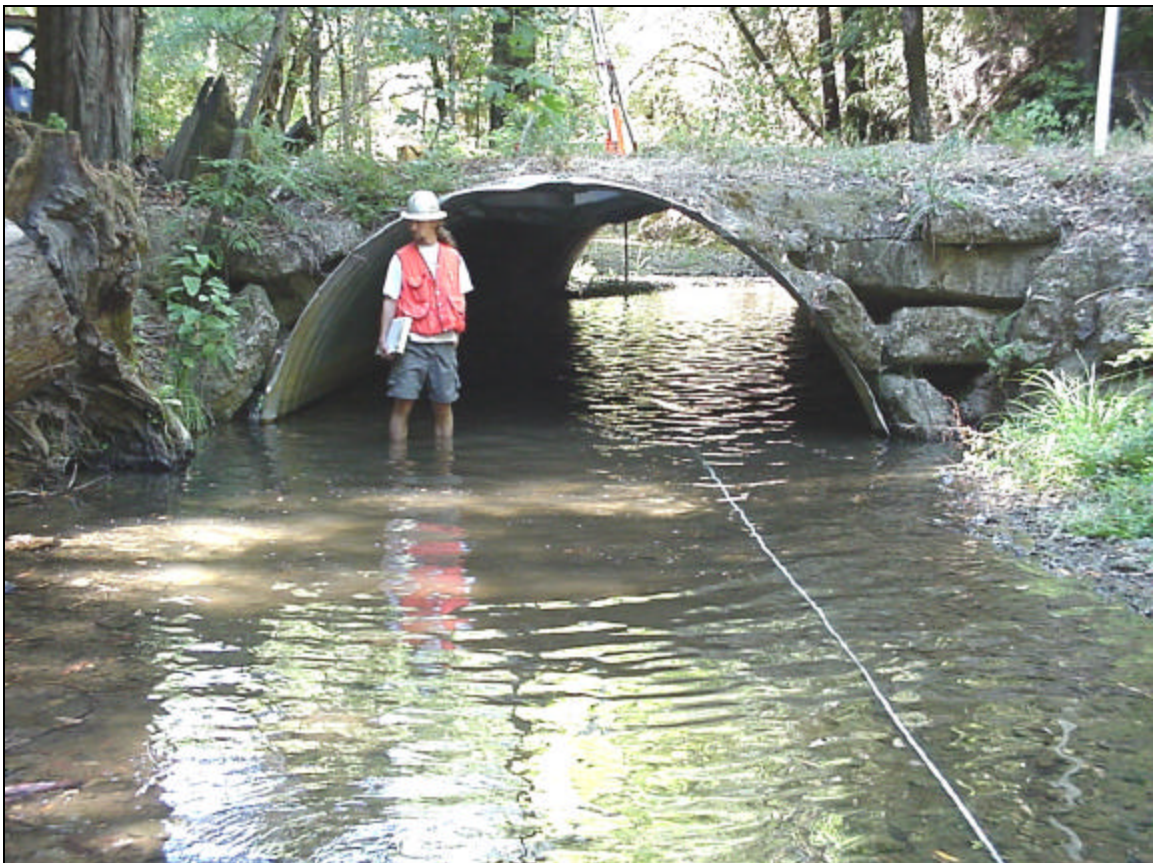
Site ID #S-084: Mill Creek/Mill Creek Road; Dry Creek; Russian River **Road Ownership:** County

Culvert Type: Open Bottom Arch, SSP. **Corrugations:** 9.5" x 2.5" **Dimensions:** 7.5' rise x 13.0' span
Length: 61.3' **Slope:** -1.06% **Modifications:** None. **Rustline Height:** 2.5' **Average Active Channel Width:** 15.6'
Fill Estimate: 228 cubic yards. **Overall Condition:** Fair, sides of arch are abraded.

Preferred Treatment: None recommended because the current crossing provides unimpeded passage, however the culvert is extremely undersized. Periodically inspect for condition and maintenance. When needed, replace with a properly sized open-bottom arch set on concrete footings.

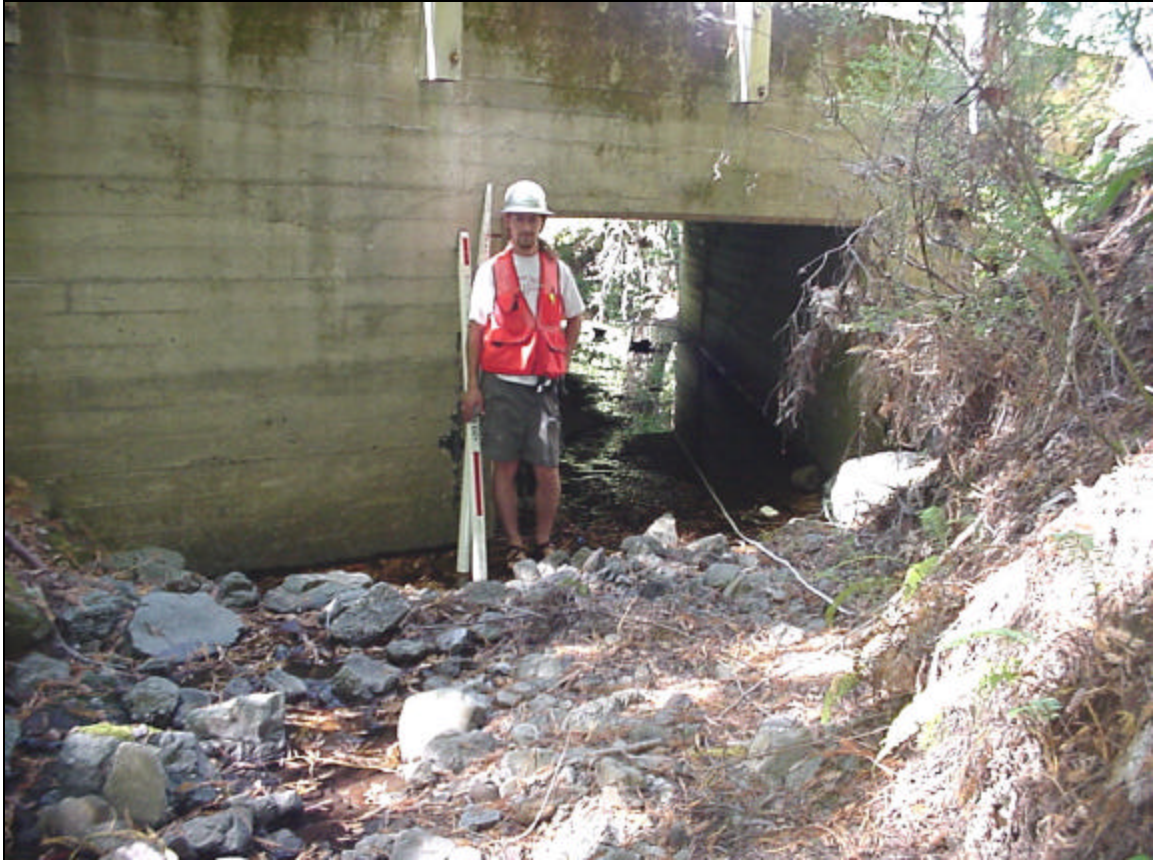
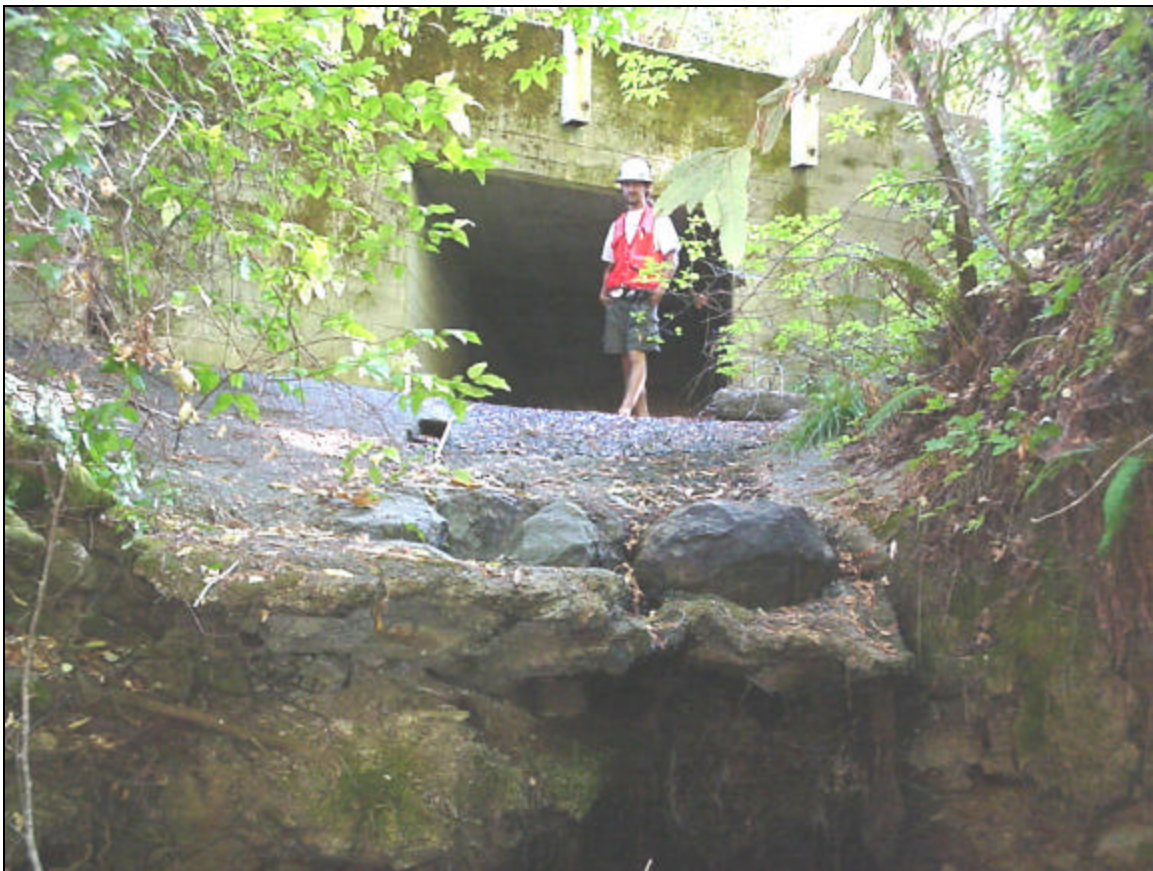
Site ID #S-085: Boyd Creek/Mill Creek Road; Mill Creek; Dry Creek; Russian River **Road Ownership:** County

Culvert Type: Box, Concrete. **Corrugations:** None. **Dimensions:** 5.5' height x 7.0' width **Length:** 45.0'
Slope: 0.22% **Modifications:** None. **Rustline Height:** N/A **Average Active Channel Width:** 8.7'
Fill Estimate: 296 cubic yards. **Overall Condition:** Good.

Barrier Status: **RED:** the Green-Gray-Red filter determined this crossing fails to meet passage criteria for adult steelhead and all age classes of juveniles due to the extremely perched outlet = 9.6 foot drop.

Preferred Treatment: Although a complete migration barrier, the limited upstream habitat (and a second barrier just upstream) and the extremely perched outlet would make this a very expensive project with minimal biological benefit.

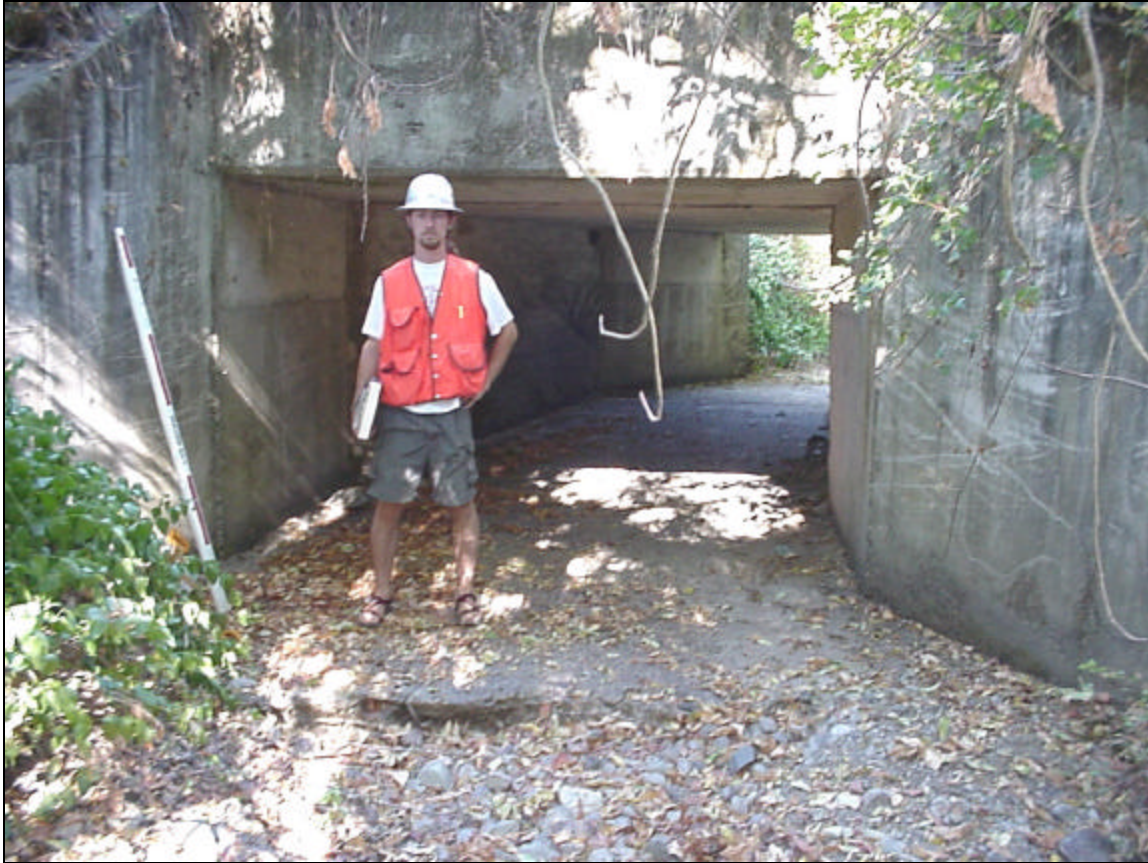
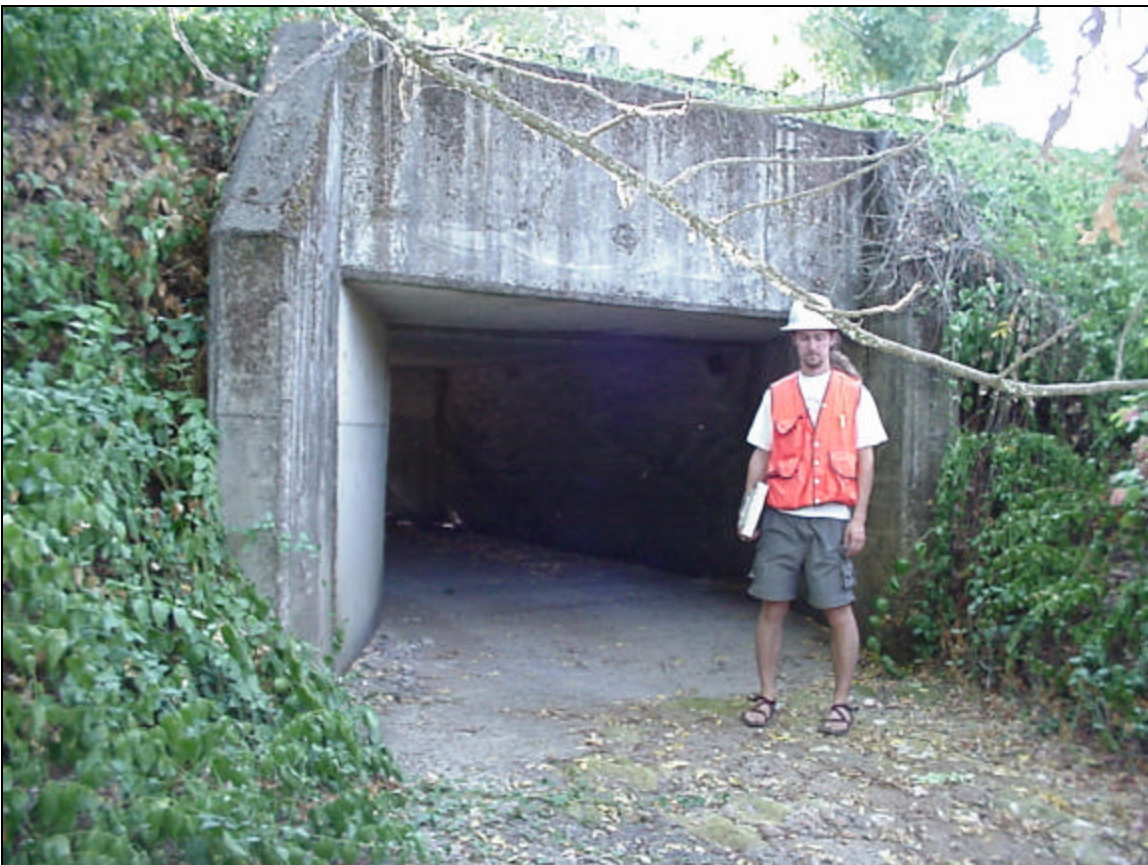
Site ID #S-086: Kelley Creek/West Dry Creek Road; Dry Creek; Russian River **Road Ownership:** County

Barrier Status: **GRAY:** FishXing determined this crossing meets the 8-16-16 ft/sec passage criteria for adult steelhead on 68% of the range of estimated migration flows and fails to meet passage criteria for all age classes of juvenile salmonids. Juvenile passage probably occurs because the only passage criteria violation for all age classes is lack-of-depth.

Preferred Treatment: Construction of a single downstream boulder weir to back-water the culvert outlet and installation of corner baffles within the box culvert would cost-effectively improve passage conditions.

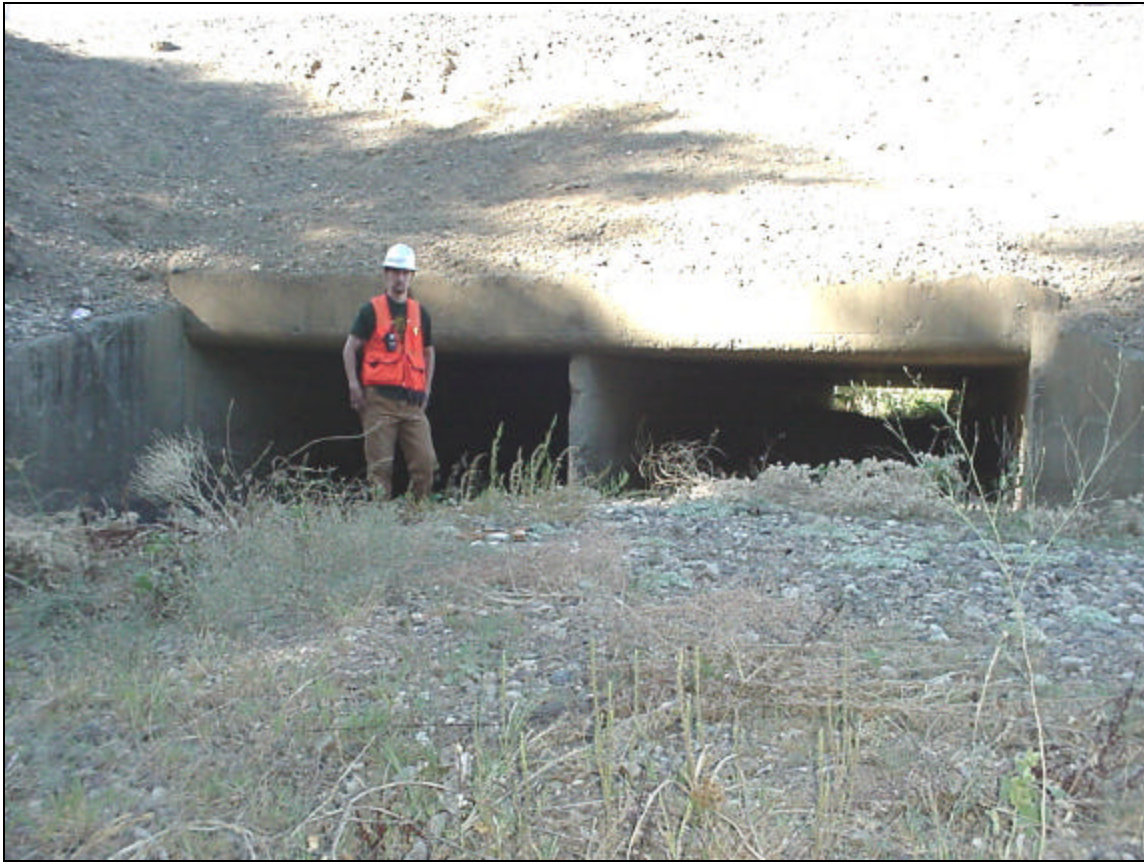
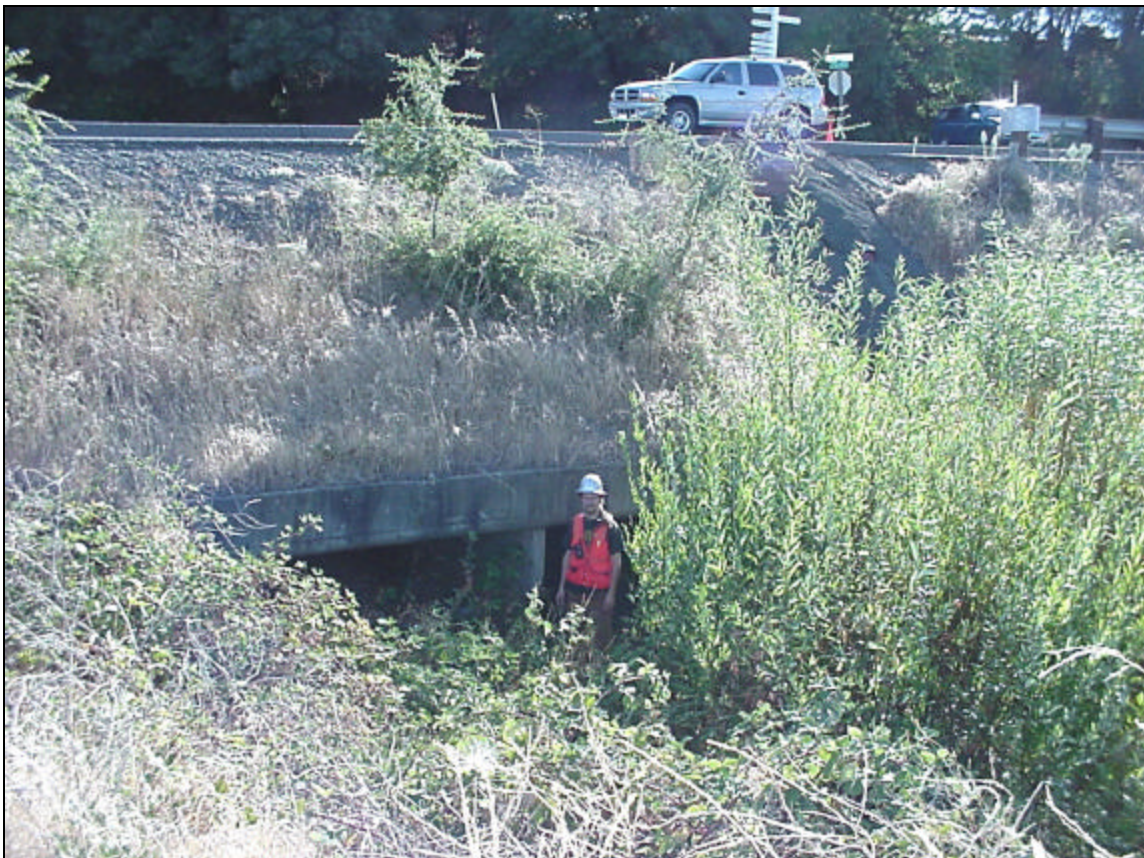
Site ID #S-087: Lytton Springs Creek/Dry Creek Road; Dry Creek; Russian River **Road Ownership:** County

Culvert Type: Two Bay Box, Concrete. **Corrugations:** None. **Dimensions:** Each Bay= 5.0' height x 10.0' width **Length:** 81.8' **Slopes:** LB = -0.23%; RB = 0.12% **Modifications:** None. **Rustline Height:** N/A **Average Active Channel Width:** 12.3' **Fill Estimate:** 862 cubic yards. **Overall Condition:** Good. **Sizing:** Properly sized; HW/D = 1 on a storm flow with more than a 250-year recurrence interval. Dry Creek Road is overtopped on more than a 250-year storm flow.

Barrier Status: LB=**GRAY**: FishXing determined this crossing meets the 8-16-16 ft/sec passage criteria for adult steelhead on 91% of the range of estimated migration flows and fails to meet passage criteria for all age classes of juvenile salmonids. The bay's slightly perched outlet impedes juvenile migration. RB=**RED**: this bay is highly embedded and it was assumed that all migration-level flows passed through the LB bay.

Preferred Treatment: Construction of two or three downstream boulder weirs to back-water the culvert outlet and installation of corner baffles within the LB bay of the box culvert would cost-effectively improve passage conditions. However, crossing does provide nearly unimpeded passage for adult steelhead.

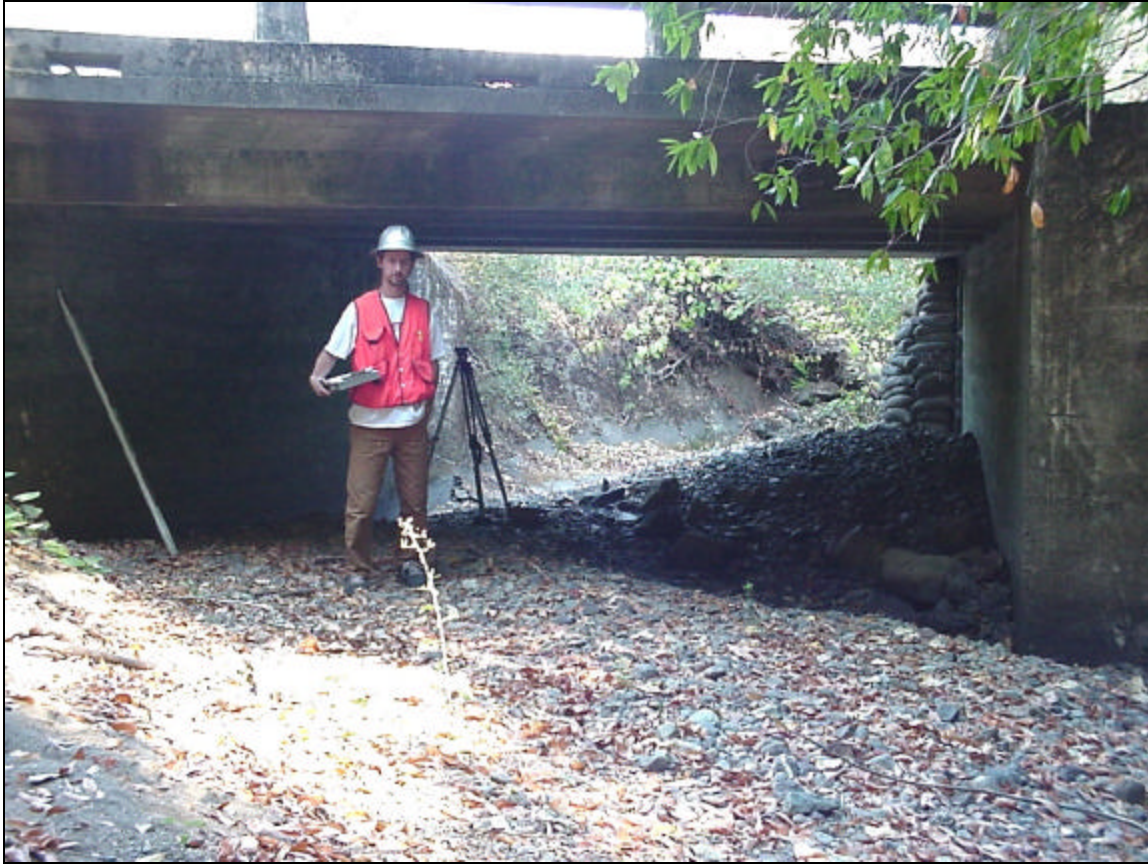
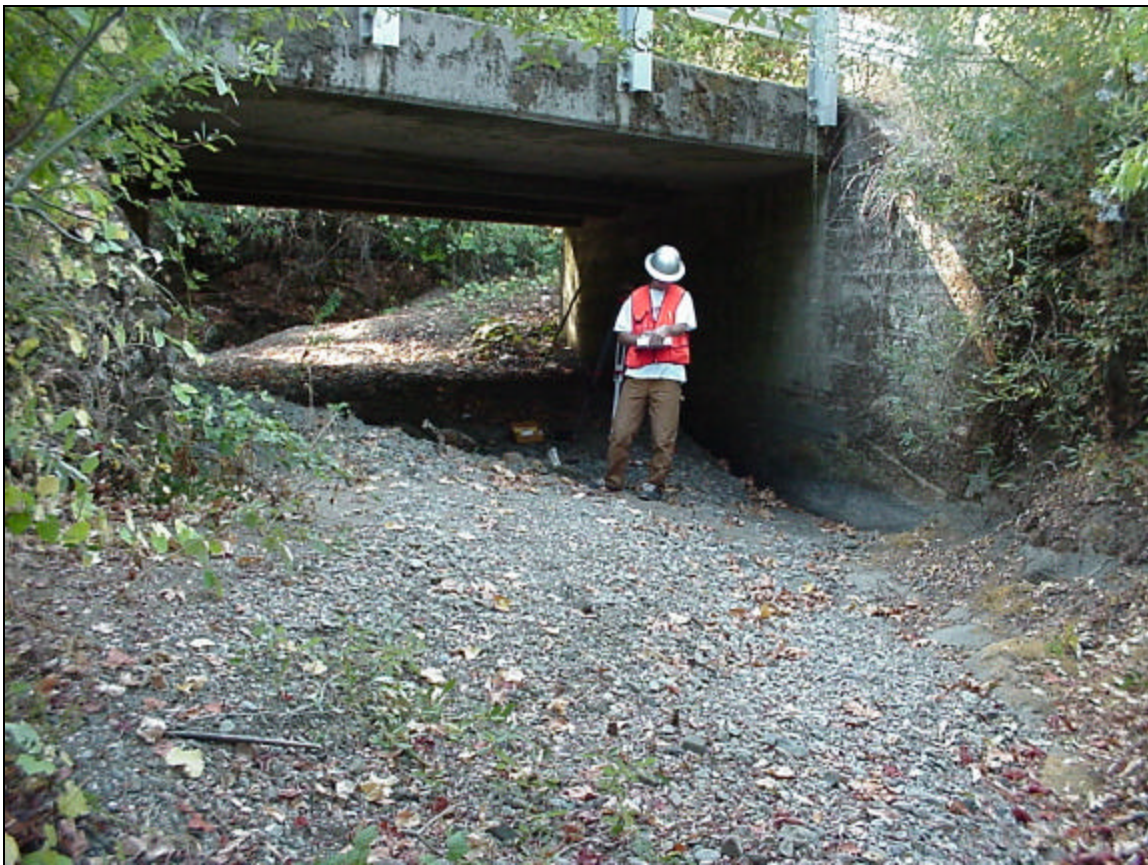
Site ID #S-088: Crane Creek Tributary to Dry Creek/West Dry Creek Road; Dry Creek; Russian River
Road Ownership: County

Culvert Type: Box, Concrete. **Corrugations:** None. **Dimensions:** 9.0' height x 18.0' width **Length:** 30.0'
Slope: - 0.27% **Modifications:** None. **Rustline Height:** N/A **Average Active Channel Width:** 14.6'

Fill Estimate: 198 cubic yards. **Overall Condition:** Good. **Sizing:** Properly sized; HW/D = 1 on a storm flow with more than a 250-year recurrence interval. West Dry Creek Road is overtopped on more than a 250-year storm flow.

Preferred Treatment: None recommended because the current box culvert provides nearly unimpeded passage for all age classes of steelhead, is properly sized for more than a 100-year storm flow, and is in good condition.

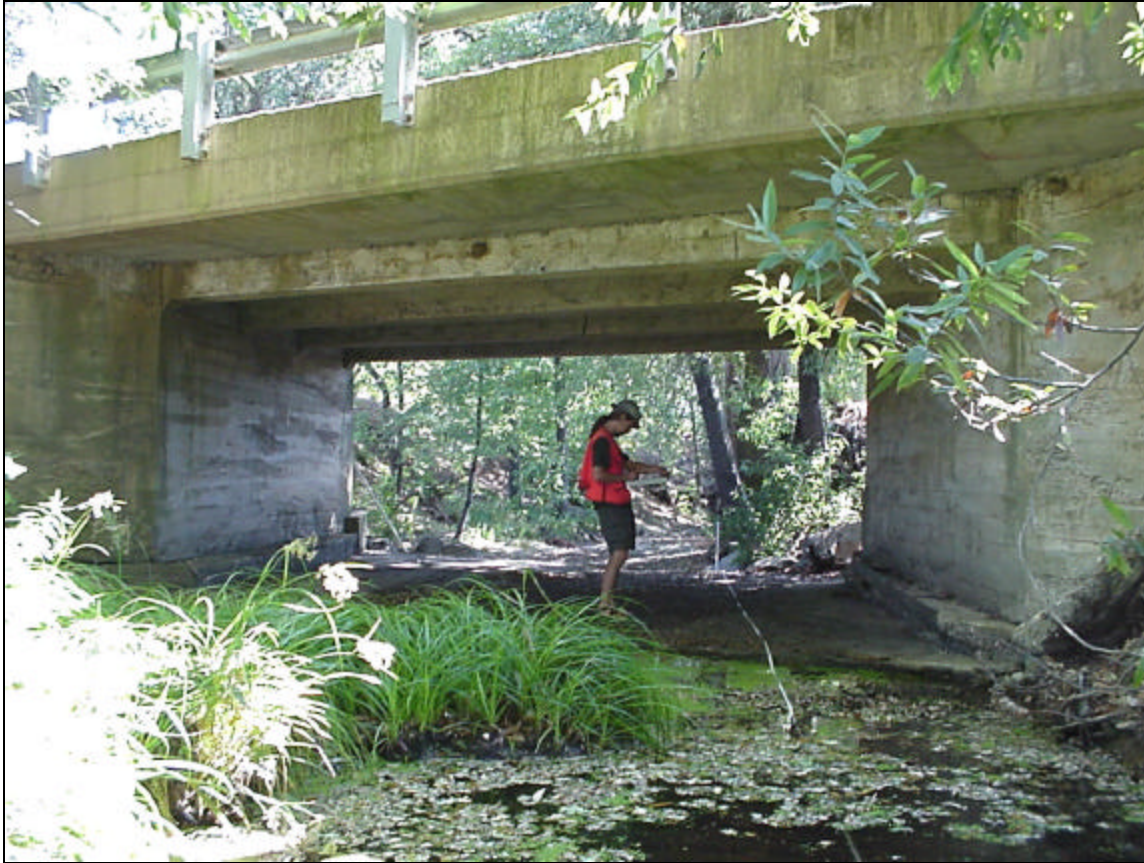
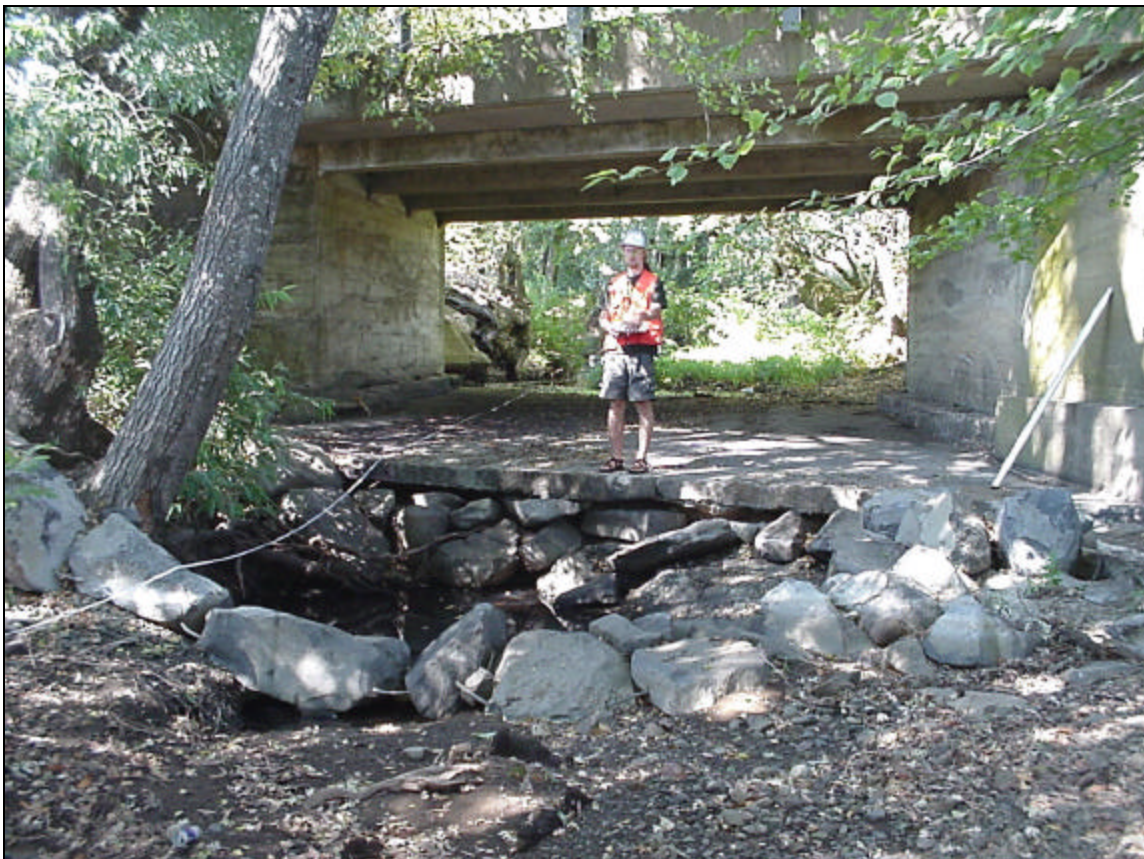
Site ID #S-089: Grape Creek #1/West Dry Creek Road; Dry Creek; Russian River **Road Ownership:** County
County Ranking: #14 = High-Priority **Basin-wide Ranking: #19 = High-Priority**

Culvert Type: Box, Concrete. **Corrugations:** None. **Dimensions:** 9.5' height x 22.15' width **Length:** 35.0'
Slope: 1.54% **Modifications:** None. **Rustline Height:** N/A **Average Active Channel Width:** 11.9'
Fill Estimate: 372 cubic yards. **Overall Condition:** Good. **Sizing:** Properly sized; HW/D = 1 on a storm flow with more than a 250-year recurrence interval. West Dry Creek Road is overtopped on more than a 250-year storm flow.

Barrier Status: GRAY: FishXing determined this crossing meets the 8-16-16 ft/sec passage criteria for adult steelhead on 28% of the range of estimated migration flows and fails to meet passage criteria for all age classes of juvenile salmonids. Actual adult passage may be higher than predicted by FishXing because there is strictly a lack-of-depth criteria violation (up to 80 c.f.s. and $Q_{hp} = 101$ c.f.s.). The culvert's perched outlet (2.2 feet) impedes juvenile migration.

Preferred Treatment: Construction of three to four downstream boulder weirs to raise tail-water elevation (and possibly back-water the culvert outlet) and installation of sloped concrete weirs within the box culvert would cost-effectively improve passage conditions for adult steelhead and all age classes of juveniles.

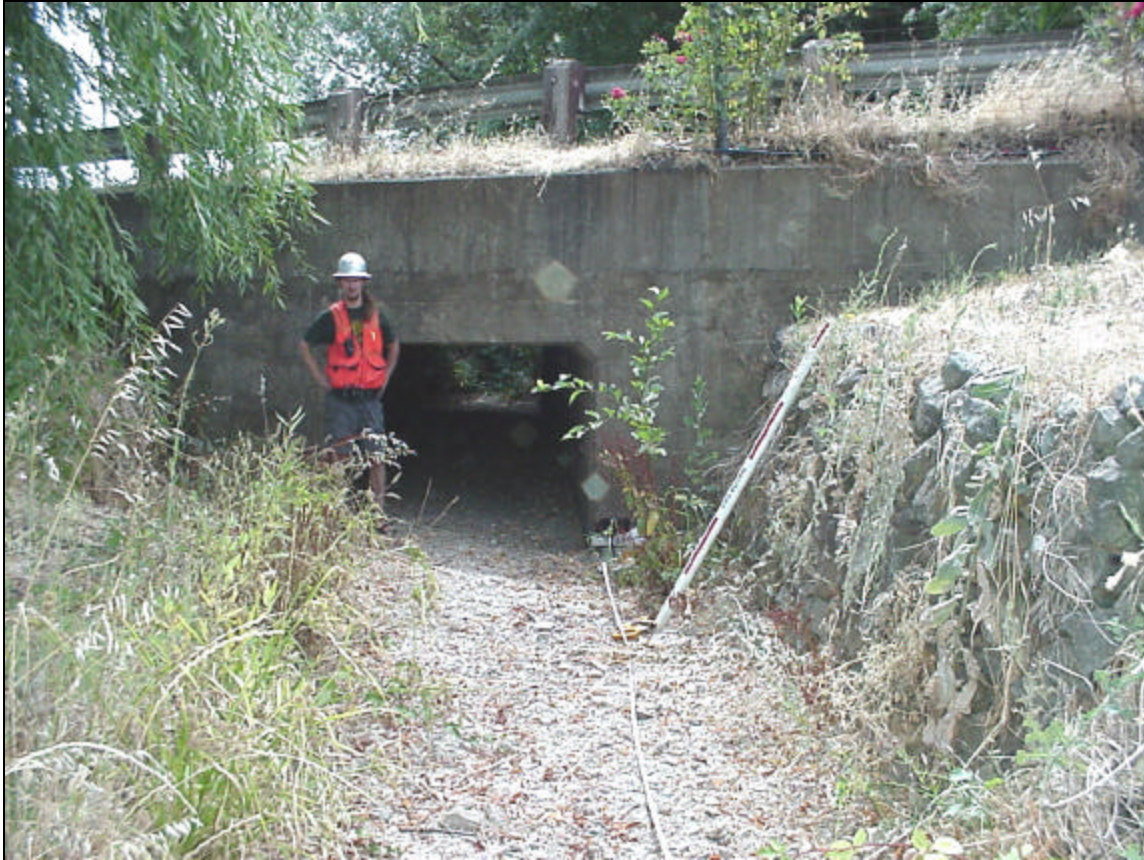
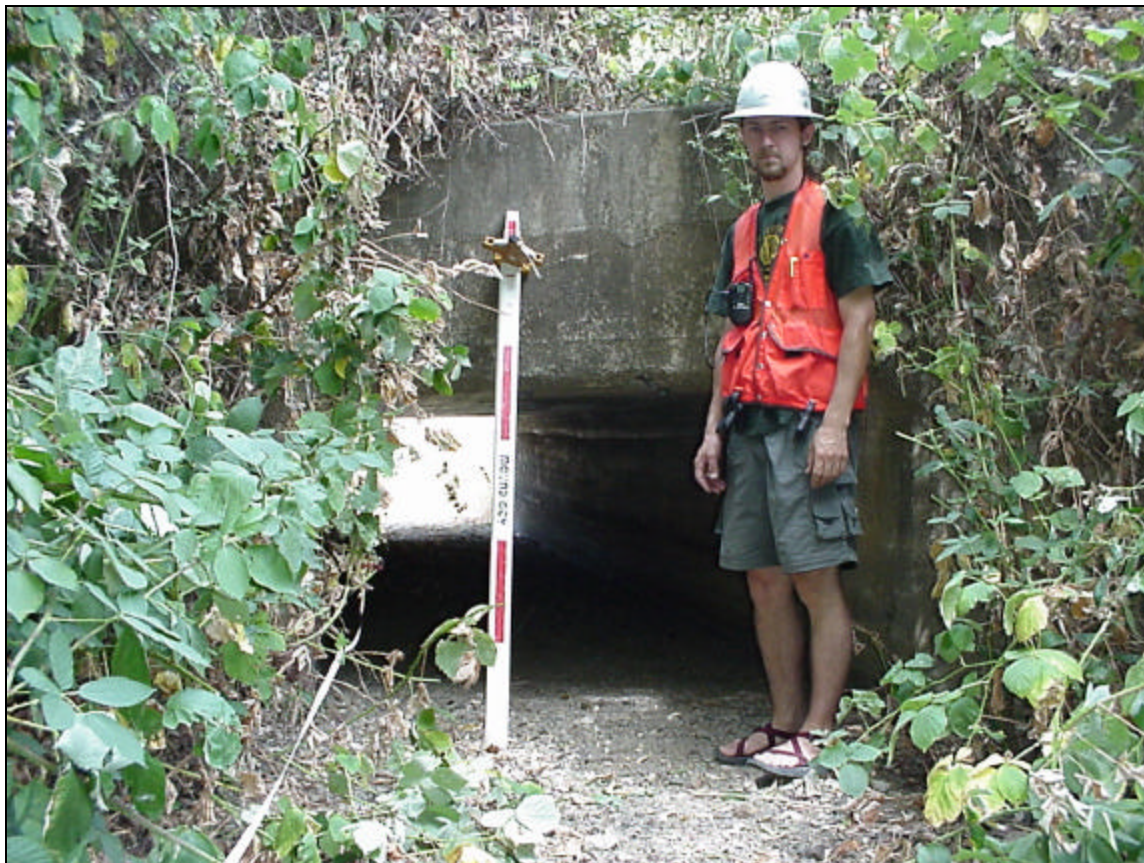
Site ID #S-090: Wine Creek #1/Wine Creek Road; Grape Creek; Dry Ck; Russian River **Road Ownership:** County

Culvert Type: Box, Concrete. **Corrugations:** None. **Dimensions:** 5.5' height x 6.05' width **Length:** 35.7' **Slope:** -0.08% **Modifications:** None. **Rustline Height:** N/A **Average Active Channel Width:** 6.4' **Fill Estimate:** 165 cubic yards. **Overall Condition:** Good. **Sizing:** Extremely undersized; HW/D = 1 on a storm flow with approximately a four-year recurrence interval. Wine Creek Road is overtopped on approximately a 29-year storm flow.

Preferred Treatment: None recommended because the culvert is providing ample passage. However, the box culvert is extremely undersized and has the potential to scour the downstream channel and create a perched outlet. Recommend periodic inspection for maintenance and condition – including inspection of the outlet and tail-water condition. Best long-term solution is replacement with a properly sized open-bottom arch or a bridge.

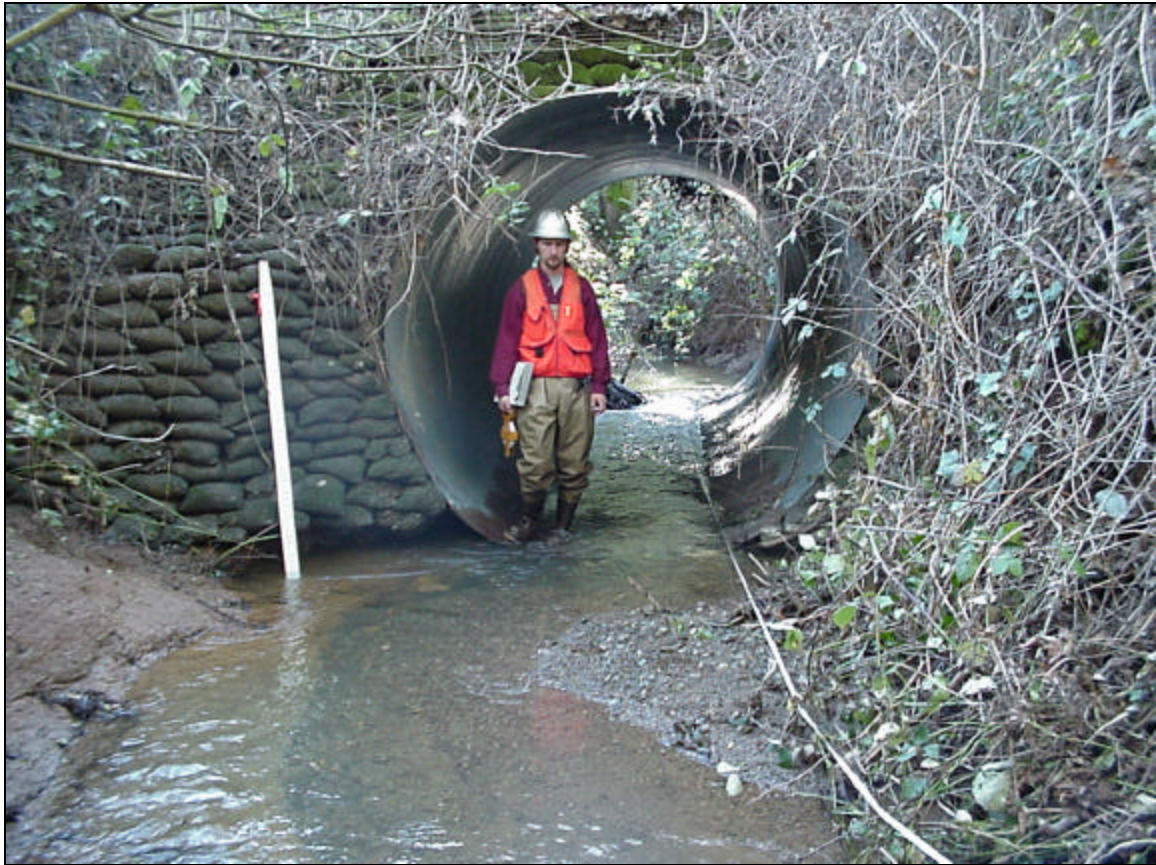
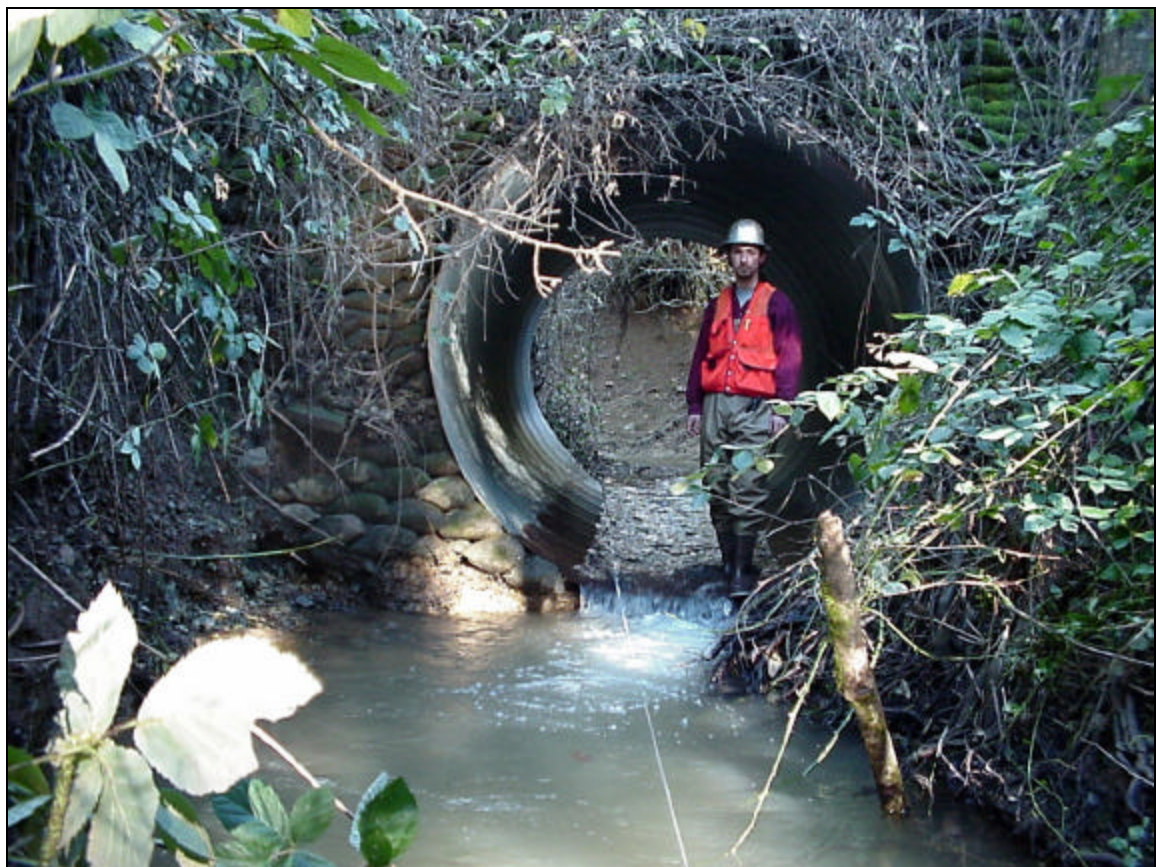
Site ID #S-091: Wine Creek #2/Koch Road; Grape Creek; Dry Creek; Russian River **Road Ownership:** Private
County Ranking: #40 = Low-Priority **Basin-wide Ranking:** less than 20.0 points – not ranked

Culvert Type: Circular, CSP. **Corrugations:** 2-2/3" x 1/2" **Dimensions:** diameter=8.0' **Length:** 20.2'
Slope: 2.43% **Modifications:** None. **Rustline Height:** 1.2' **Average Active Channel Width:** 9.9'
Fill Estimate: 178 cubic yards. **Overall Condition:** Fair – invert is abraded. **Sizing:** Undersized; HW/D = 1 on a storm flow with approximately a 34-year recurrence interval. Koch Road is overtopped on approximately a 190-year storm flow. **Barrier Status:** **GRAY:** FishXing determined this crossing meets the 8-16-16 ft/sec passage criteria for adult steelhead on 93% of the range of estimated migration flows and fails to meet passage criteria for all age classes of juvenile salmonids. There are excessive velocities caused by the culvert's 2.43% slope which impede juvenile migration.

Preferred Treatment: None immediately recommended because culvert allows ample adult passage and older juveniles are probably able to swim through culvert too by using the low-velocity edges along the culvert walls (FishXing modeled passage using an average velocity). Periodically inspect for condition of pipe and tail-water characteristics. If outlet becomes perched, consider downstream boulder weirs to back-water the crossing. When needed replace with a flatcar bridge set on abutments spaced at least at the bankfull channel width.

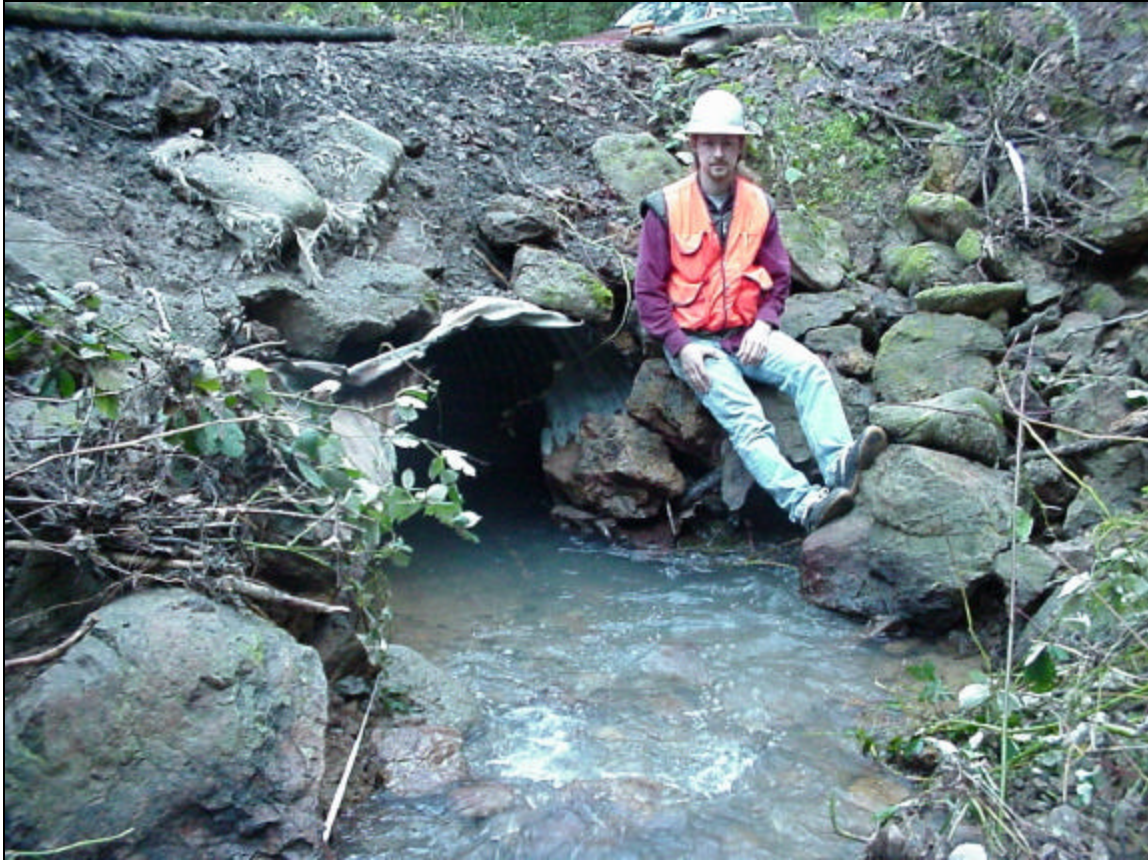
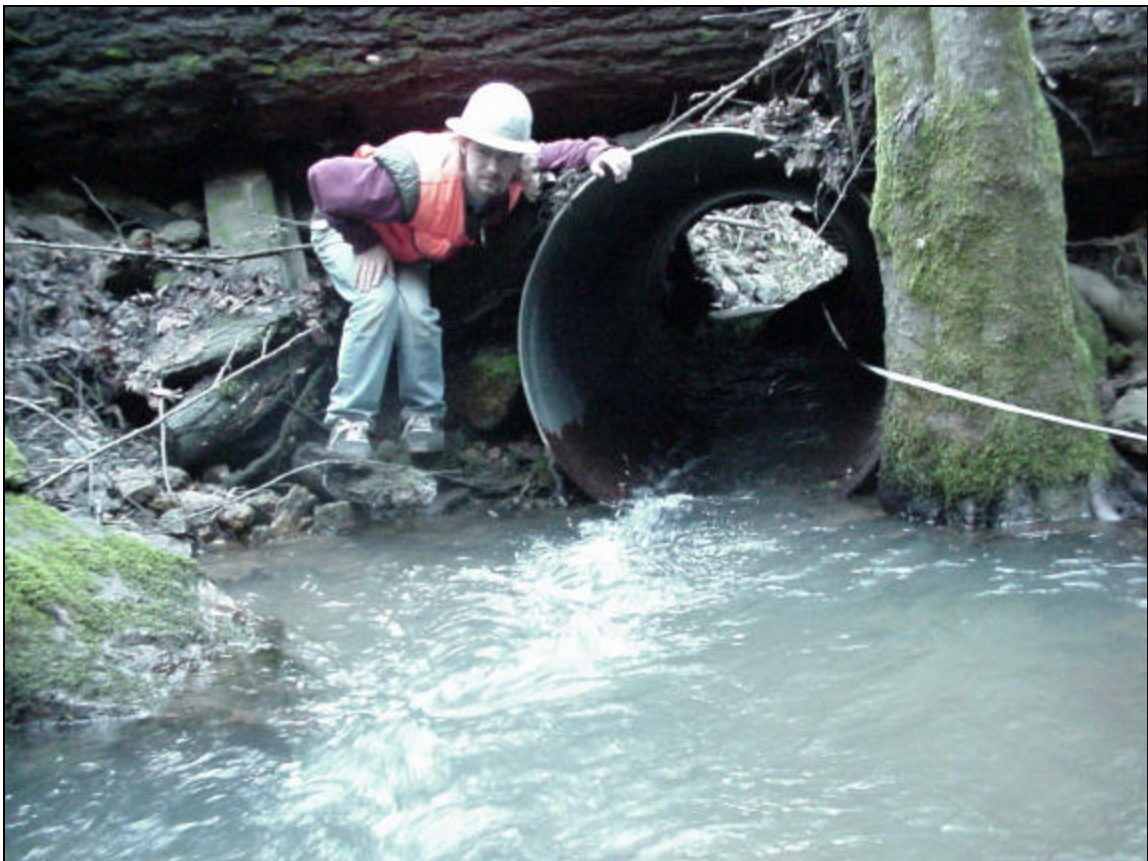
Site ID #S-092: Wine Creek #3/Koch Road; Grape Creek; Dry Creek; Russian River **Road Ownership:** Private

Culvert Type: Circular, CSP. **Corrugations:** 2-2/3" x 1/2" **Dimensions:** diameter = 4.0' **Length:** 19.8' **Slope:** 4.24% **Modifications:** None. **Rustline Height:** 1.3' **Average Active Channel Width:** 9.4' **Fill Estimate:** 117 cubic yards. **Overall Condition:** Extremely poor – rusted through invert and crushed/torn inlet. **Sizing:** Extremely undersized; HW/D = 1 on a storm flow with approximately a one-year recurrence interval. Koch Road is overtopped on approximately a three-year storm flow.

Barrier Status: GRAY: FishXing determined this crossing meets the 8-16-16 ft/sec passage criteria for adult steelhead on 94% of the range of estimated migration flows and fails to meet passage criteria for all age classes of juvenile salmonids. Excessive velocities caused by the culvert's 4.24% slope impede juvenile migration.

Preferred Treatment: Due to the extremely poor condition and sizing of the current culvert, replace either a properly sized embedded SSP culvert or a flatcar bridge set on abutments spaced at least at the bankfull channel width. Although there is limited upstream habitat, a replacement is recommended before the crossing fails and impacts downstream spawning habitat.
