CATALOG OF SONOMA COUNTY STREAM CROSSINGS WITH CULVERTS LOCATED ON FISH-BEARING STREAM REACHES WITHIN THE RUSSIAN RIVER BASIN

By
Ross Taylor and Associates

Site ID# S-001: Unnamed Tributary/Willow Creek Road; Willow Creek; Russian River **Road Ownership** County

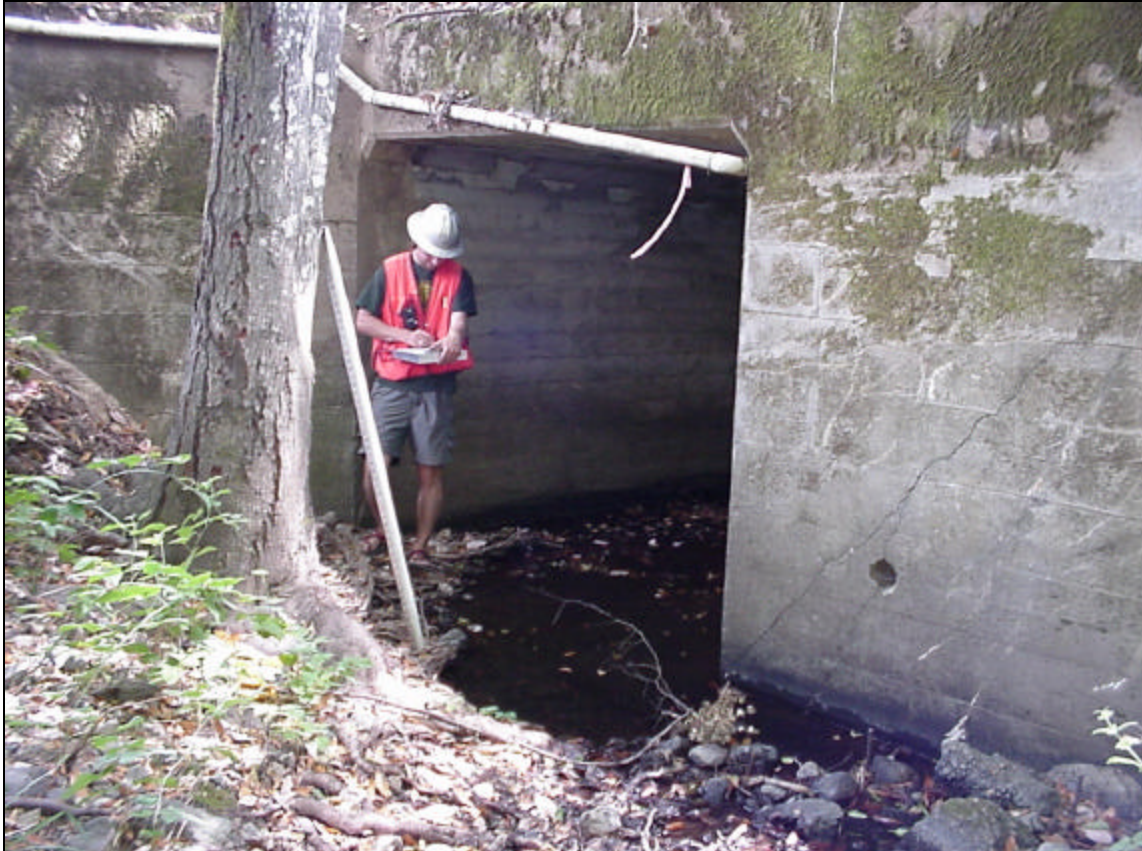
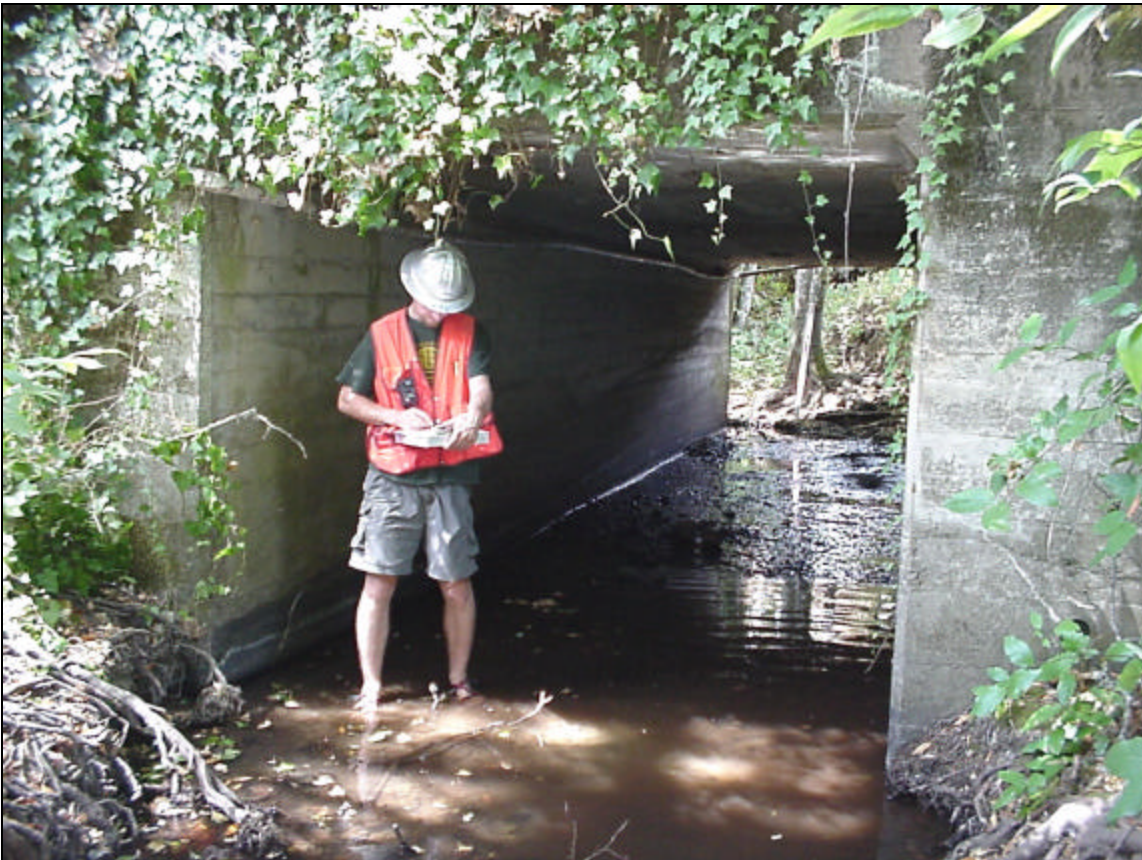
Site ID #S-093: Grape Creek #2/Wine Creek Road; Dry Creek; Russian River

Culvert Type: Box, Concrete. **Corrugations:** None. **Dimensions:** 7.0' height x 8.0' width **Length:** 43.4' **Slope:** 2.17% **Modifications:** None. **Rustline Height:** N/A **Average Active Channel Width:** 8.7' **Fill Estimate:** 453 cubic yards. **Overall Condition:** Good. **Sizing:** Properly sized; HW/D = 1 on a storm flow with approximately a 150-year recurrence interval. Wine Creek Road is overtopped on more than a 250-year storm flow.

Barrier Status: **GRAY:** FishXing determined this crossing meets the 8-16-16 ft/sec passage criteria for adult steelhead on 30% of the range of estimated migration flows and fails to meet passage criteria for all age classes of juvenile salmonids. The 2% slope over a smooth concrete floor creates excessive velocities that impede juvenile migration.

Preferred Treatment: Construction of one or two downstream boulder weirs to raise tail-water elevation (and possibly back-water the culvert outlet) and installation of corner baffles within the box culvert would cost-effectively improve passage conditions for adult steelhead and all age classes of juveniles.

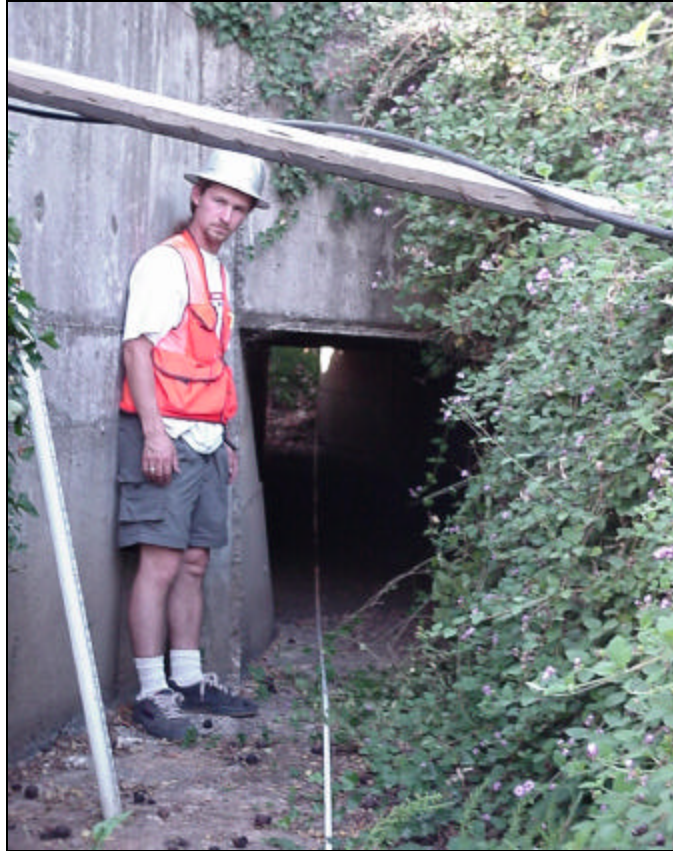
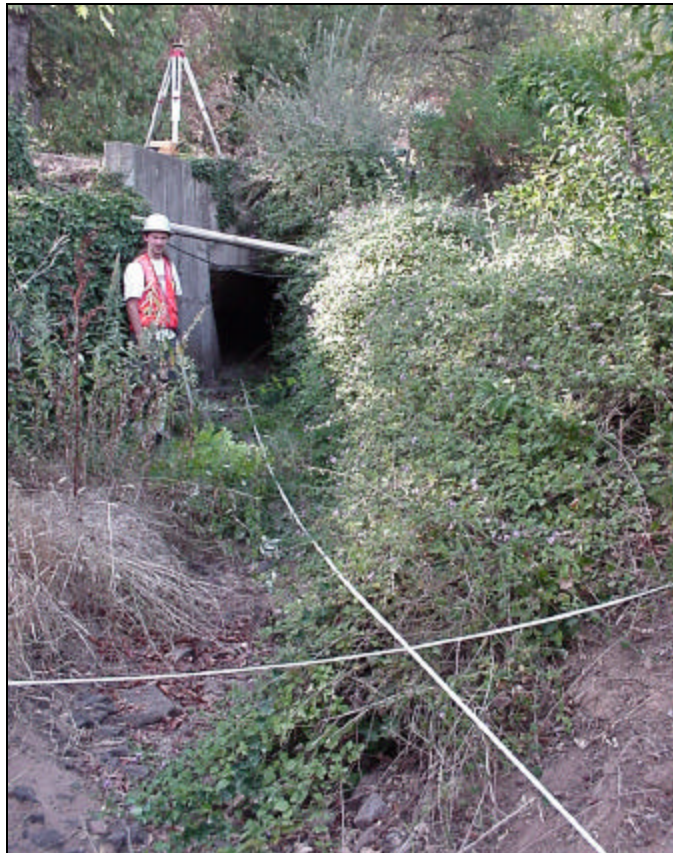
Site ID #S-094: Unnamed Tributary #1/West Dry Creek Road; Dry Creek; Russian River **Road Ownership:** County

Barrier Status: **GRAY:** FishXing determined this crossing meets the 8-16-16 ft/sec passage criteria for adult steelhead on 50% of the range of estimated migration flows and fails to meet passage criteria for all age classes of juvenile salmonids.

Preferred Treatment: None recommended because this creek has minimal, if any, fisheries potential. The current box culvert is in good condition. Recommend dropping the site in the final ranking due to lack of fish habitat.

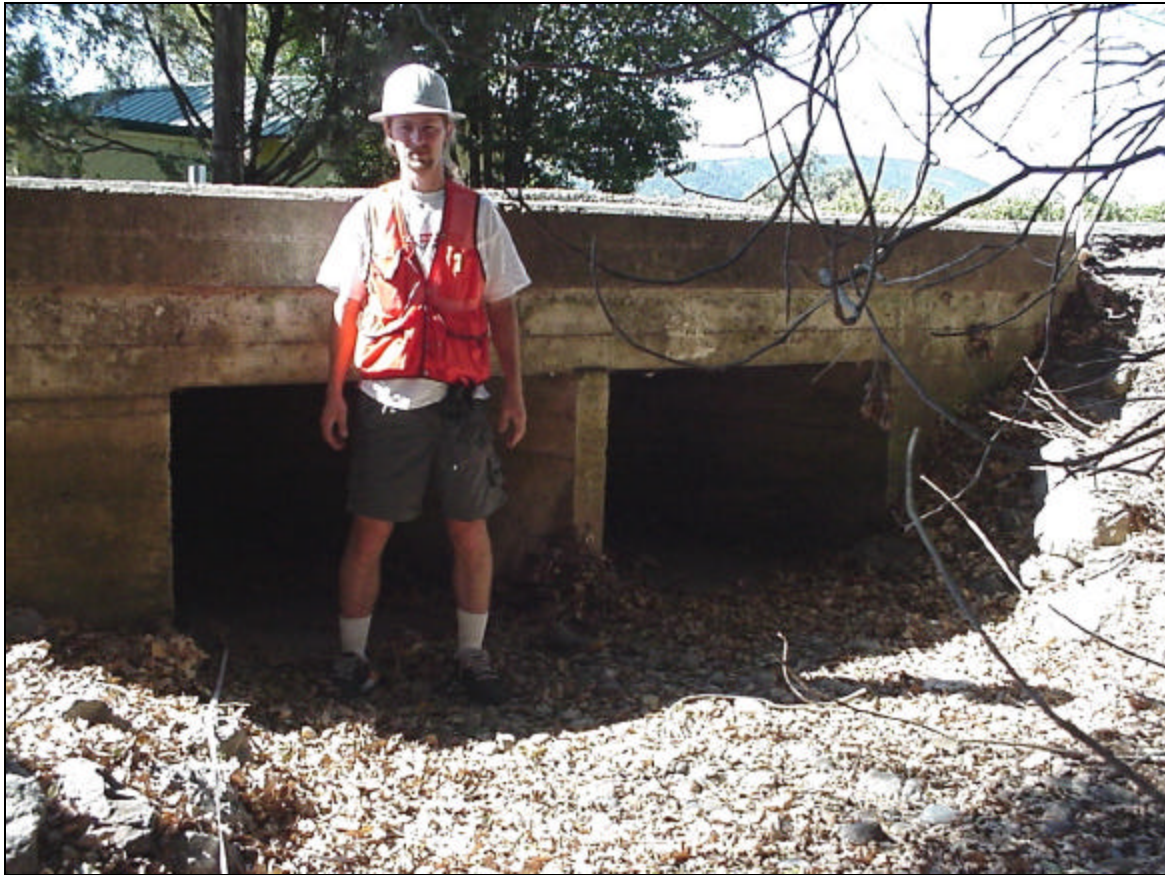
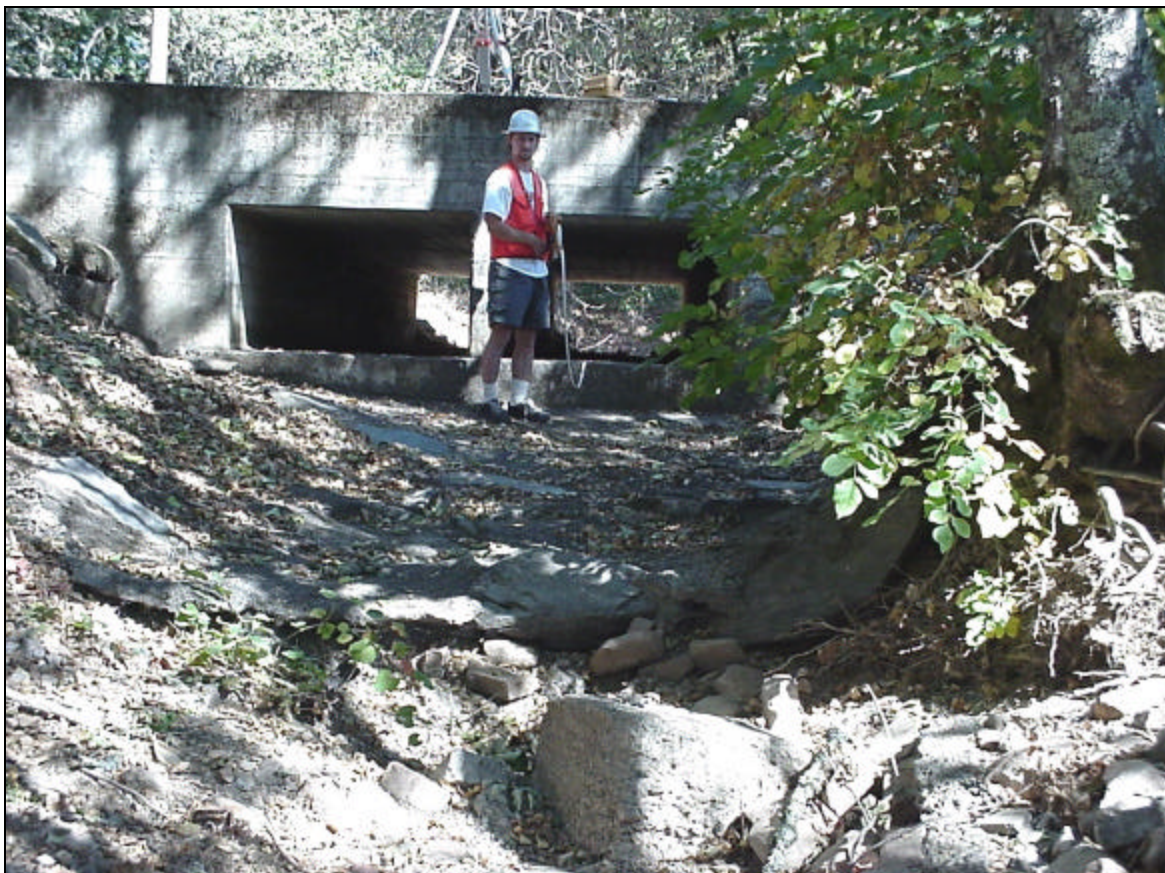
Site ID #S-095: Unnamed Tributary #2/Dry Creek Road; Dry Creek; Russian River

Culvert Type: Two Bay Box, Concrete. **Corrugations:** None. **Dimensions:** 3.0' height x 10.5' width
Length: 37.8' **Slope:** 0.48% **Modifications:** None. **Rustline Height:** N/A **Average Active Channel Width:** 9.8' **Fill Estimate:** 181 cubic yards. **Overall Condition:** Good.

Barrier Status: **GRAY:** FishXing determined this crossing meets the 8-16-16 ft/sec passage criteria for adult steelhead on 9% of the range of estimated migration flows and fails to meet passage criteria for all age classes of juvenile salmonids. For adults, the only passage criteria violation was lack-of-depth, thus actual passage may be higher than predicted by FishXing. For all age classes of juveniles, the perched outlet impedes passage.

Preferred Treatment: Because the current box culvert is sized for less than a 10-year storm flow, downstream weirs to raise the tail-water elevation are not recommended due to the potential for increased likelihood of flooding or damage. The best long-term option is replacement with a bridge, but this is not a cost-effective project based on the quality and quantity of upstream habitat. Recommend dropping site in final ranking to low-priority.

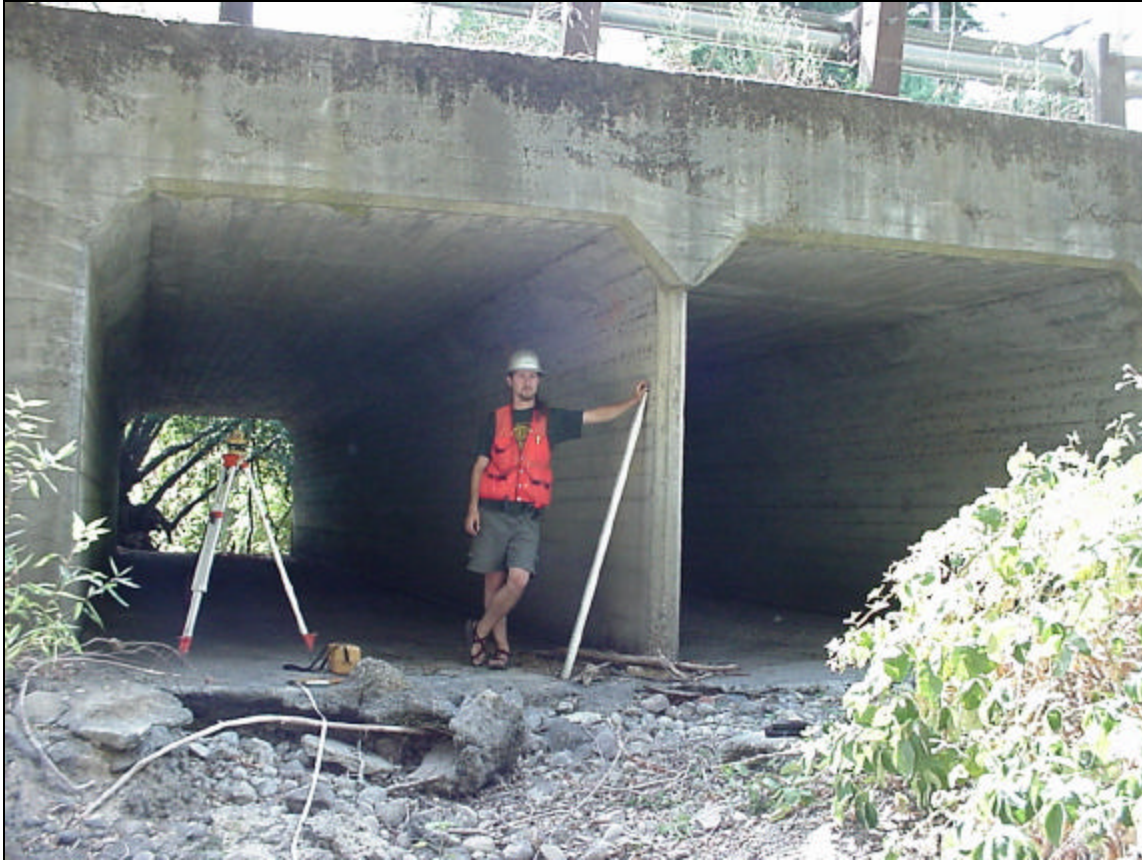
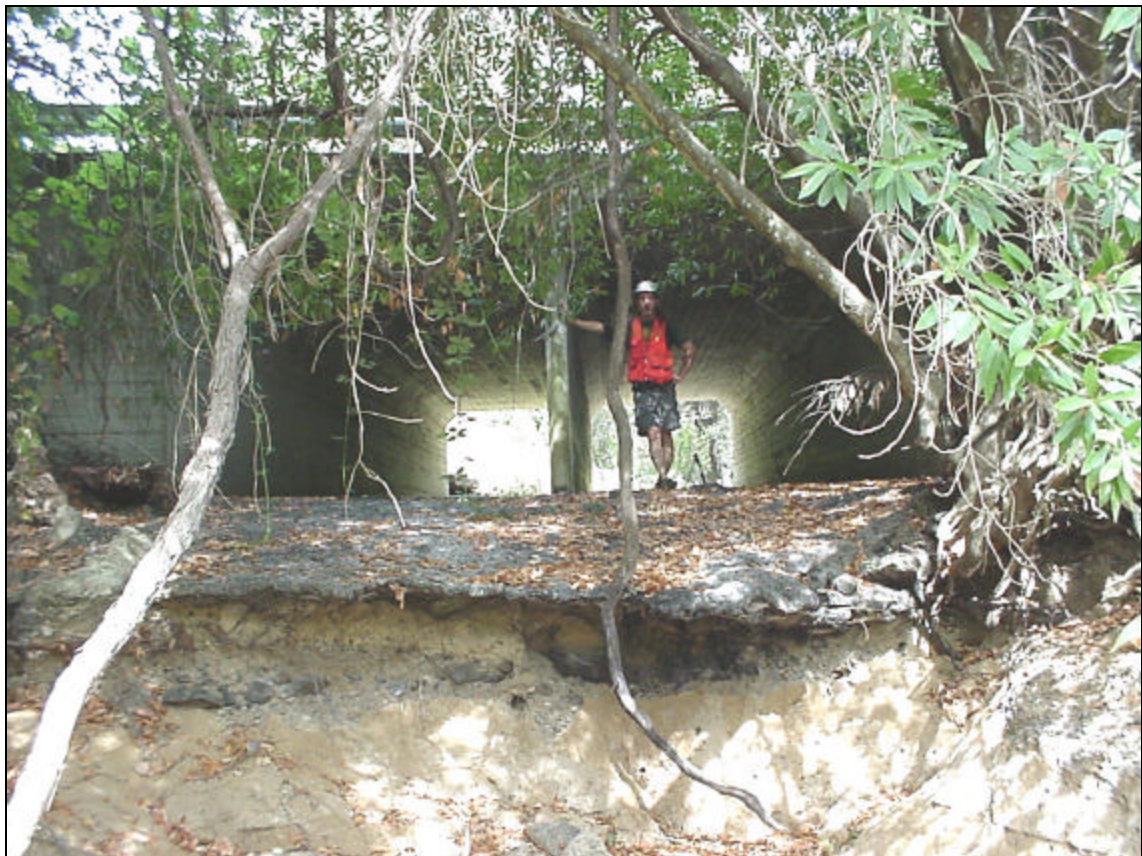
Site ID #S-097: Canyon Creek/Dry Creek Road; Dry Creek; Russian River **Road Ownership:** County

Barrier Status: **RED:** FishXing determined this crossing fails to meet the 8-16-16 ft/sec passage criteria for adult steelhead and passage criteria for all age classes of juveniles due to the extremely perched outlet.

Preferred Treatment: Because the current crossing is properly sized, five to six downstream boulders weirs would raise the tail-water elevation. Not sure if there would be access to private property to construct the weirs. Status of upstream private crossings is also unknown and access was not permitted for evaluation.

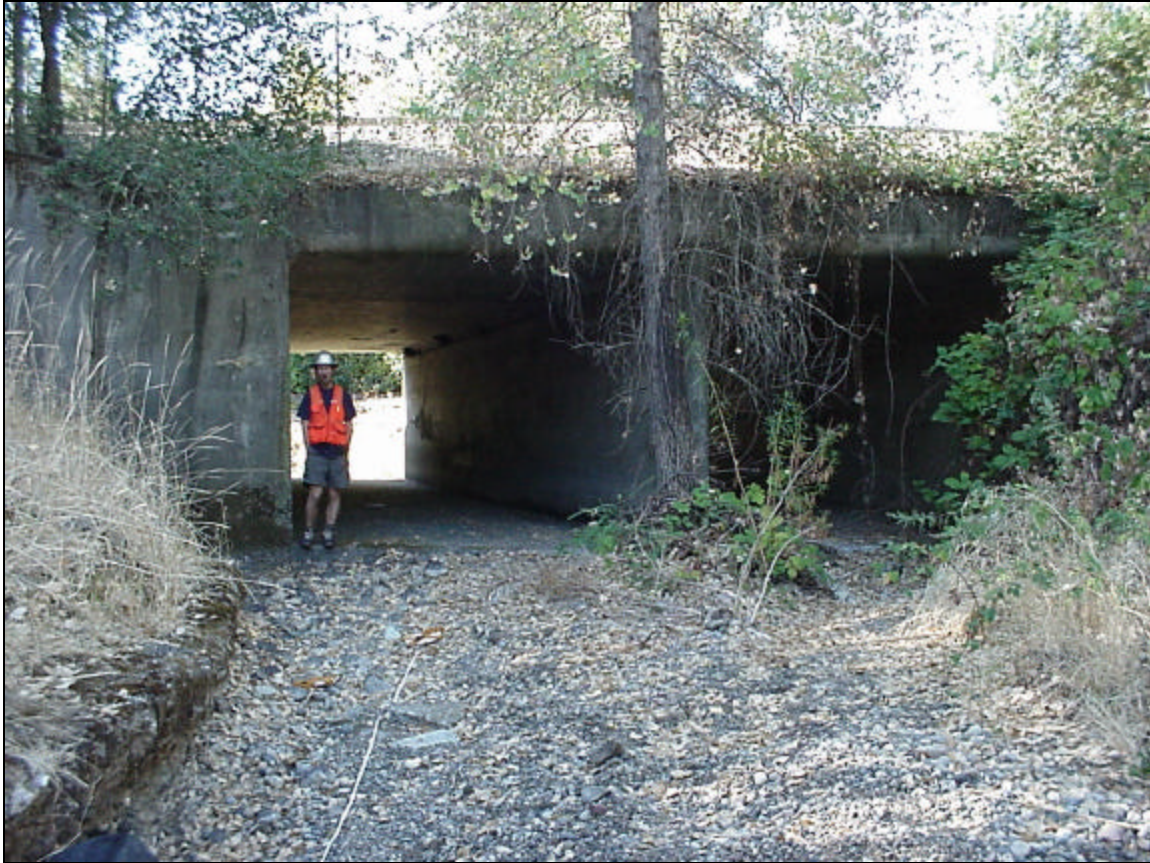
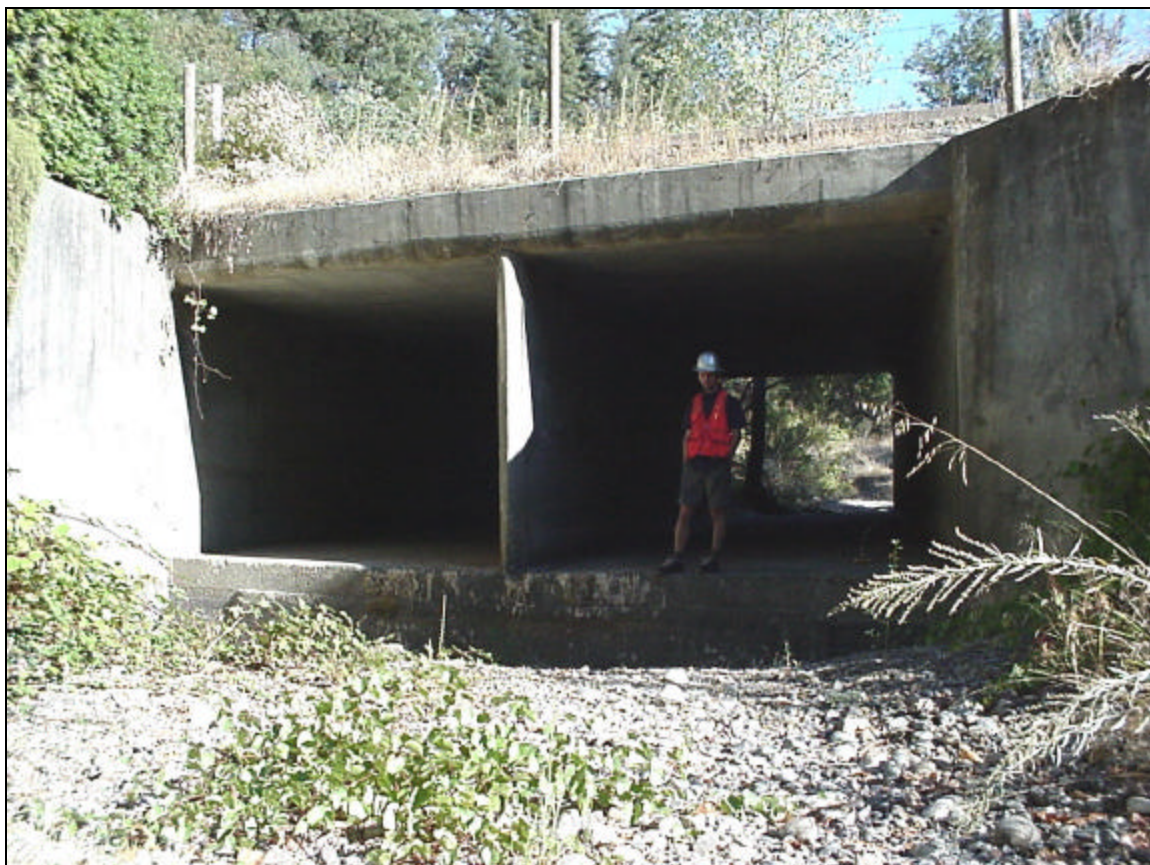
Site ID #S-098: Dutcher Creek #1/Dry Creek Road; Dry Creek; Russian River **Road Ownership:** County
County Ranking: Tied for #28 = Moderate -Priority **Basin-wide Ranking:** less than 20.0 points – not ranked

Barrier Status: **GRAY:** FishXing determined this crossing meets the 8-16-16 ft/sec passage criteria for adult steelhead on 61% of the range of estimated migration flows and fails to meet passage criteria for all age classes of juvenile salmonids. For adults, there is a lack-of-depth at lower flows and excessive velocities at upper migration flows. For juveniles, the perched outlet and excessive velocities impede passage.

Preferred Treatment: Because the current crossing is properly sized, two to three downstream boulders weirs would raise the tail-water elevation. Corner baffles within the culvert would increase depths and decrease velocities. Consider a beam across one of the inlets to concentrate lower migration flows into a single bay.

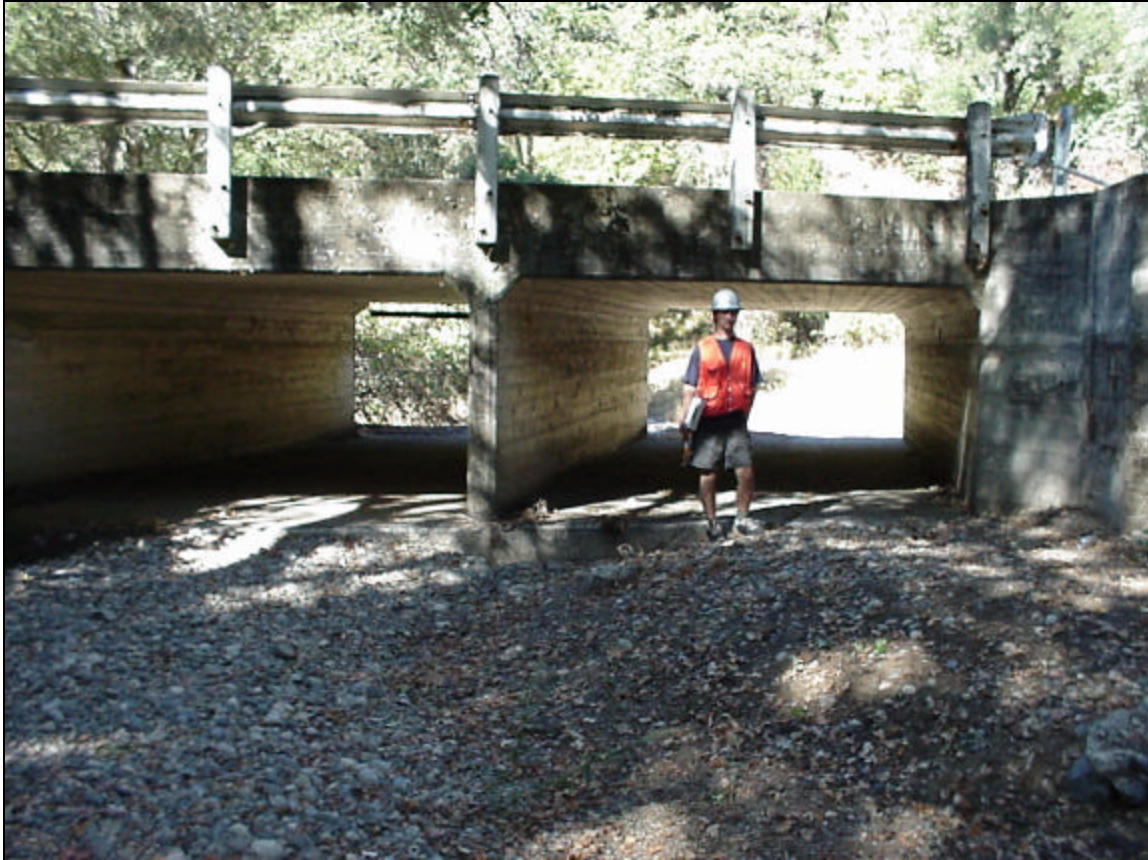
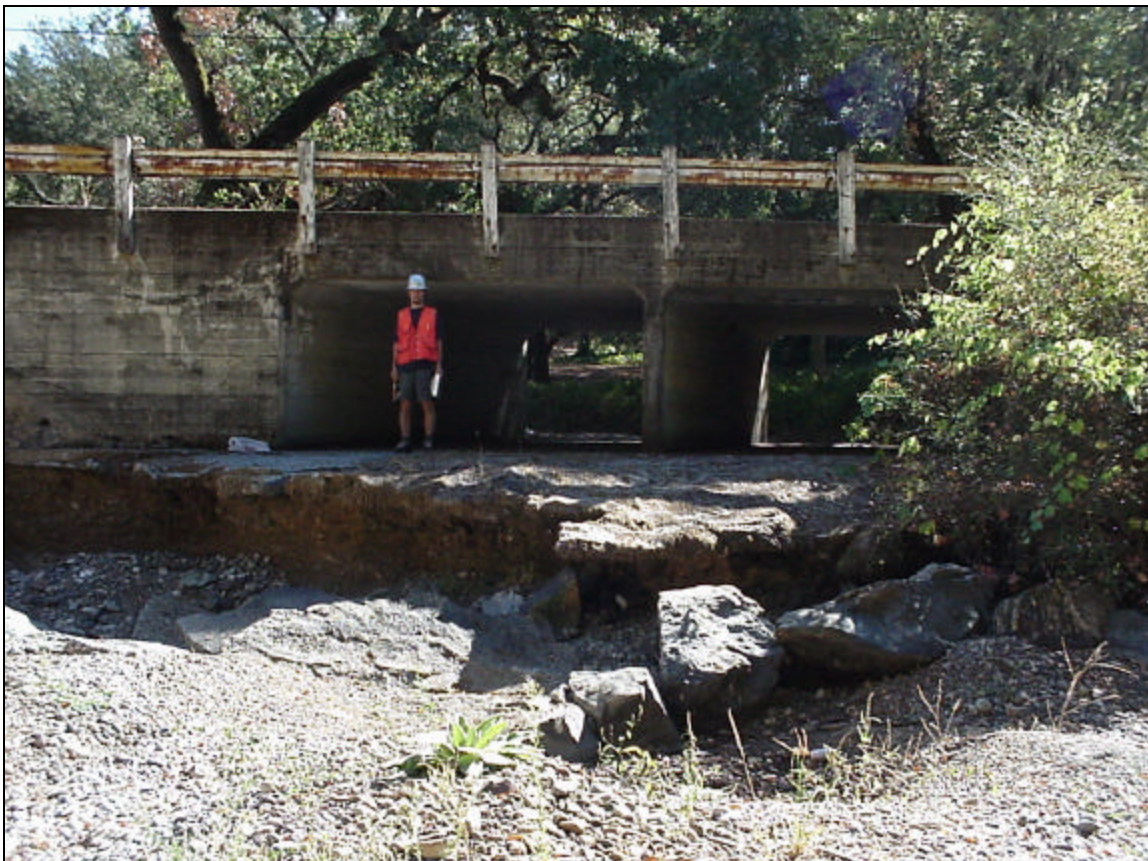
Site ID #S-099: Dutcher Creek #2/Dutcher Creek Road; Dry Creek; Russian River **Road Ownership:** County
County Ranking: #10 = High-Priority **Basin-wide Ranking: #13 = High-Priority**

Barrier Status: RED: FishXing determined this crossing fails to meet the 8-16-16 ft/sec passage criteria for adult steelhead and passage criteria for all age classes of juveniles due to the perched outlet (3.5 feet). If some adults are able to enter the culvert there is a lack-of-depth throughout the culvert.

Preferred Treatment: Because the current crossing is properly sized, four to five downstream boulders weirs would raise the tail-water elevation. Corner baffles within the culvert would increase depths and decrease velocities. Consider a beam across one of the inlets to concentrate lower migration flows into a single bay. County will need access to private property for placement of boulder weirs. If not feasible, consider the construction of a series of concrete weirs attached to the outlet designed to function as a fish ladder or consider a replacement with a bridge.

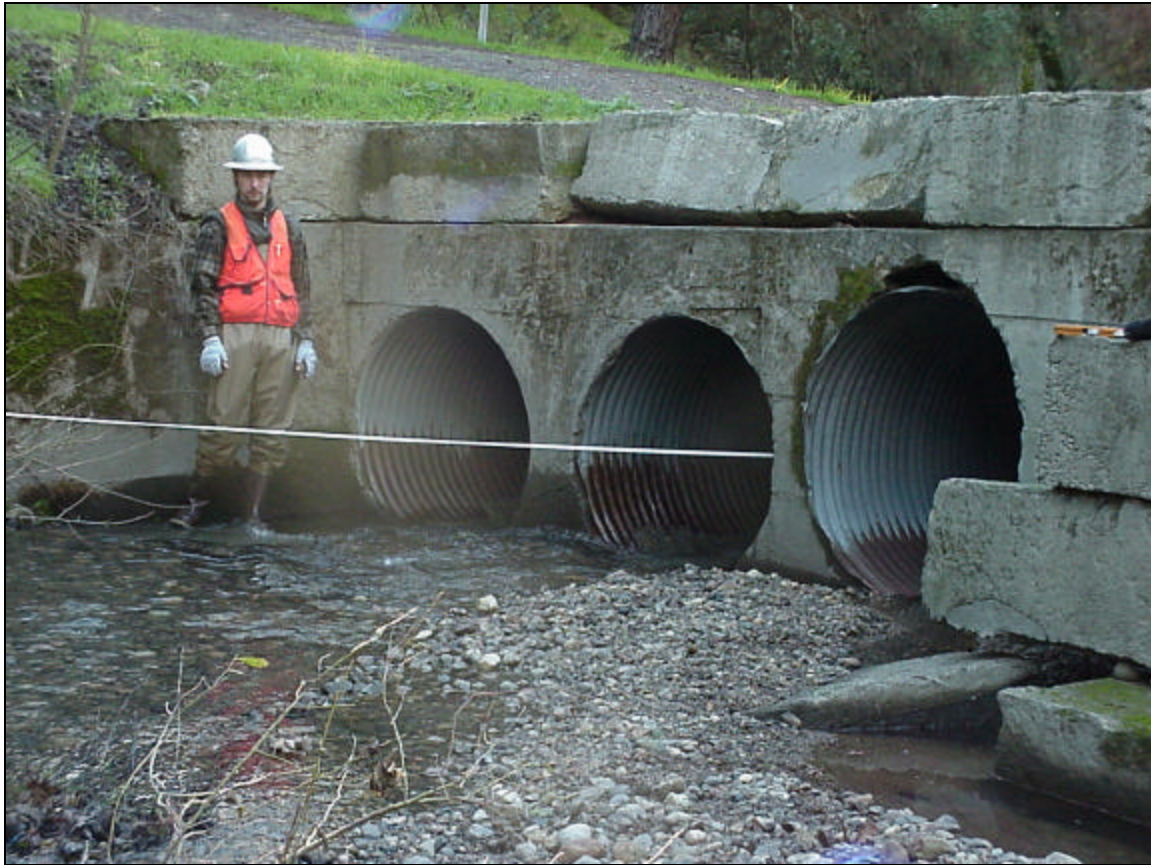
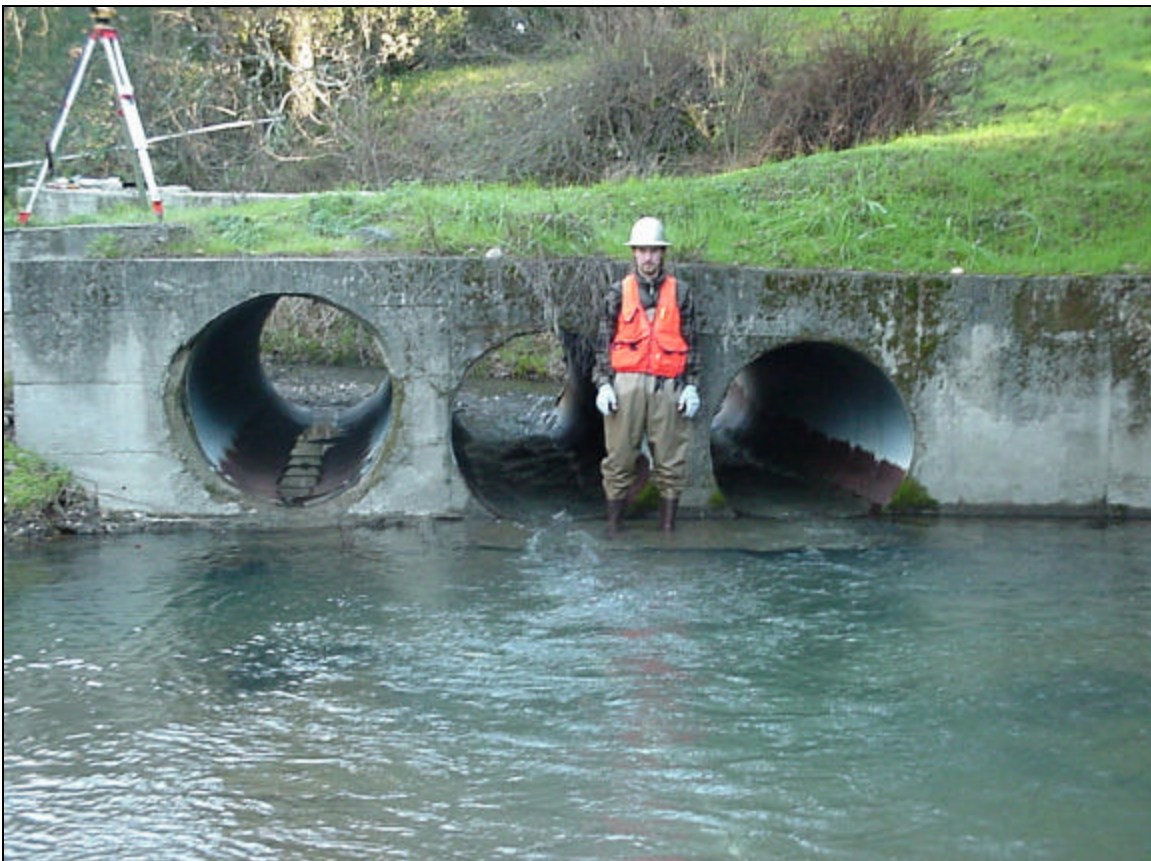
Site ID #S-100: Dutcher Creek #3/Private Driveway; Dry Creek; Russian River

Barrier Status: **GRAY:** FishXing determined the culverts at this crossing meet the 8-16-16 ft/sec passage criteria for adult steelhead on (LB=91%; MB=91%; RB=84%) of the range of estimated migration flows and fail to meet passage criteria for all age classes of juvenile salmonids. For all age classes of juveniles, excessive velocities impede passage.

Preferred Treatment: Because the current crossing is extremely undersized, the placement of downstream boulders weirs to raise the tail-water elevation is not recommended. Recommend replacement with a flatcar bridge. Also recommend treatment of downstream sites prior to treatment of Site ID #S-100.

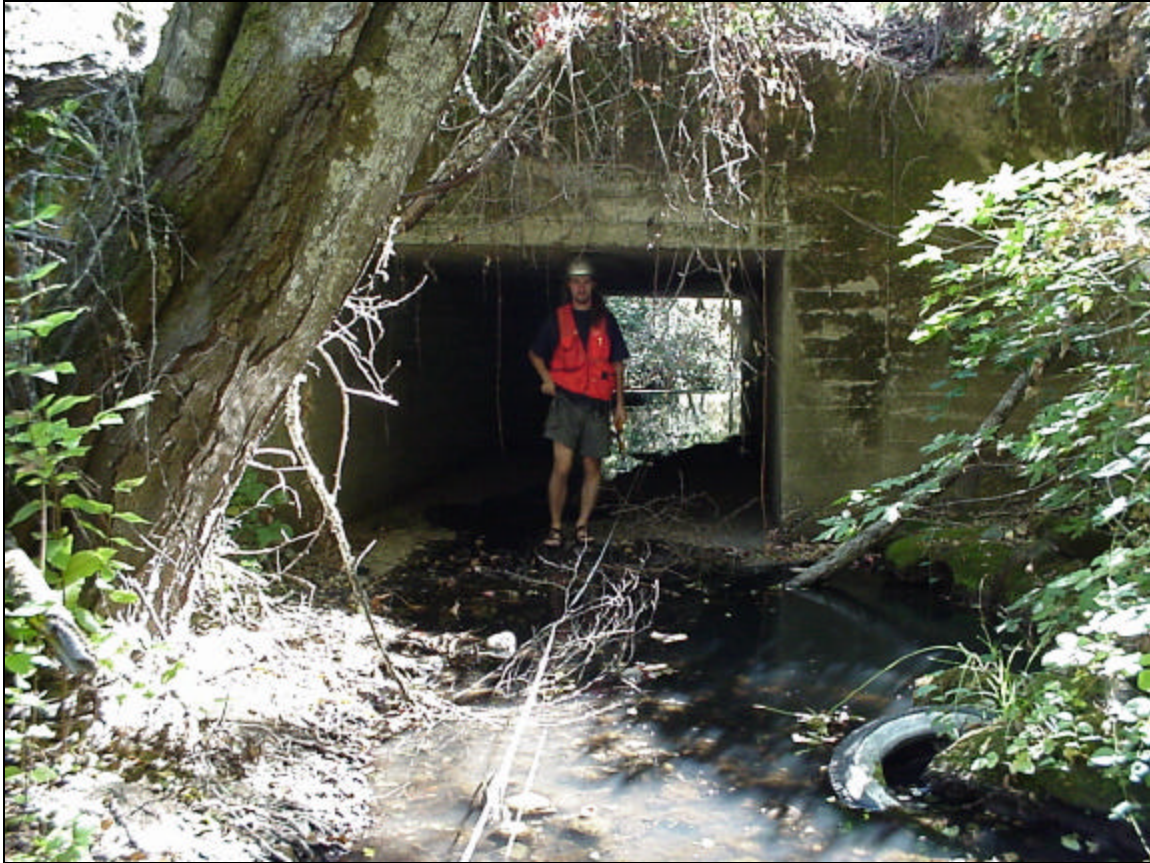
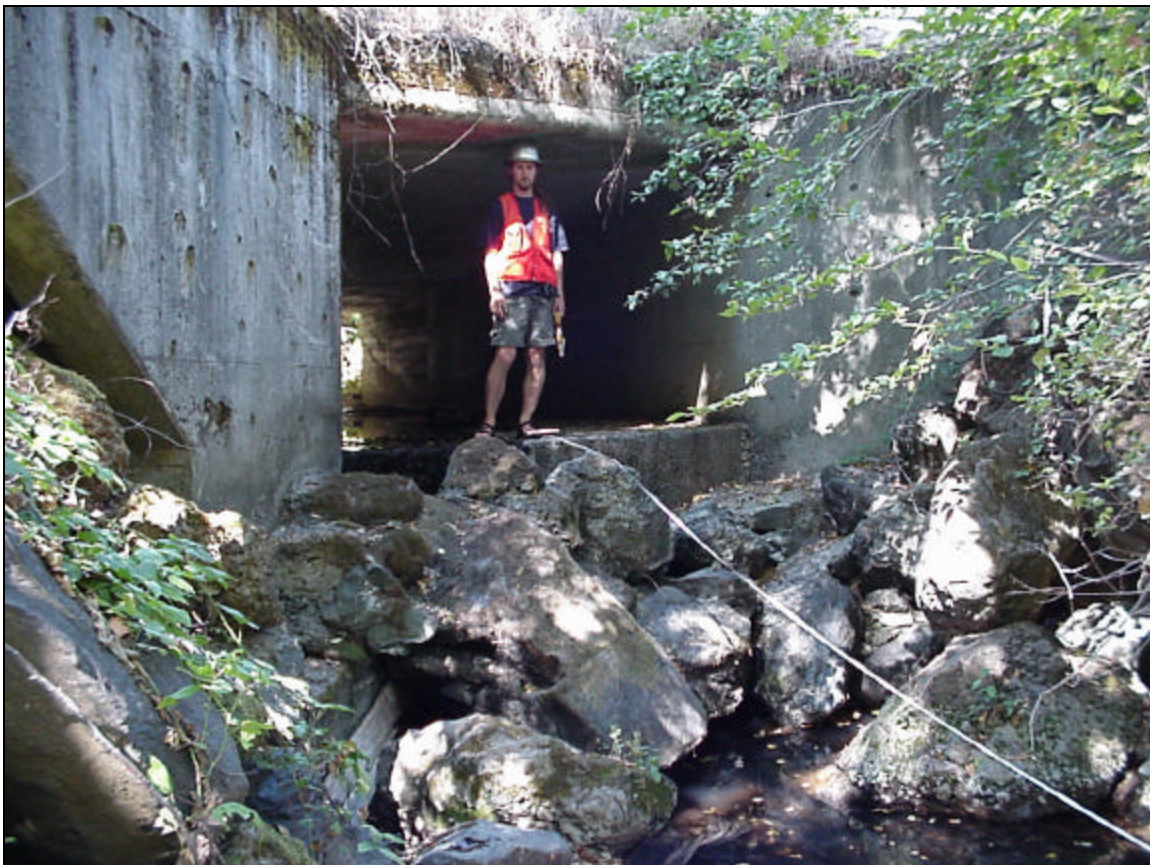
Site ID #S-101: Dutcher Creek #4/Dutcher Creek Road; Dry Creek; Russian River

Barrier Status: **RED:** the Green-Gray-Red filter determined this crossing fails to meet passage criteria for all species of adult salmonids and all age classes of juveniles due to the extremely perched outlet (> 5 feet).

Preferred Treatment: Because the current crossing is undersized, the placement of downstream boulders weirs to raise the tail-water elevation and corner baffles to increase depths and decrease velocities should be cautiously considered. Best long-term solution to restore passage and increase storm flow capacity is a replacement with a properly sized bridge. Also recommend treatment of downstream sites prior to treatment of Site ID #S-101.

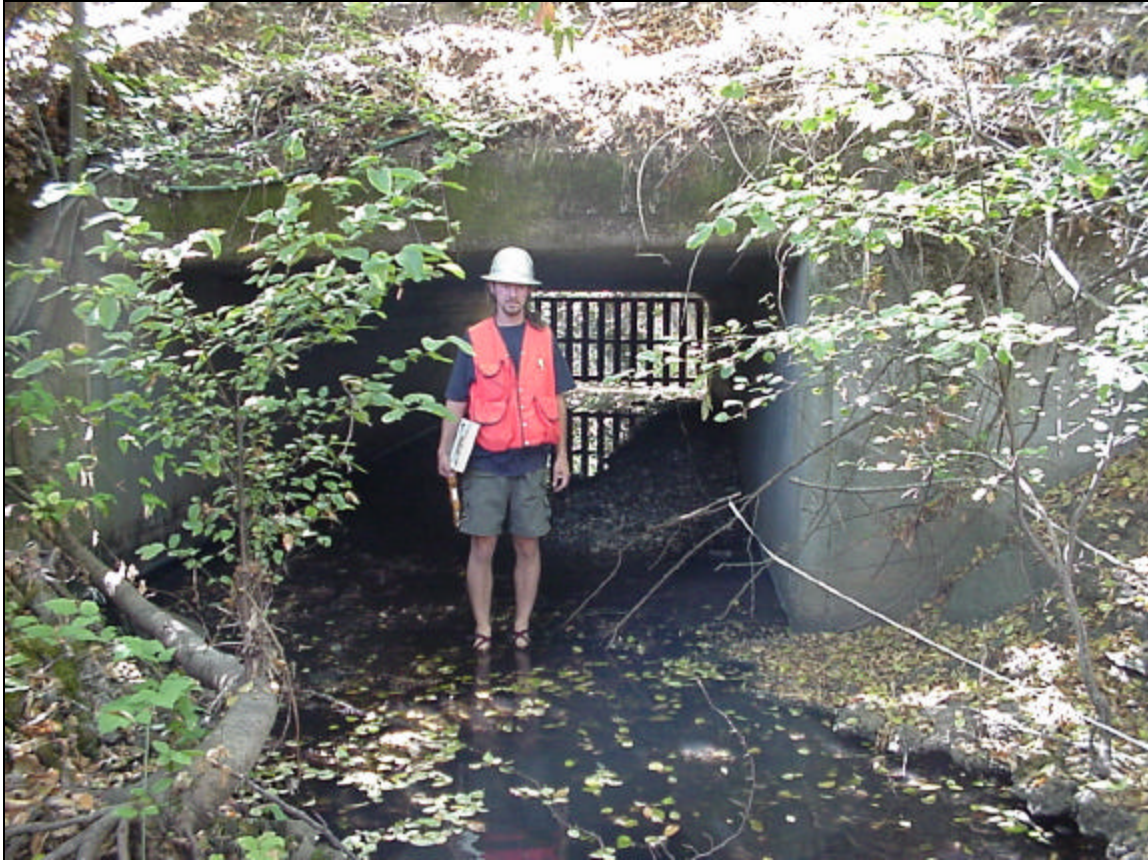
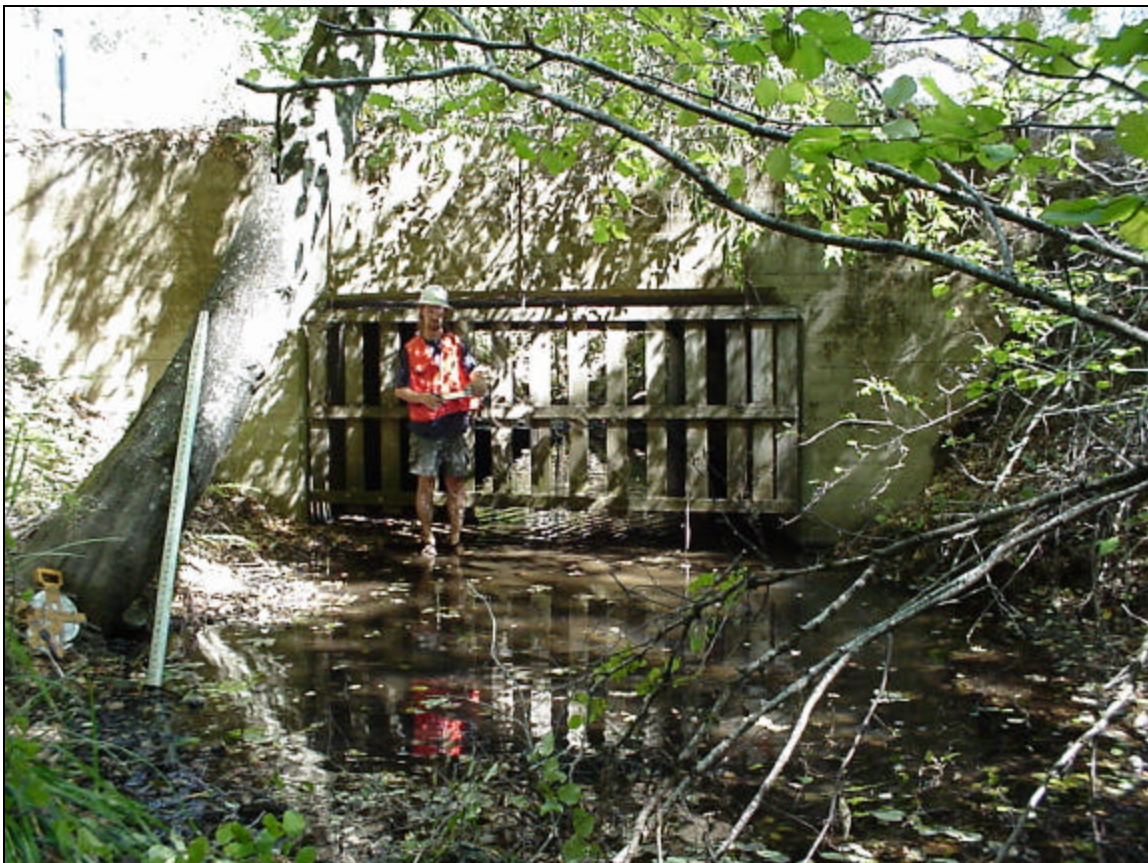
Site ID #S-102: Dutcher Creek #5/Dutcher Creek Road; Dry Creek; Russian River

Barrier Status: **GRAY:** FishXing determined this crossing meets the 8-16-16 ft/sec passage criteria for adult steelhead on 78% of the range of estimated migration flows, meets passage criteria for resident trout/2+ juveniles on 57% of the range of estimated migration flows, and fails to meet passage criteria for 1+/young-of-year juveniles.

Preferred Treatment: None recommended until the downstream sites and the dam immediately upstream of this crossing are treated. Actual passage of both adult steelhead and older juveniles is probably higher than predicted by FishXing software because lack-of-depth was the primary violation of the passage criteria. Cattle guard across inlet could be a problem during high flows by catching storm debris – periodically inspect and clean.

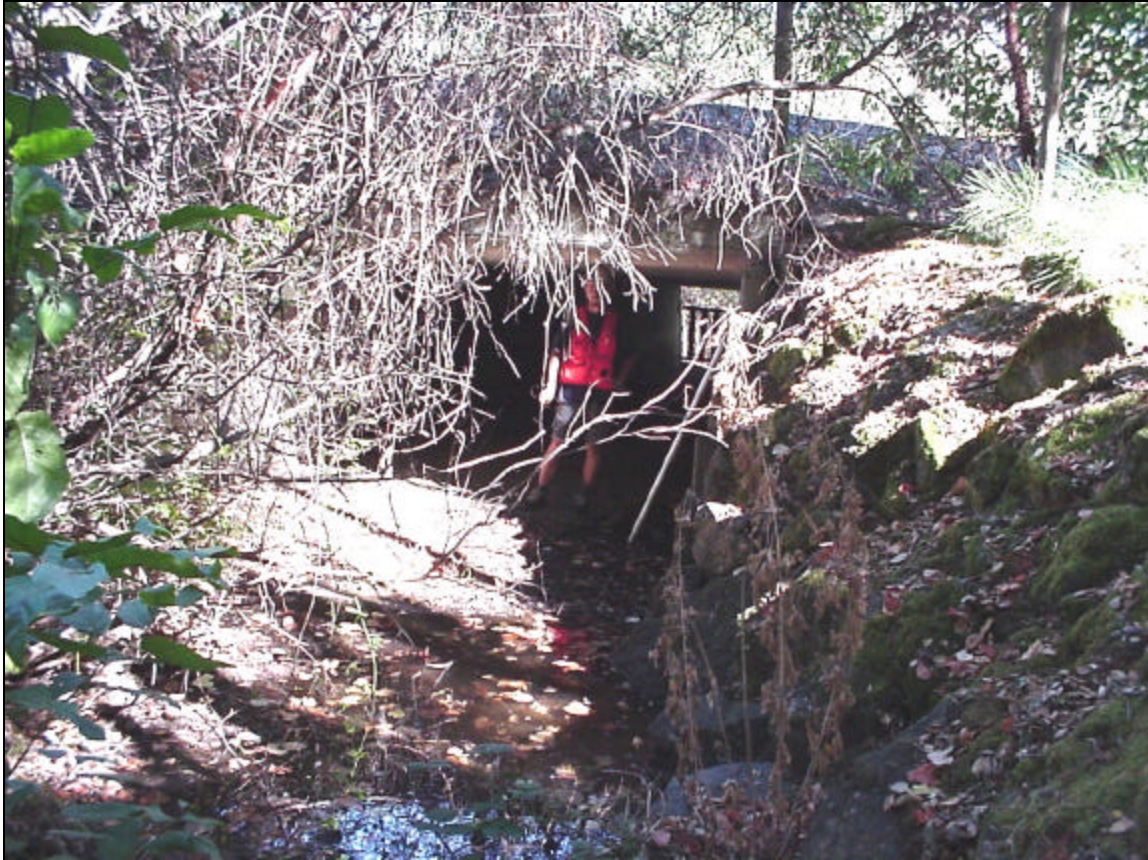
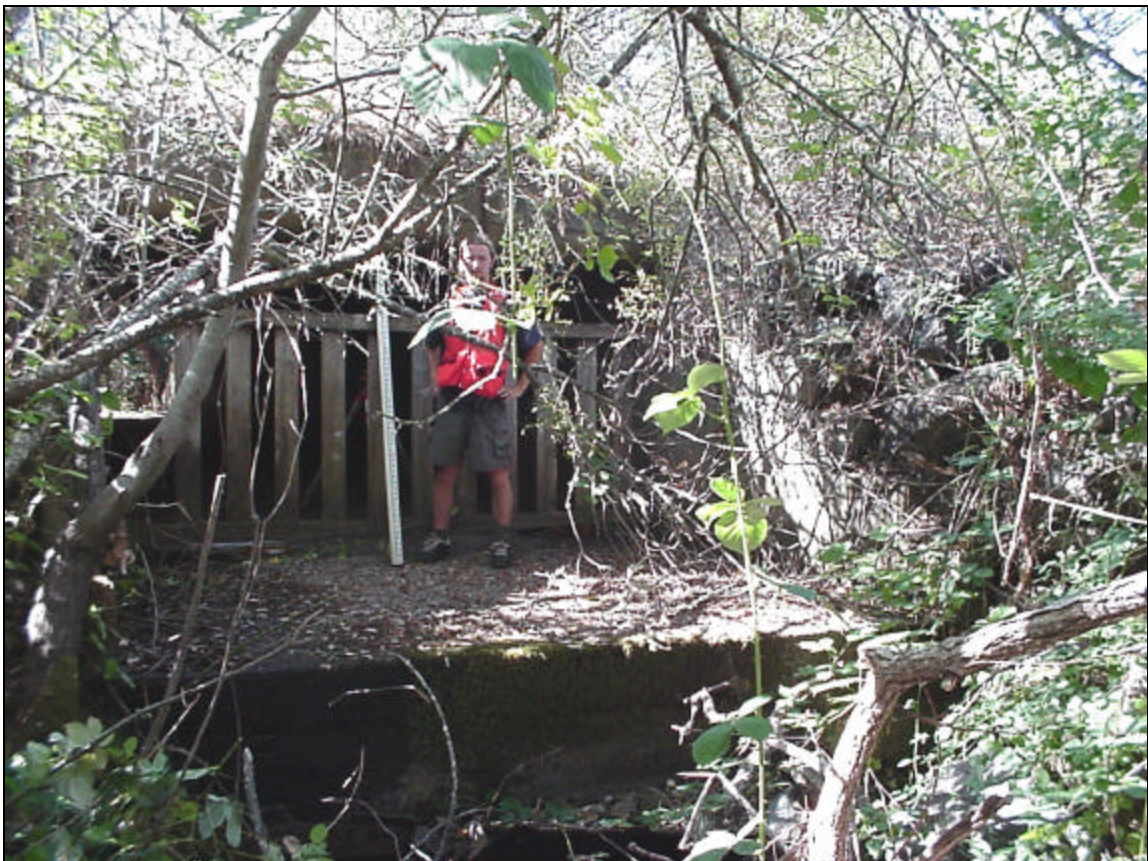
Site ID #S-103: Dutcher Creek #6/Dutcher Creek Road; Dry Creek; Russian River **Road Ownership:** County

Barrier Status: **GRAY:** FishXing determined this crossing meets the 8-16-16 ft/sec passage criteria for adult steelhead on 12% of the range of estimated migration flows and fails to meet passage criteria for all age classes of juvenile salmonids. Perched outlet (2.5 feet) impedes juvenile migration.

Preferred Treatment: Because the current crossing is properly sized, three to four downstream boulders weirs would raise the tail-water elevation. Corner baffles within the culvert would increase depths and decrease velocities. Recommend treating downstream migration barriers prior to addressing this crossing. Cattle guard across inlet could be a problem during high flows by catching storm debris – periodically inspect and clean.
